Inspection Photos  
Operator: Rim Operating  
API: 067-09814  
Date: 6/13/2022

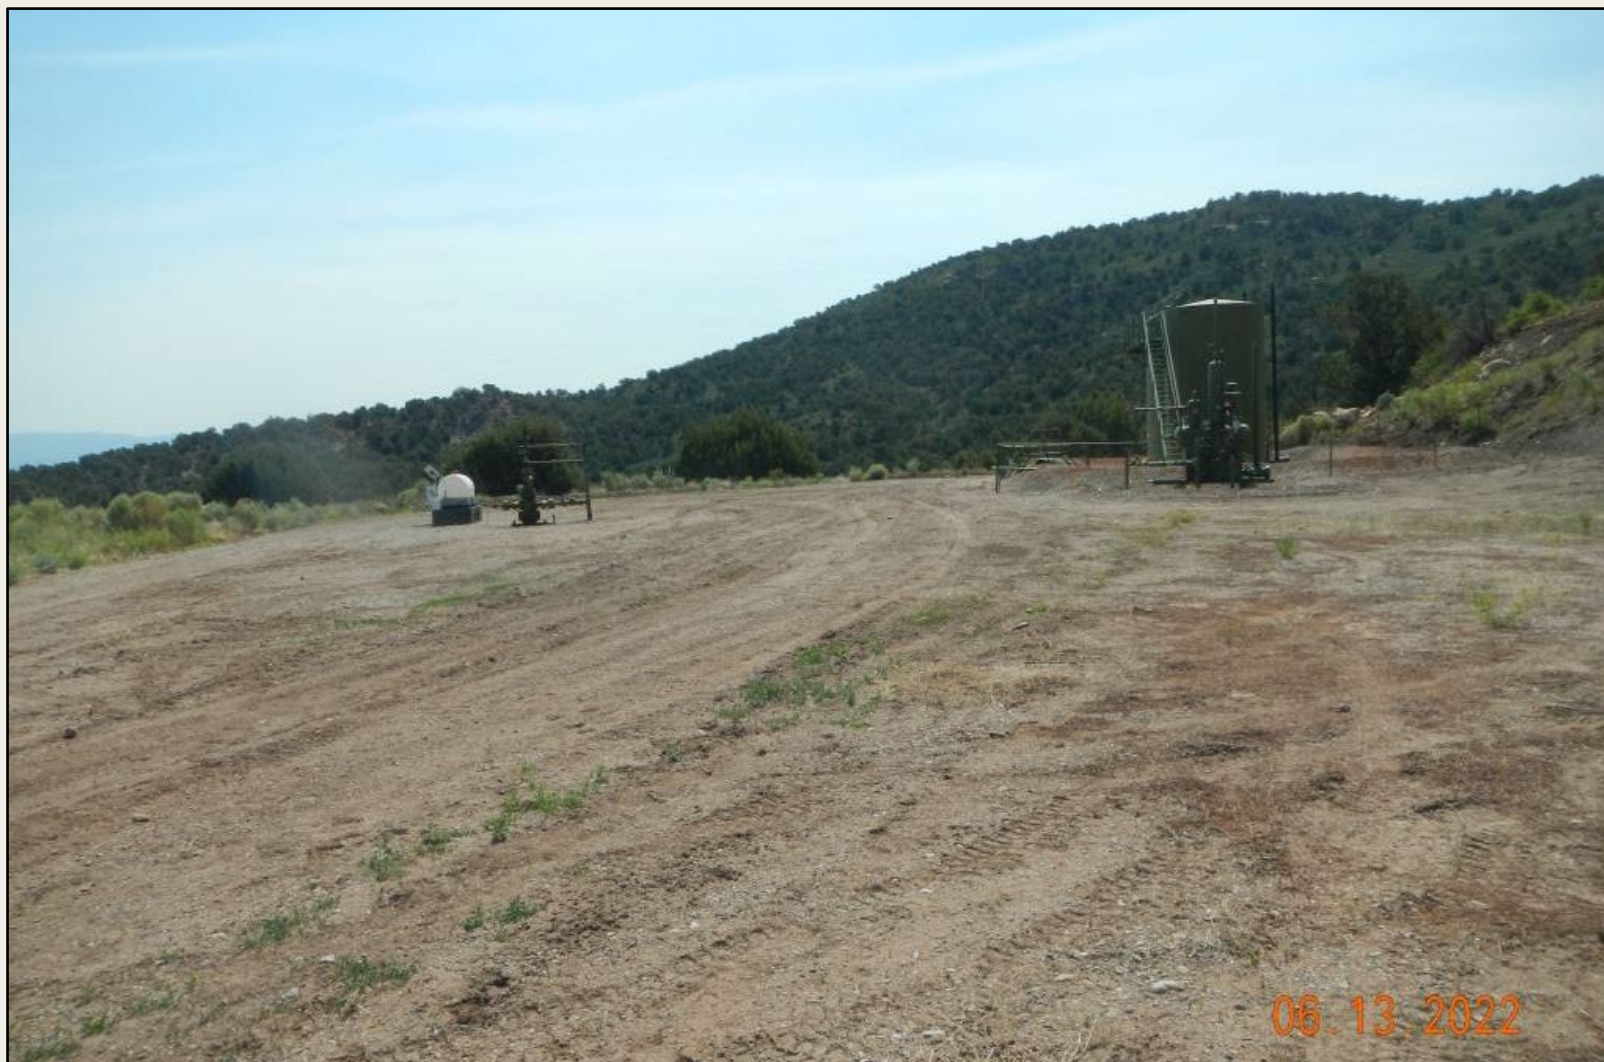
Photo 1. View of the project area from the well pad entrance facing center.

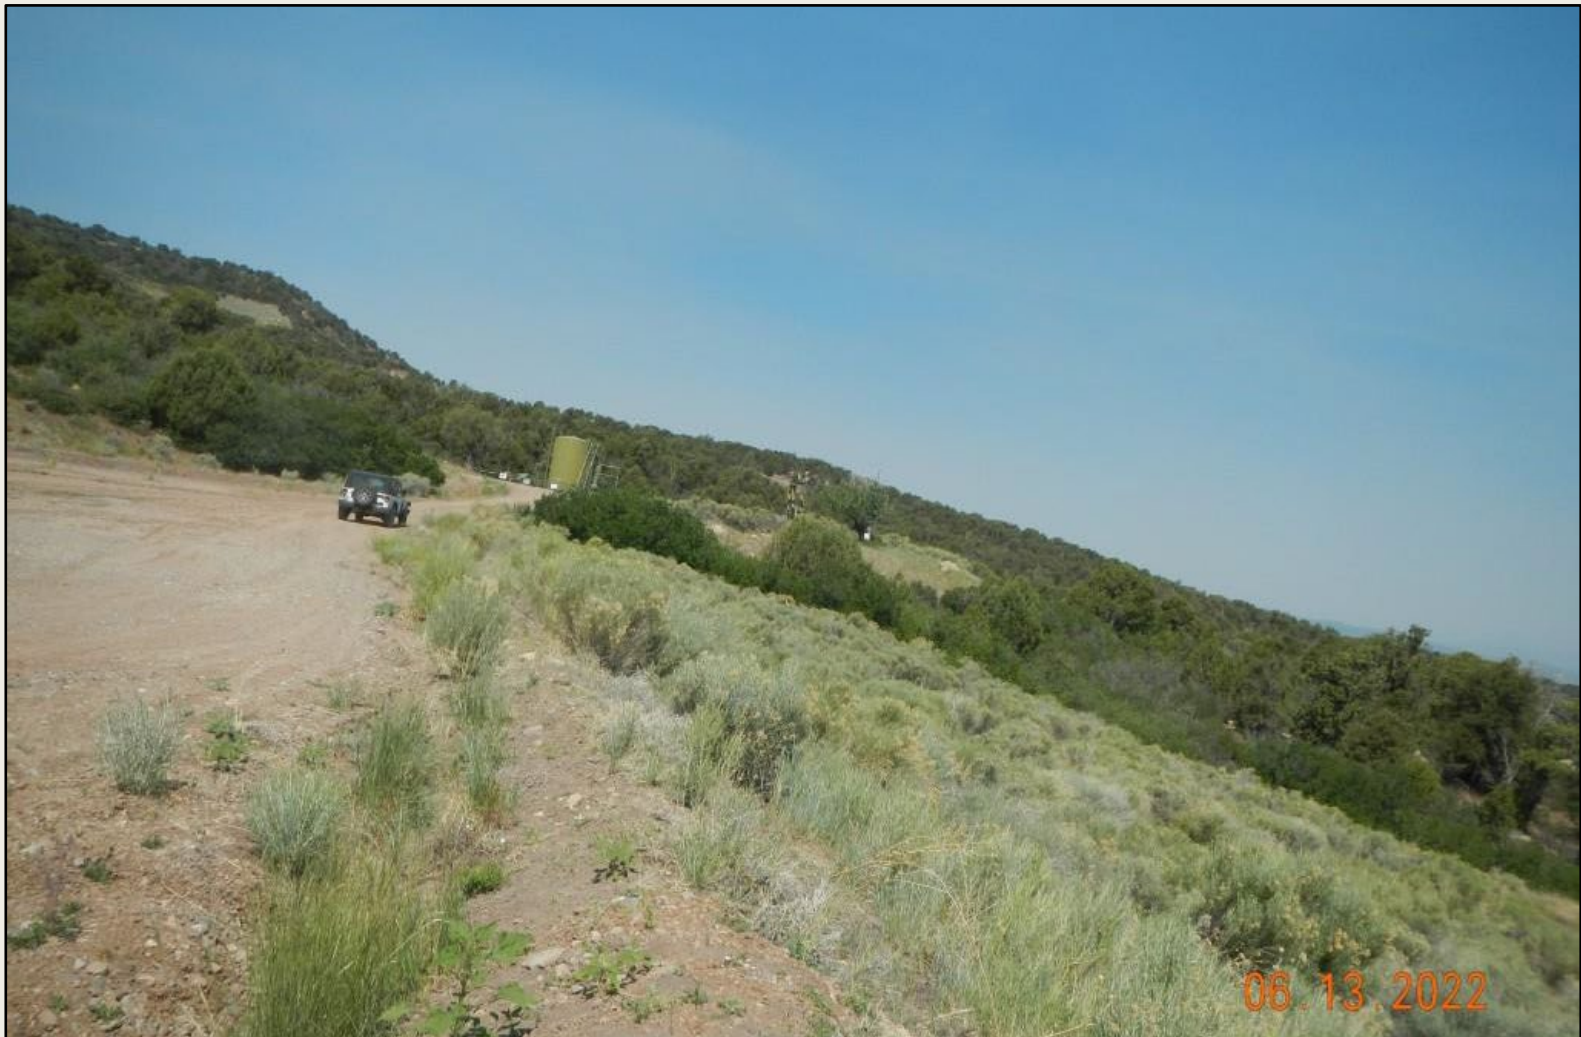
Photo 2. View of the northern project area from the northeastern corner facing westward. Revegetation is progressing with western wheatgrass, rubber rabbitbrush, smooth brome and crested wheatgrass.

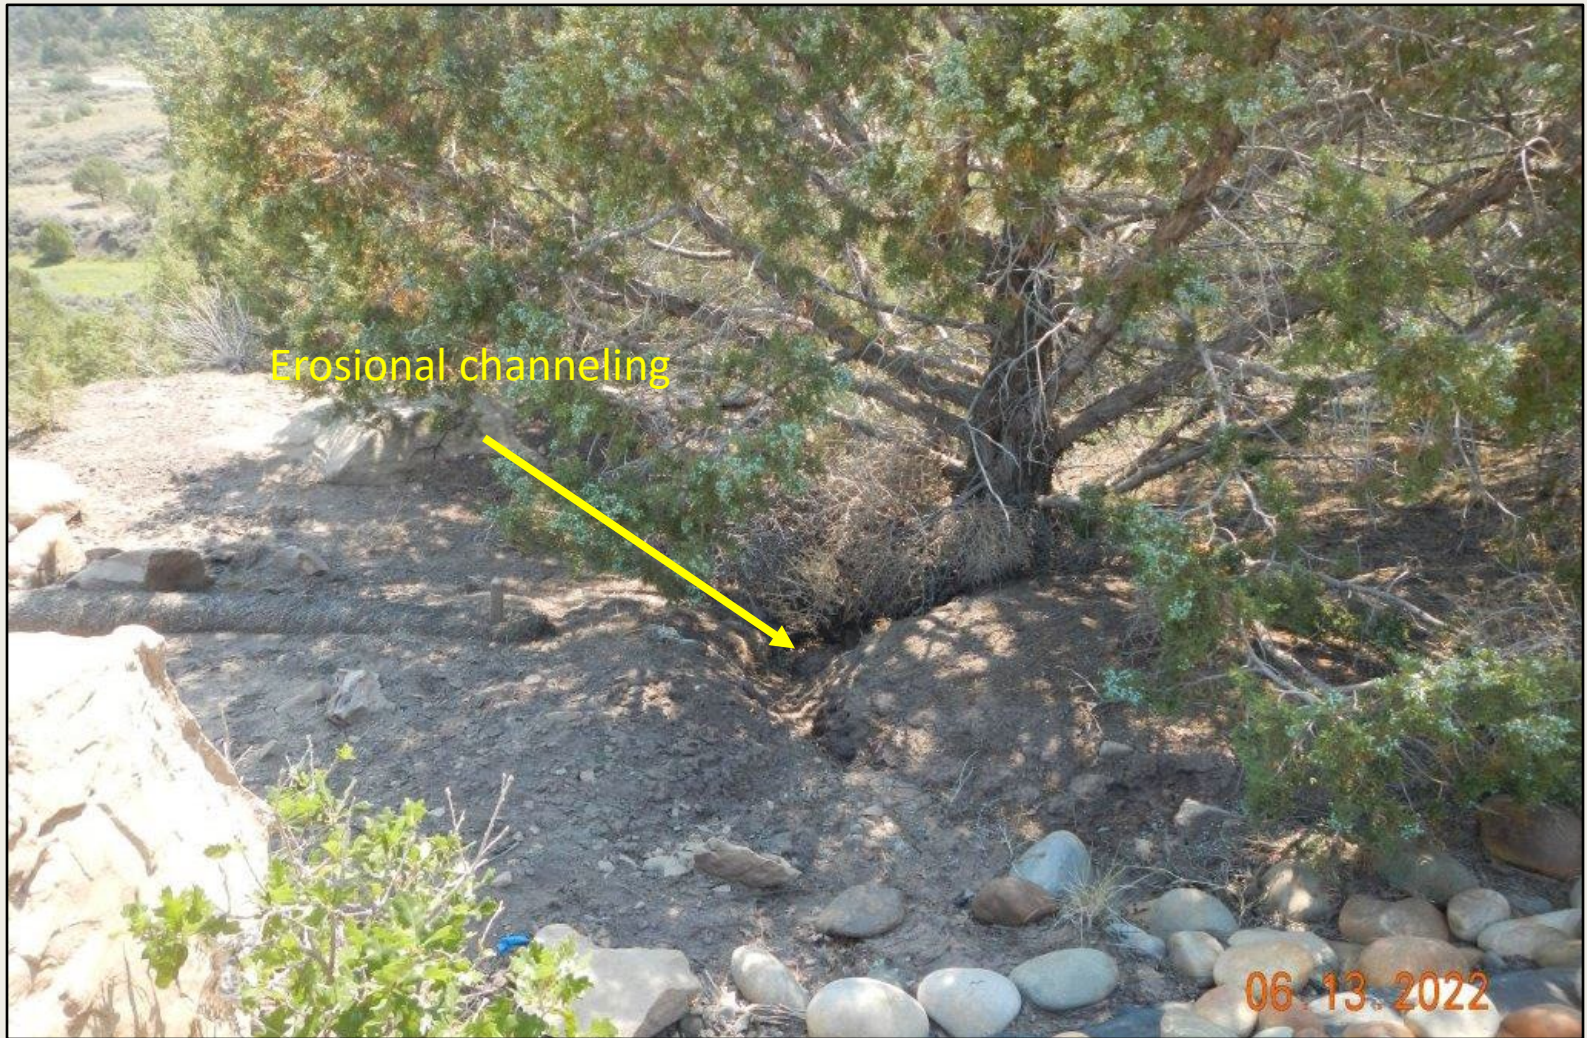
Photo 3. View of area downslope of cobble BMP in the southeastern project area, where erosional channeling continues (approx 12-15 inches wide and deep) and additional stabilization is needed. Wattle is no longer functioning.

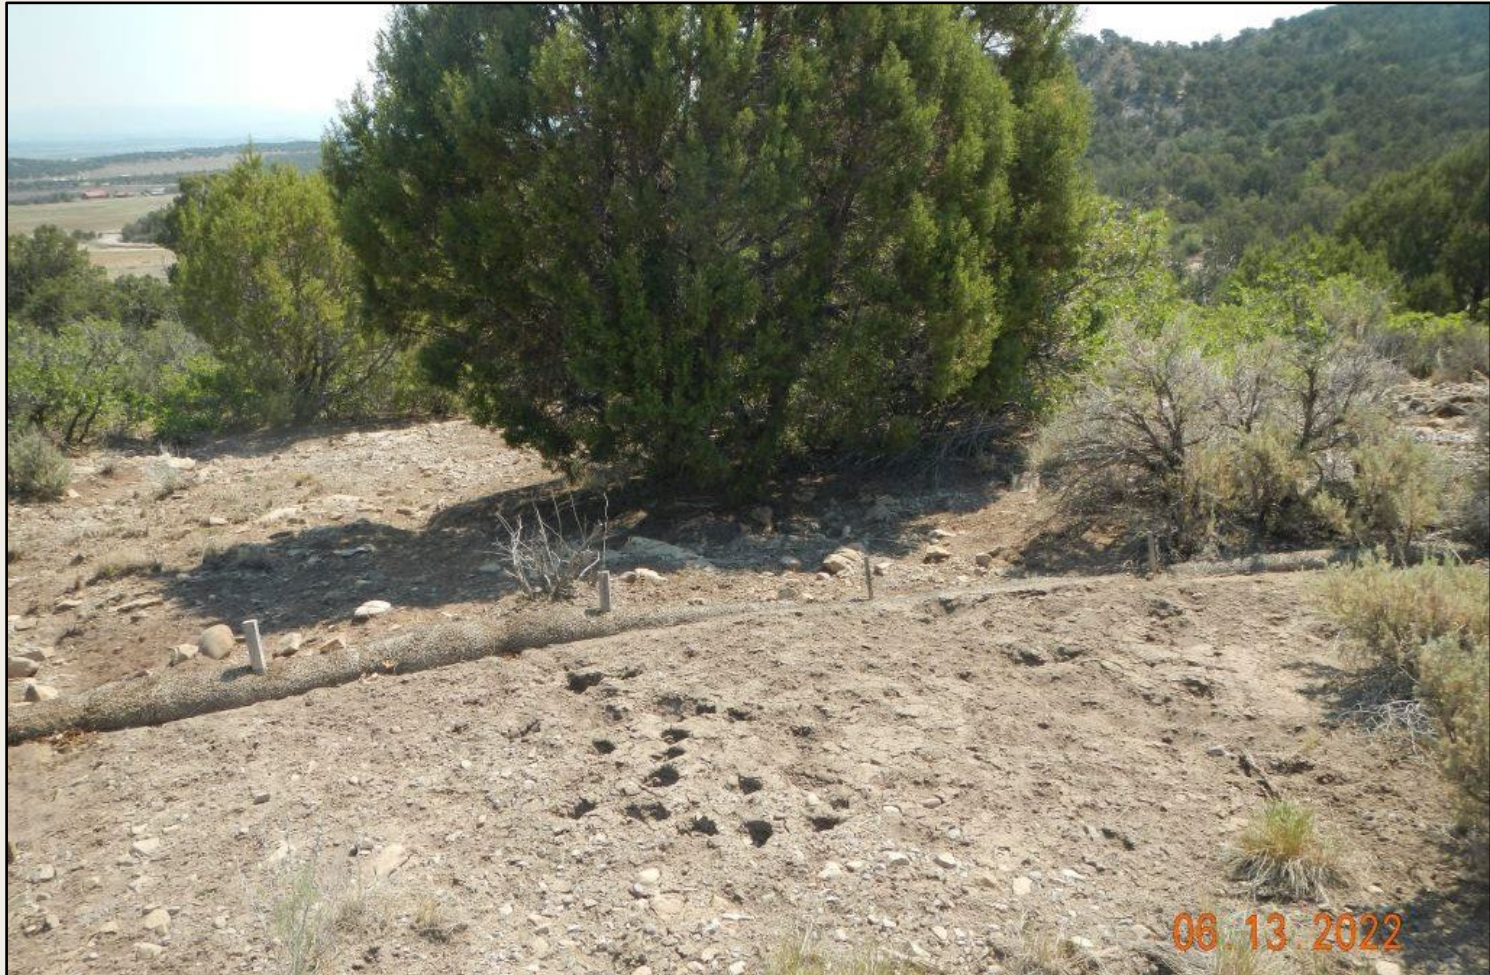
Photo 4. View of area within the northeastern project area where wattles are full of sediment and need replacement and continued maintenance.

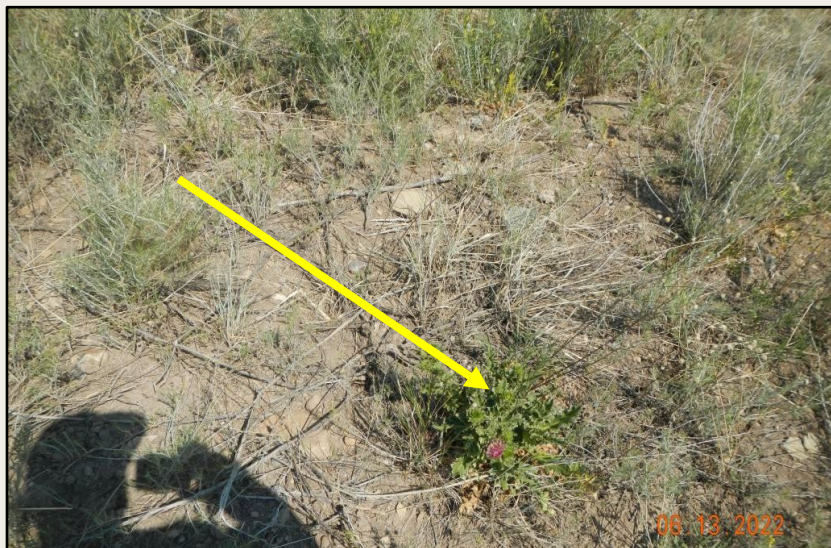
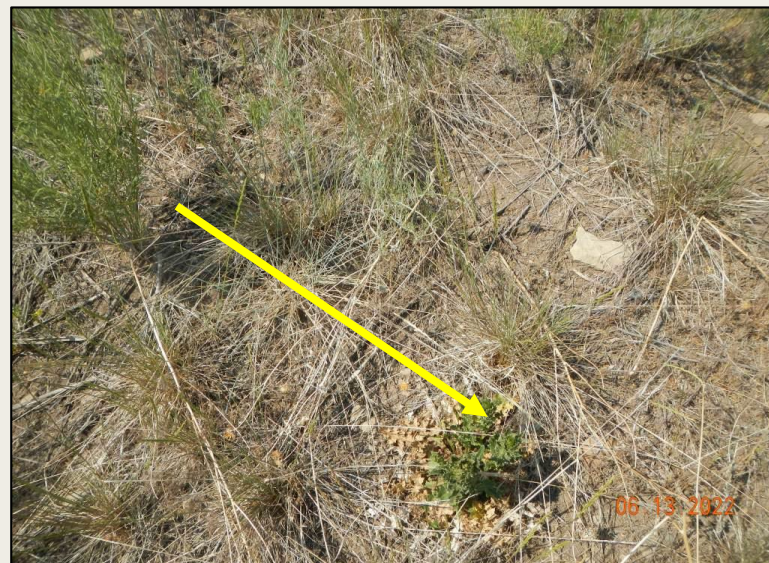
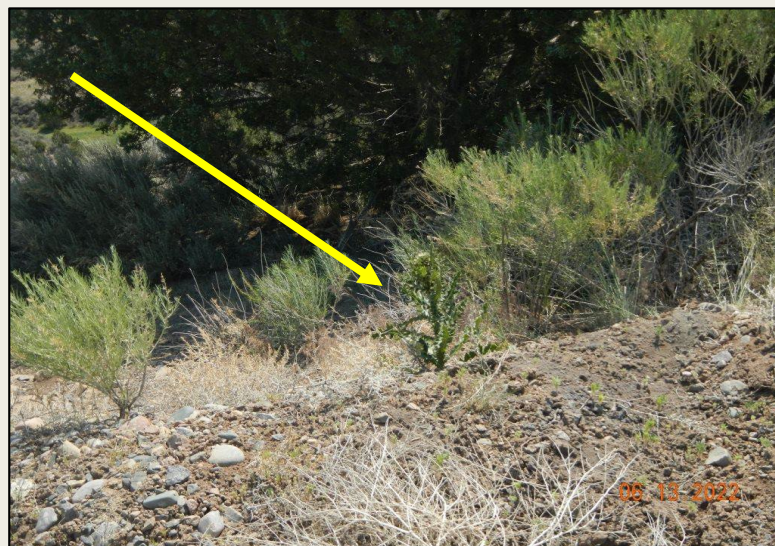
Photos 5-7. View of musk thistles within the project area. Approximately 250-350 individuals observed.

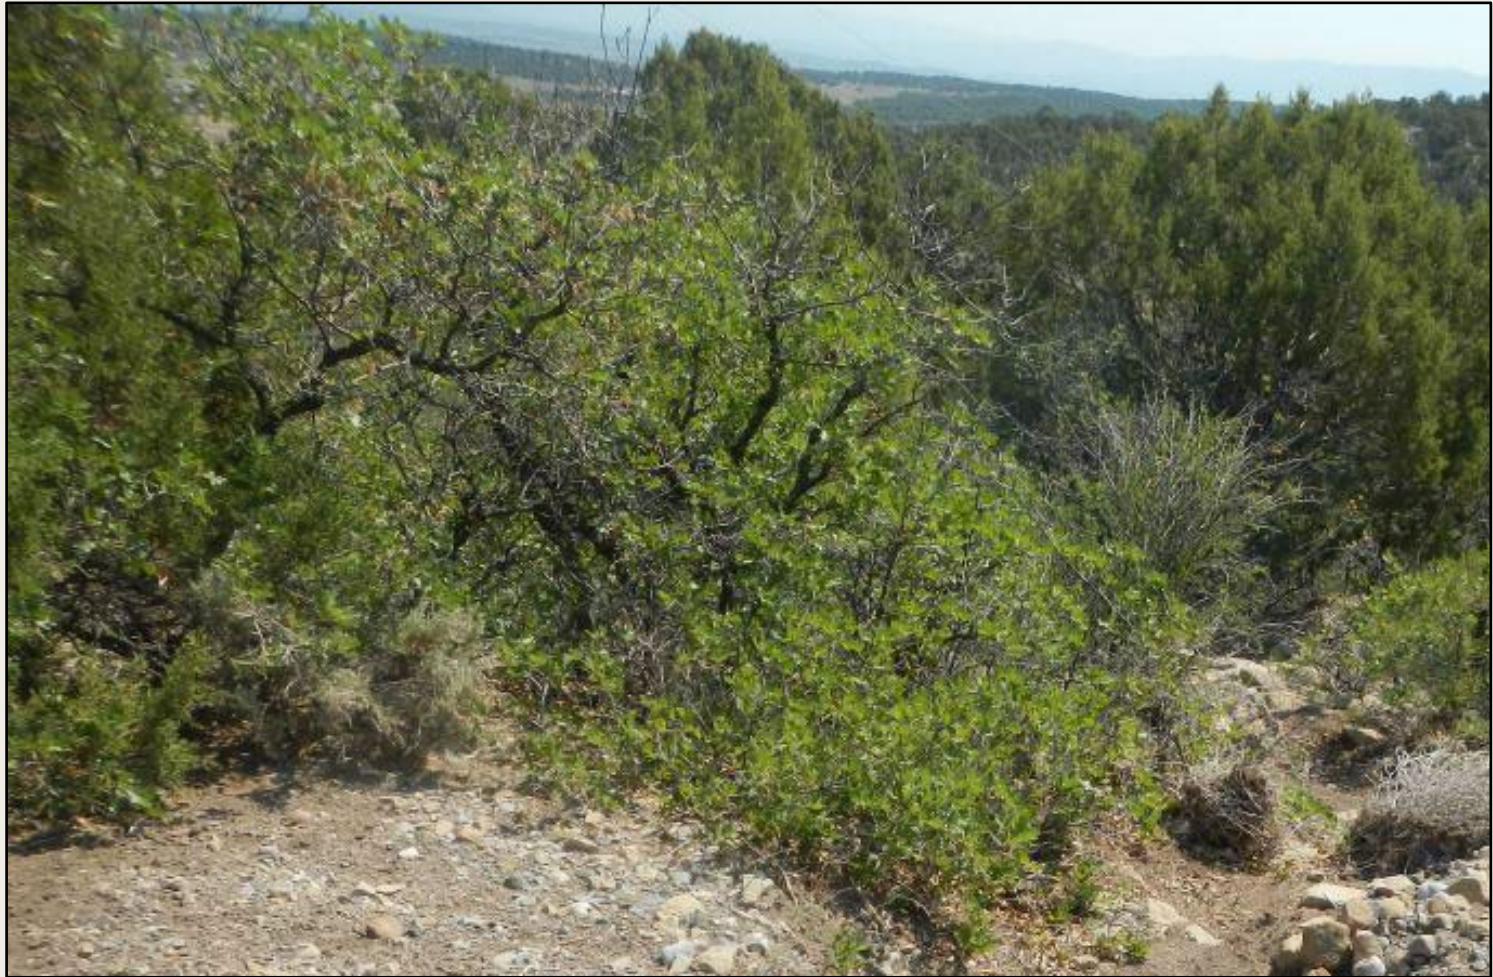
Photo 8. View of reference area comprised of pinyon and juniper woodland with gambel oak, mountain mahogany, sagebrush, serviceberry, Indian ricegrass, and Palmer's penstemon.
