Inspection Photos
Operator: Rim Operating
API: 067-09286
Date: 6/13/2022

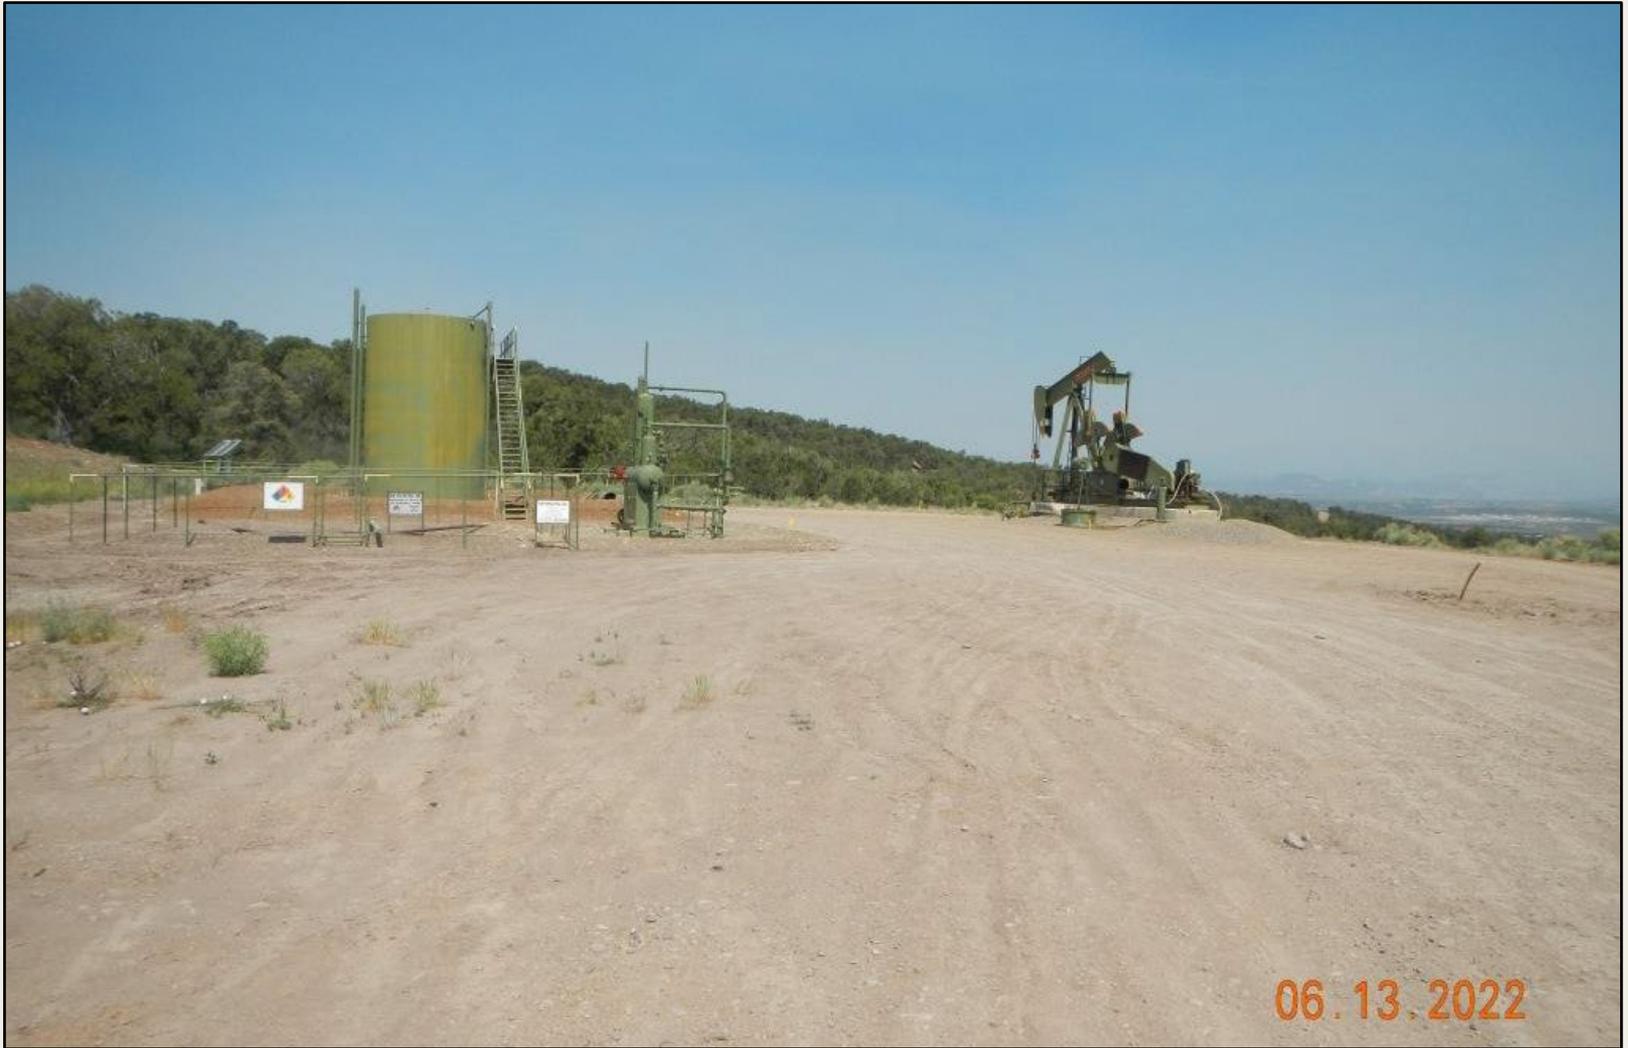
Photo 1. View of the project area from the well pad entrance facing center.

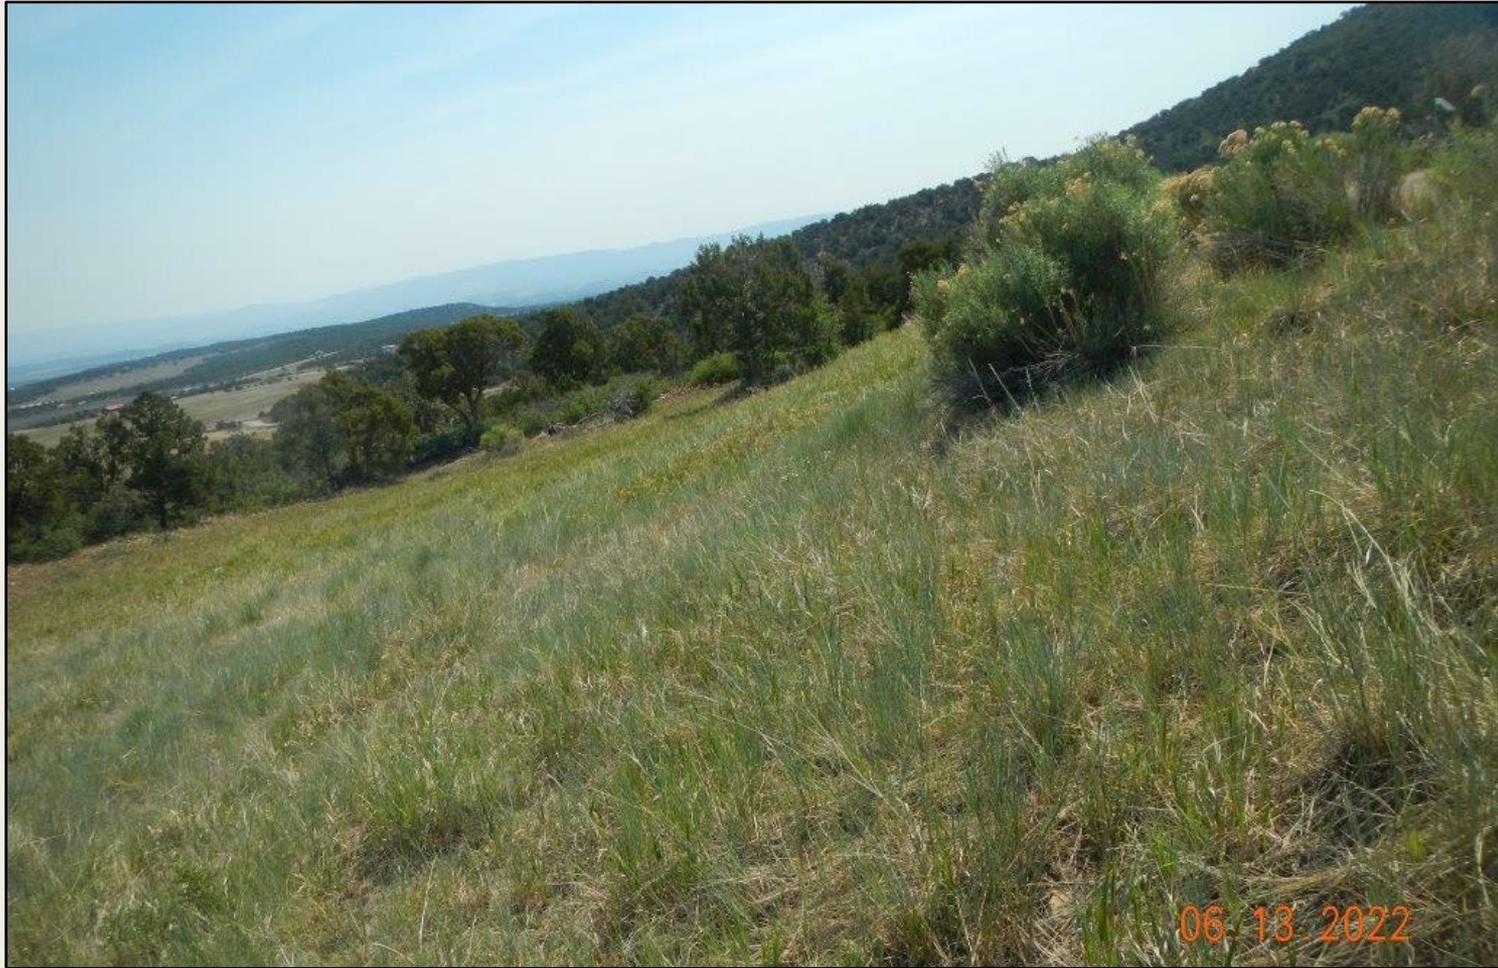
Photo 2. View of the northern project area from the northwestern corner facing eastward. Revegetation is progressing with western wheatgrass, rubber rabbitbrush, smooth brome and crested wheatgrass.

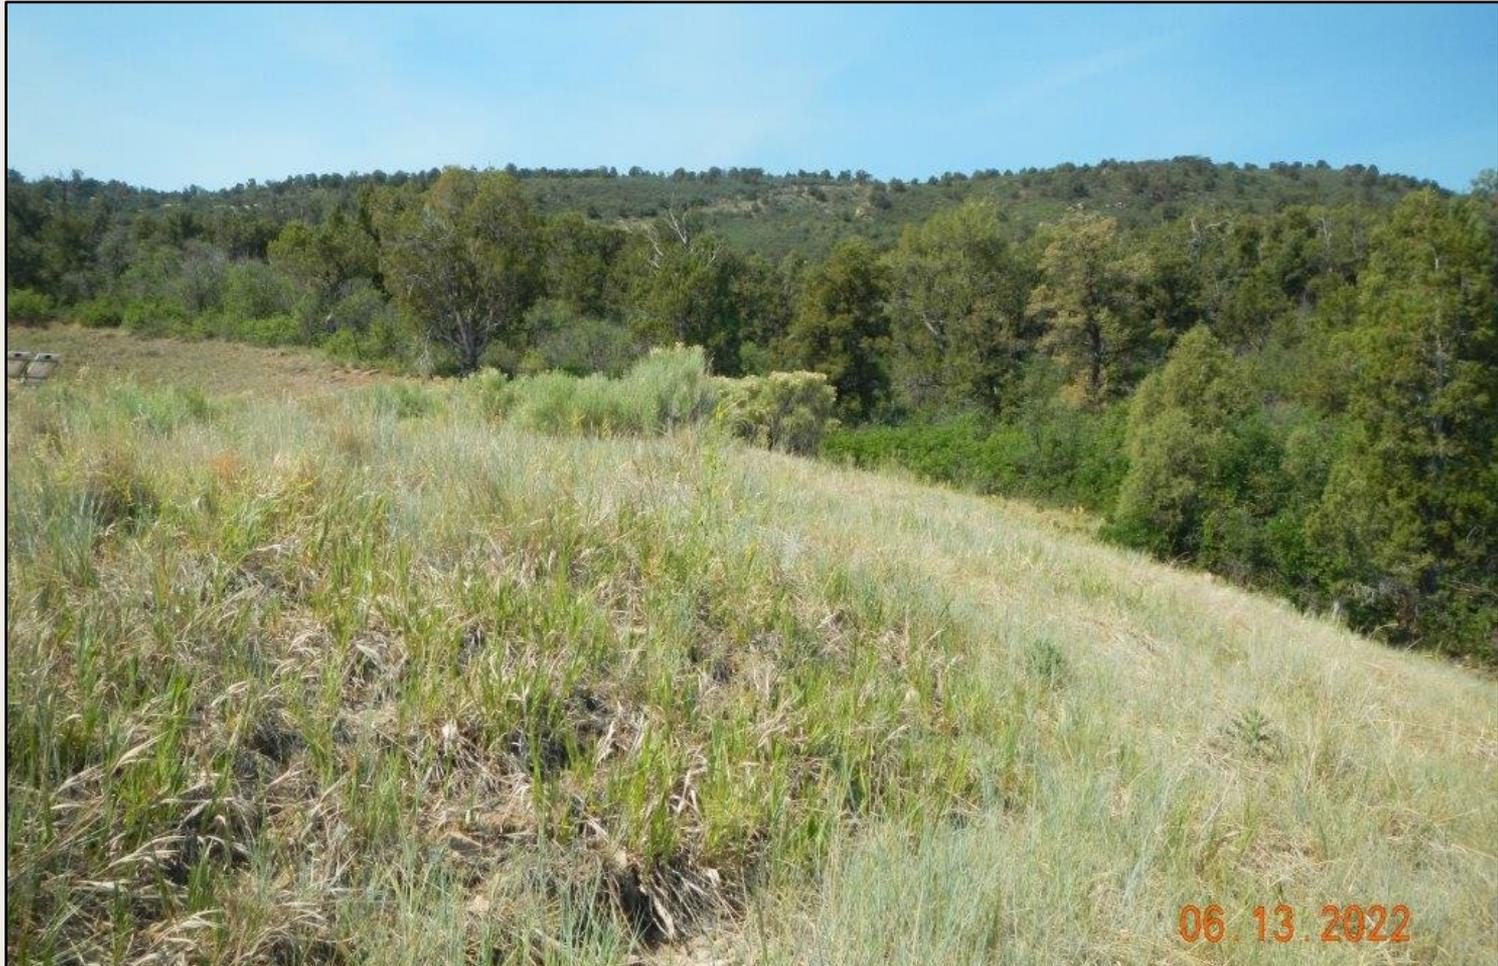
Photo 3. View of the western project area from the northwestern corner facing southward.

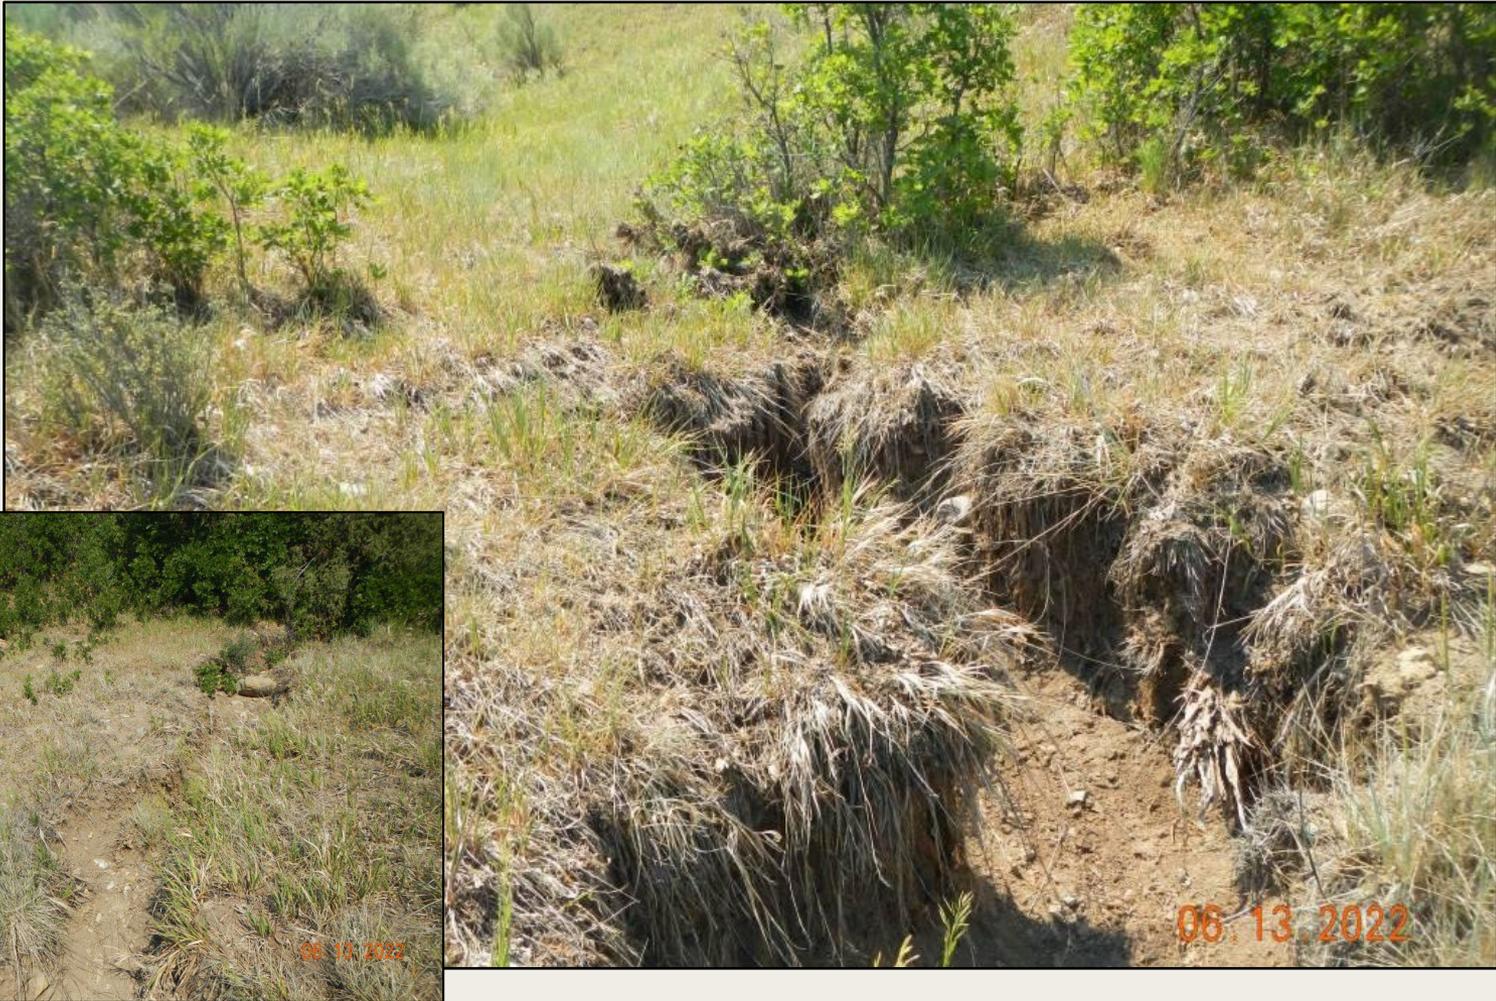
Photo 4. View of erosional headcutting and channeling (inset) within the southwestern corner of the project area where diverted stormwater flows off of the well pad (approx. 2-3ft wide and deep).

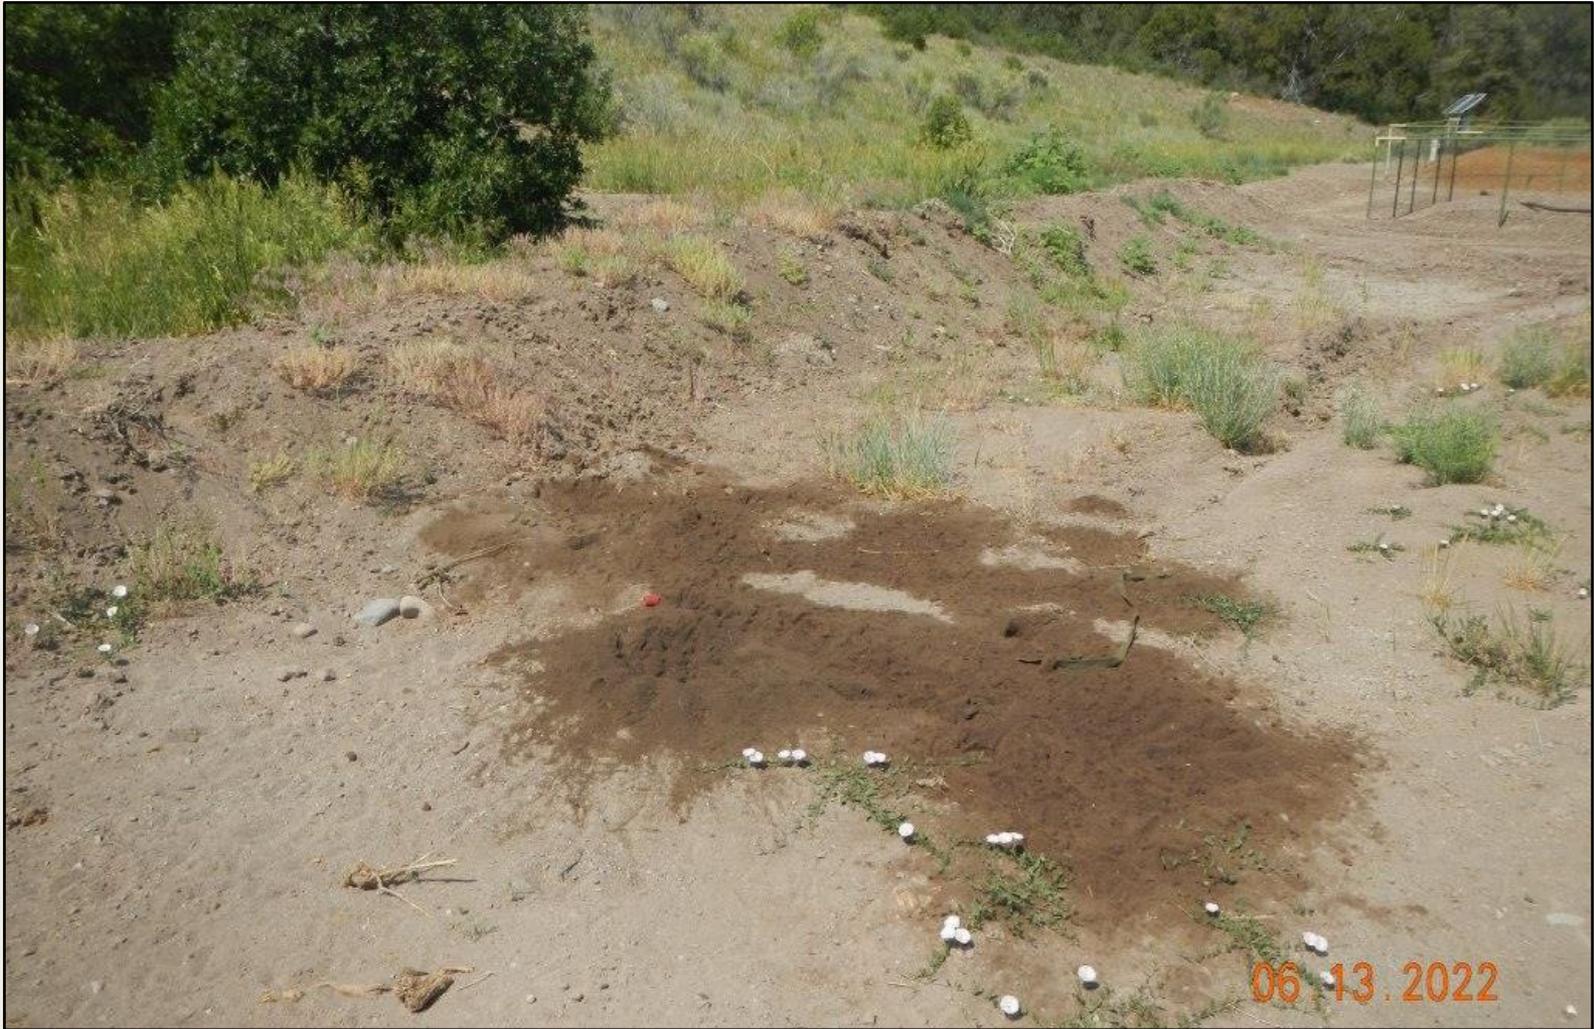
Photo 5. View of stained soils approximately 6 ft wide and long, within the eastern project area.

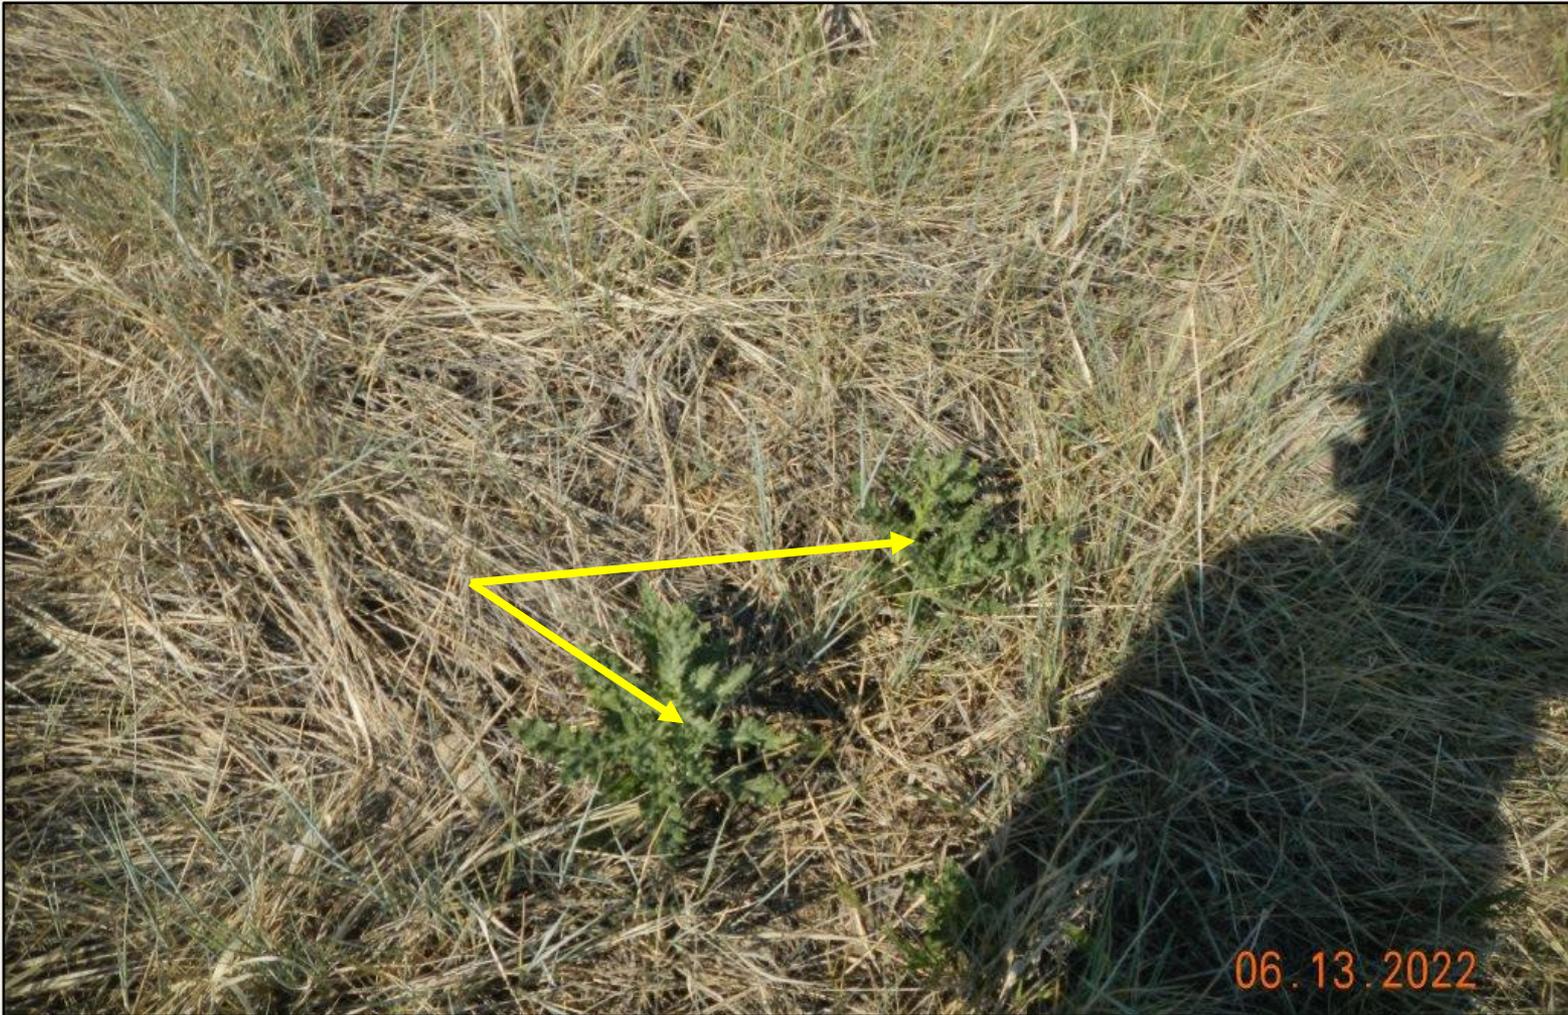
Photos 6. View of Canada thistles (yellow arrows) observed within the project area, approximately 50 Canada and musk thistles observed.

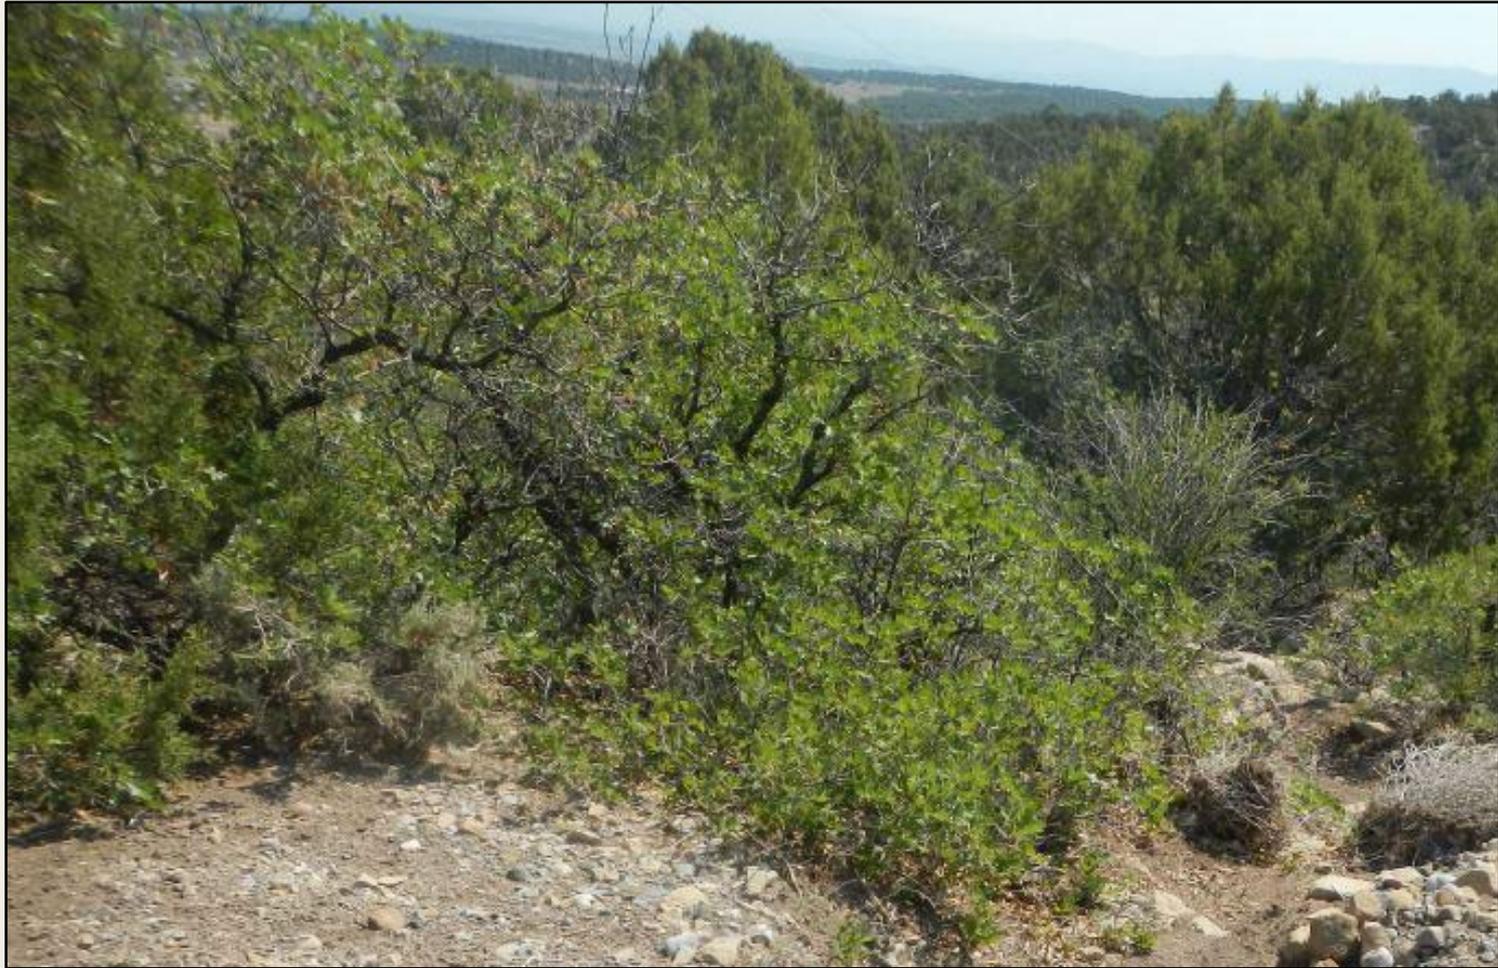
Photo 7. View of reference area comprised of pinyon and juniper woodland with gambel oak, mountain mahogany, sagebrush, serviceberry, Indian ricegrass, and Palmer's penstemon.
