Inspection Photos
Location Name: Dakota Fee 1
API # : 067-06141

COLORADO
Oil & Gas Conservation
Commission
Department of Natural Resources

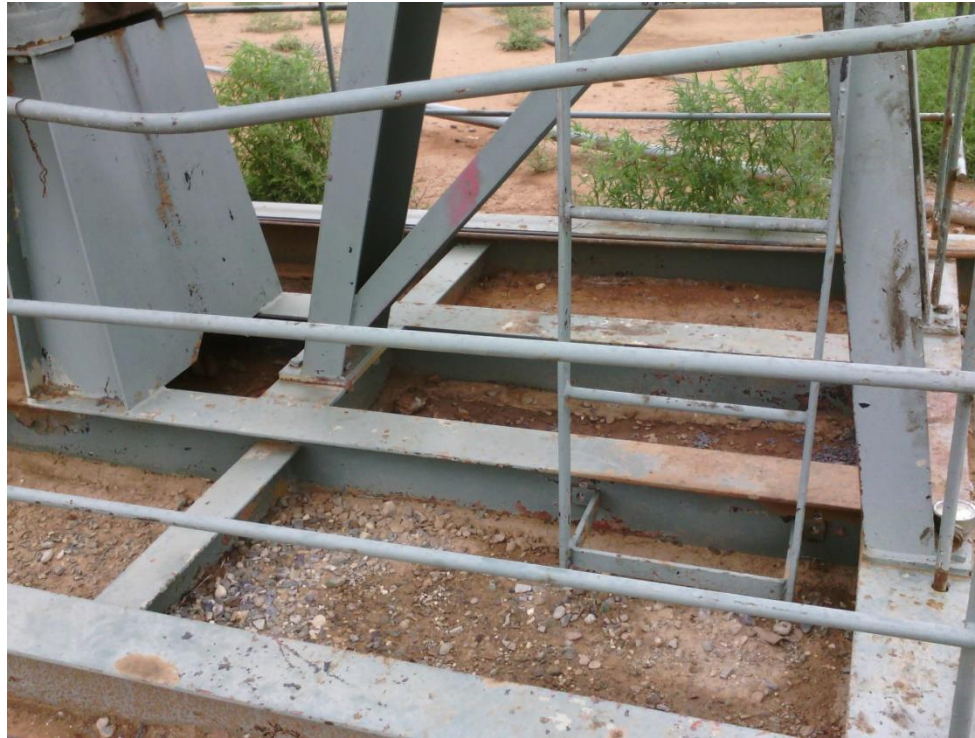
Corrective action completed, unused part removed

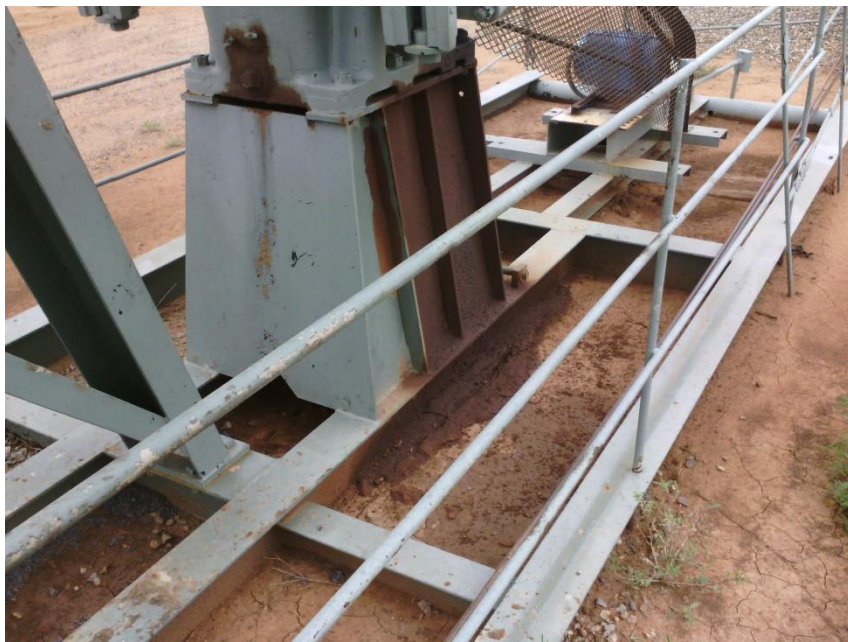
Gear box leak and impacted material

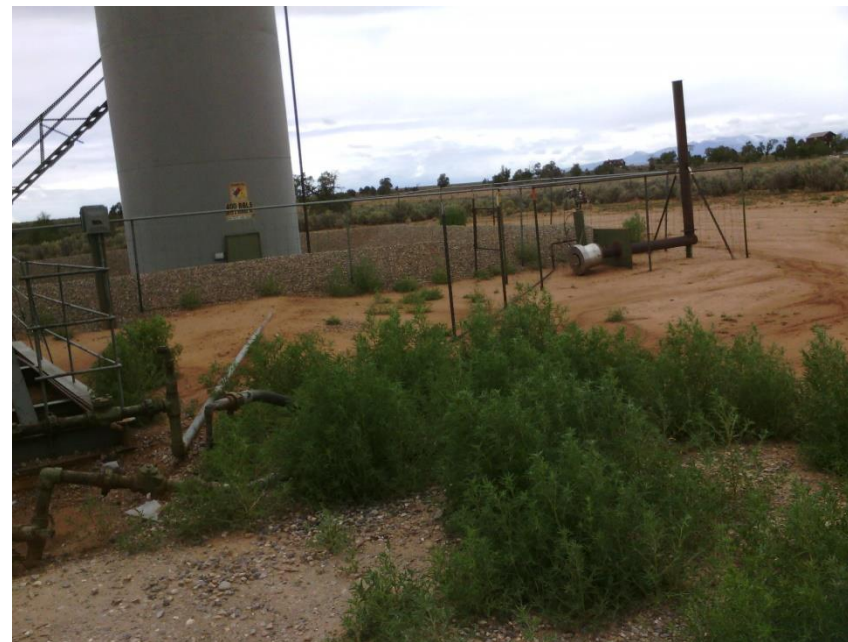
Weeds growing up around equipment and near wellhead

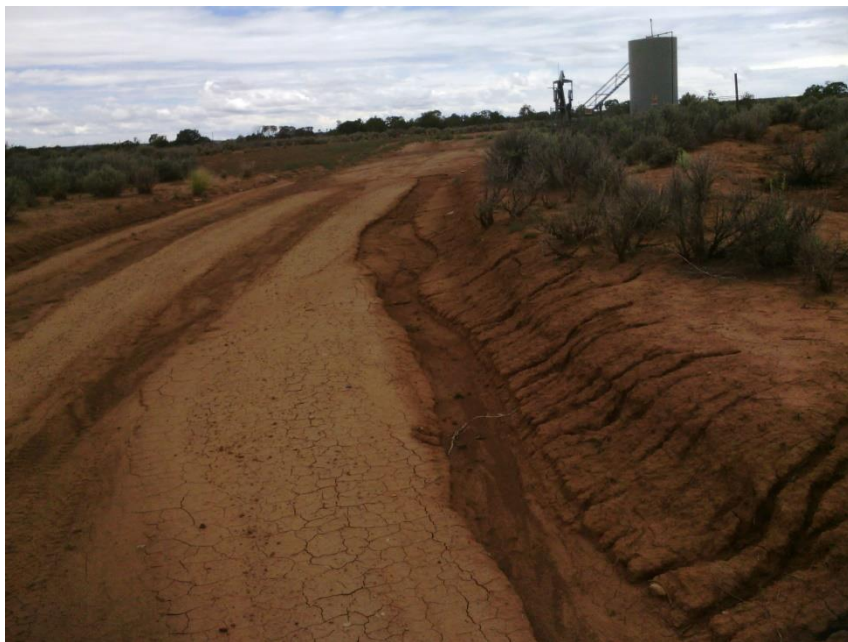
Erosion from sheet flow and channeling from pad and on access road, looking north towards pad

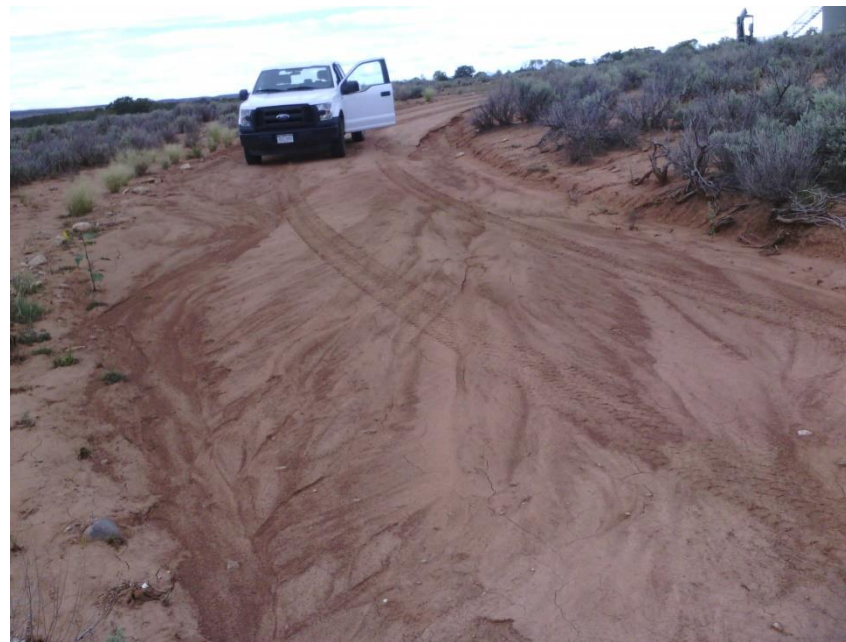
Taken from further south looking north back towards pad

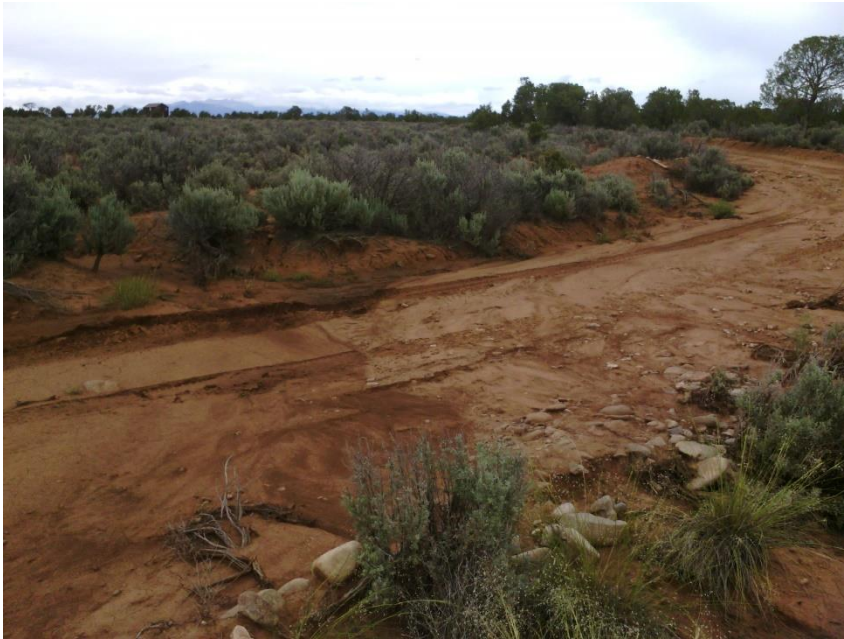
Access road eroded away, sediment migration onto and off road, no functioning erosion control BMPs

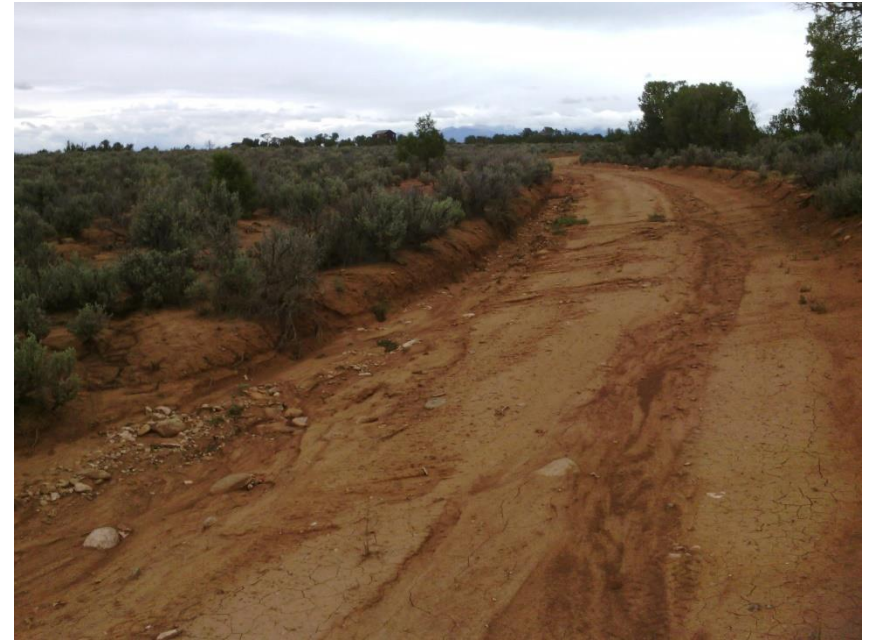
Erosion, sediment migration, no erosion control BMPs, road not designed or maintained properly for stormwater

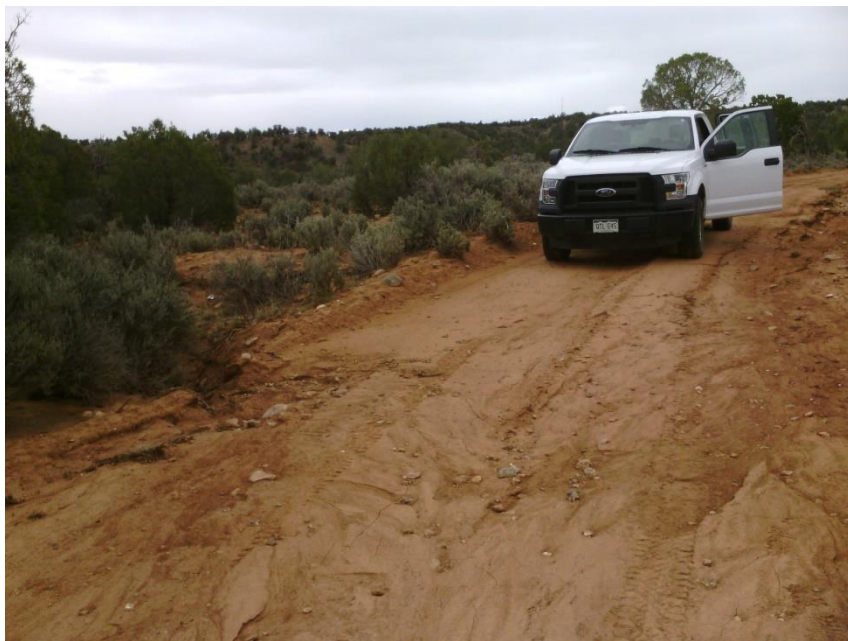
Erosion off access road, looking south about half way to location

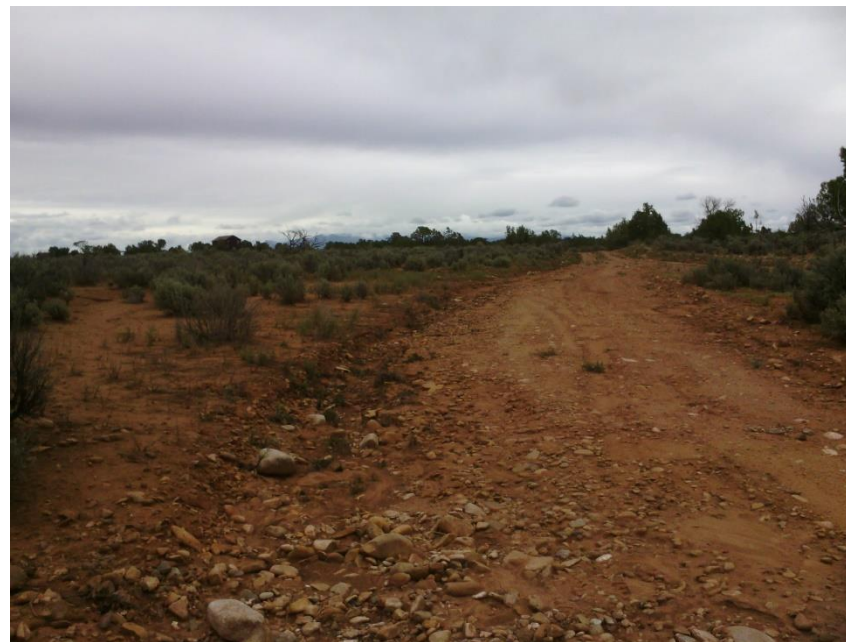
Erosion on access, no BMPs, looking north towards private road
