**Inspection Photos**  
**Location Name: Padgett 32-6 4-2**  
**Location ID: 333798**

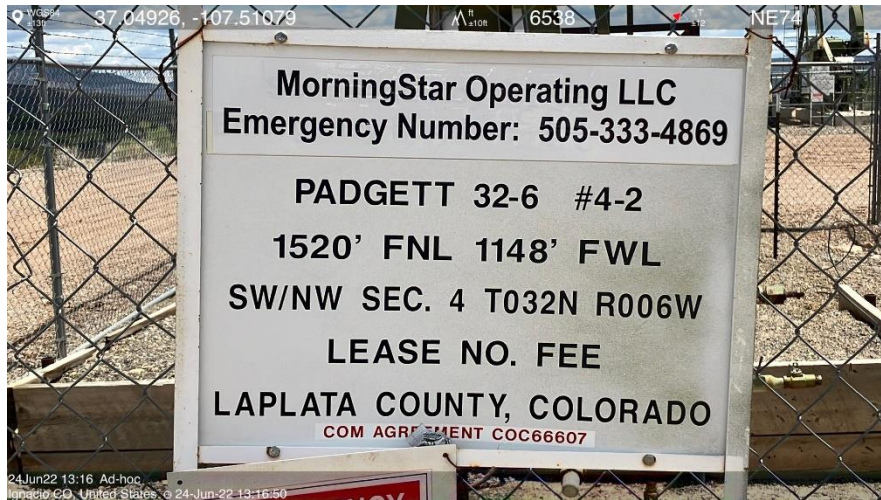
**IMG 01**  
**Well sign**

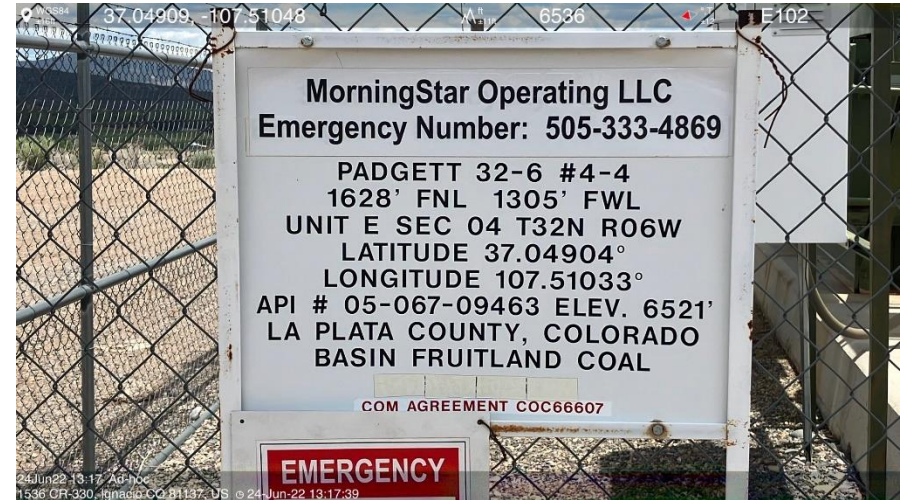
**IMG 02**  
**Well sign**

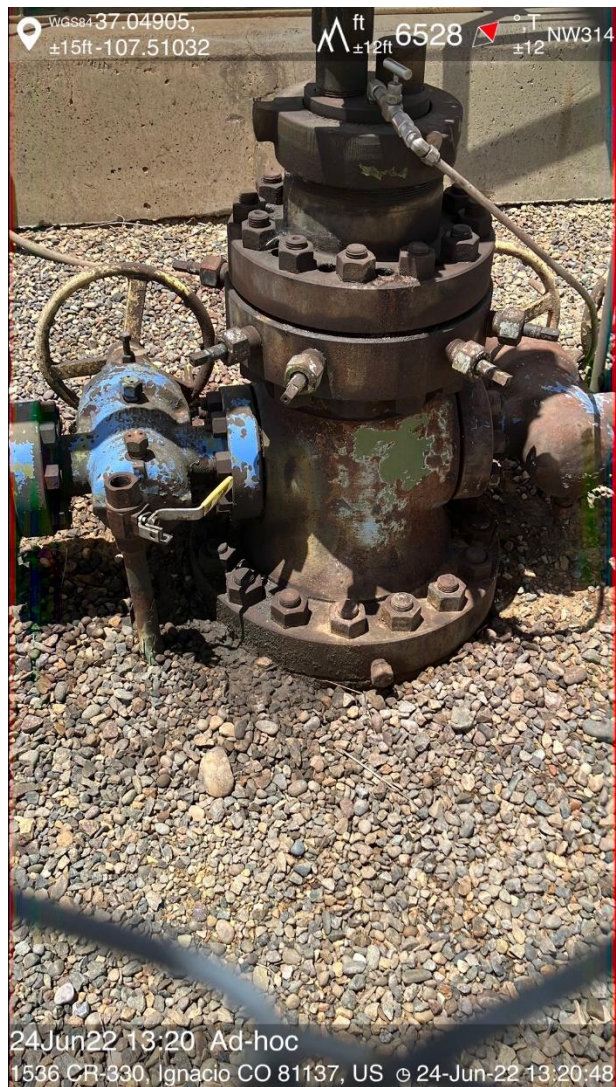
**IMG 03**

**Lube oil has begun to impact material**

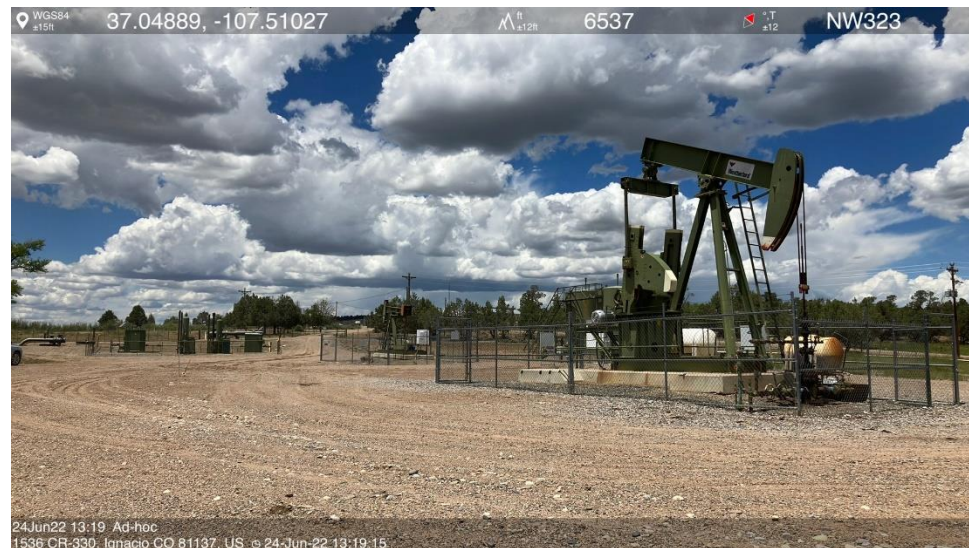
**IMG 04**

**Location overview**

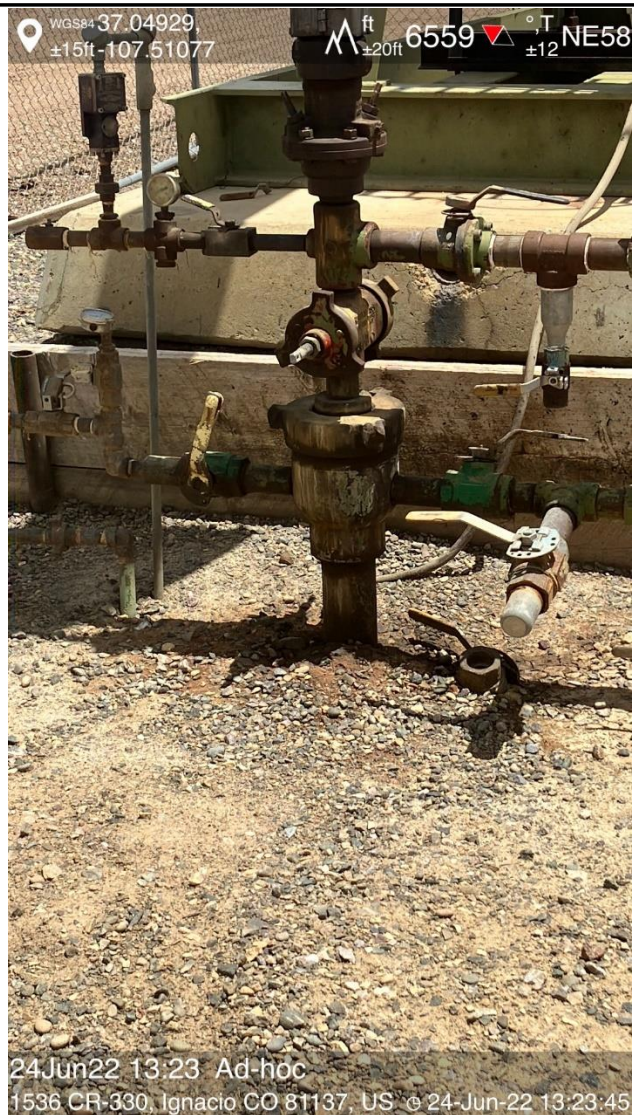
**IMG 05**

**Lube oil has begun to impact material**

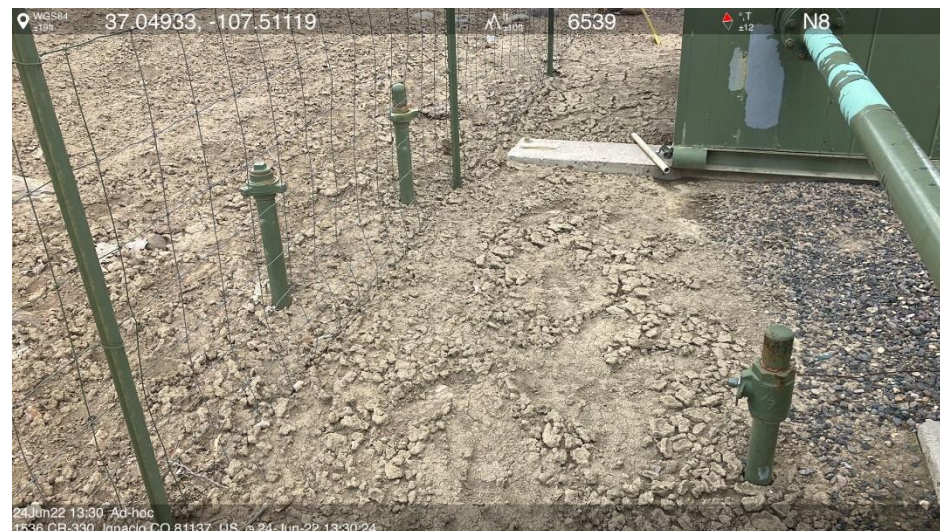
**IMG 06**

**Unused flowline risers not locked and tagged out**

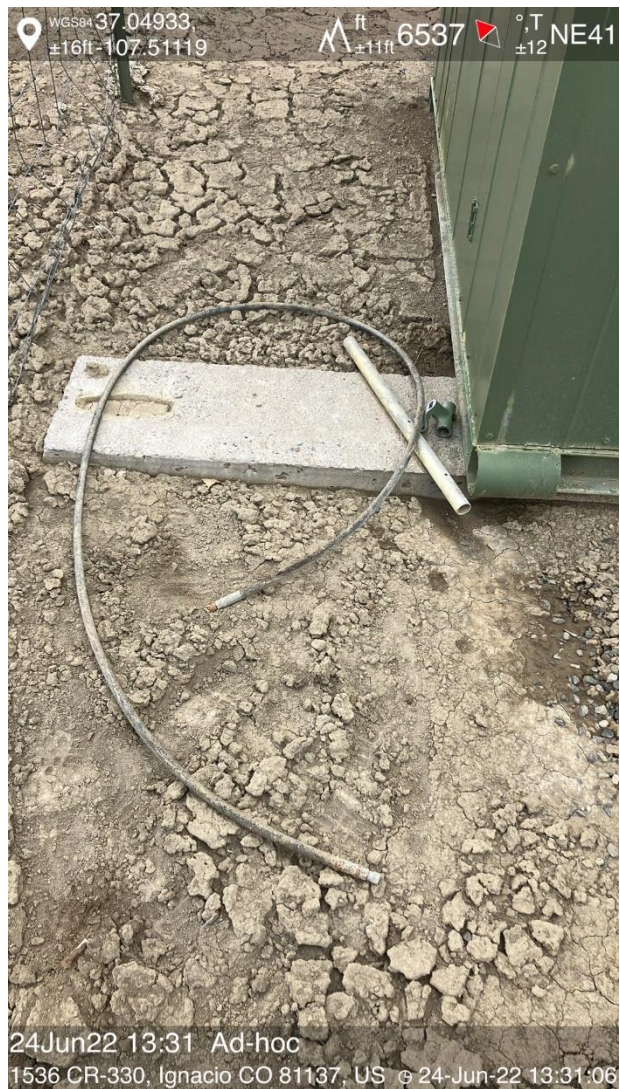
**IMG 07**  
Unused equipment/debris

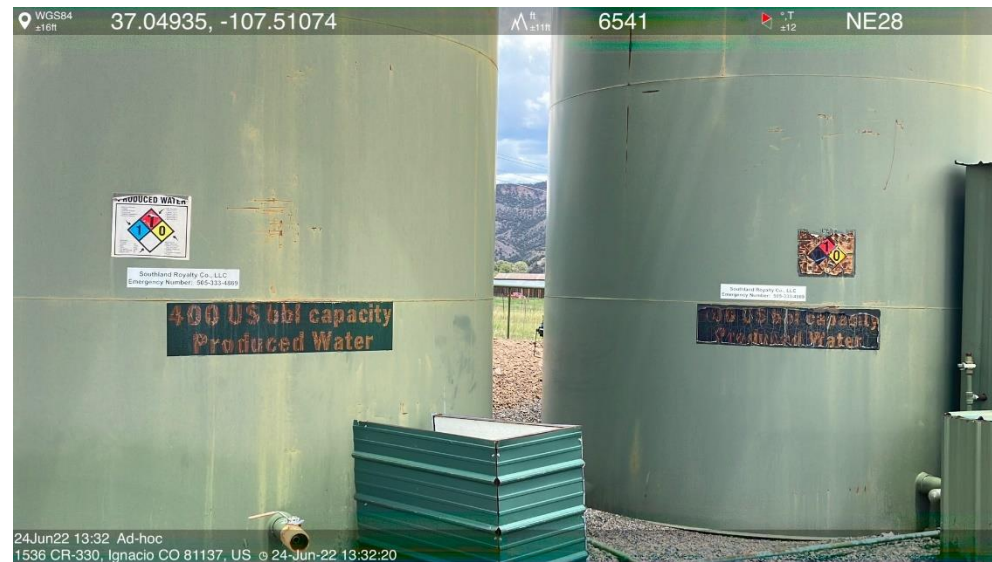
**IMG 08**  
Signs are deteriorating and capacity of tank on right now legible.

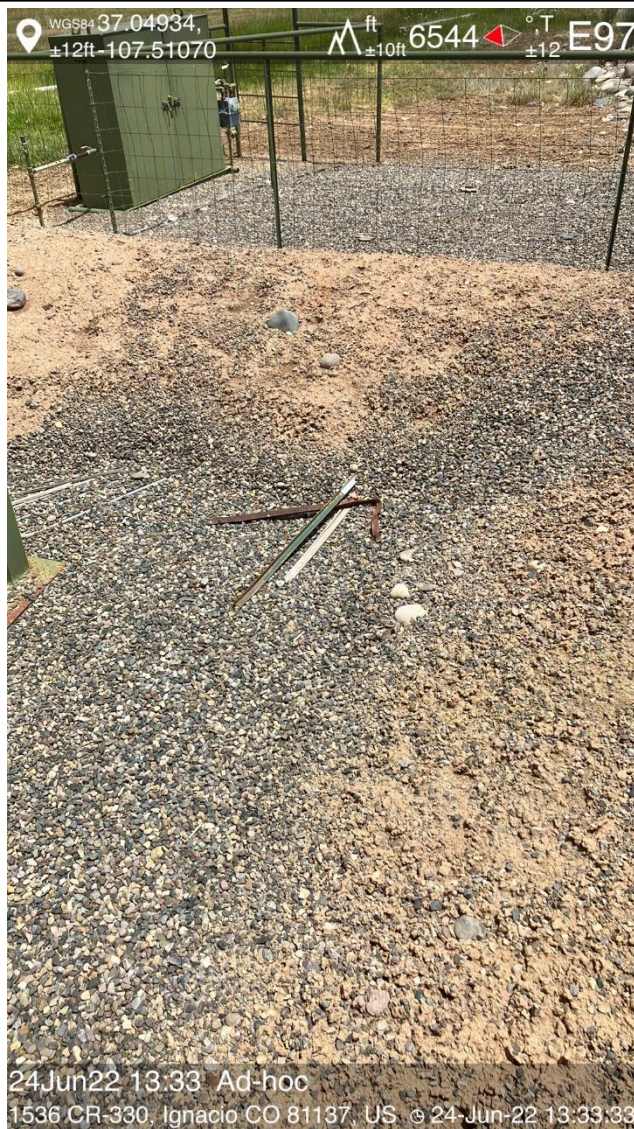
IMG 09

Debris near produced water tanks
