Inspection Photos and Issue Report

Operator: CAERUS PICEANCE LLC #10456

Location ID: 479149

COGCC

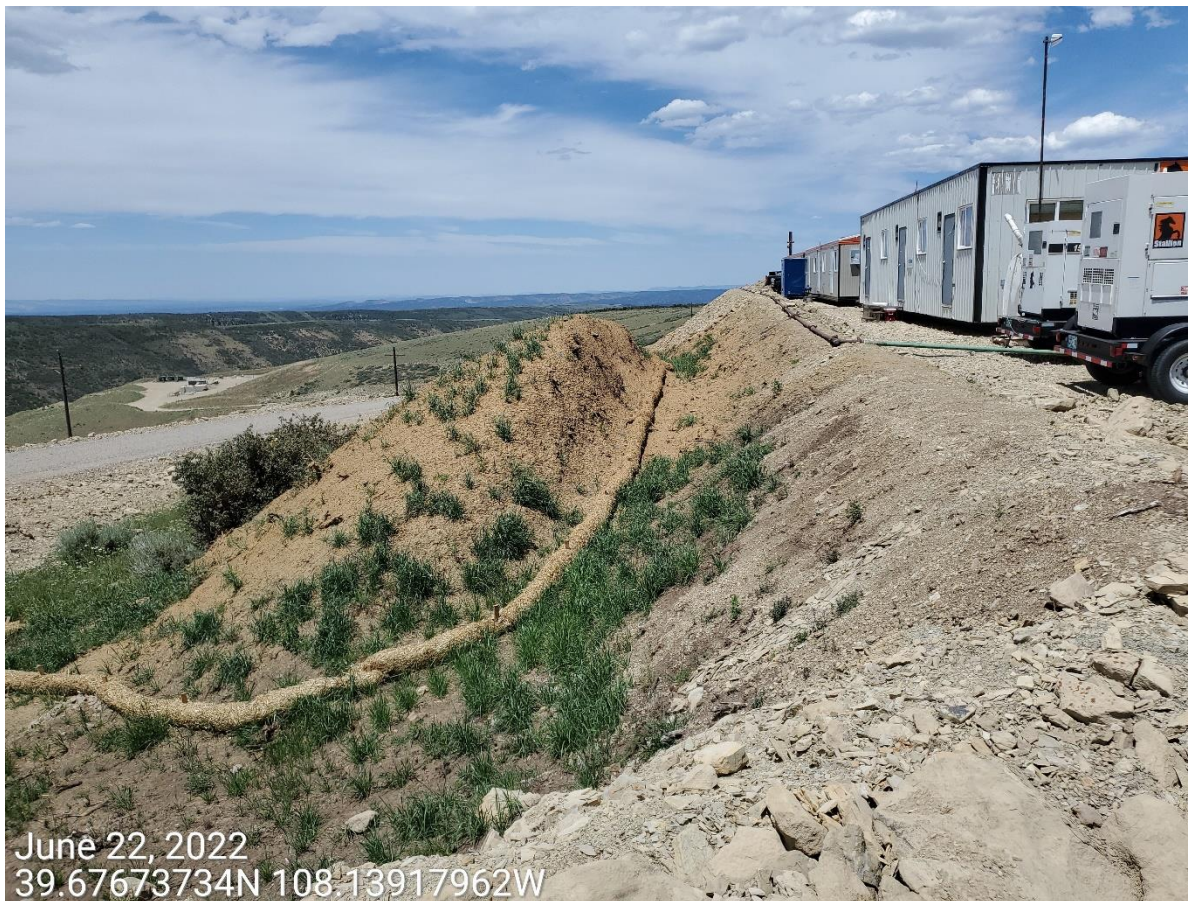
Photo 1: Photo taken from the west end of the Location. Photo shows Operator has implemented hydramulch in conjunction with a wattle in order to minimize erosion, degradation, and transport of sediment; wattles along topsoil stockpile only observed along western perimeter berm, and separate stockpiled soils on the south end of the Location.

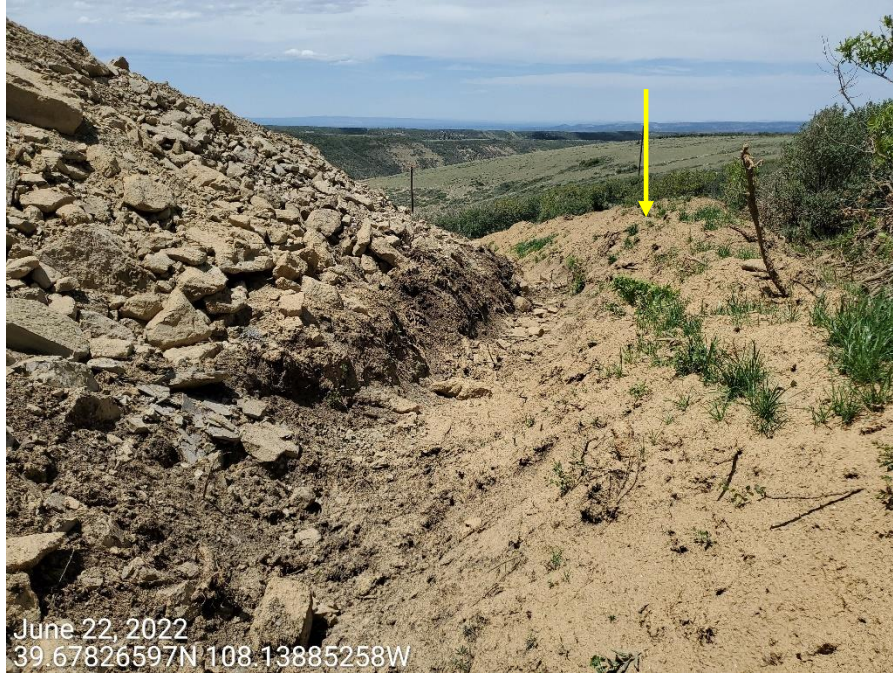
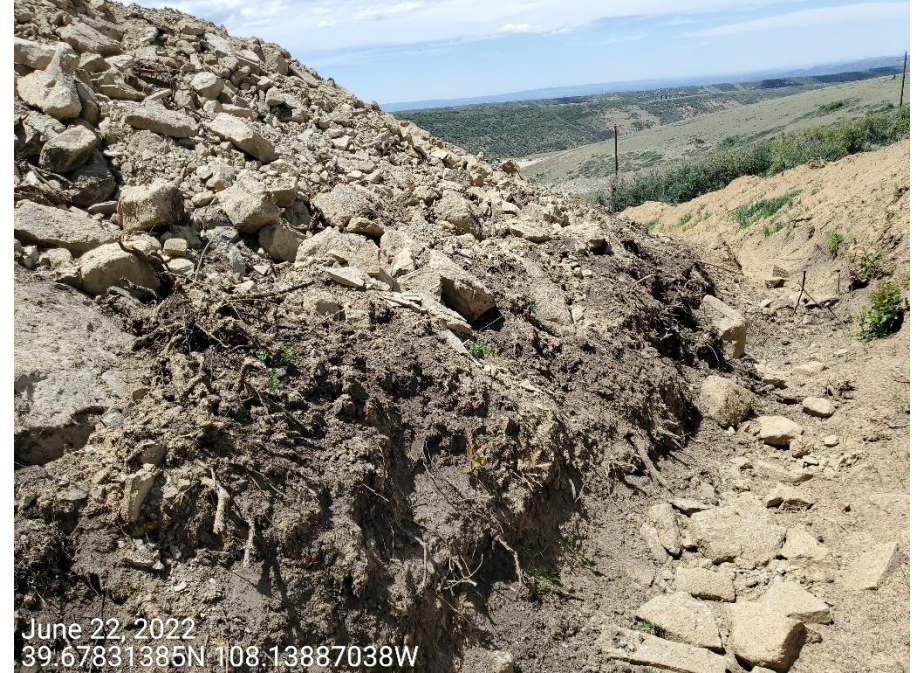
Photo 2: Though hydromulch has been installed at the topsoil berms, photos examples of areas where the topsoil stockpiles (arrow) remain in use as part of the Location's perimeter stormwater BMPs. Photos also provide examples of areas where Hydromulch has been applied to the perimeter stormwater diversion ditch; per good engineering, this is not an appropriate control for use in areas for channelized or concentrated flows, such as stormwater ditches. Unable to find evidence of other work to address the vertical slopes within sections of the ditch, and the unconsolidated soils within the ditch.

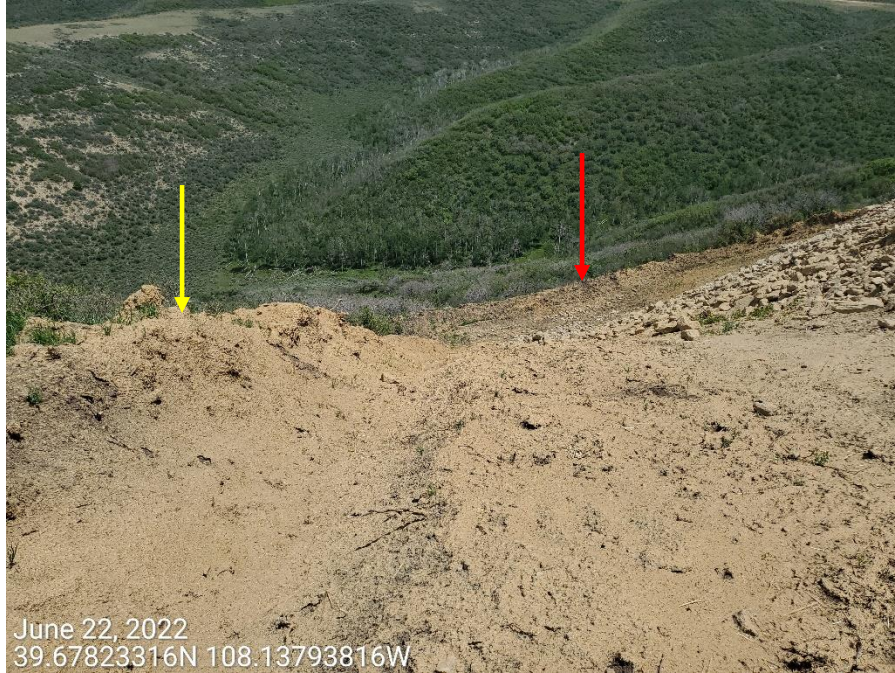
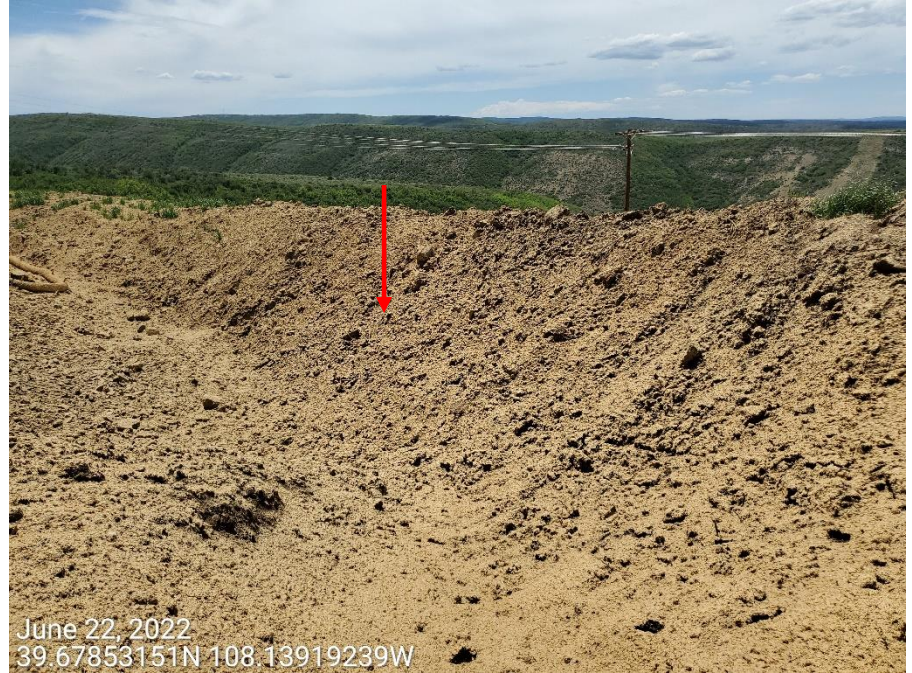
Photo 3: Photos examples showing topsoil stockpiles (arrow) remain in use as part of the Location's perimeter stormwater BMPs. Red arrows showing topsoil stockpiles remaining in use as part of the three sediment traps/ponds on the Location. In addition to the traps/ponds being constructed with topsoil, the three BMPs also lacks a properly engineered outlet per good engineering.

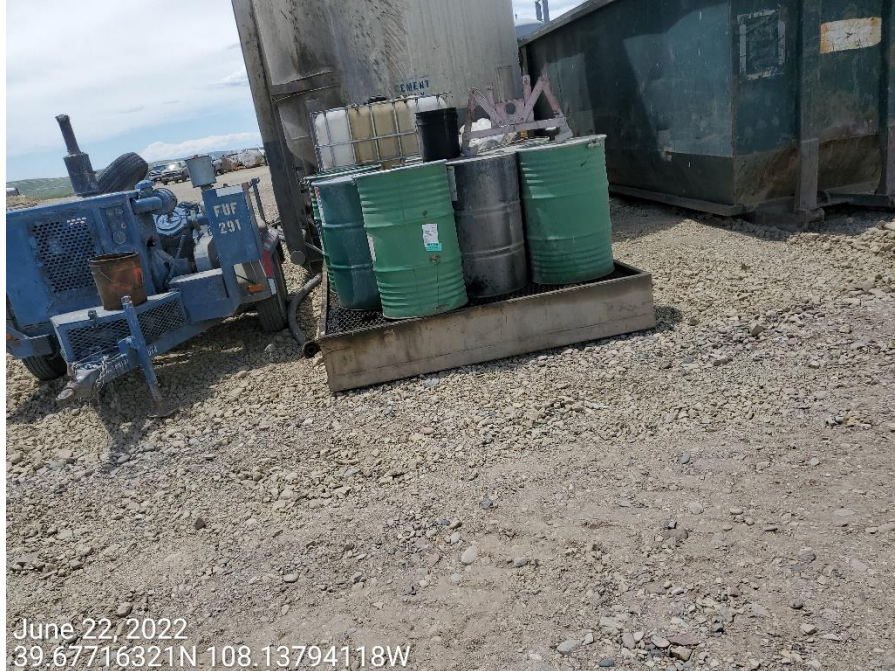
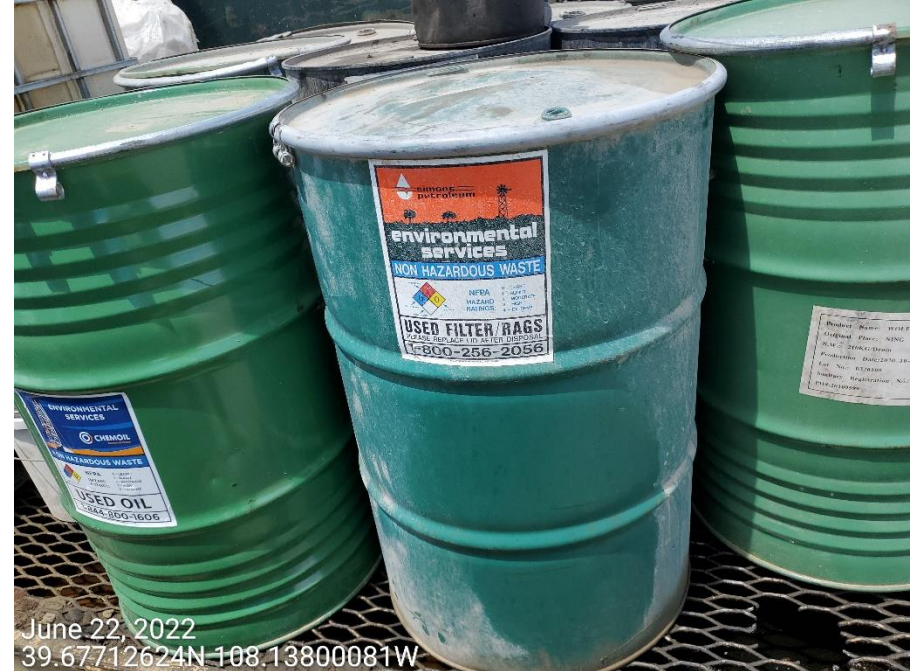
Photo 4: Photos provide example showing proper spill prevention/containment BMPs. Photos also example showing constrainers/materials/etc... have been labelled for identification purposes.

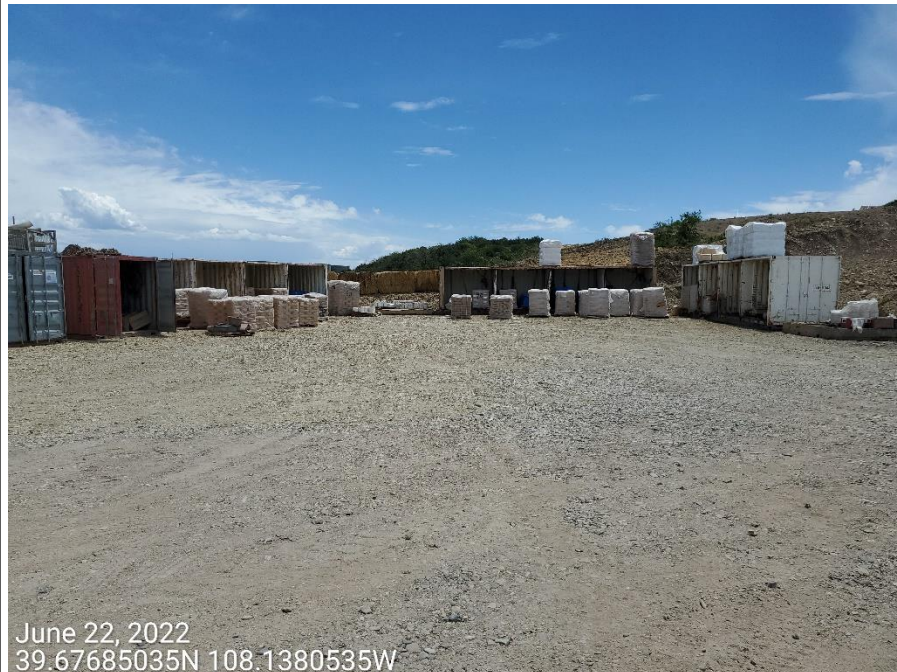
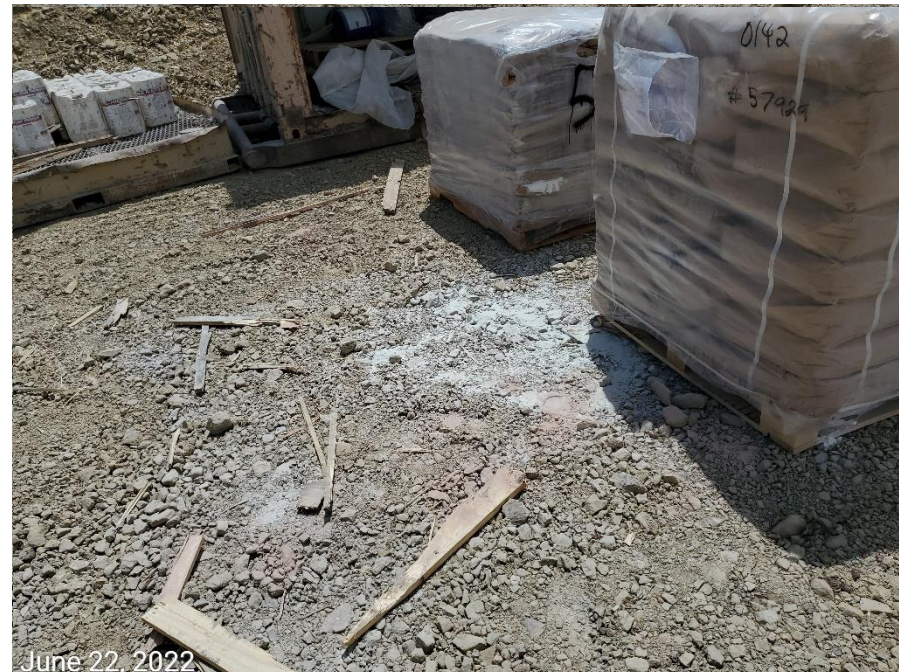
Photo 5: Photos taken from the southeast end of the Location. Though material handling and covering BMPs largely adequate throughout the Location, photo shows material spills observed on the south end of the Location.

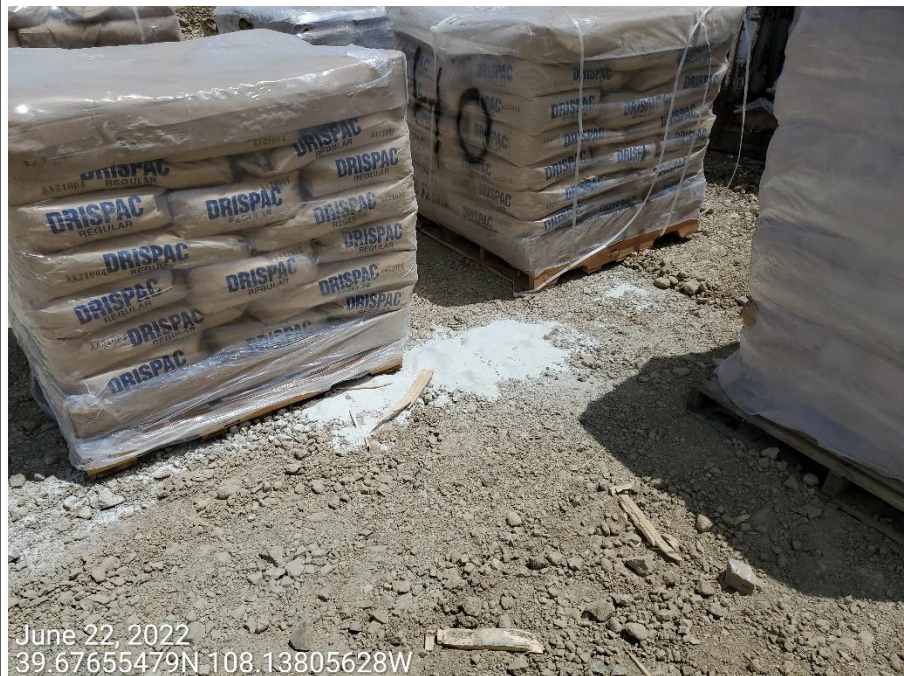
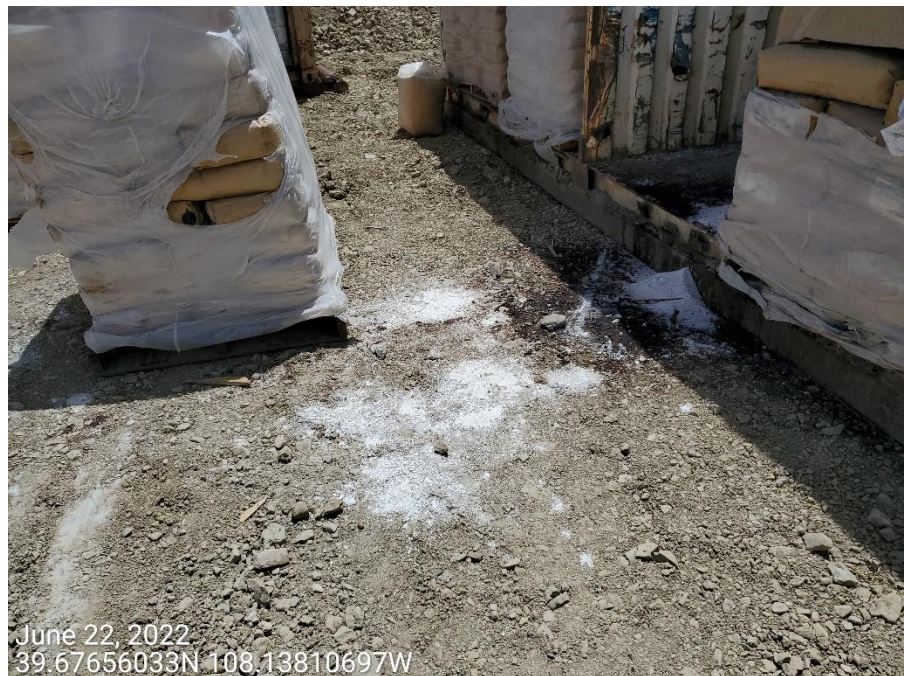
Photo 6: See comments under photo 5.
