Final Reclamation Inspection

Operator: PDC ENERGY INC - 69175

Location ID: 330982

Inspection Document #: 701900376

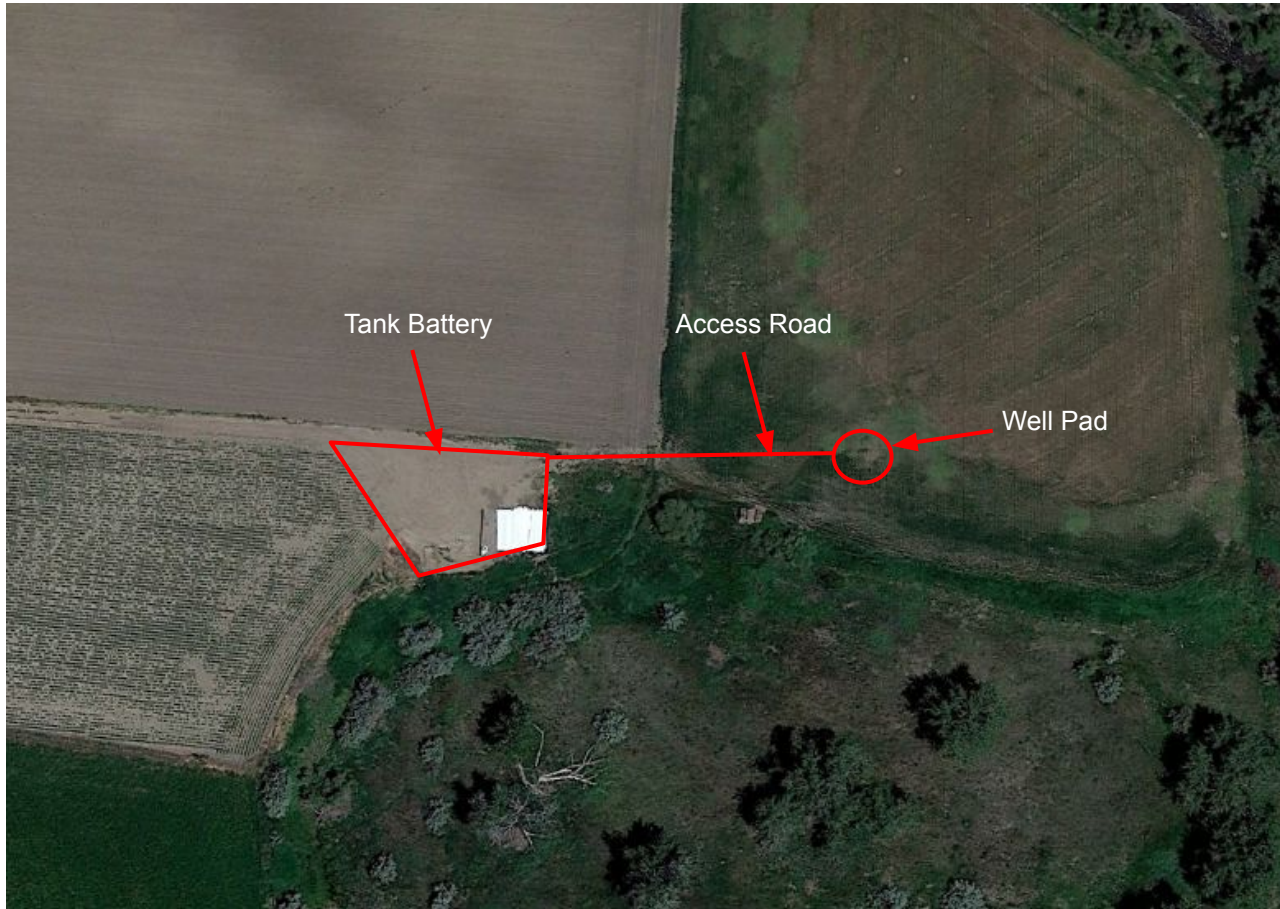
Photo 1. 2021 aerial imagery of the well pad, access road and tank battery.

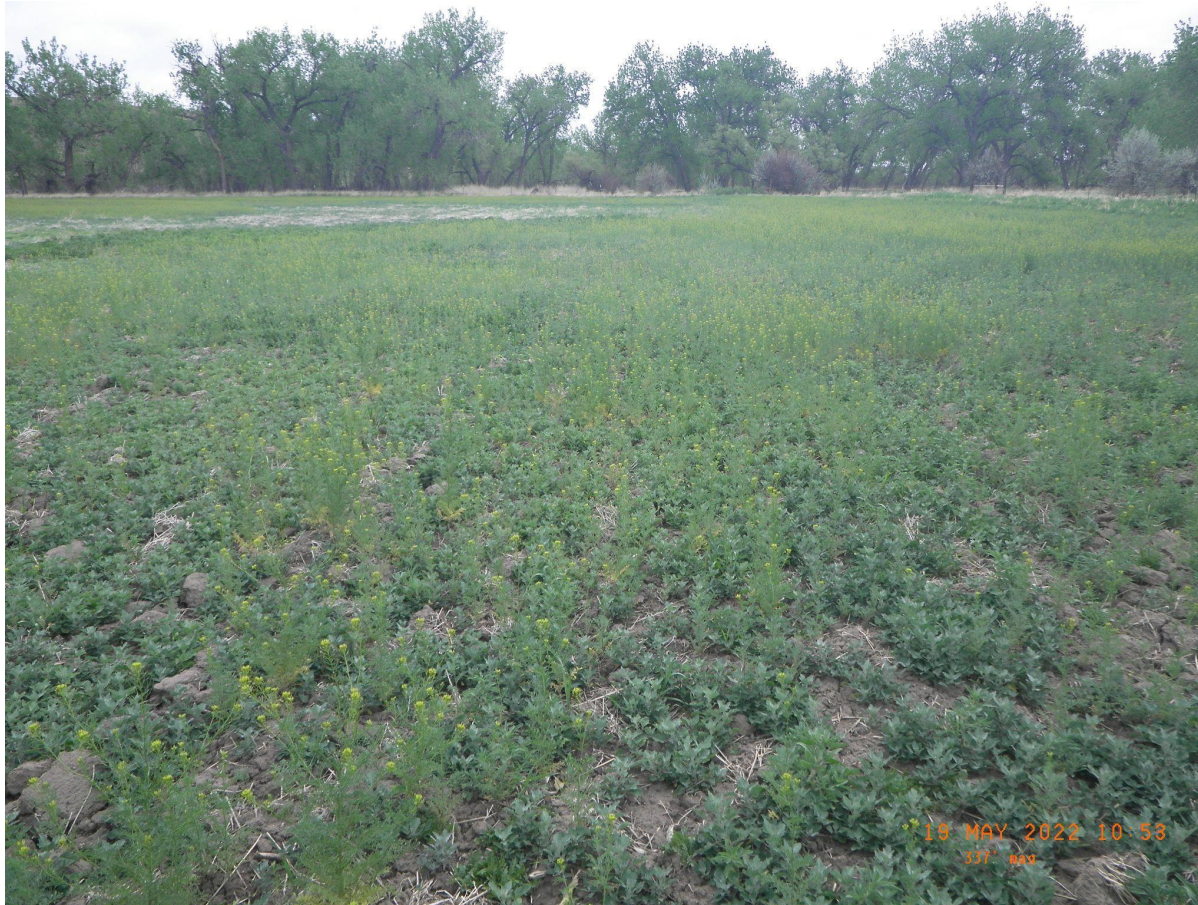
Photo 2. Overview photo of the well pad taken at ground level from the western edge looking east. Note: well pad resides in a fallow agricultural field and appears consistent with reference area.

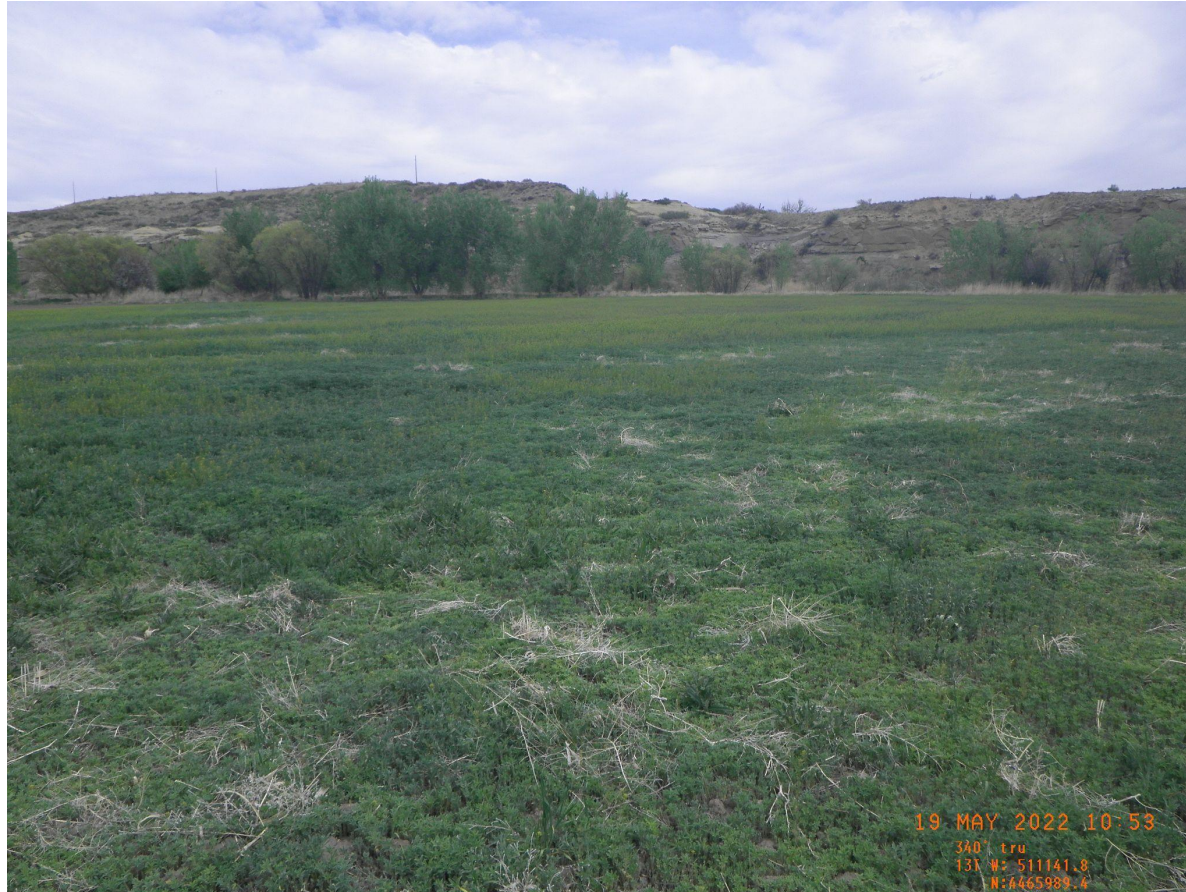
Photo 3. Reference area to the north of the well pad.

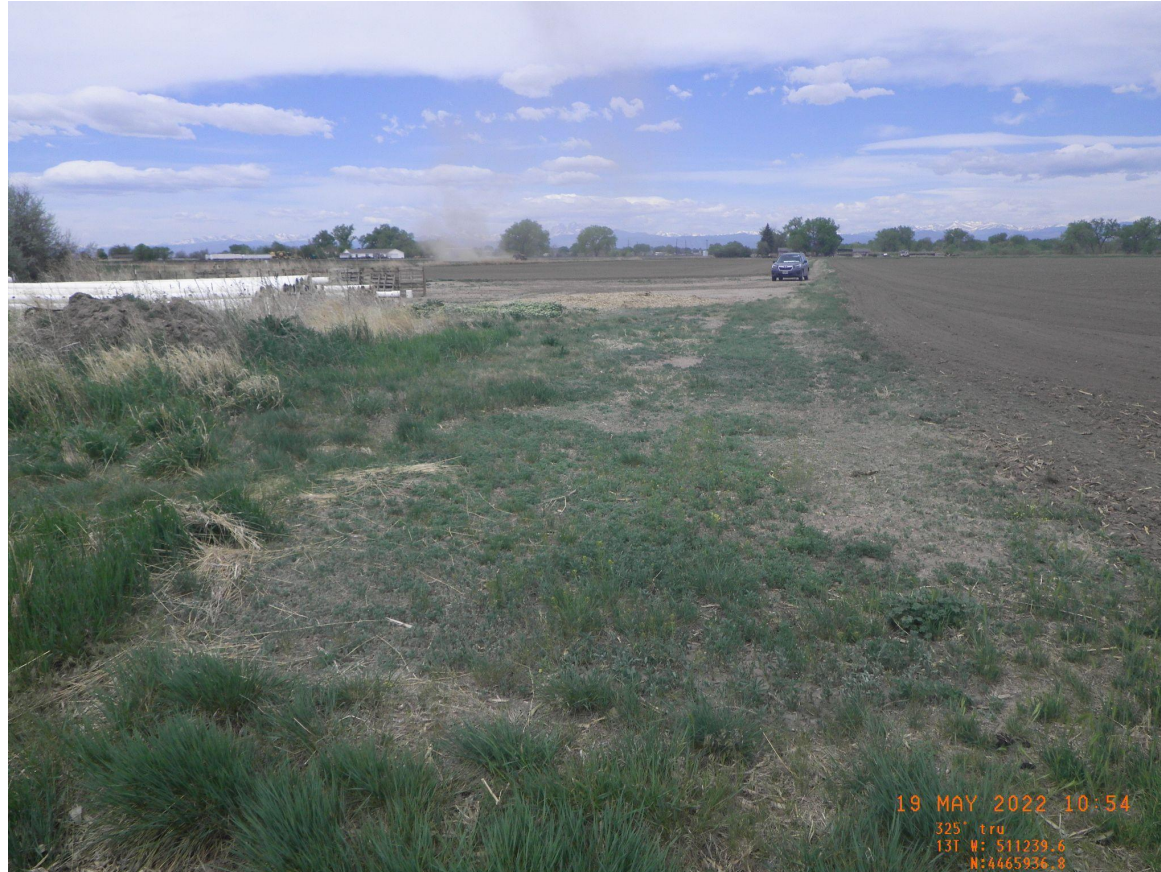
Photo 4. Overview photo of the access road taken from the eastern edge looking west. Note: appears consistent with reference area.

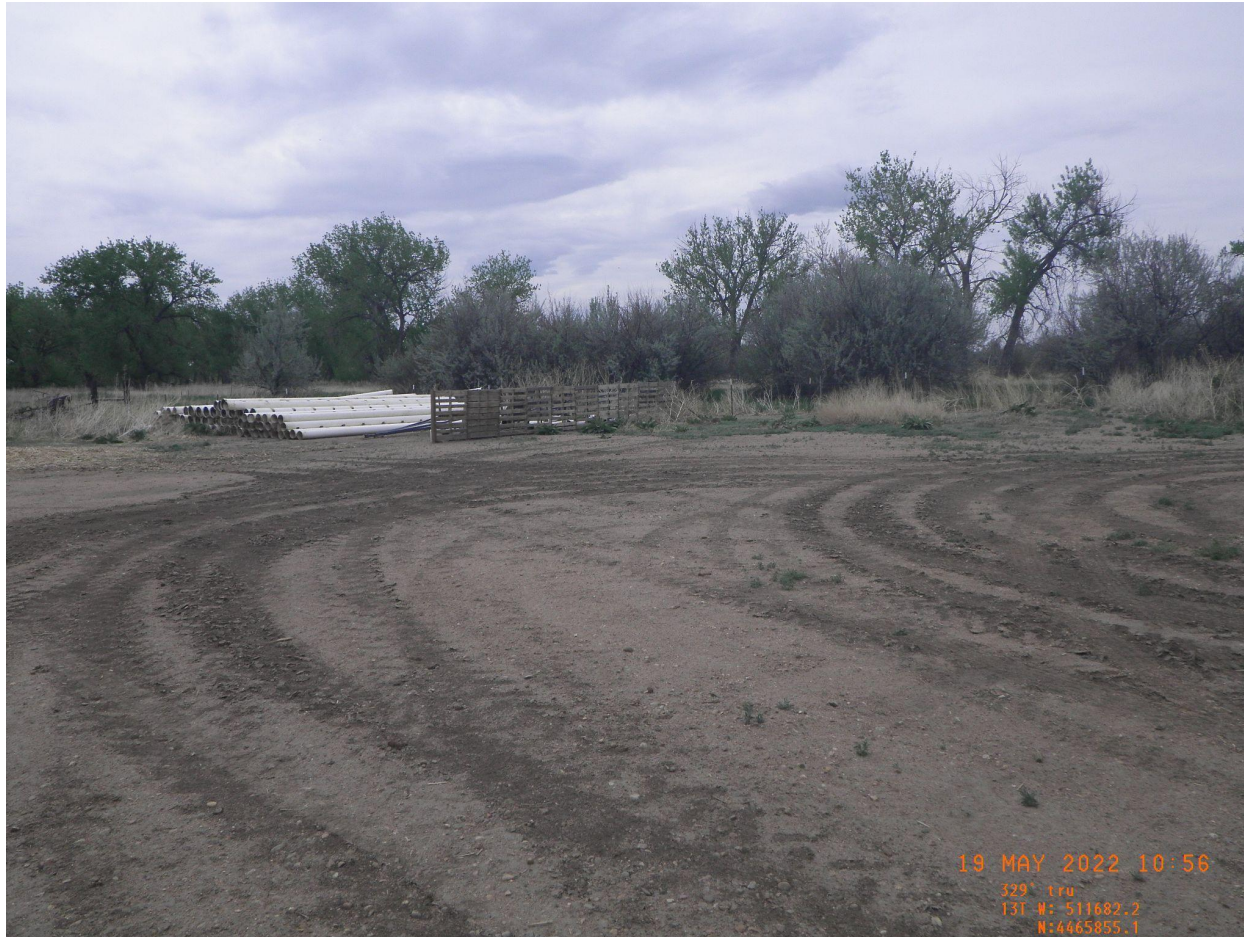
Photo 5. Overview photo of the tank battery. Note: southern edge of the disturbance is dominated by kochia, musk thistle and hoary cress.

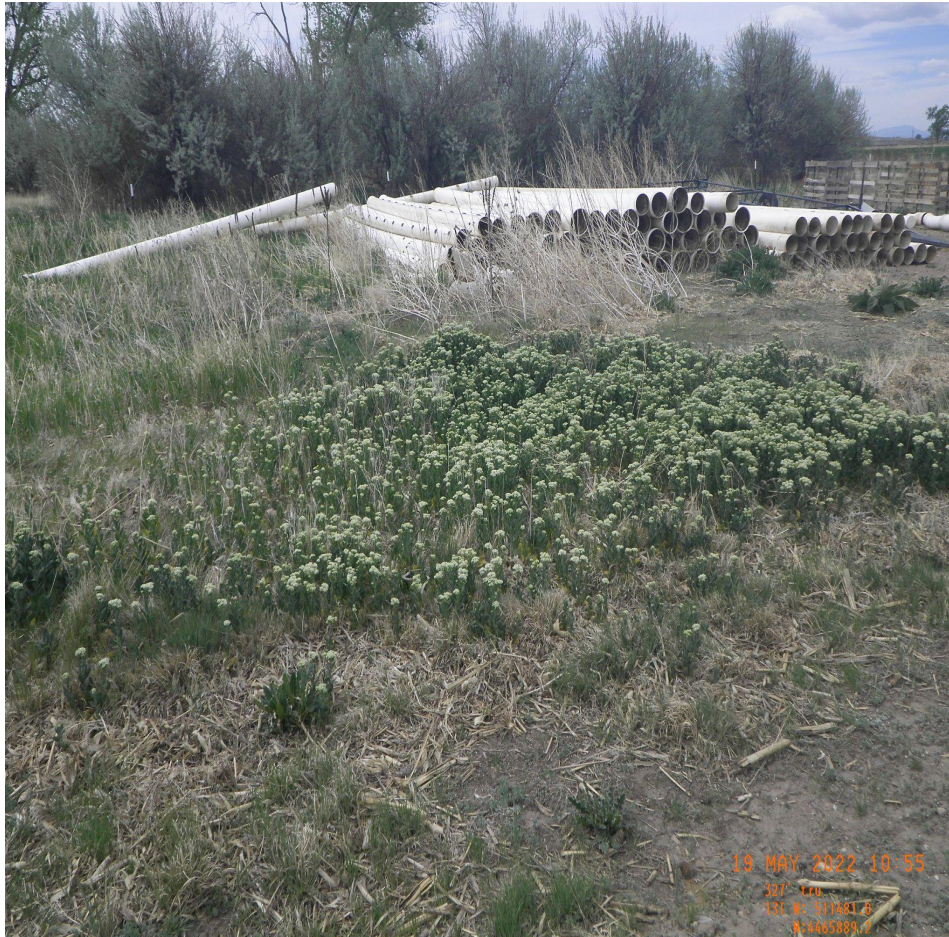
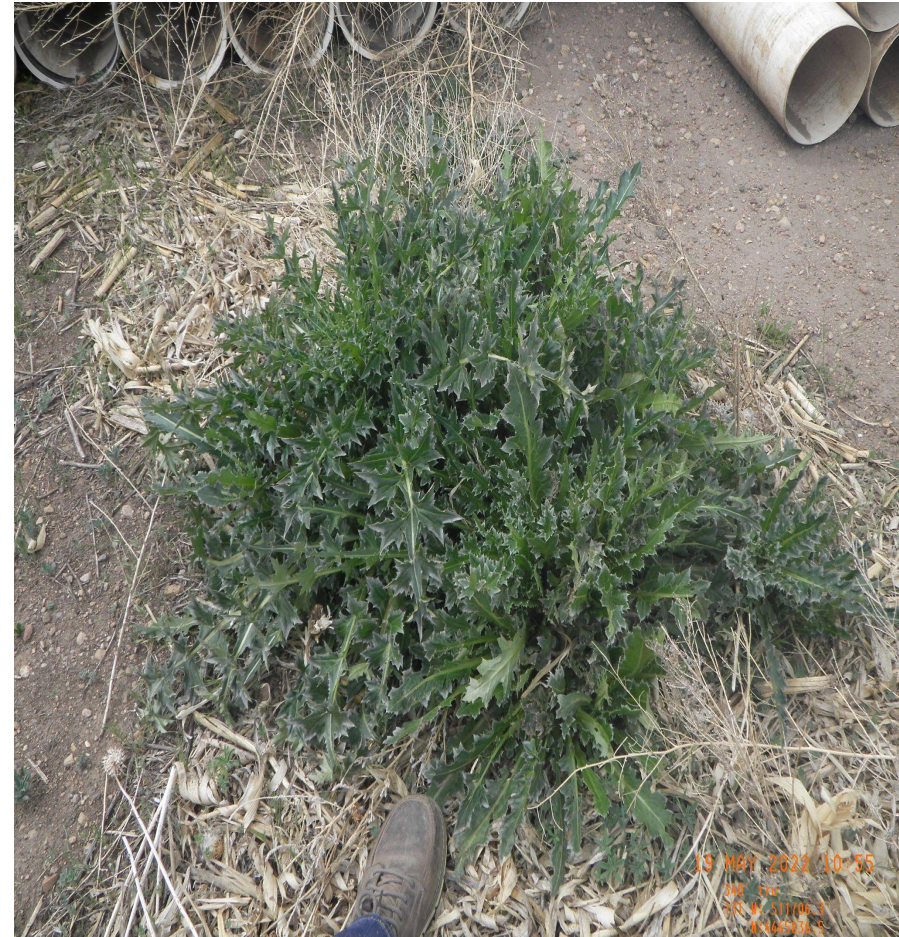
Photo 6. Hoary cress (left photo) and musk thistle (right photo) on southern edge of the tank battery.
