Resolved Photos – ALLISON UNIT 19M

05.067.08223

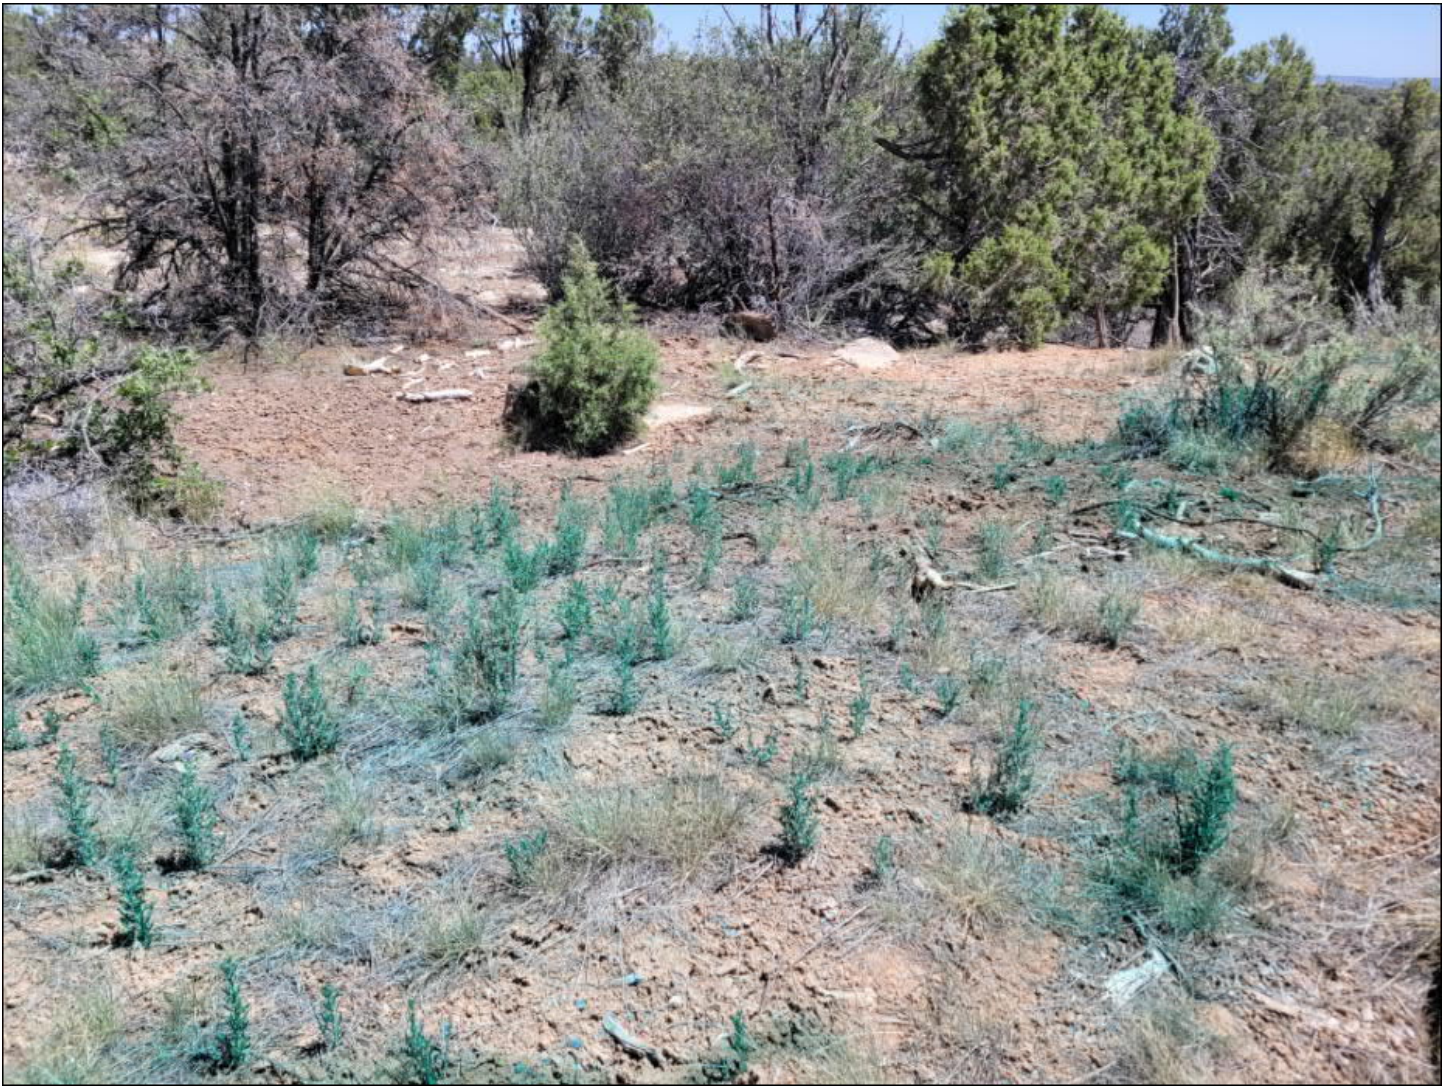
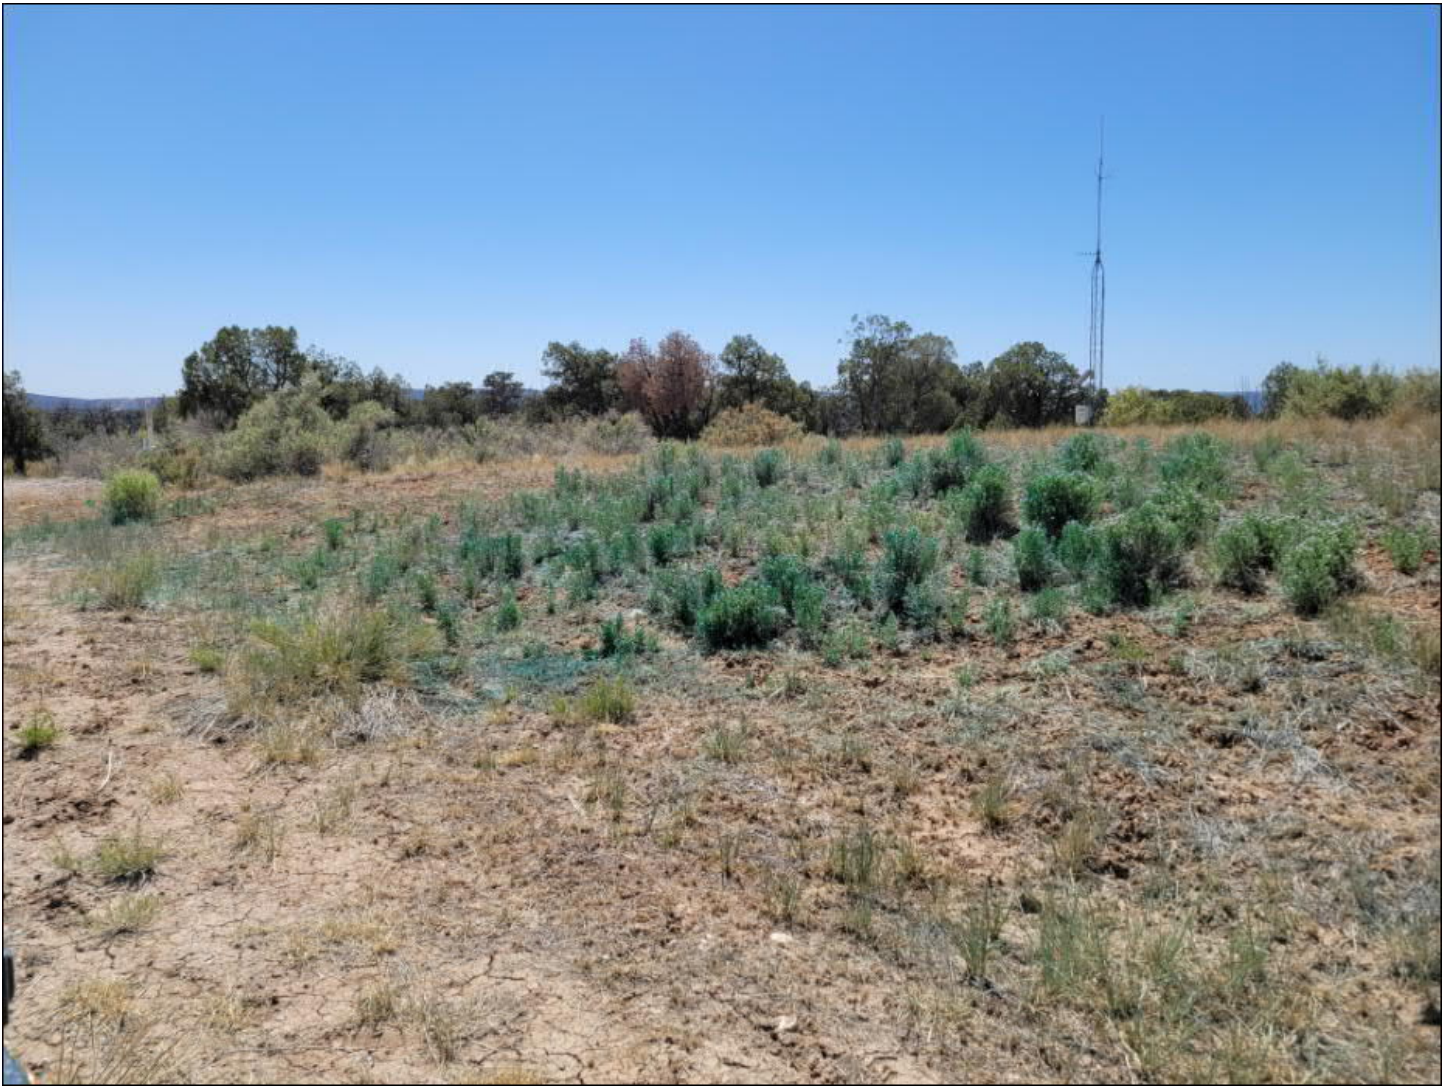
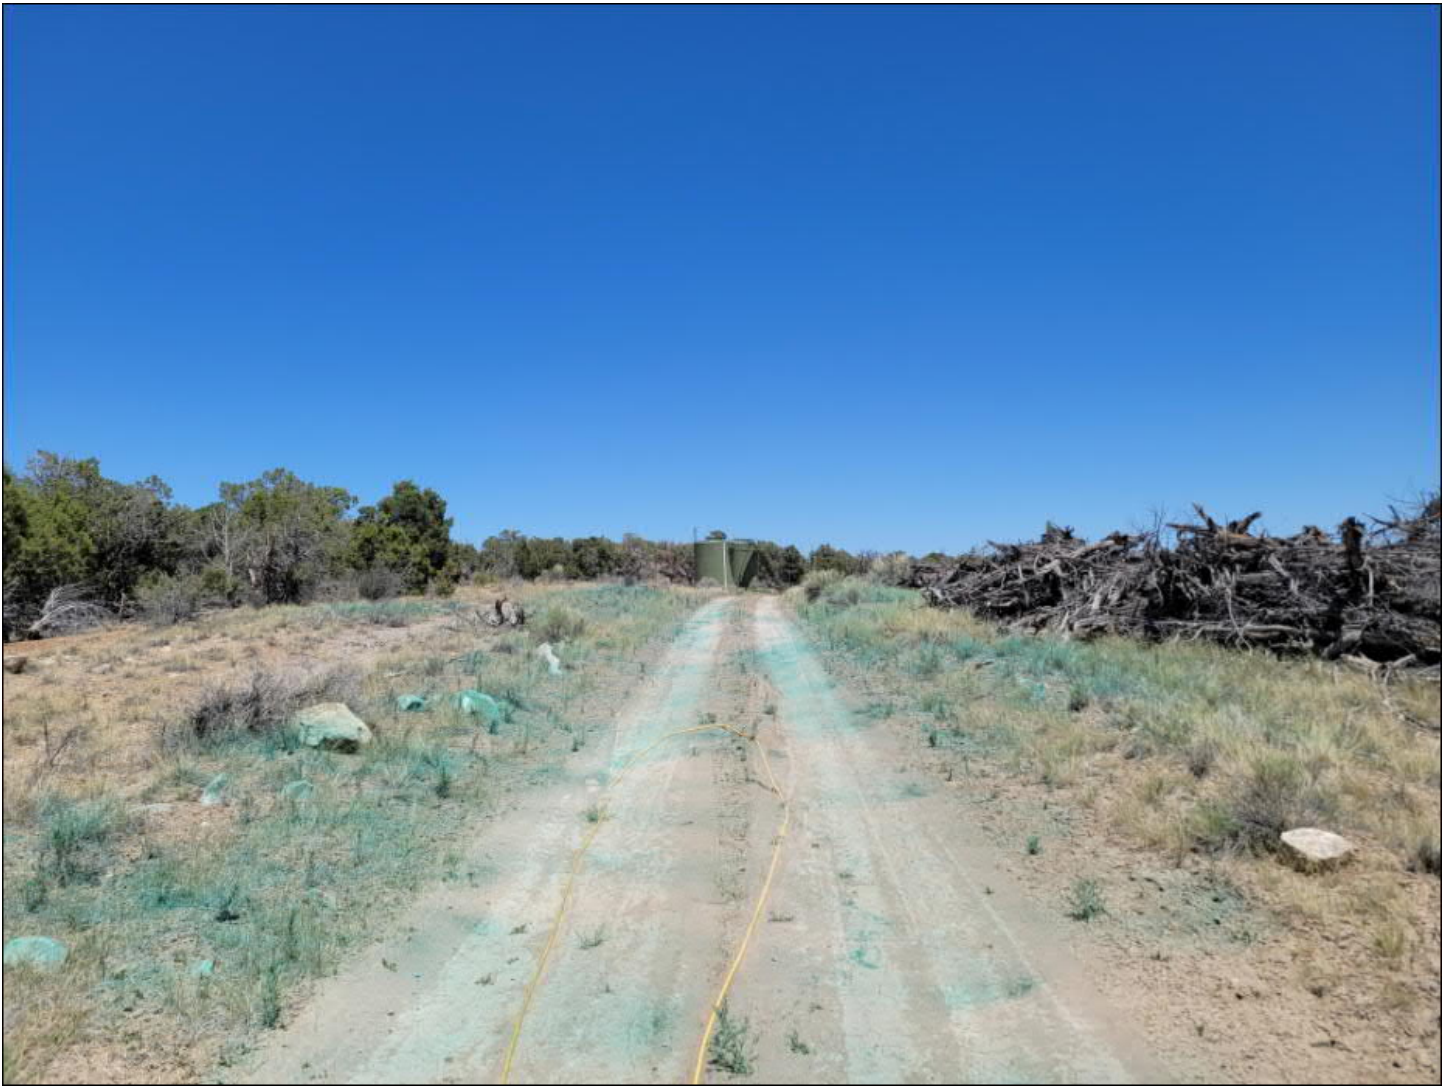
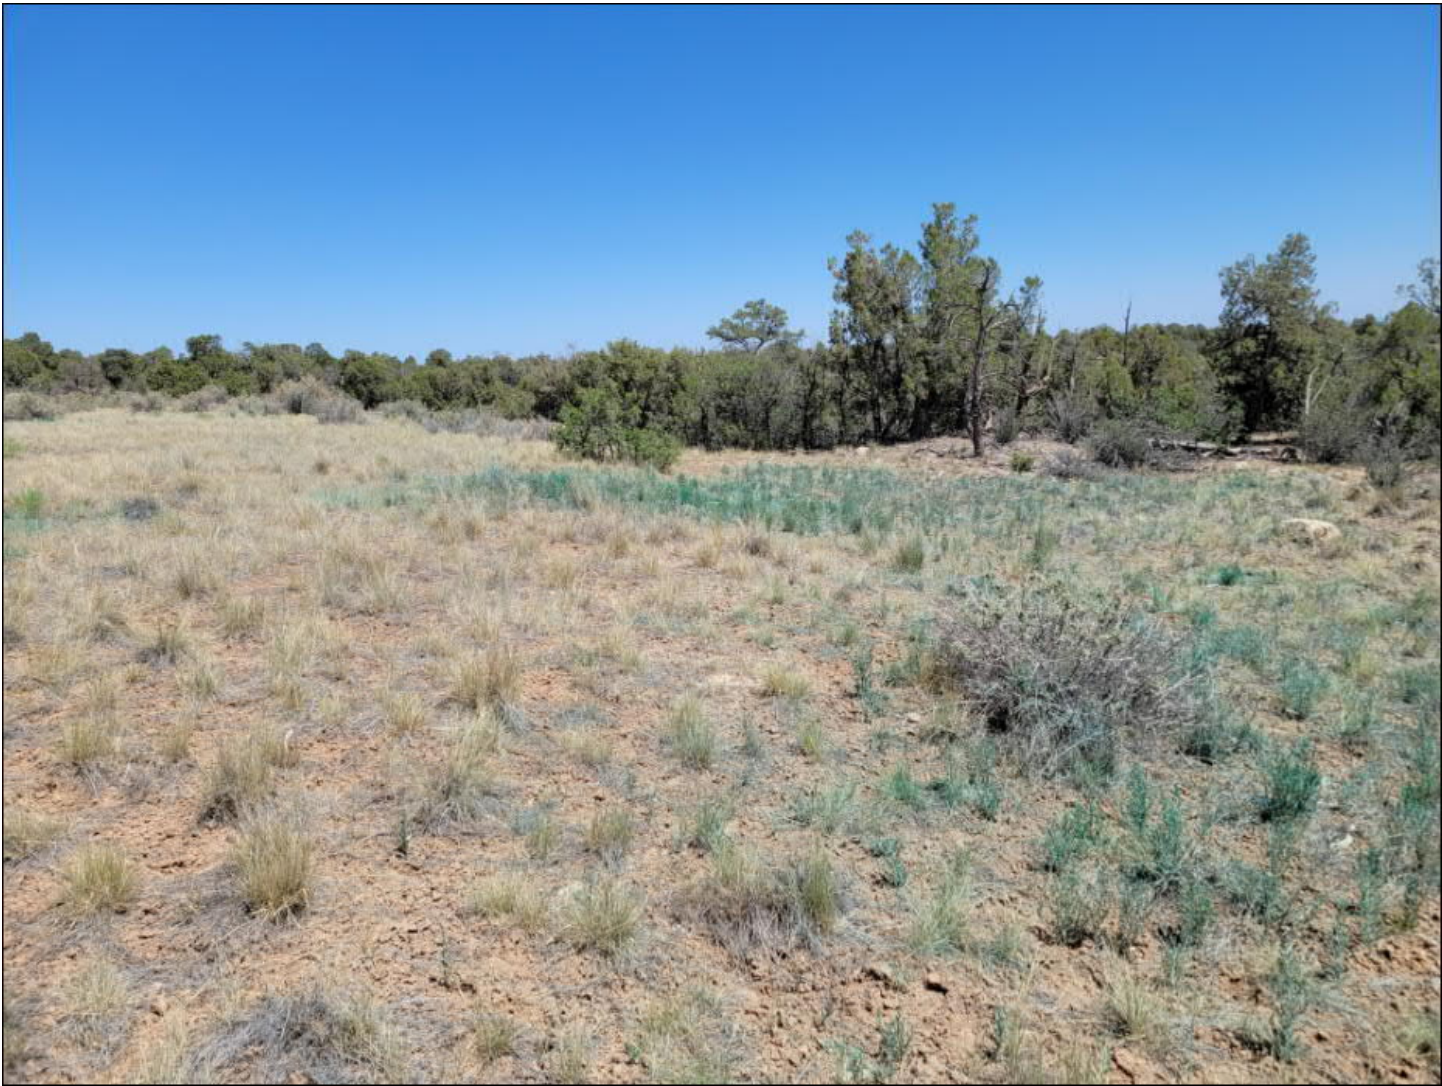
Today's Date:	5/26/2022					
Well Name:	ALLISON UNIT 19M	Location:	Sec: 24	Twn: 032N	Rng: 007W	UL: G
API Number:	05.067.08223	Footage:	2480' FNL & 2320' FEL			
Operator:	Hilcorp Energy Company	Area/Run/MSO:	05	0509	Brian Van Caster	
Meter #:	7670701		Pipeline:	HAR		
INC Number:	693904555	Agency:	COGCC	Inspector:	Catherine Roy	
Type of INC:	Written	Photos Required:	Yes	Due Date:	6/30/2022	
Issue of Concern:	On 5/24/2022 Catherine Roy conducted a reclamation and stormwater inspection. During this inspection the following compliance issues were observed: -Control weeds. Due to the extent of the infestation a treatment plan is needed and multiple treatments will likely be needed. Seeding in treatment areas may be needed after infestation is controlled. Corrective action date: 6/30/2022					
	See below, and attached photos for additional detail.					
	Thousands of Russian knapweeds observed within the interim reclamation areas and along the western access road.

-Control weeds. Due to the extent of the infestation a treatment plan is needed and multiple treatments will likely be needed. Seeding in treatment areas may be needed after infestation is controlled. Corrective action date: 6/30/2022

Russian Knapweeds have been sprayed. See pics.
