Today's Date:	5/26/2022					
Well Name:	ALLISON UNIT 25M	Location:	Sec: 19	Twn: 032N	Rng: 006W	UL: G
API Number:	05.067.08186	Footage:	2410' FNL & 2305' FEL			
Operator:	Hilcorp Energy Company	Area/Run/MSO:	05	0509	Brian Van Caster	
Meter #:	7666701		Pipeline:	HAR		
INC Number:	693904549	Agency:	COGCC	Inspector:	Catherine Roy	
Type of INC:	Written	Photos Required:	Yes	Due Date:	6/30/2022	
Issue of Concern:	<p>On 5/24/2022 Catherine Roy conducted a reclamation and stormwater inspection. During this inspection the following compliance issues were observed:</p> <p>-Treat and remove tamarisk tree on access road. Corrective action back-dated to original date: 6/1/2020 -Stabilization measures need to be conducted on the well pad to prevent deep tracking and stabilize driving surface. Additionally, operator needs to close reclamation areas to vehicle traffic and educate personnel to avoid driving on reclamation areas in order to prevent site degradation. Corrective action date 6/30/2022.</p> <p>See below, and attached photos for additional detail.</p> <p>Deep rutting (approx 12-18 inches) observed within the northern project area. Vehicle tracking observed within the reclamation area resu

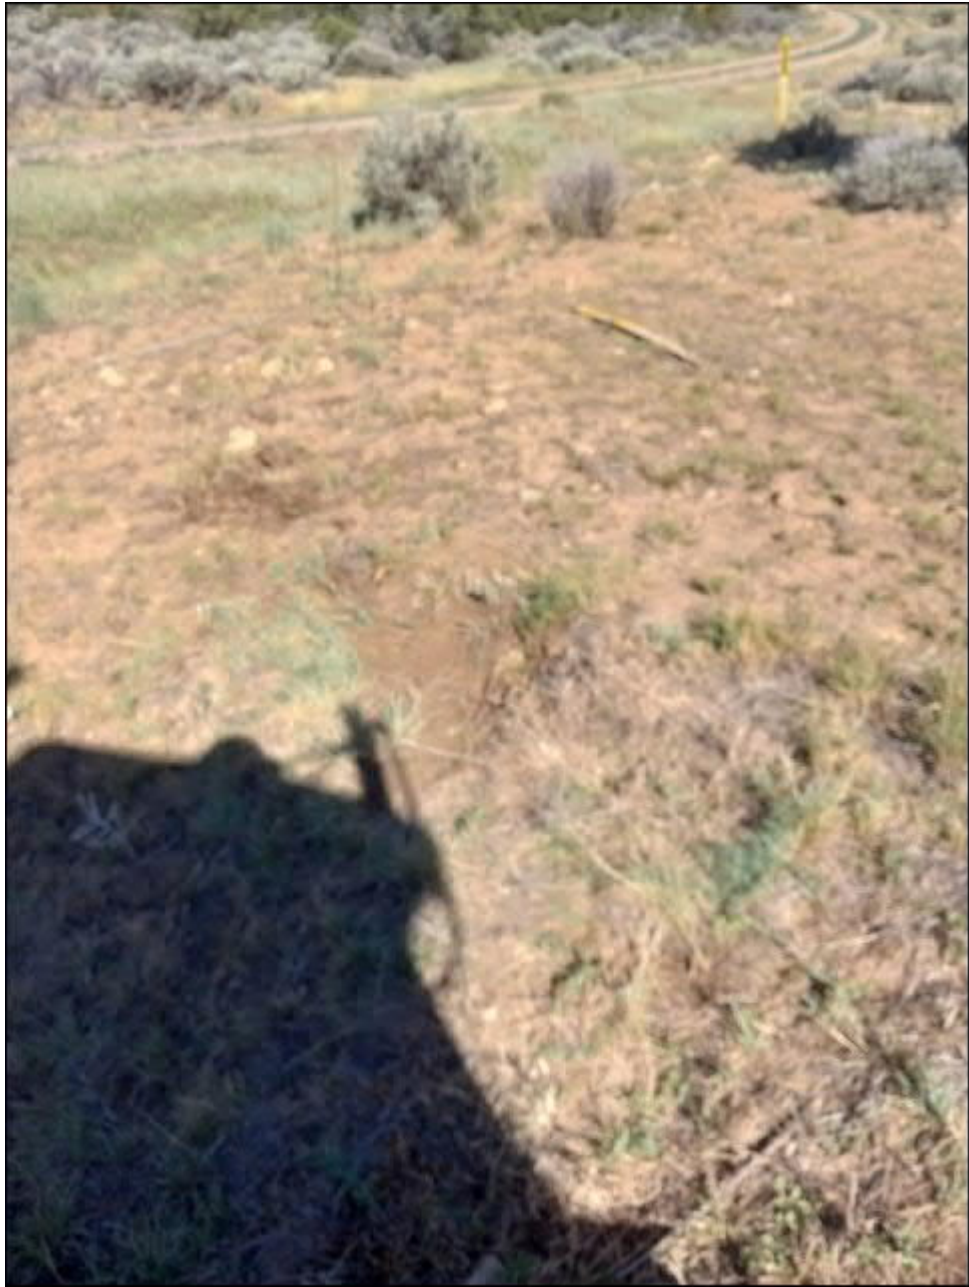
Tamarisk tree has been removed.

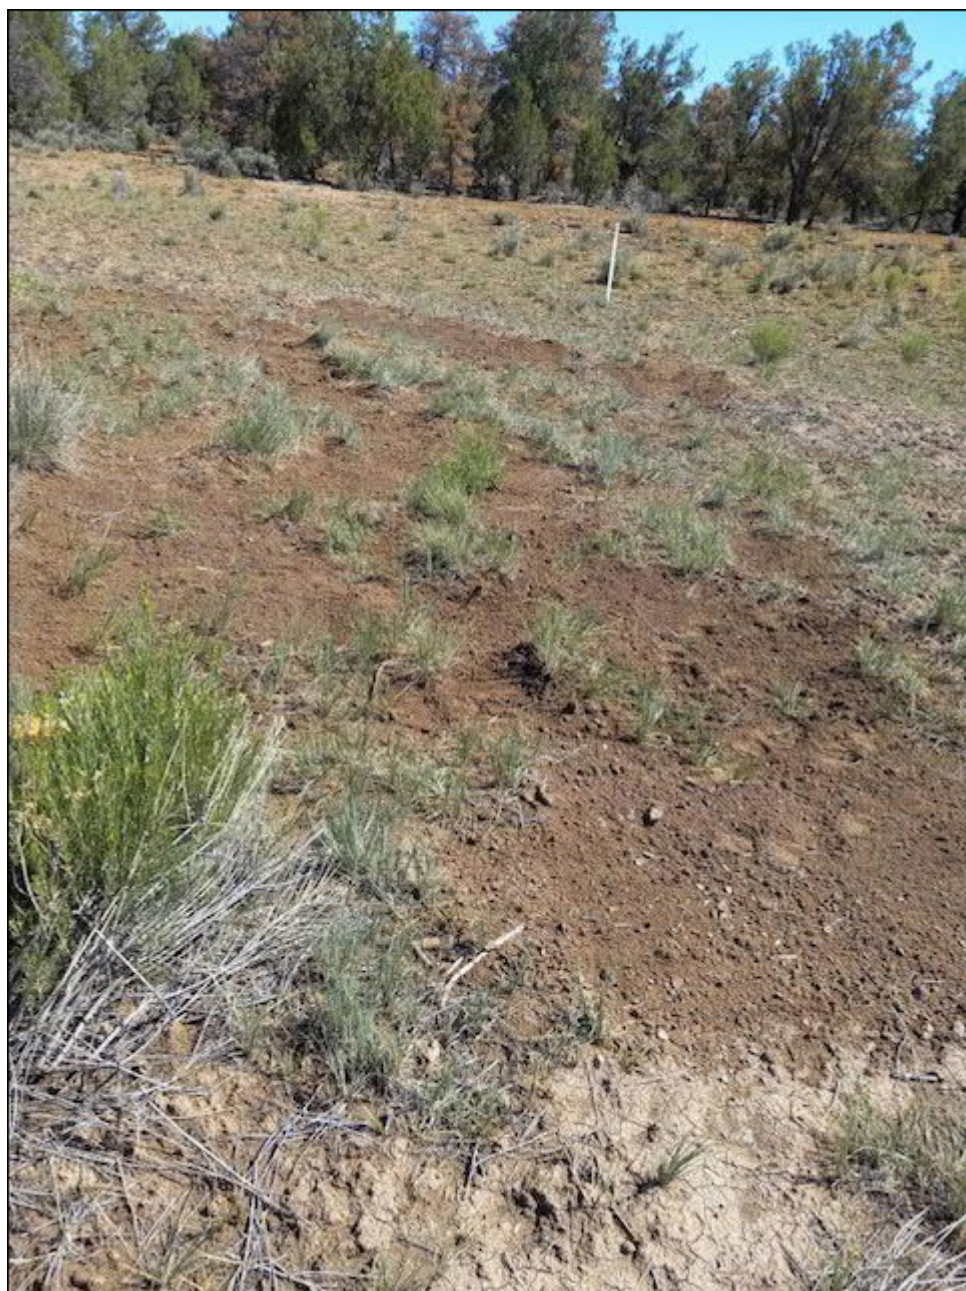
Signs and fencing installed to keep vehicles off reclaimed area

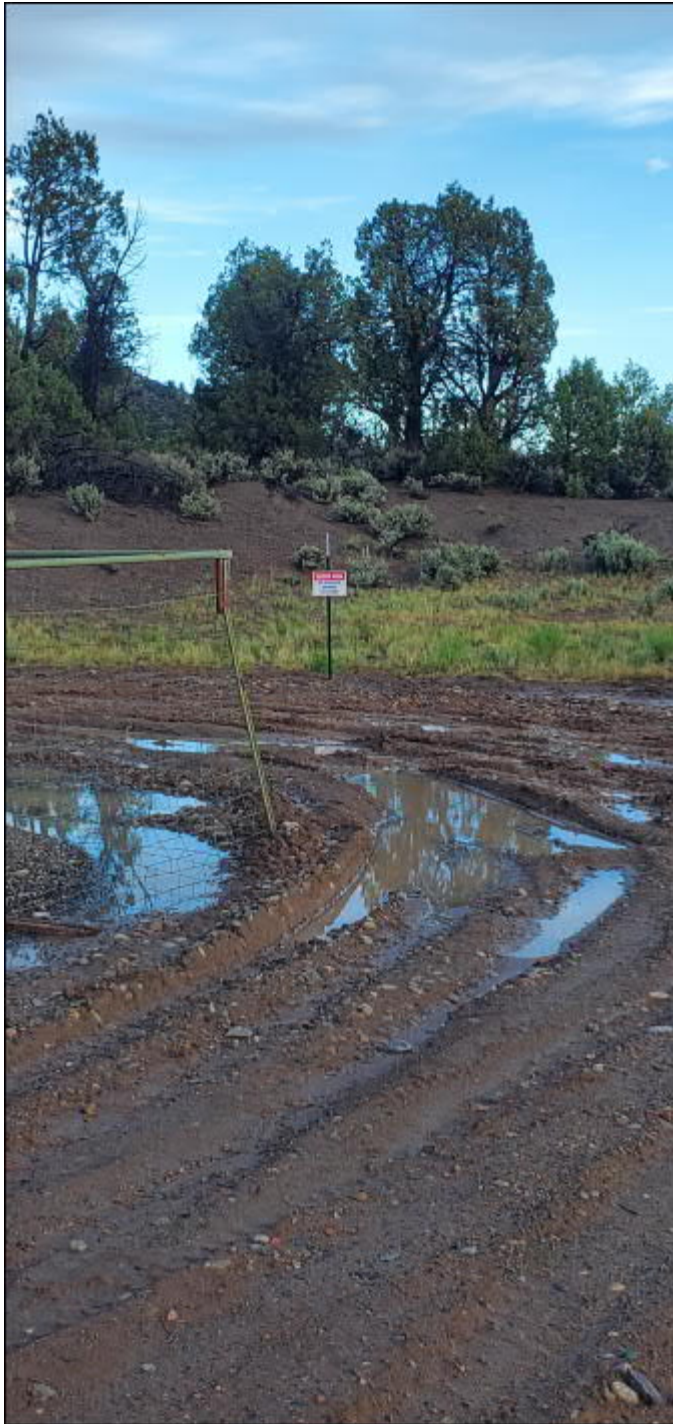
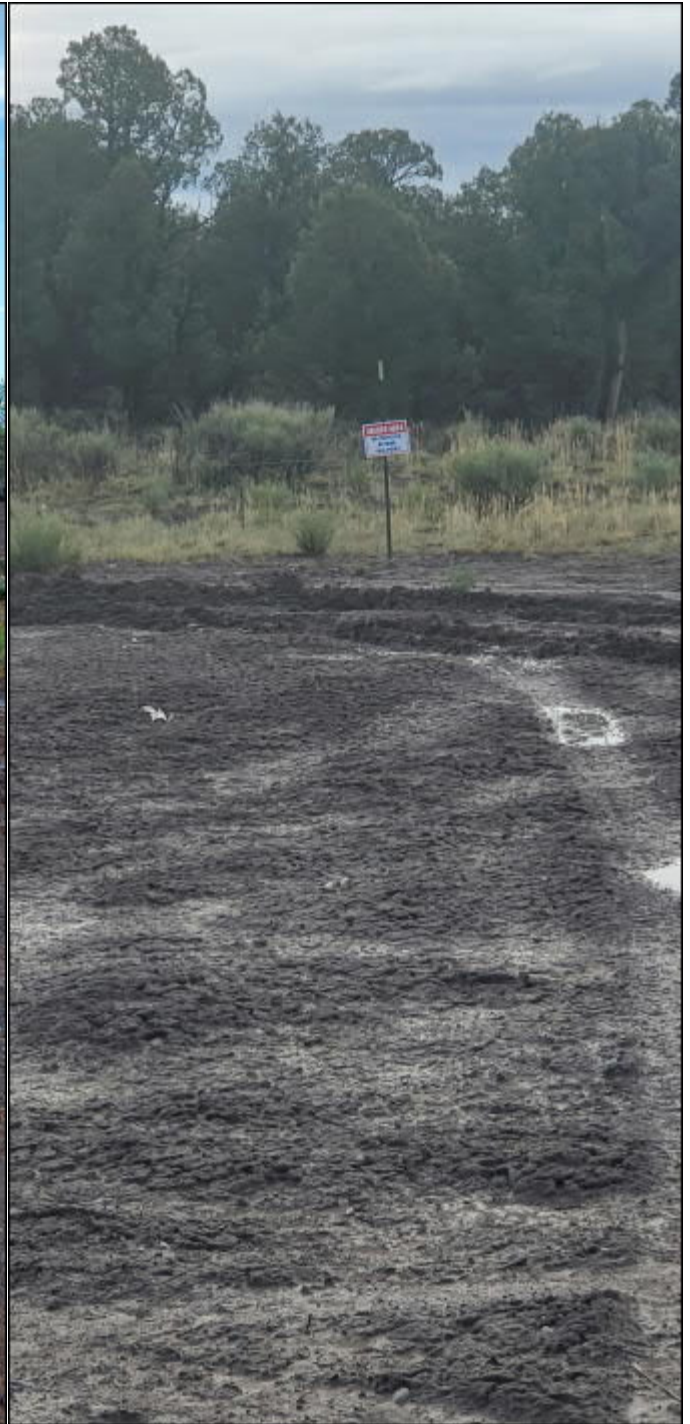
Location ruts have been filled in and repaired.
