Catamount Energy Partners
COGCC Inspection 702500119 Remedial Report
Work Completed 7/6/2022

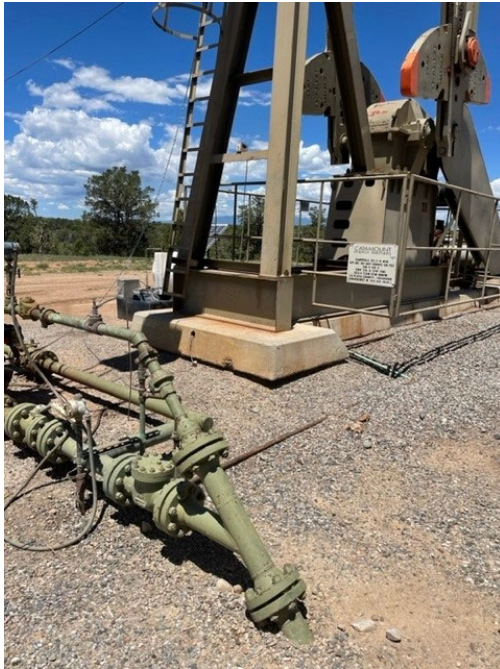
- Comment: Unused equipment near wellhead (IMG 03). Unused 2" pipe near secondary containment (IMG 05), unused filters within secondary containment (IMG 04). Use or remove unused equipment/debris per rule 606.
Action Taken: 2" pump line & temporary fencing from Campbell 33-7-4#2H wellhead to separator removed. 2" pipe on north side of tank containment removed. Tubing rotator on Campbell 33-7-4#1H removed. Water filters removed from location
- Comment: 4 marked rig anchors. 3 rig anchors are less than 4' in height (IMG 06). Install proper guy line markers per Rule 1003.a
Action Taken: All rig anchors removed.

Removed tubing rotator

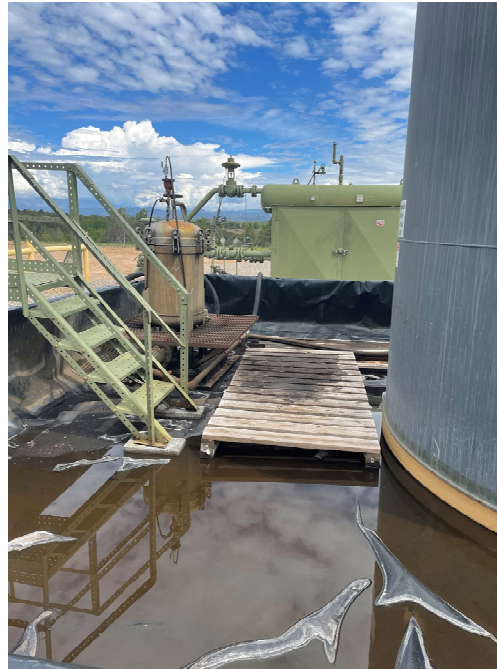
Removed Water filters

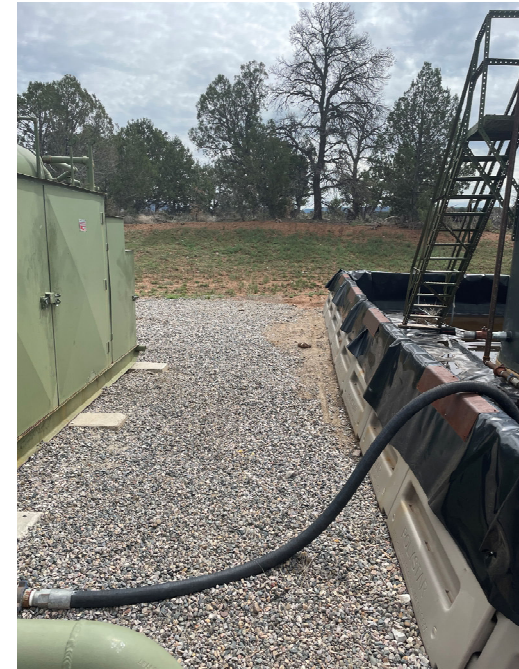
Removed unused 2" pipe

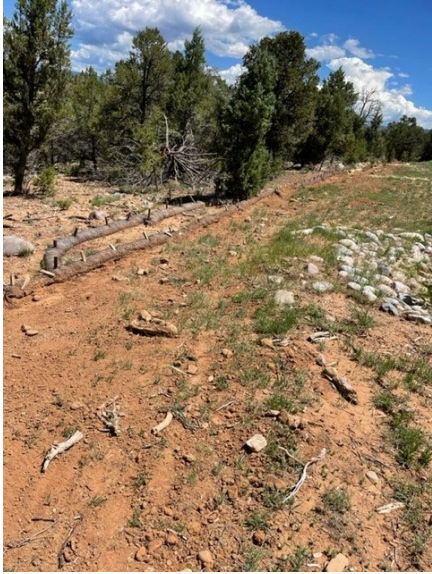
North Edge of Pad

- Comment: Several wattles on west and north side of location are filled with sediment (IMG 07). Repair required BMPs per Rule 1002.f.(2)C
Action Taken: Wattles in disrepair surrounding location have been cleaned, replaced, and/or reset. Areas near wattles raked and hand reseeded.
