# Inspection Photos

API: 061-06867

Operator: MULL DRILLING COMPANY INC

Inspection Date: 7/7/2022

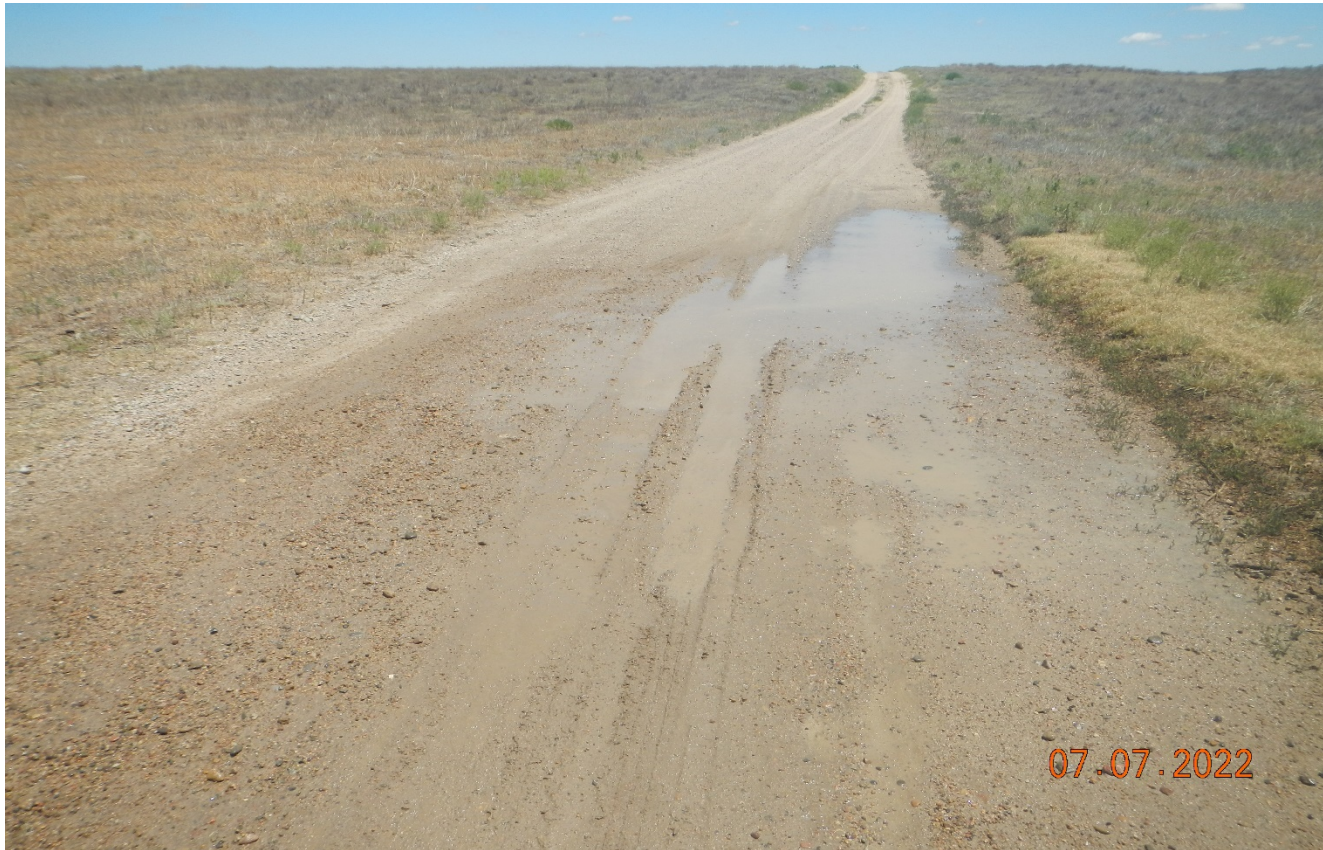
**Photo 1.** Facing northeast along the access road. There are areas where stormwater is pooling on the road causing vehicles to drive around and widen the road. This area needs to be stabilized with BMP's such as gravel. Stormwater should be diverted off the road.

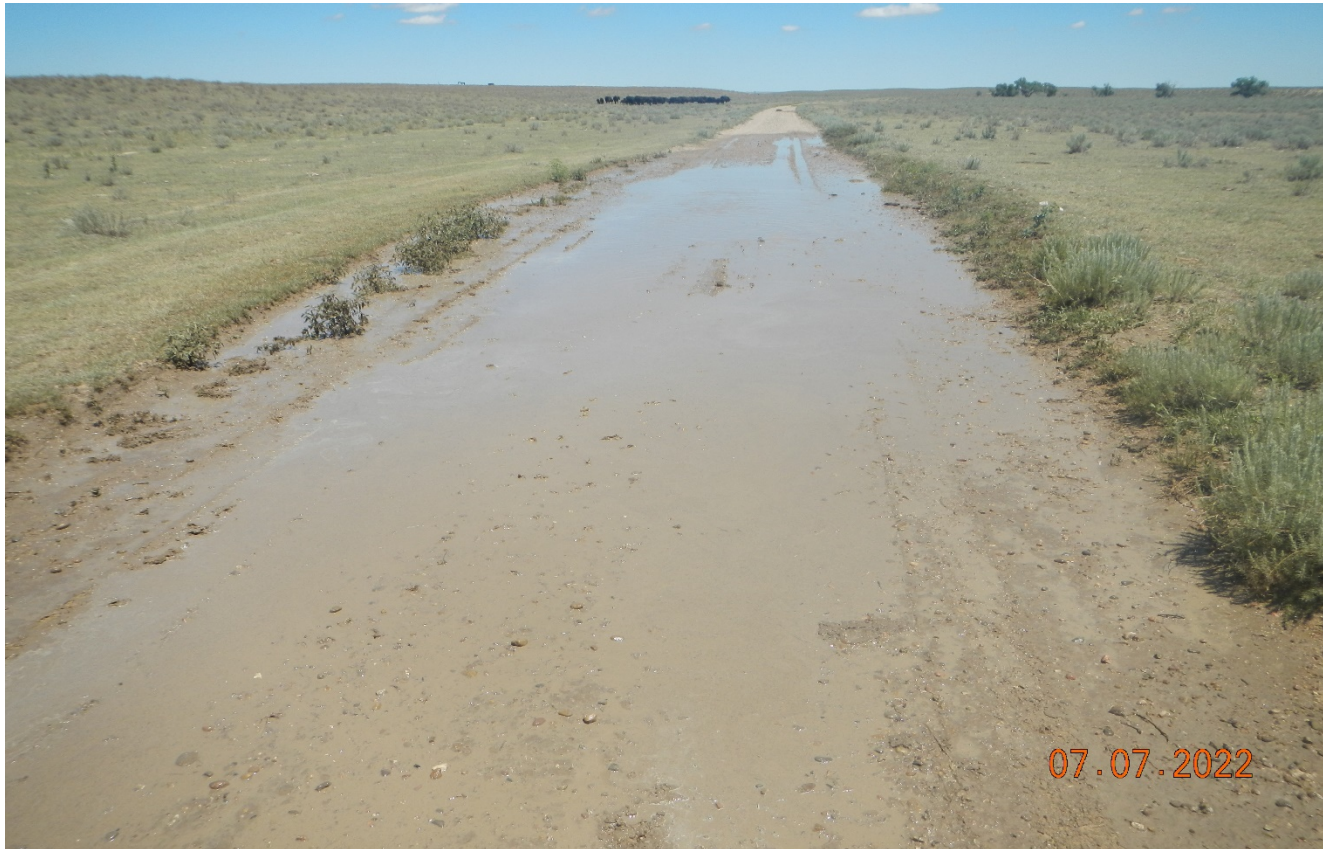
**Photo 3.** Facing northeast along the access road. There are areas where stormwater is pooling on the road causing vehicles to drive around and widen the road. This area needs to be stabilized with BMP's such as gravel. Stormwater should be diverted off the road.

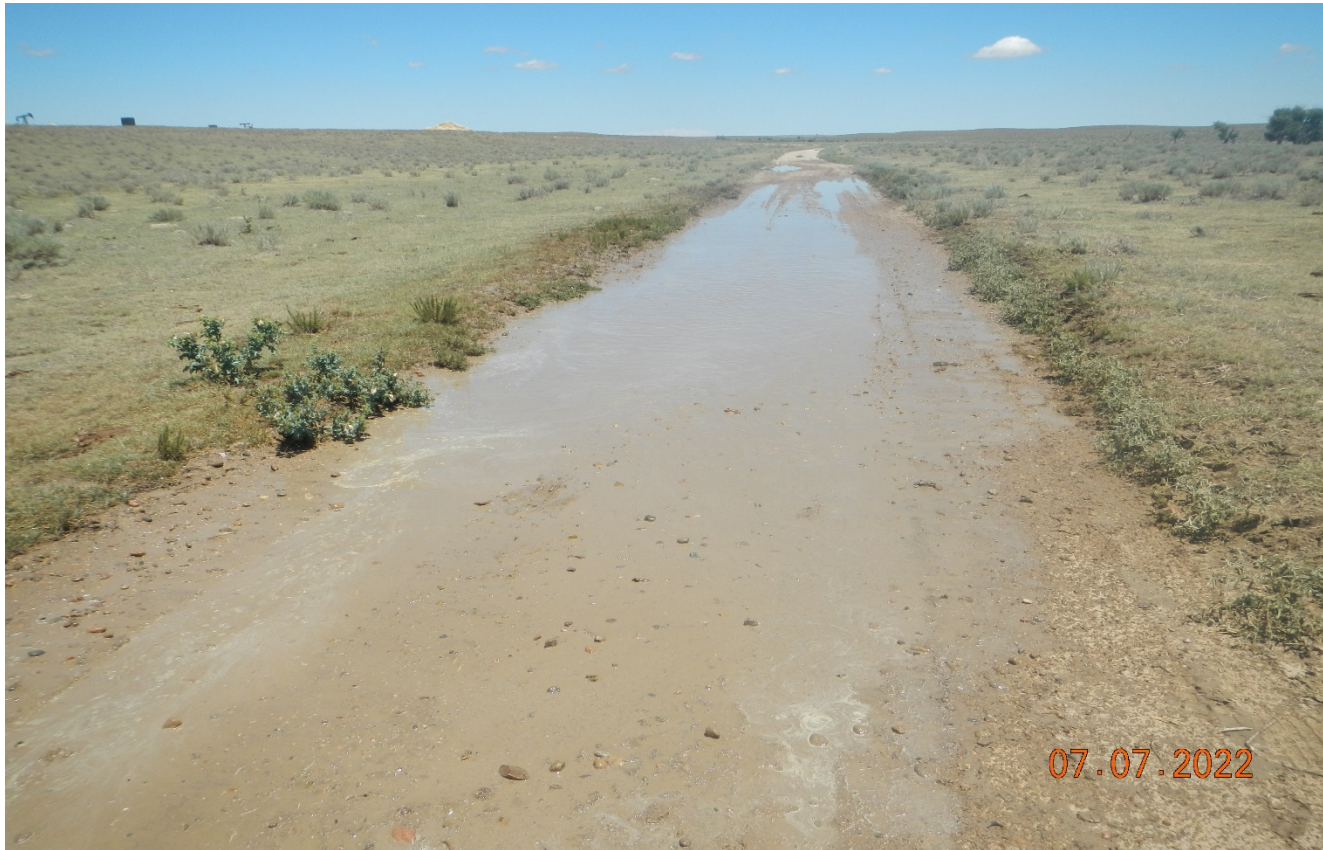
**Photo 4.** Facing northeast along the access road. There are areas where stormwater is pooling on the road causing vehicles to drive around and widen the road. This area needs to be stabilized with BMP's such as gravel. Stormwater should be diverted off the road.

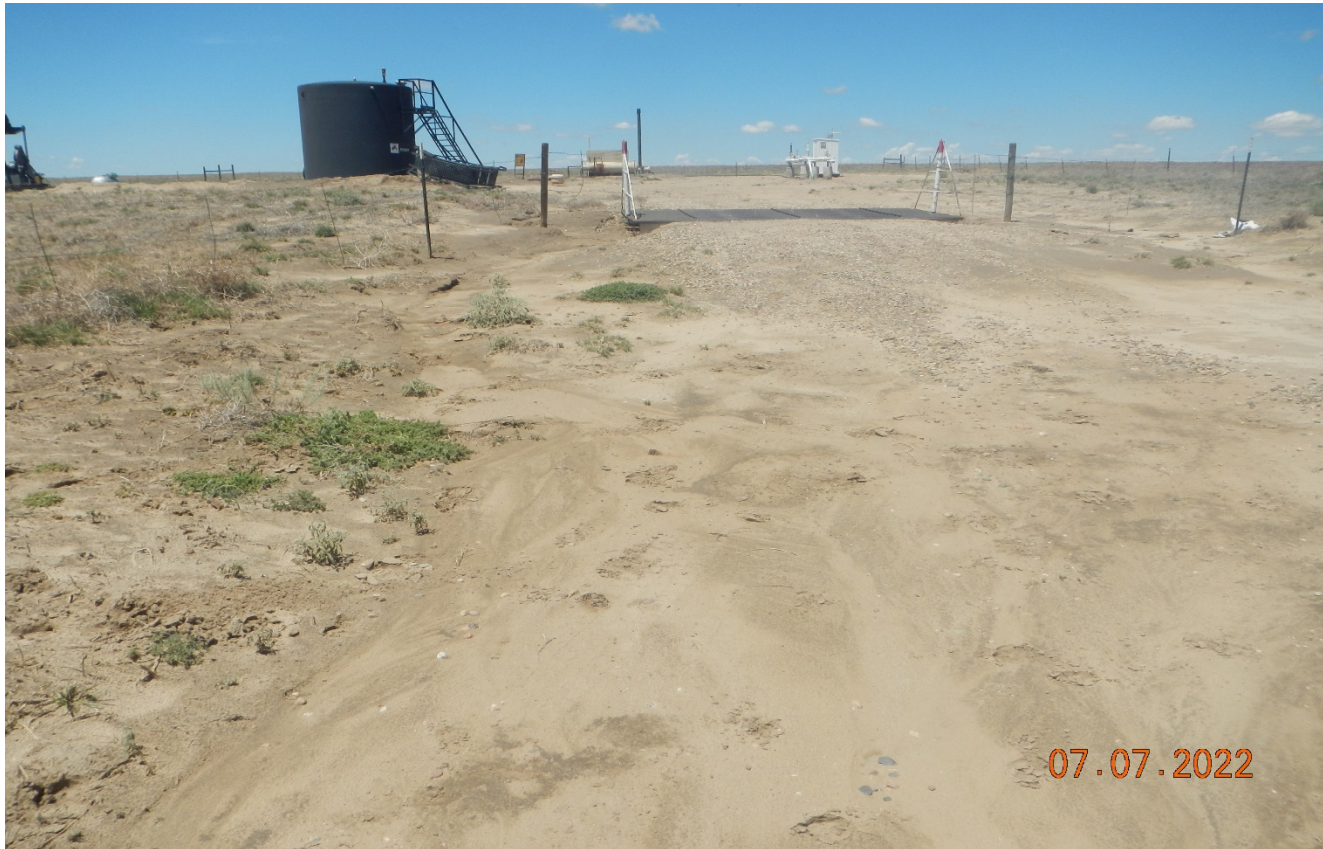
**Photo 6.** Facing west toward the well site. There is erosion occurring at the cattleguard that needs to be repaired.

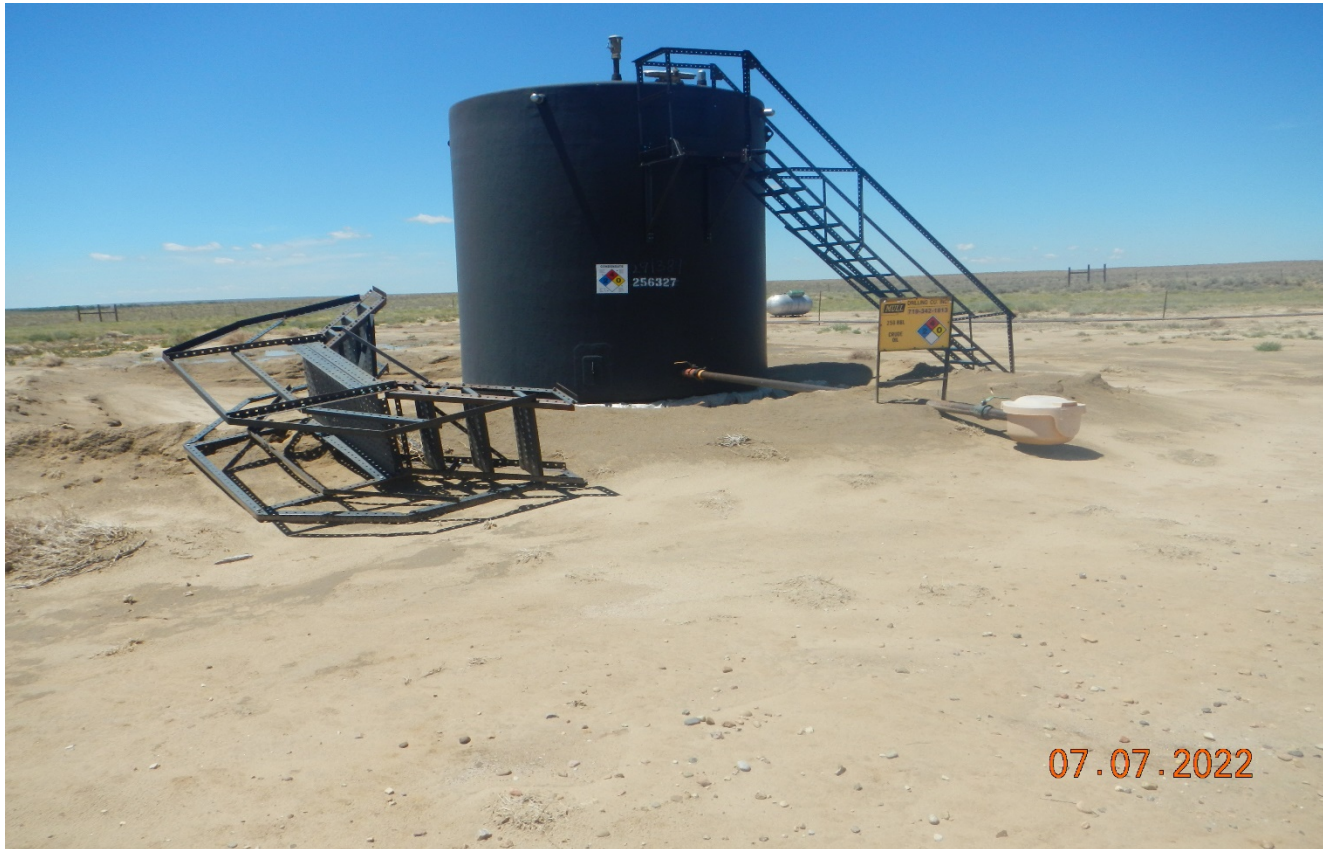
**Photo 7.** Facing southeast toward the location. The catwalk is tipped over and not in use and should be removed.

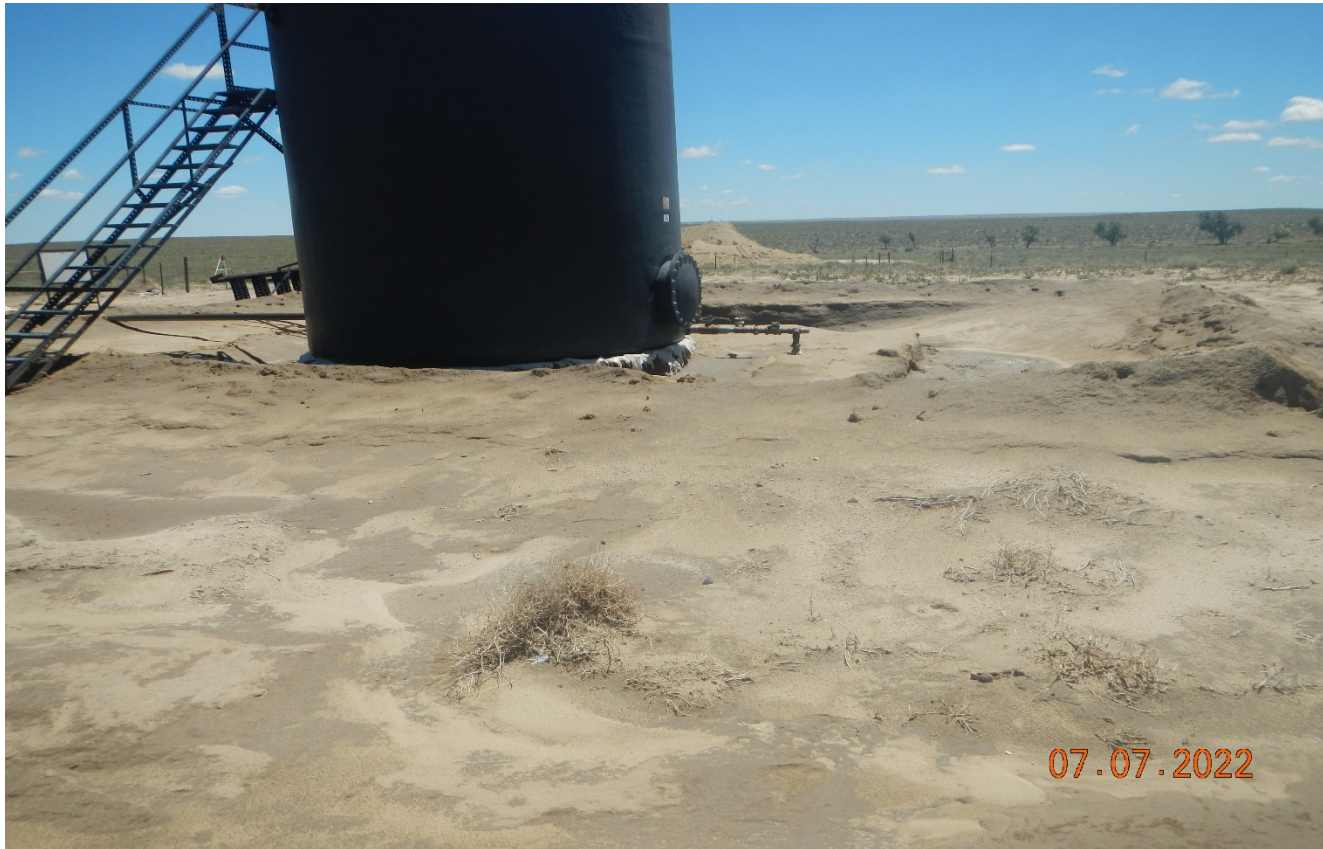
**Photo 8.** Thee berms around the tank are inadequate and need to be repaired.

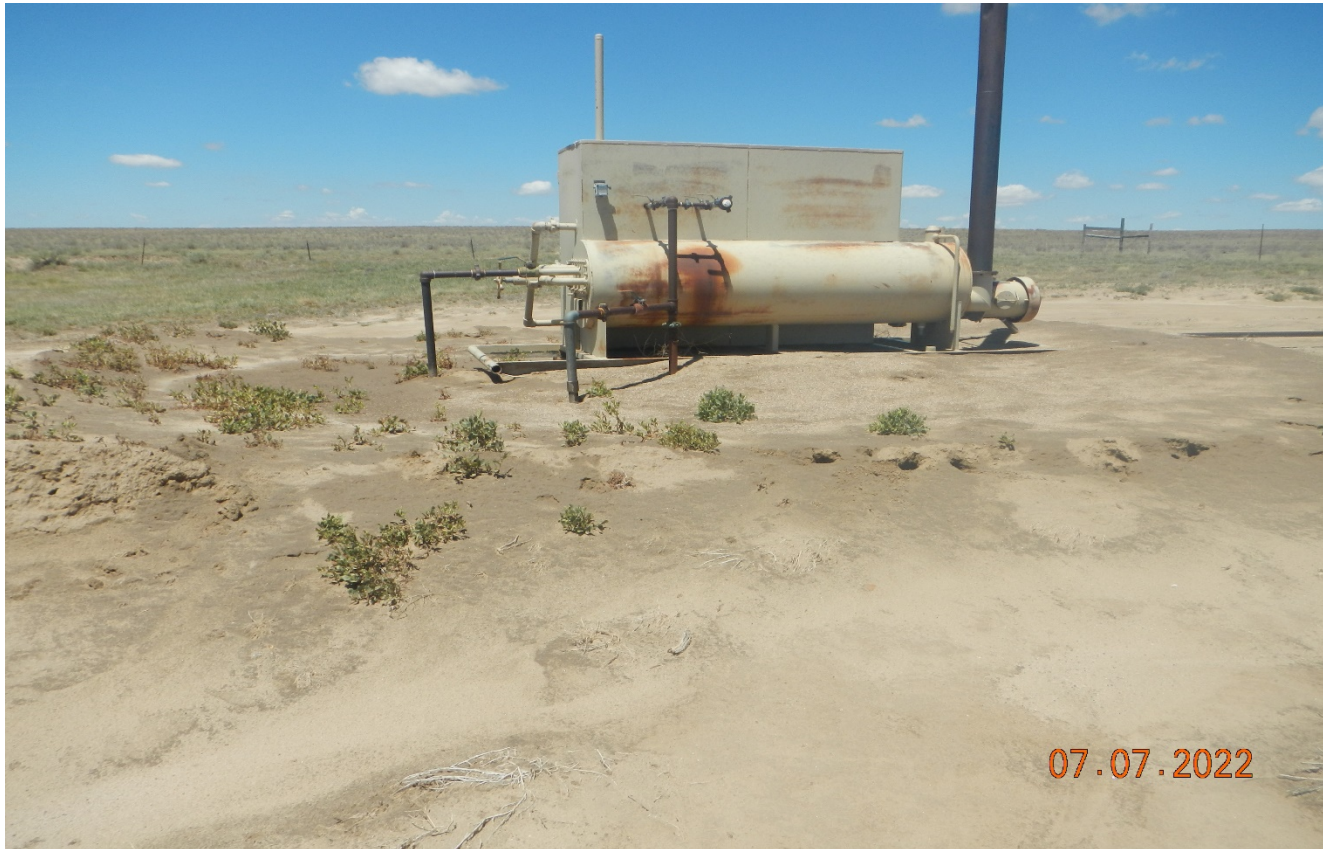
**Photo 9.** Thee berms around the separator are inadequate and should be repaired.
