Inspection Photos

Location Name: Weco-UPRC Kleitz 23-29-67N92W
/29NESW

Inspection Document #: 702800386

Moffat County, CO

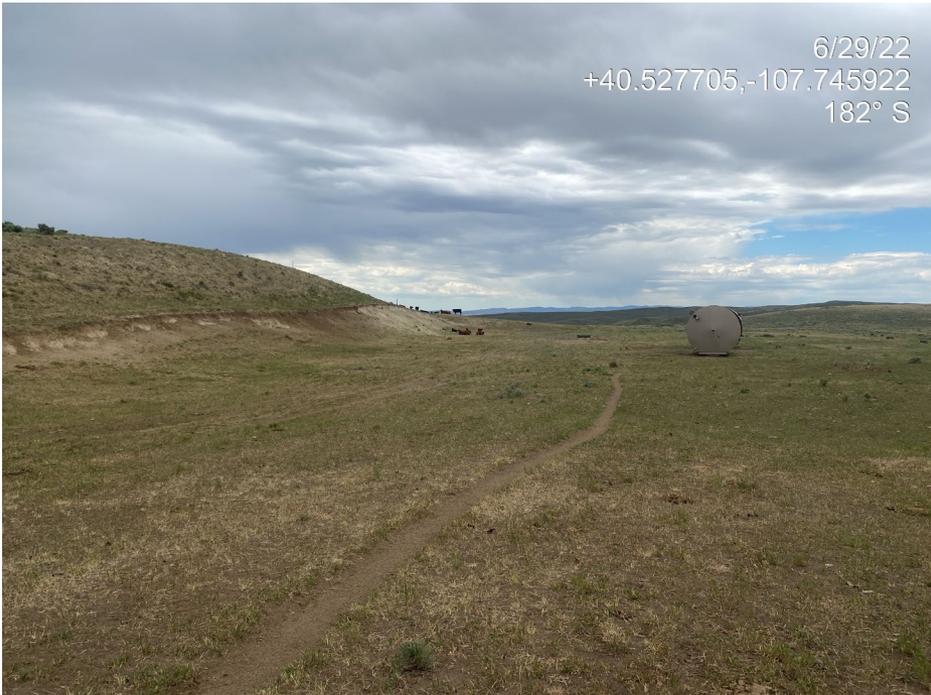
Photo 1. Photo taken from the north of the Location shows an overview of the east of the Location.

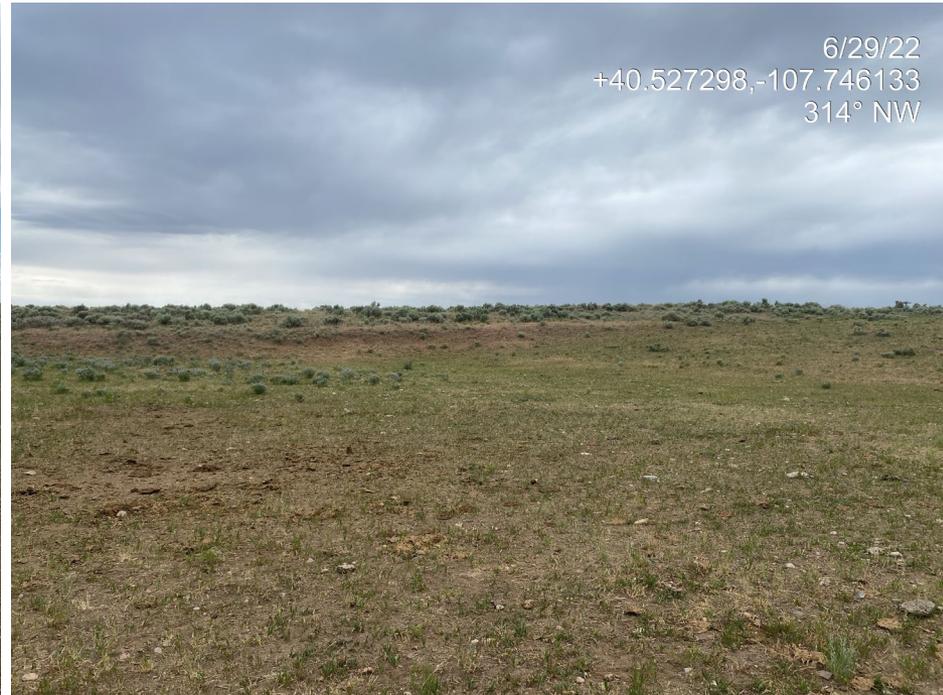
Photo 2. Photo taken from the north of the Location shows an overview of the west of the Location.

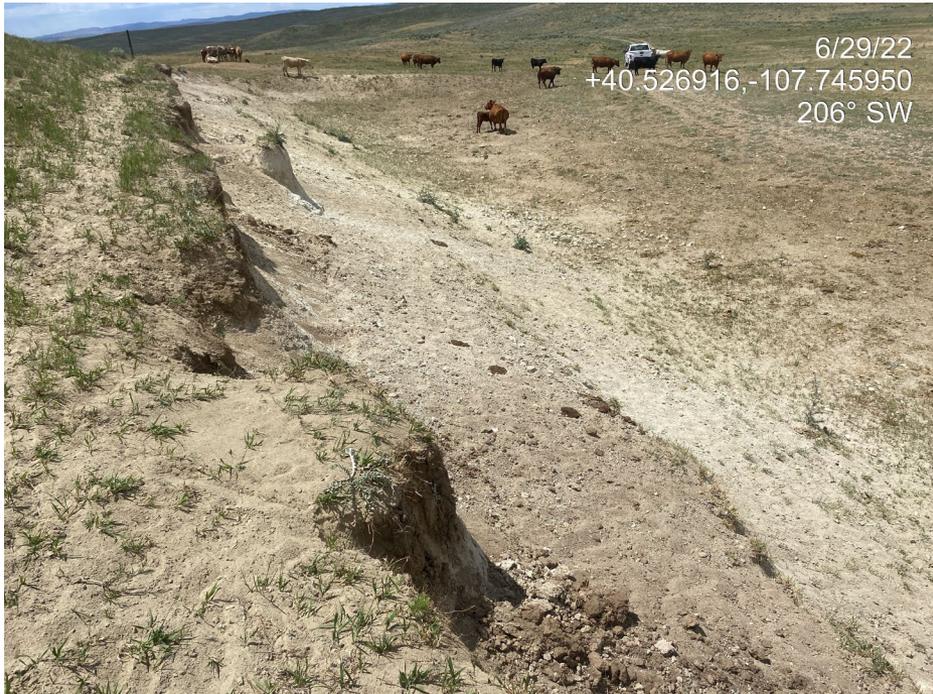
Photo 3. Photo taken from the east of the Location shows the cut slope is bare and eroded. Undercutting is occurring, resulting in soil loss.

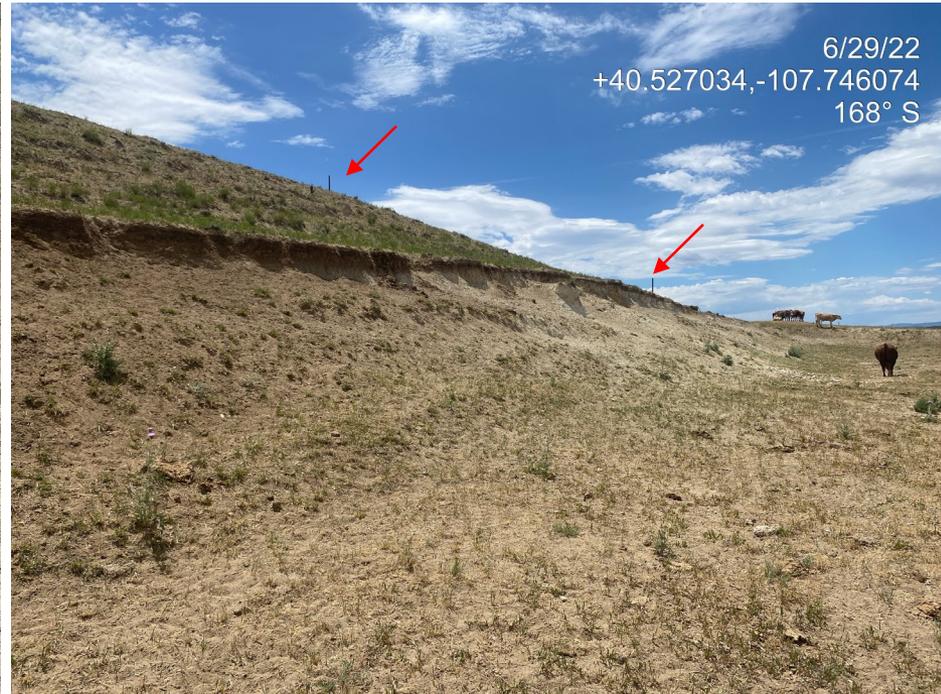
Photo 4. Photo taken from the east of the Location shows the unstabilized cut slope is undercutting. Note also, two metal poles remain on Location.

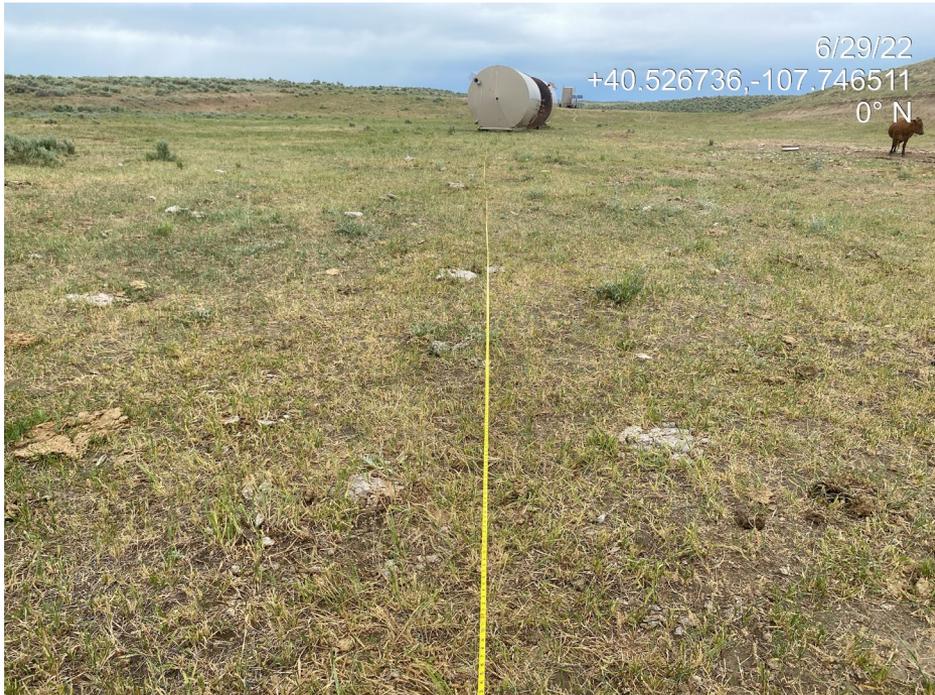
Photo 5. Photo taken from the south of the Location at the start of Disturbed Transect 1 shows an overview of the transect. Note also, two tanks remain on Location.

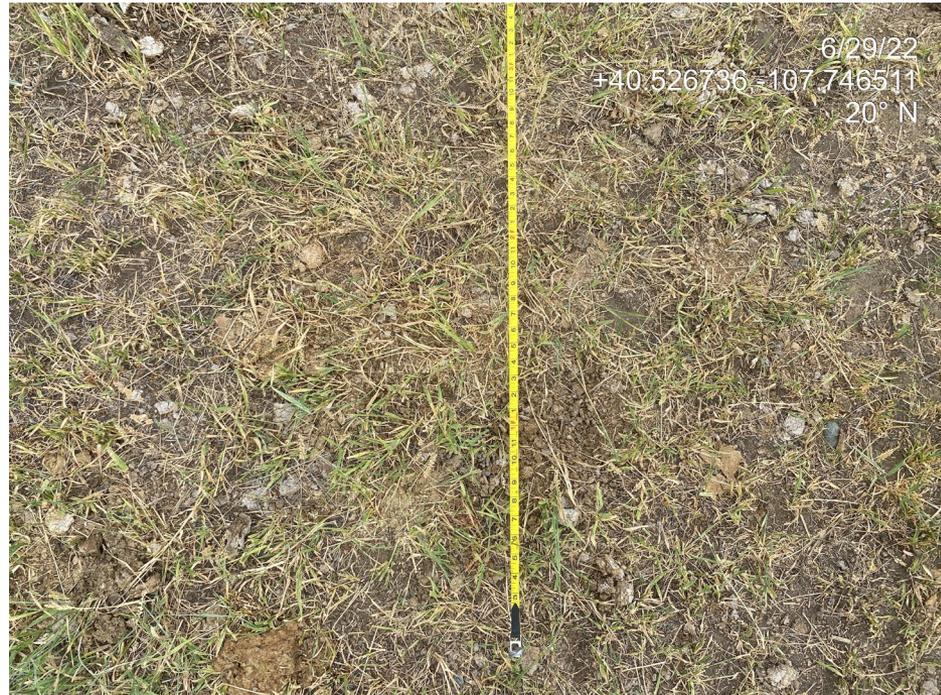
Photo 6. Photo taken from the south of the Location at the start of Disturbed Transect 1 shows the ground surface.

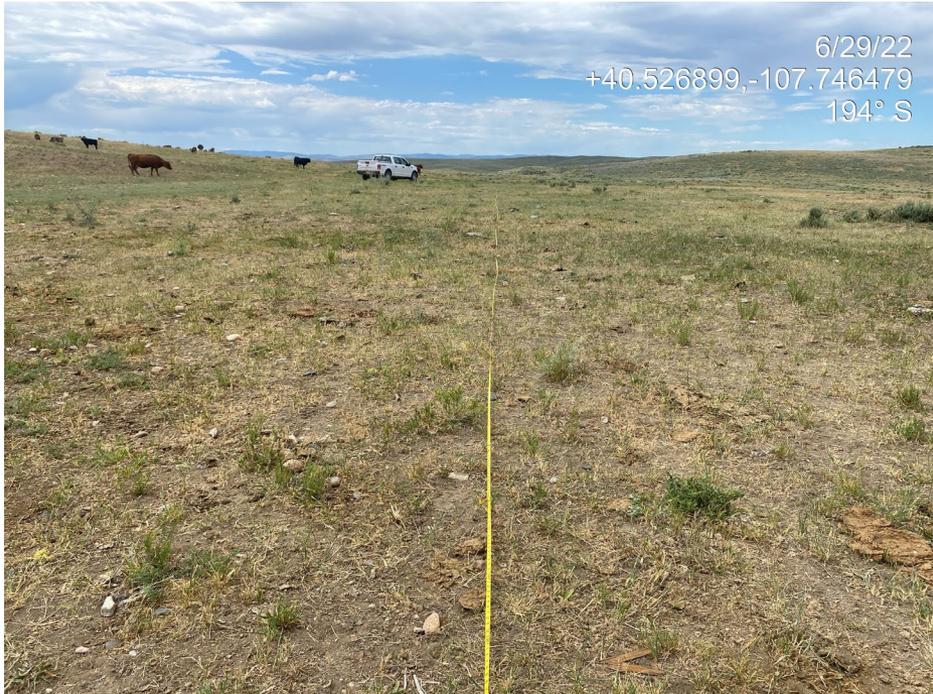
Photo 7. Photo taken from the center of the Location at the end of Disturbed Transect 1 shows an overview of the transect.

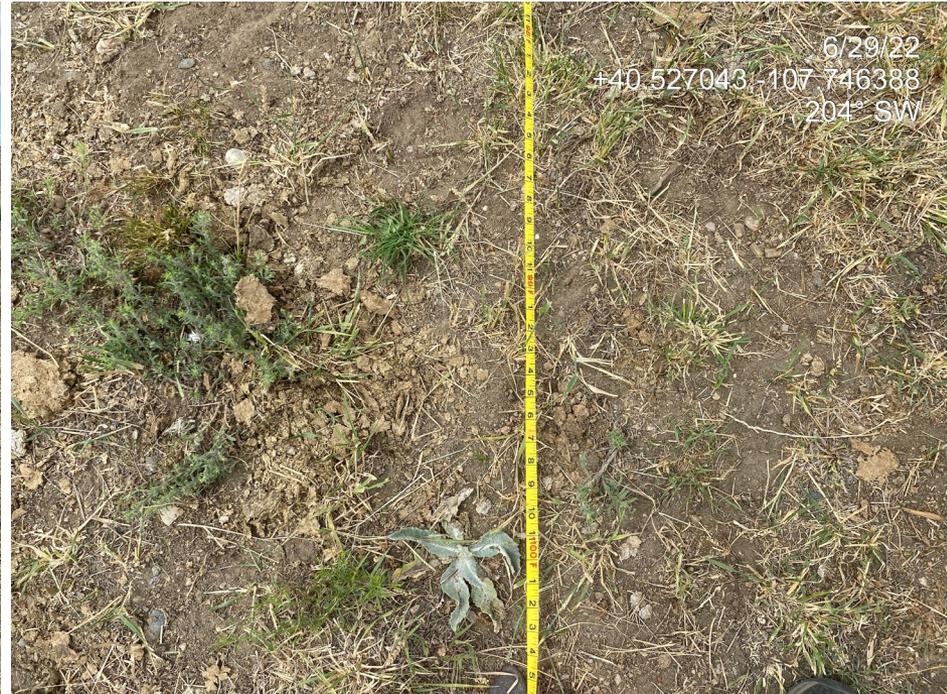
Photo 8. Photo taken from the center of the Location at the end of Disturbed Transect 1 shows the ground surface.

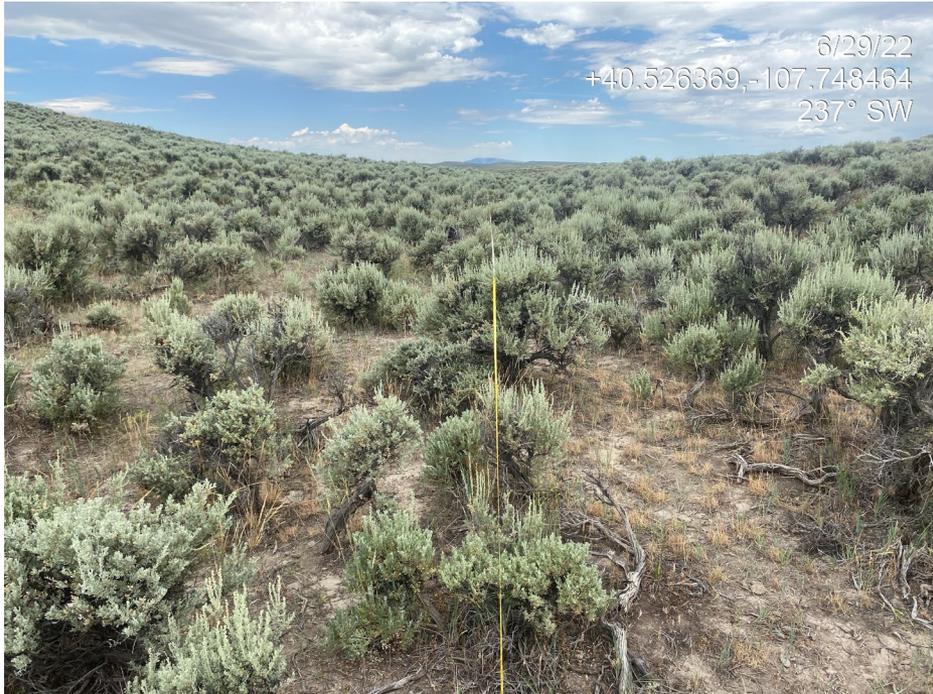
Photo 9. Photo taken in the reference area to the south of the Location at the start of Reference Transect 1 shows an overview of the transect.

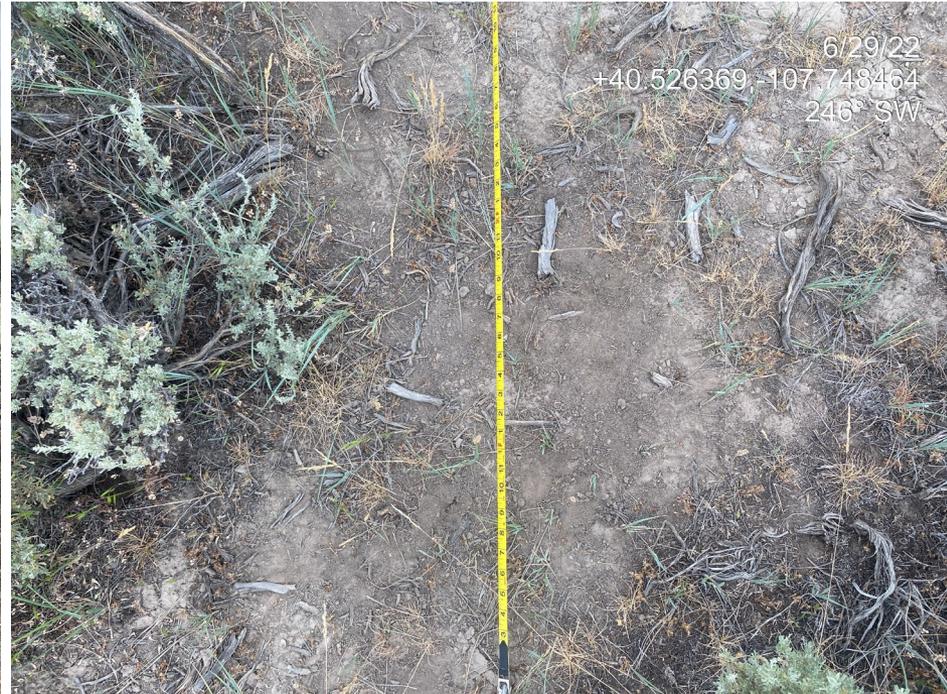
Photo 10. Photo taken in the reference area to the south of the Location at the start of Reference Transect 1 shows the ground surface.

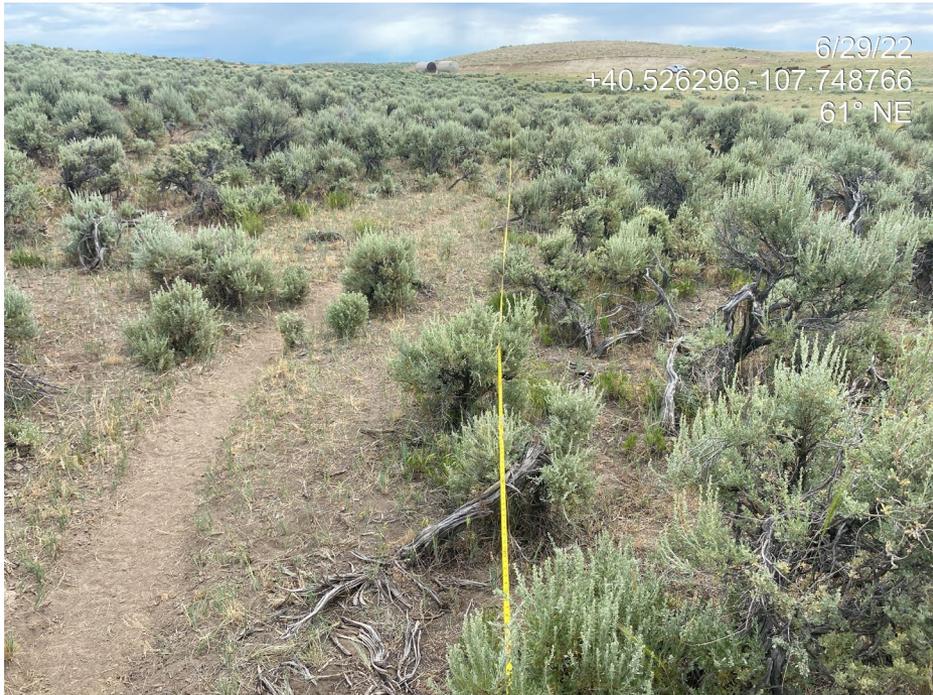
Photo 11. Photo taken in the reference area to the south of the Location at the end of Reference Transect 1 shows an overview of the transect.

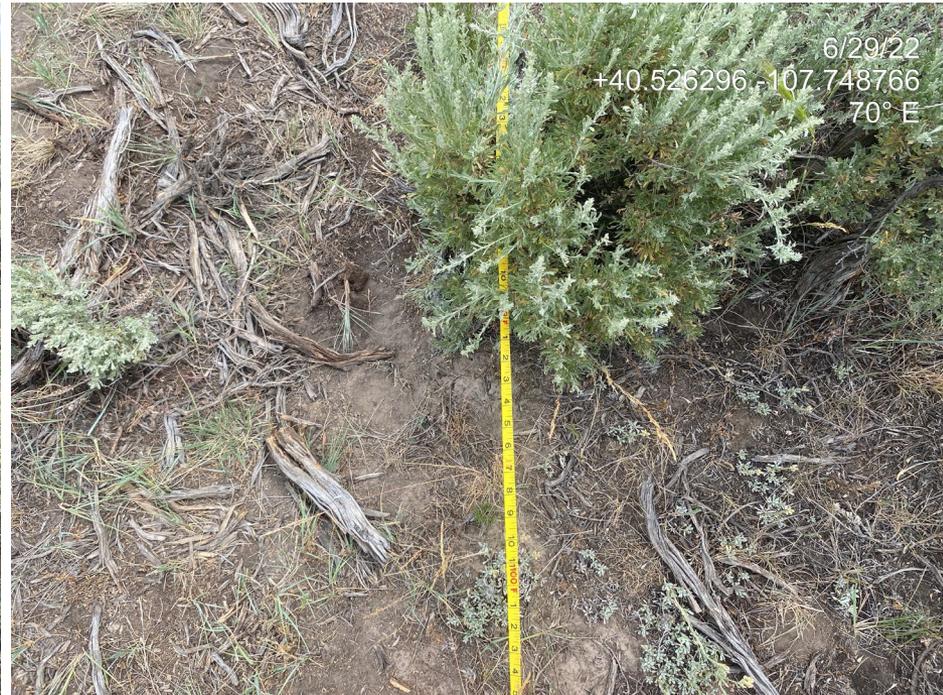
Photo 12. Photo taken in the reference area to the south of the Location at the end of Reference Transect 1 shows the ground surface.
