Inspection Photos and Issue Report

7/14/2022

Operator: CHEVRON USA INC #16700

Facility #424210 (Location #324350)

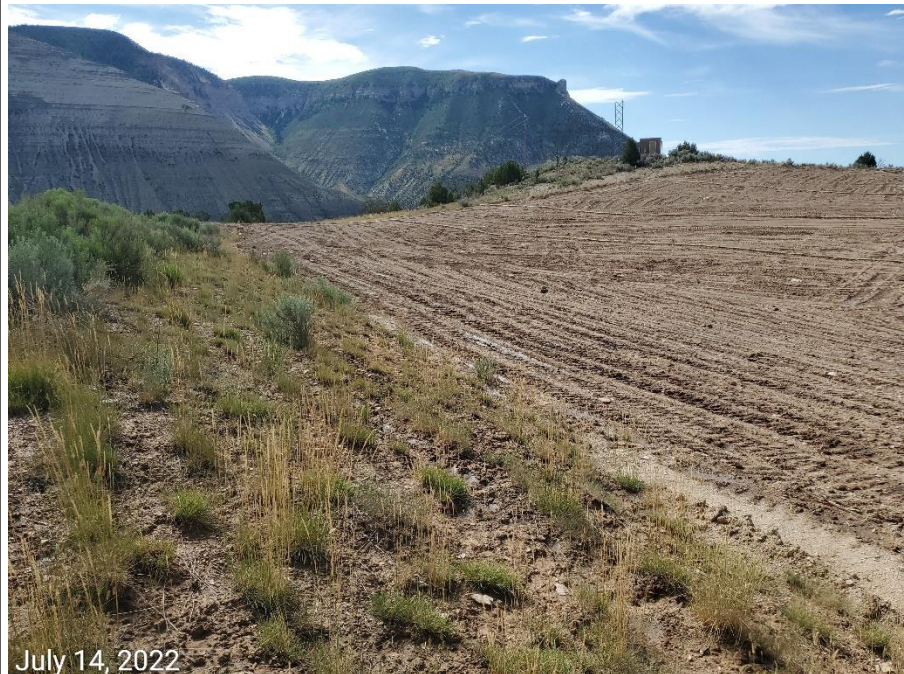
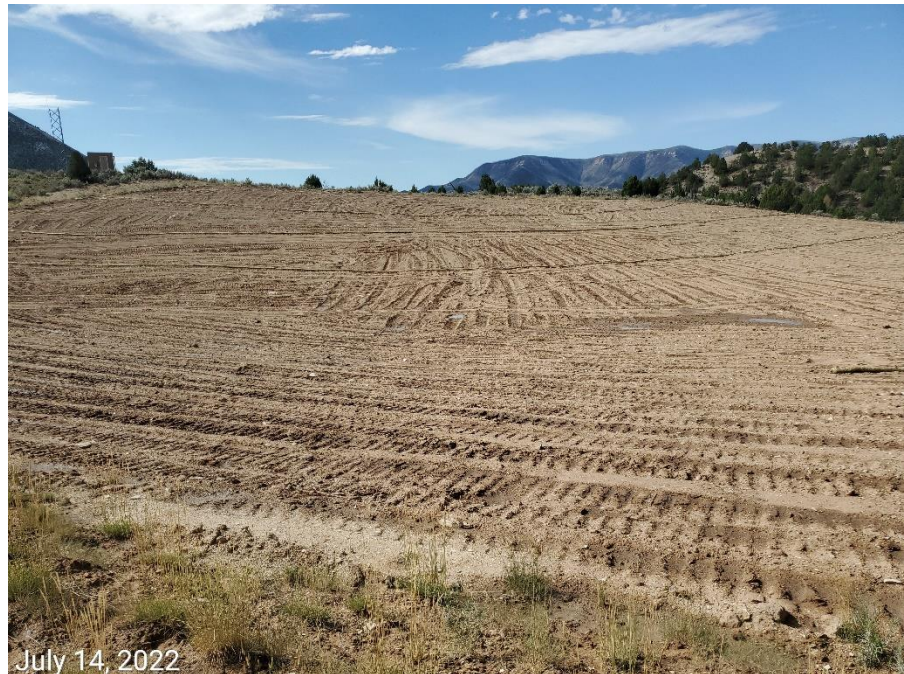
Photo 1: Photos 1-2 taken from the north end of the Pit Facility. Photos provide an overview of the Pit Facility reclamation area from southeast, south to southwest. Pit has been backfilled, recontoured and regraded. Reclamation areas are predominantly bare and at risk to wind and water erosion; stormwater and erosion control measures are missing, or inadequate/insufficient per good engineering requirements. Additionally, Reclamation Specialist was unable to find evidence that seeding/revegetation activities were performed; seed not observed at the soil surface, no soil striations from a drill seeder was observed, and no desirable plant germination was observed.

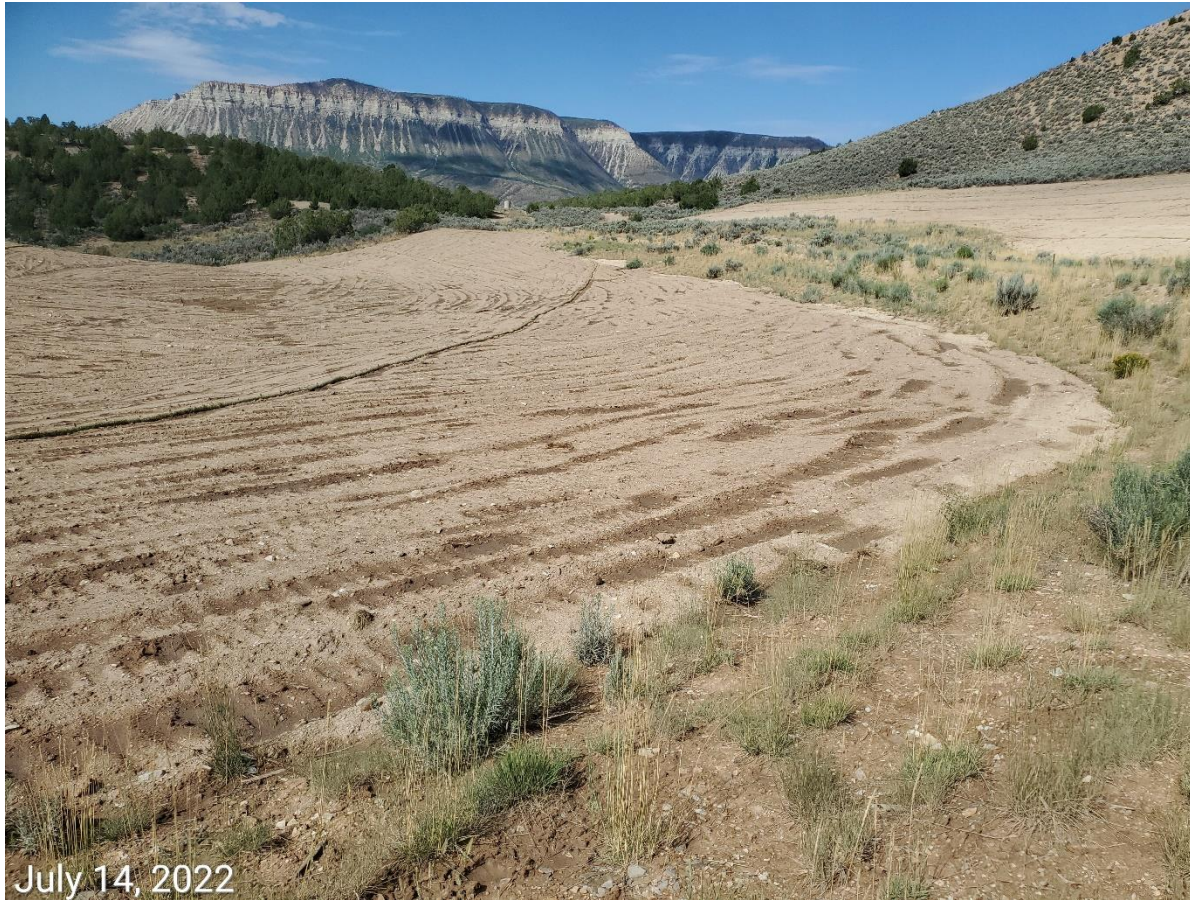
Photo 2: See comments under photo 1.

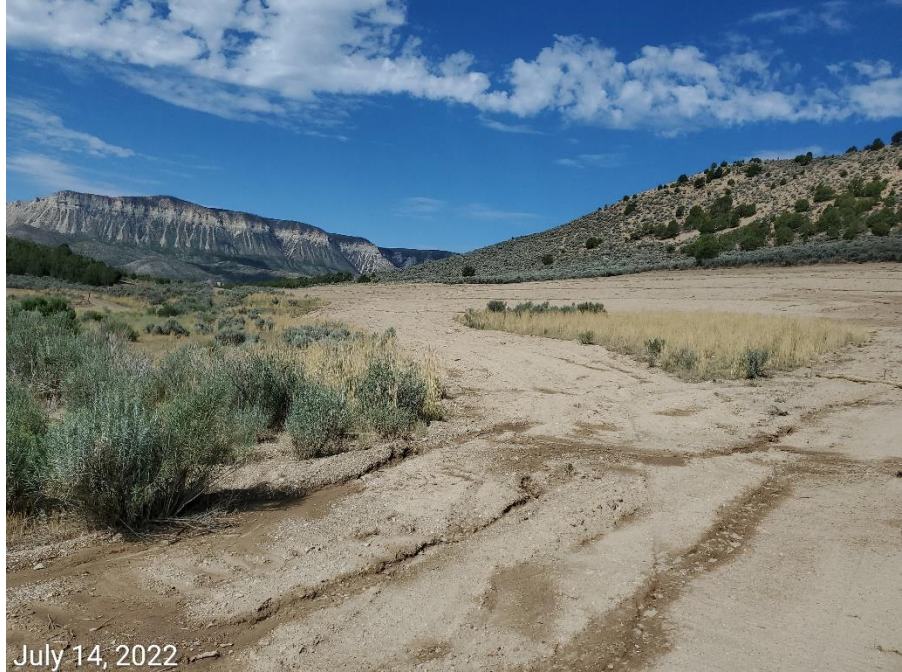
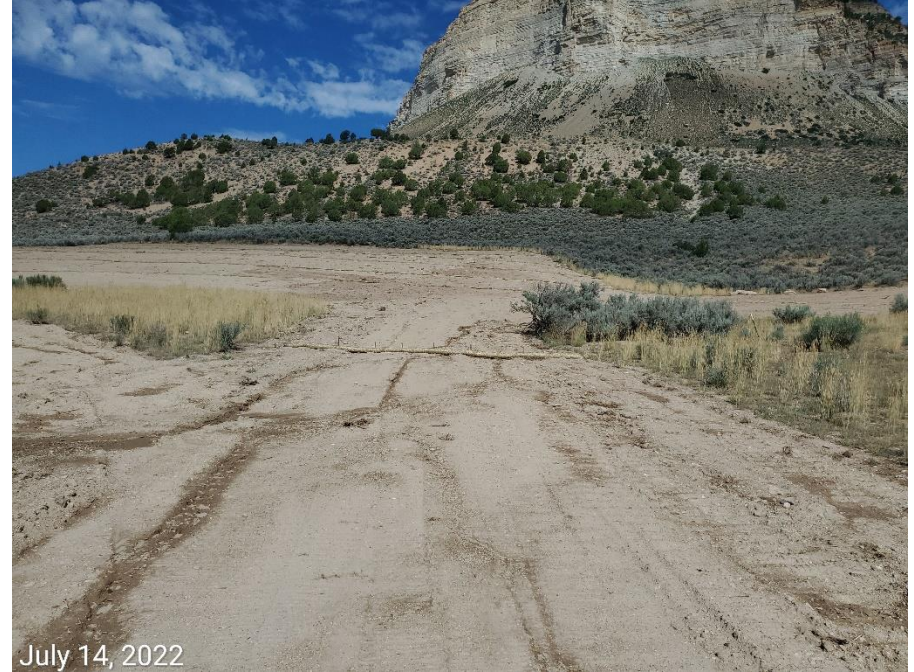
Photo 3: Photos taken from the topsoil/spoils area to the west of the pit facility. See comments under photo 1.

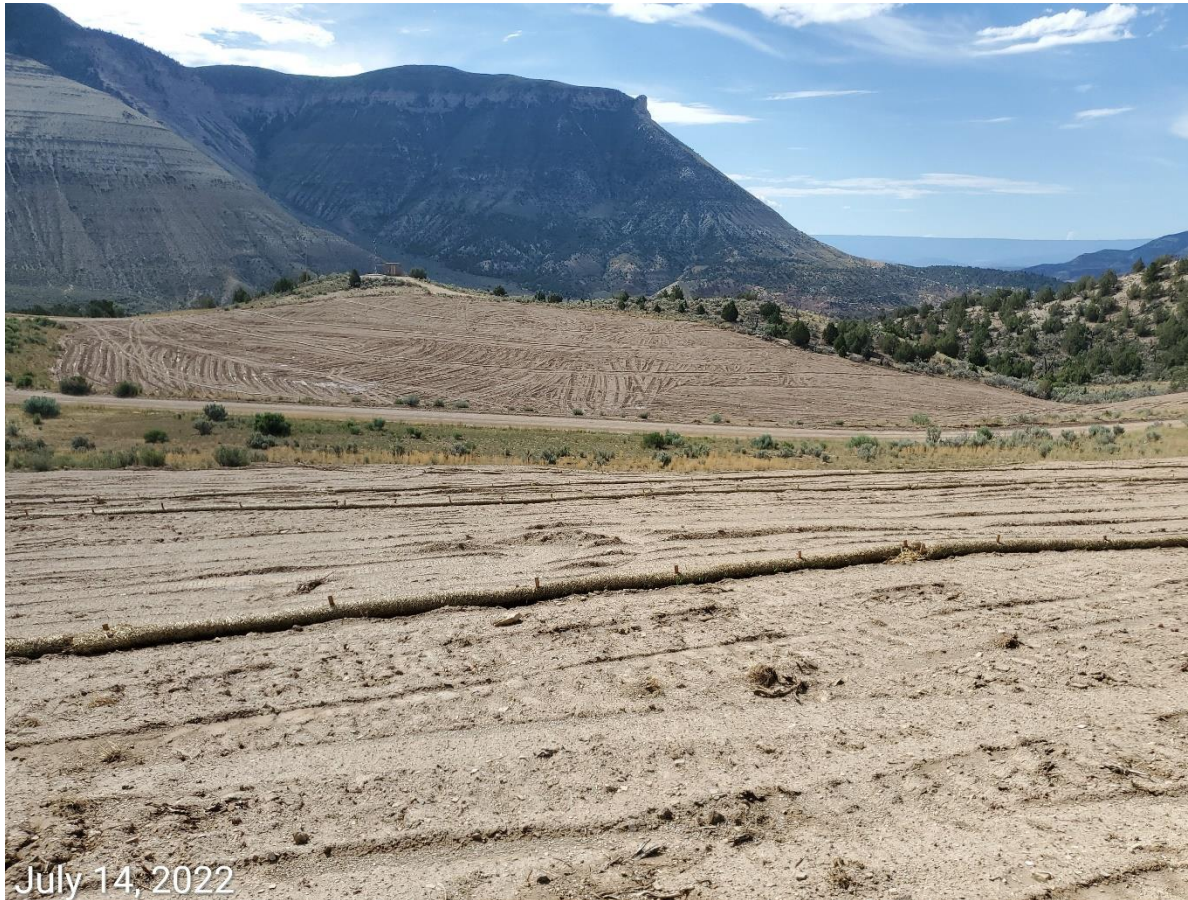
Photo 4: Photo taken from the “spoils pile” reclamation area, facing east. Photo provides overview of the reclamation areas. See comments under photo 1.

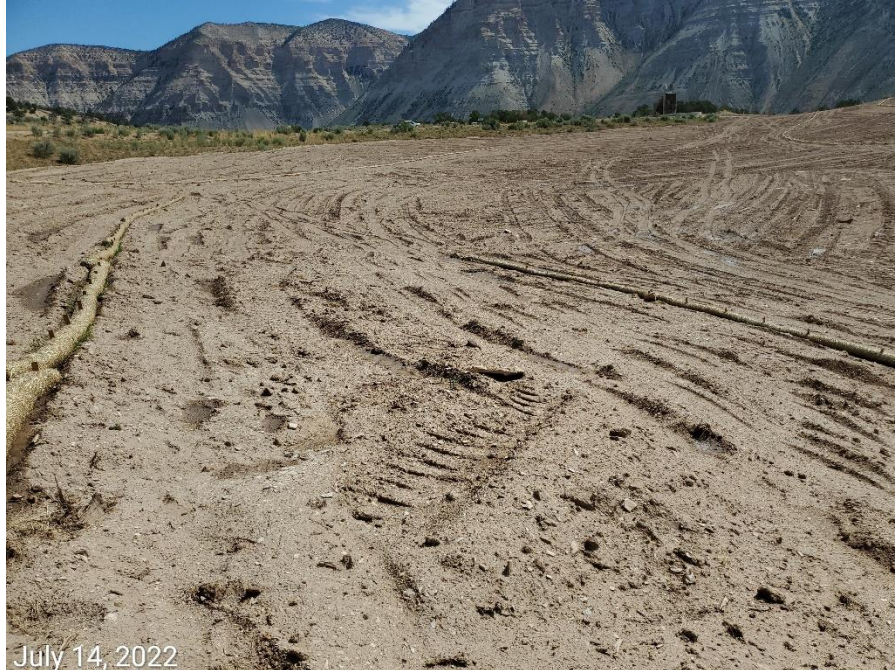
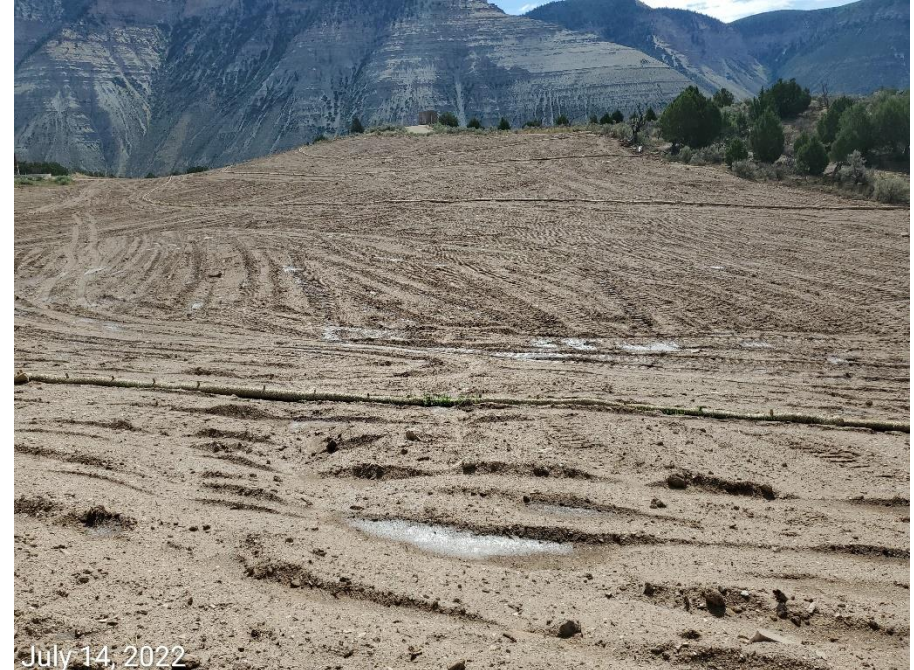
Photo 5: Photos taken from the southwest end of the Pit Facility reclamation area, facing northeast and east. See comments under photo 1.

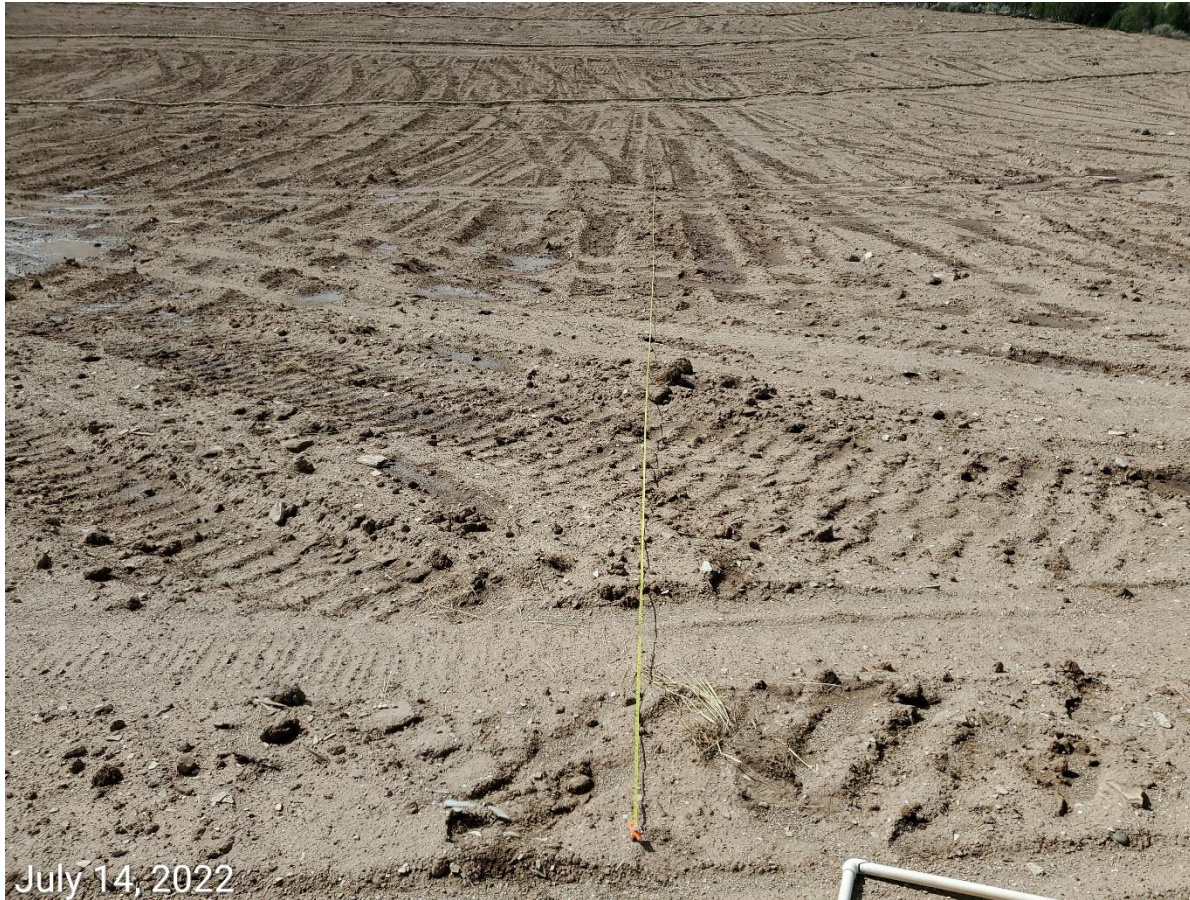
Photo 6: Photo shows starting point of the “Transect #1” transect (see “Transect Data Sheet”), on the Pit Facility reclamation area, facing south.

Additional Comment: Photos 6- 18 also show that the reclamation areas are bare and at risk to wind and water erosion; stormwater and erosion control measures are missing, or inadequate/insufficient per good engineering requirements; desirable plant germination was not observed- unable to find evidence that seeding activities were performed.

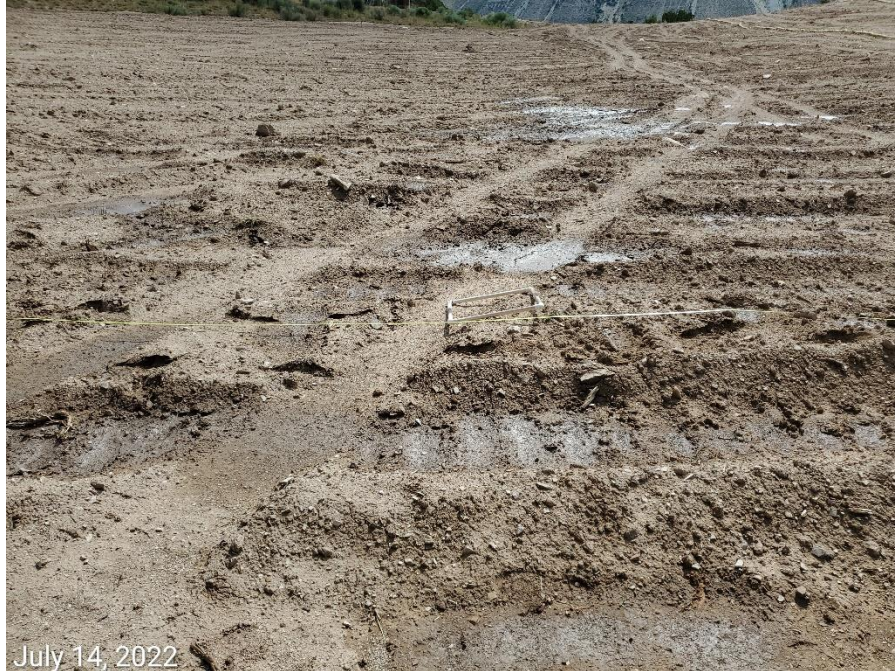
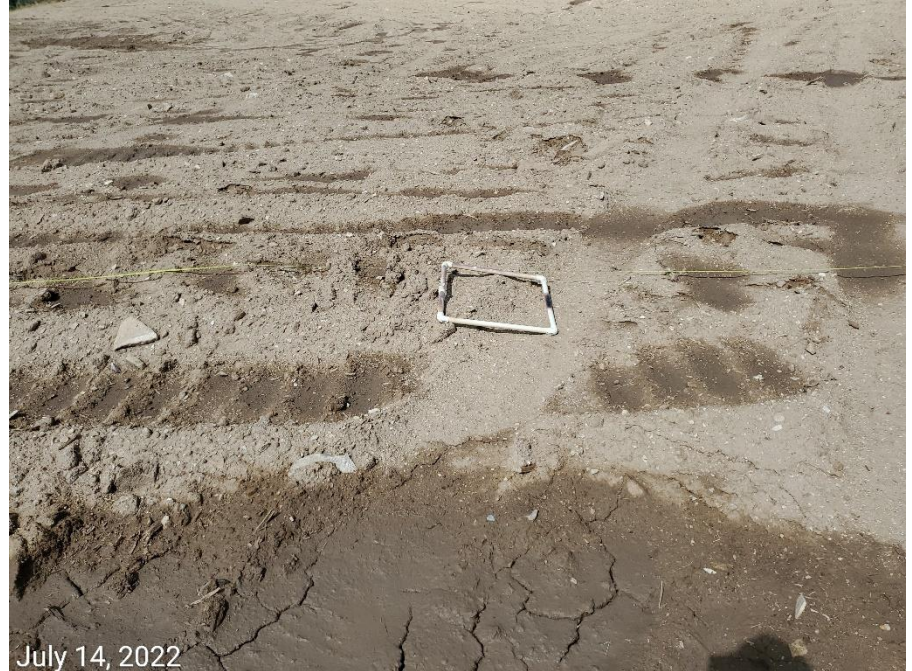
Photo 7: Photos show the Pit Facility reclamation areas, at the 50th point of Transect #1, facing east and west. See additional comments under photo 6.

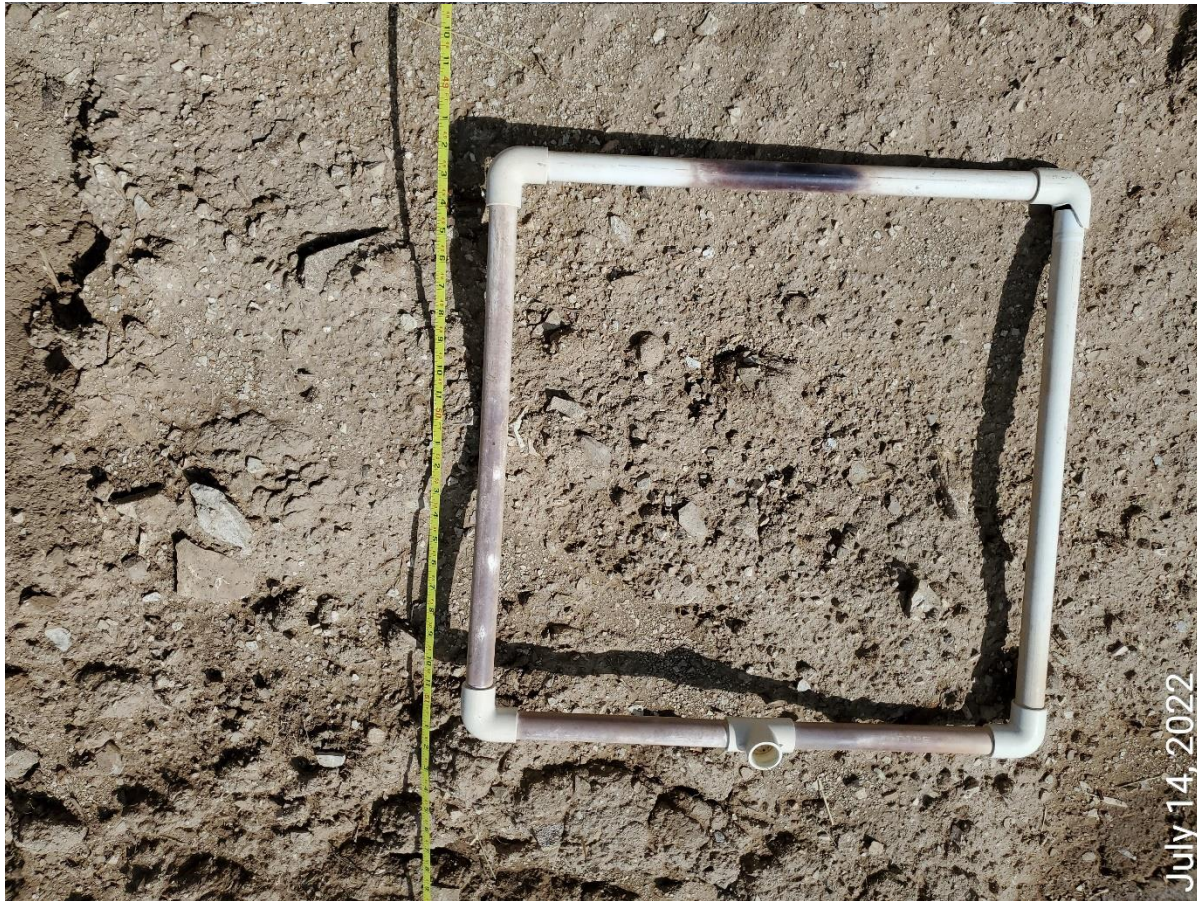
Photo 8: Pit Facility reclamation area's surface at the 50th point of Transect #1. See additional comments under photo 6.

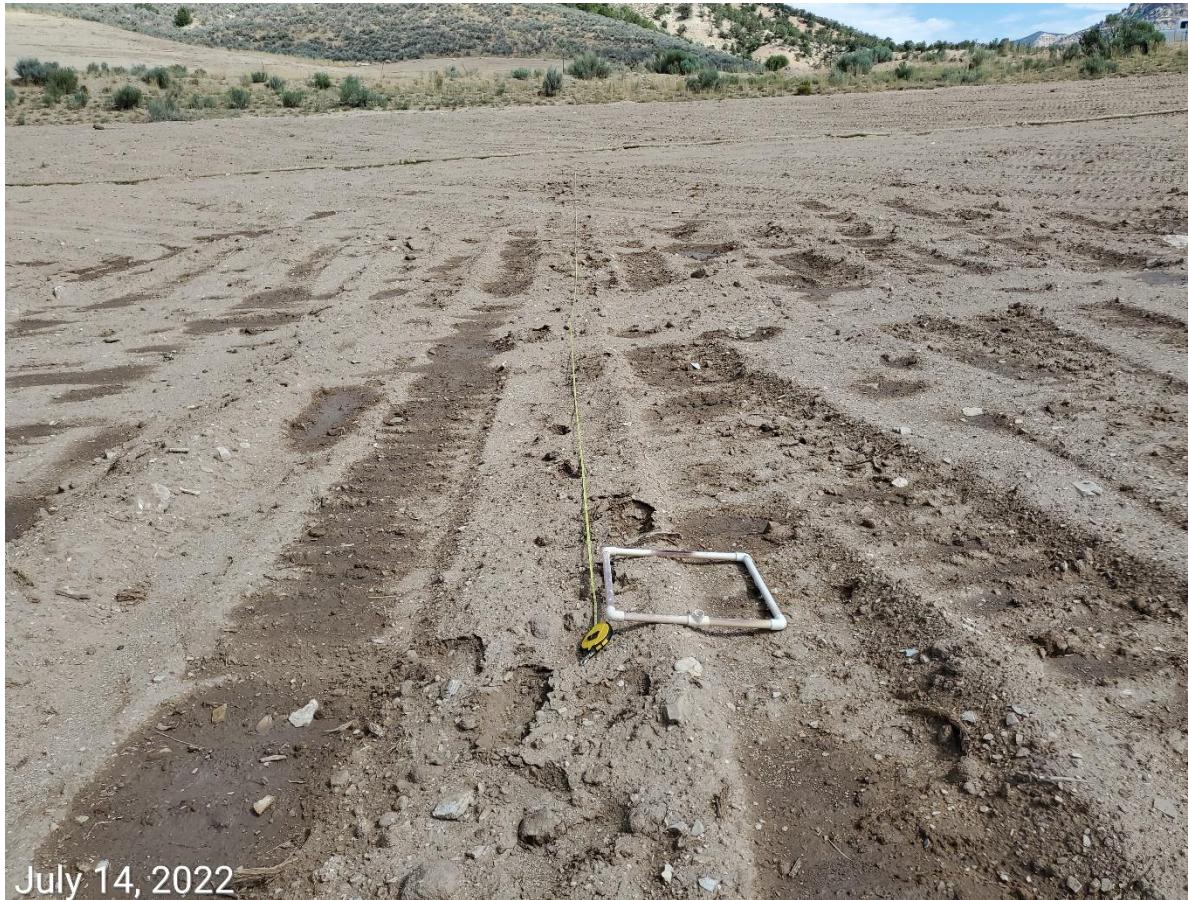
Photo 9: Photo shows the end point of the “Transect #1” transect (see “Transect Data Sheet”), on the Pit Facility, facing north. See additional comments under photo 6.

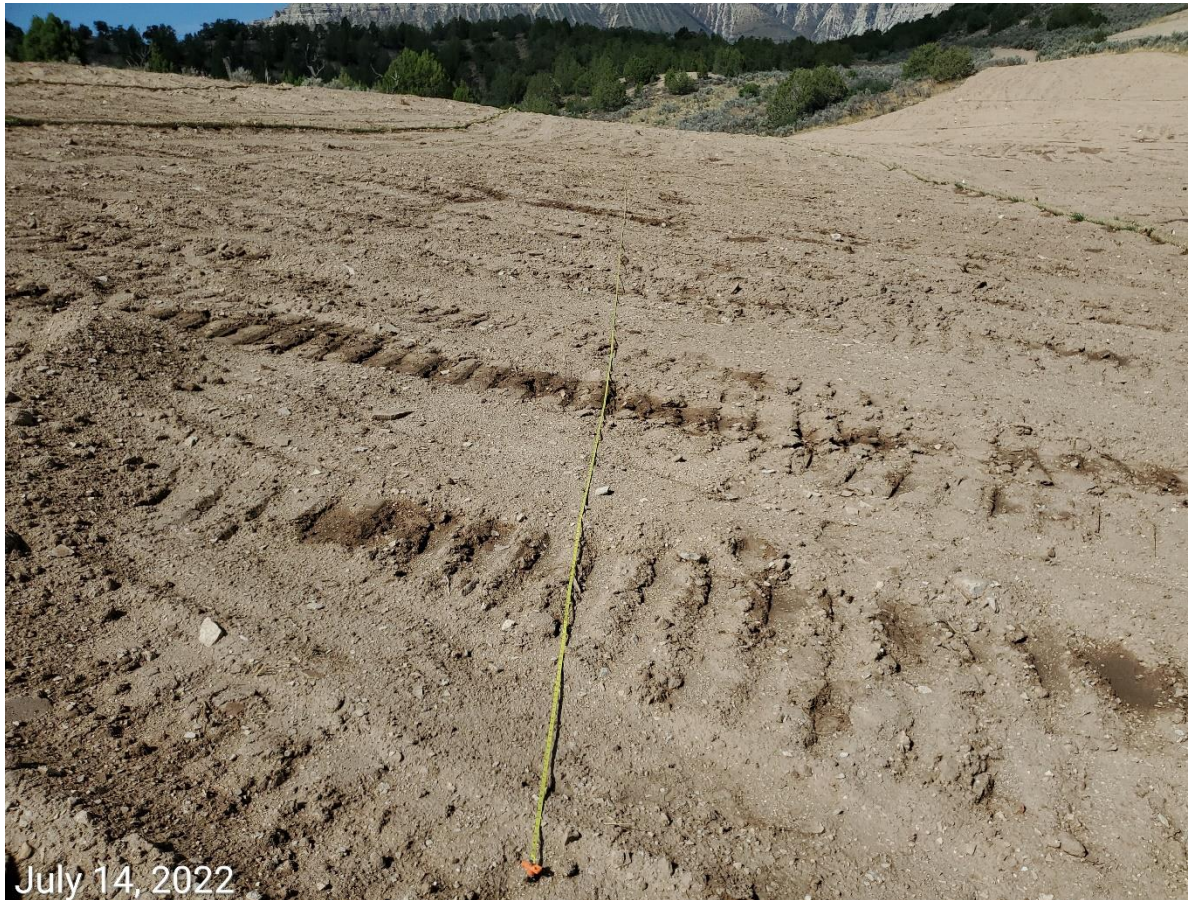
Photo 10: Photo shows starting point of the “Transect #2” transect (see “Transect Data Sheet”), on the Pit Facility, facing southwest. See additional comments under photo 6.

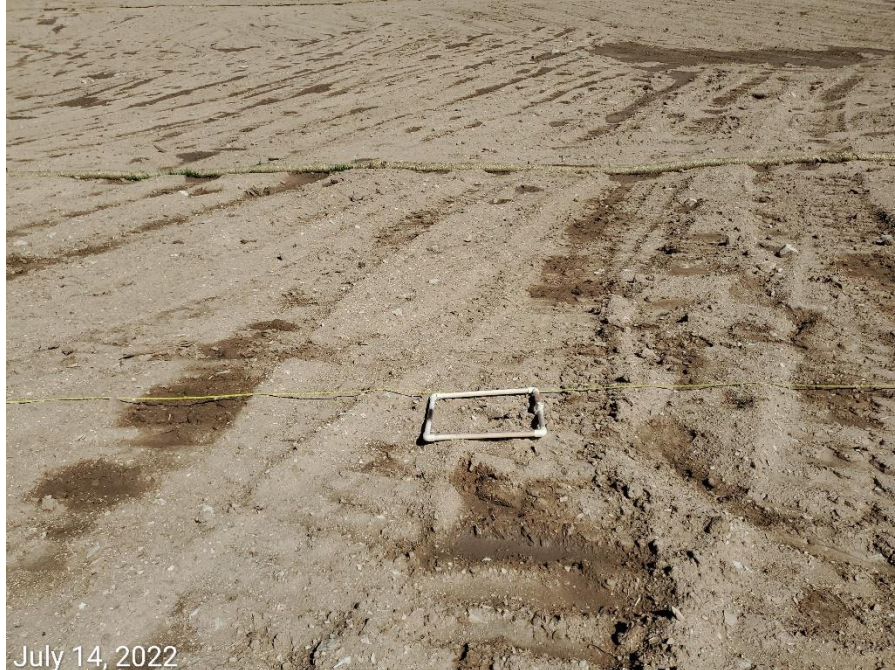
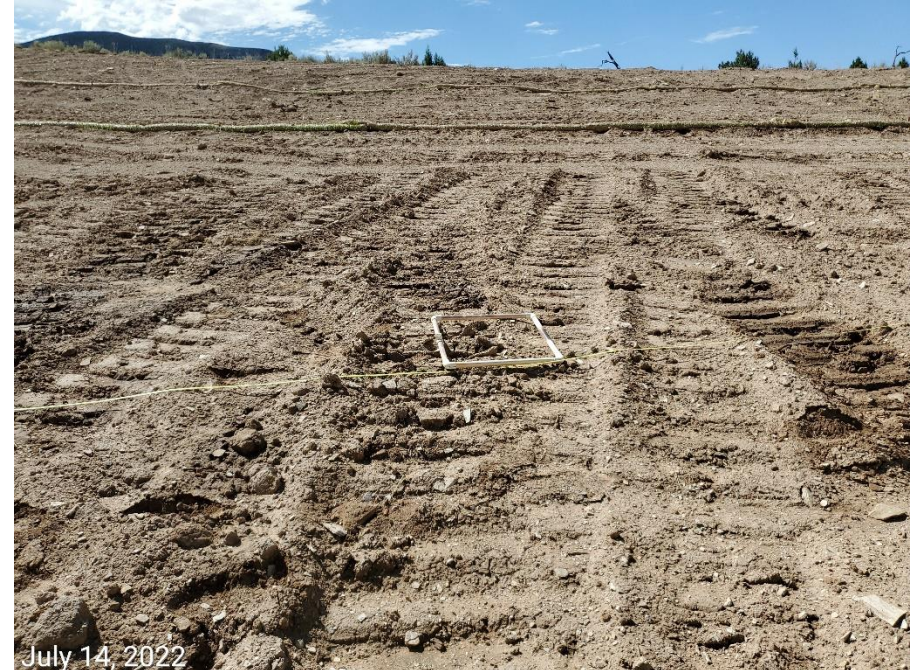
Photo 11: Photos show the Pit Facility reclamation areas, at the 50th point of Transect #2, facing northwest and southeast. See additional comments under photo 6.

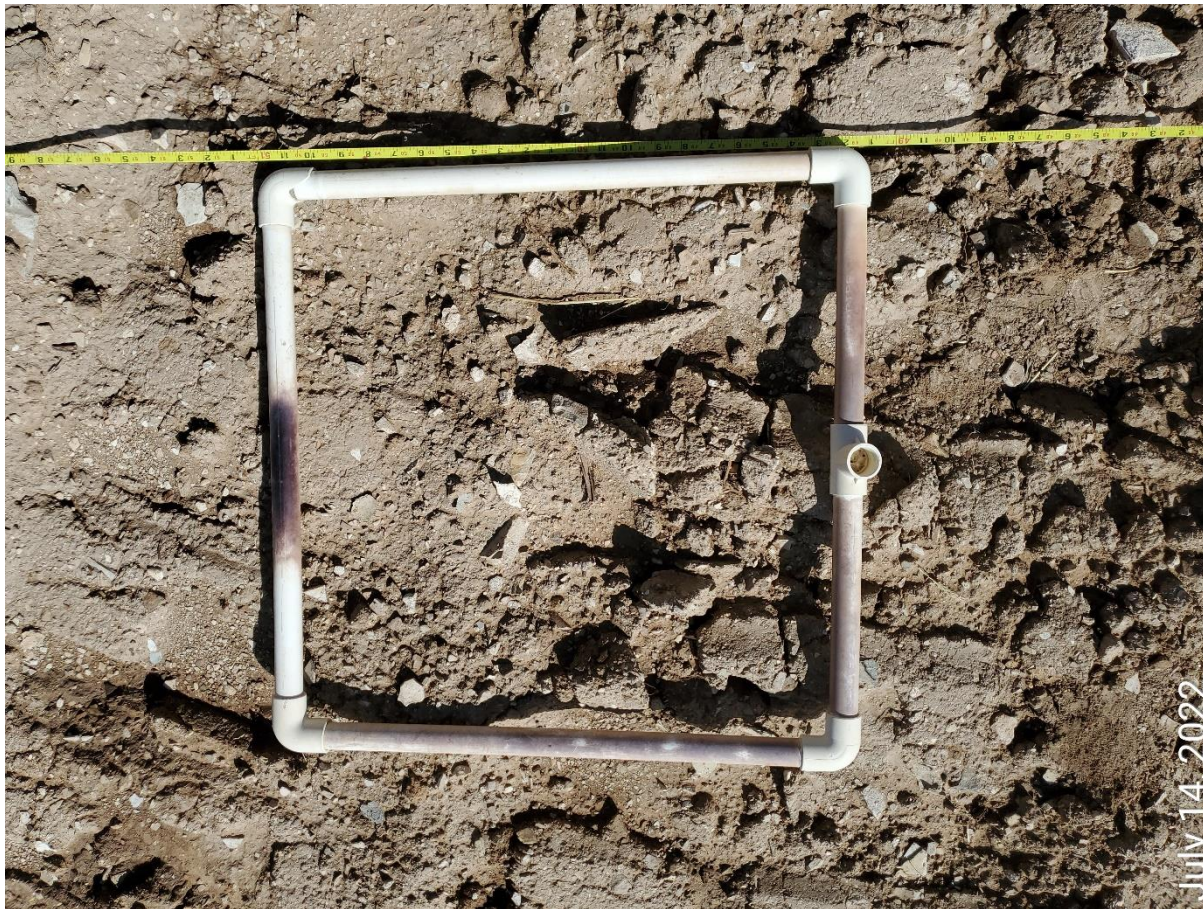
Photo 12: Pit Facility reclamation area's surface at the 50th point of Transect #1. See additional comments under photo 6.

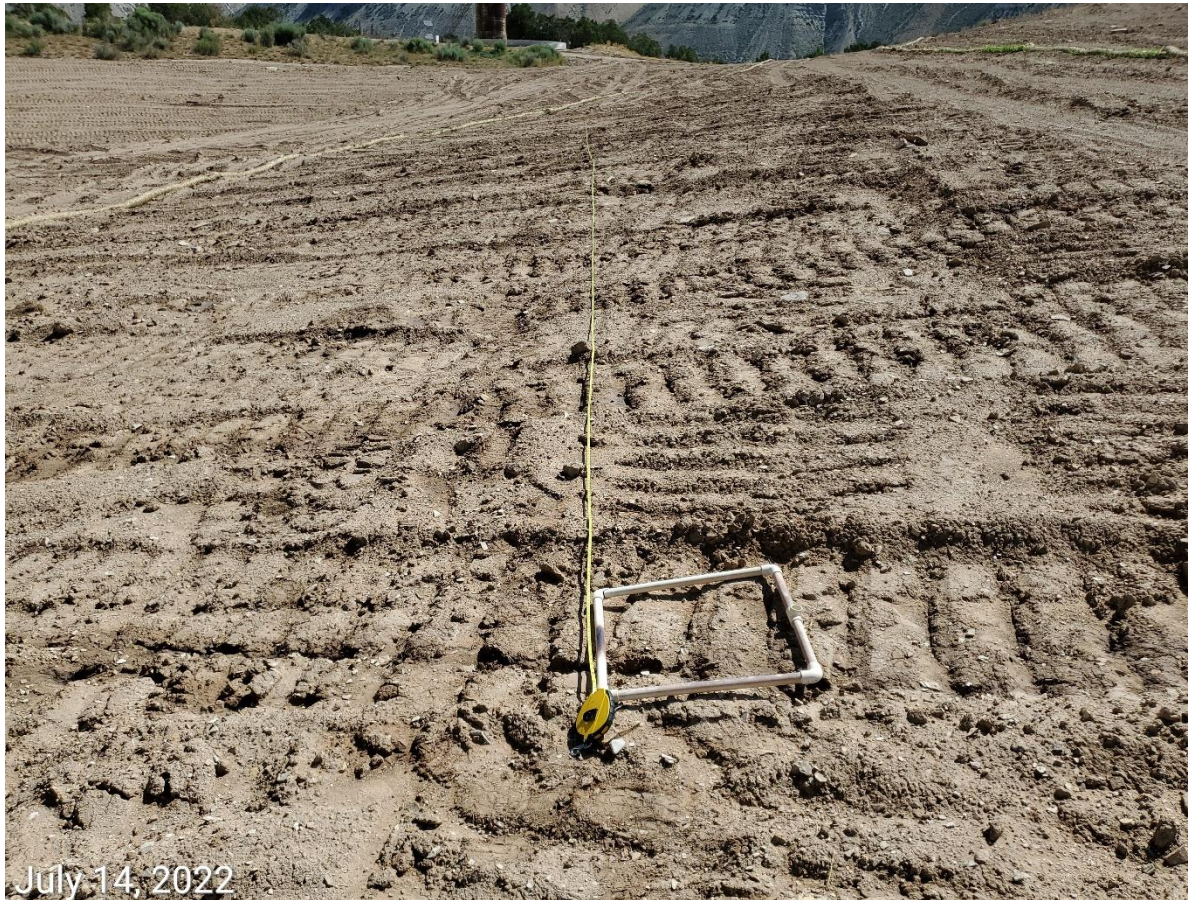
Photo 13: Photo shows the end point of the “Transect #2” transect (see “Transect Data Sheet”), on the Pit Facility, facing northeast. See additional comments under photo 6.

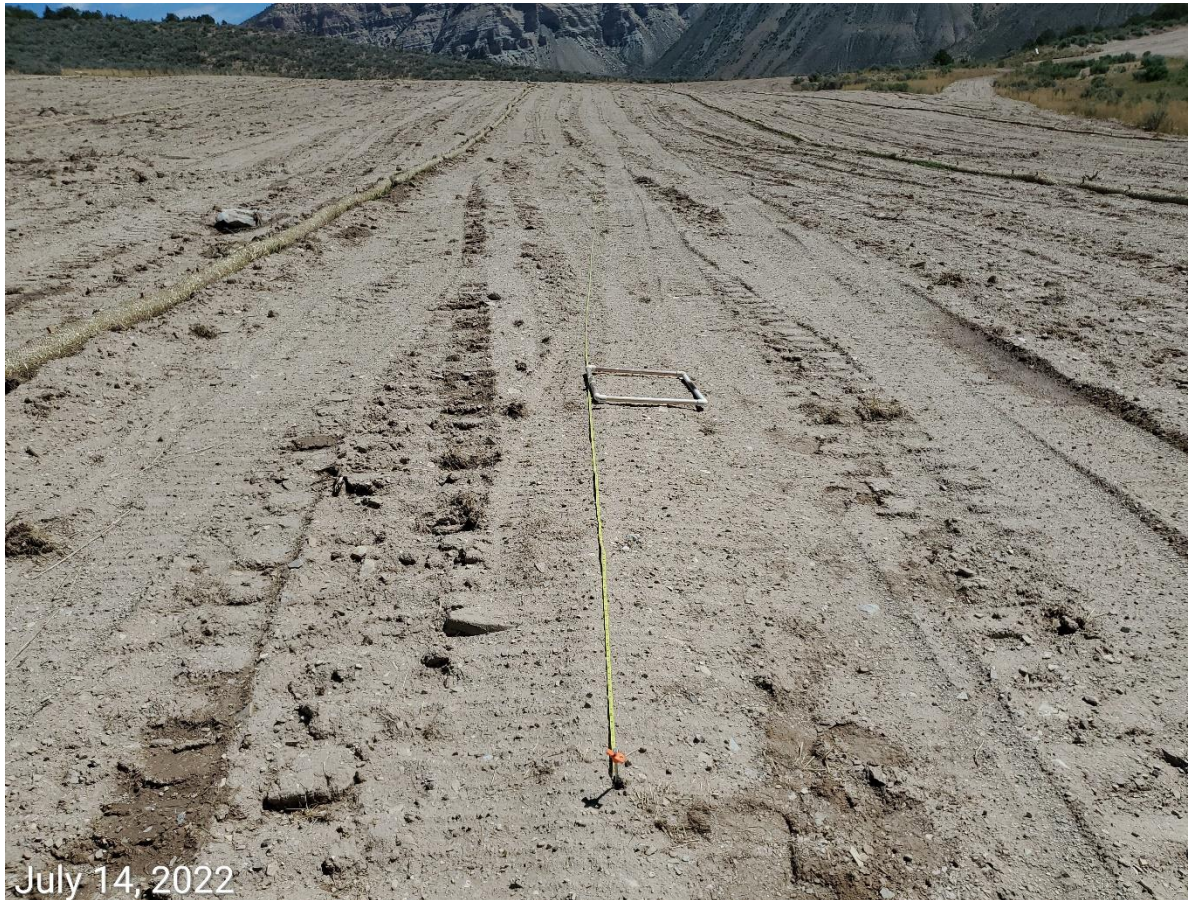
Photo 14: Photo shows starting point of the “Transect #3” transect (see “Transect Data Sheet”), at the “Spoils Pile” reclamation area, facing northeast. See additional comments under photo 6.

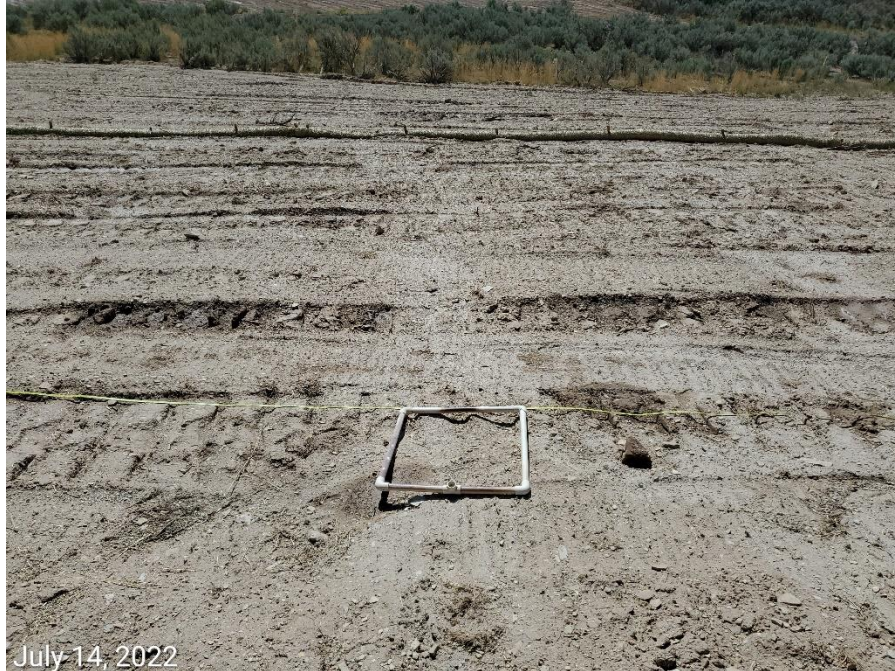
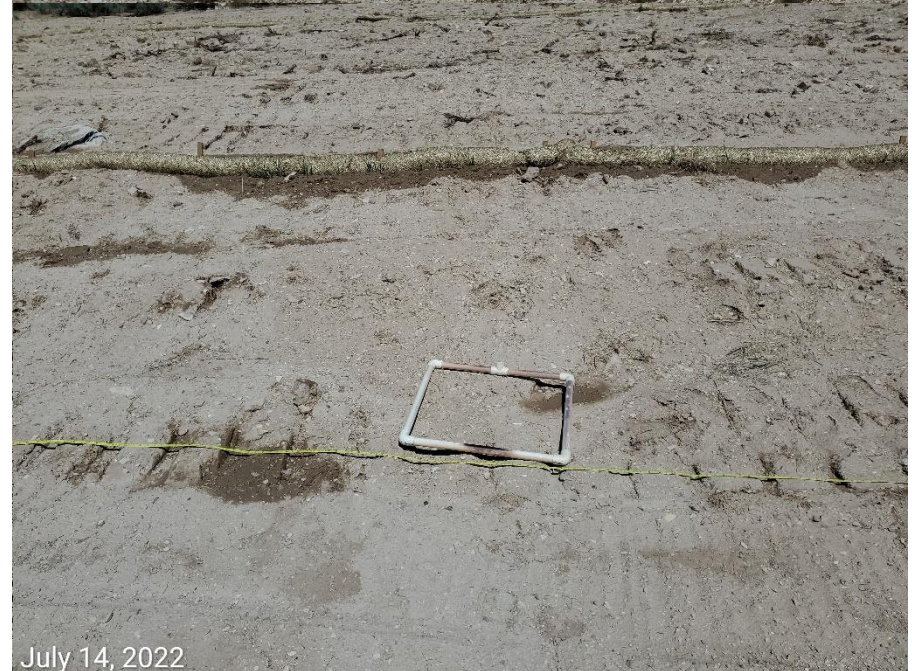
Photo 15: Photos show the “Spoils Pile” reclamation areas, at the 50th point of Transect #3, facing northwest and southeast. See additional comments under photo 6.

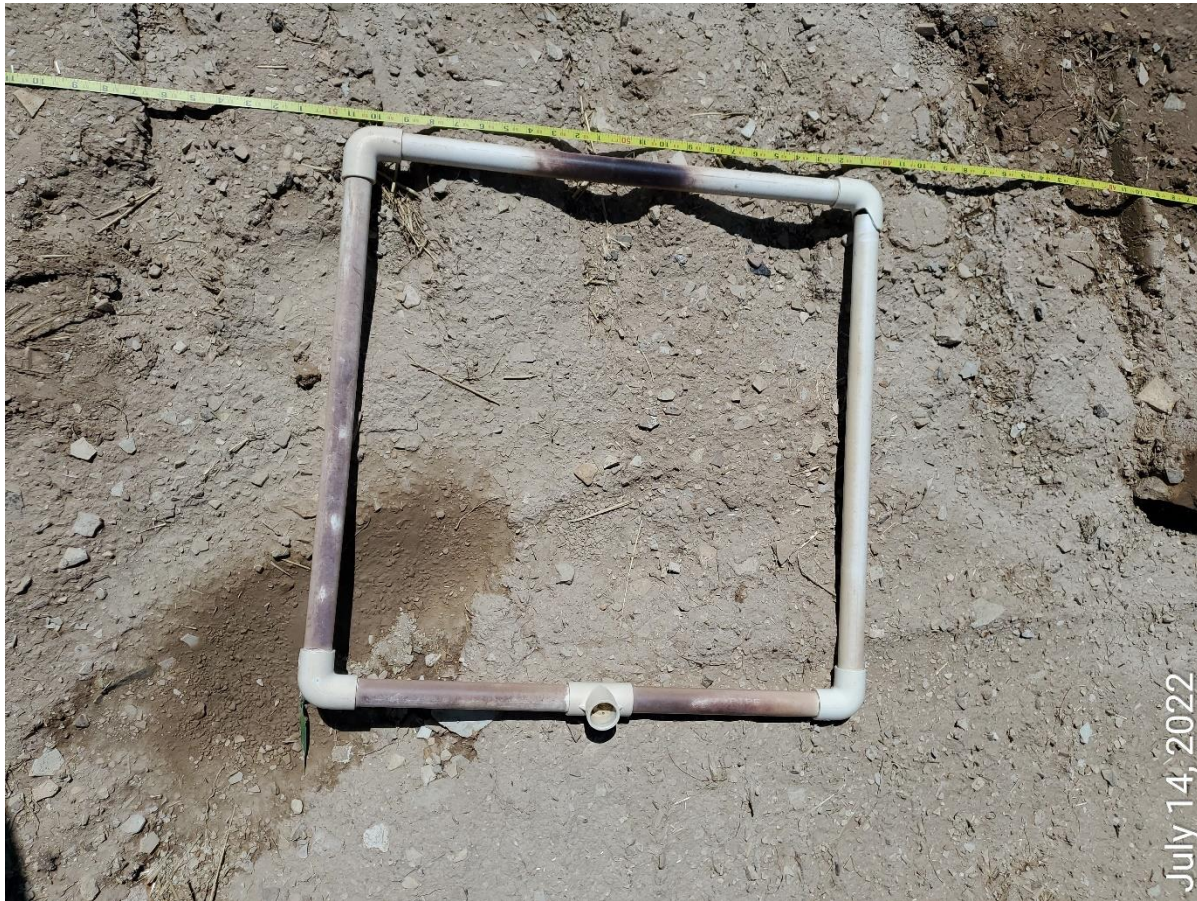
Photo 16: “Spoils Pile” reclamation area’s surface at the 50th point of Transect #3. See additional comments under photo 6.

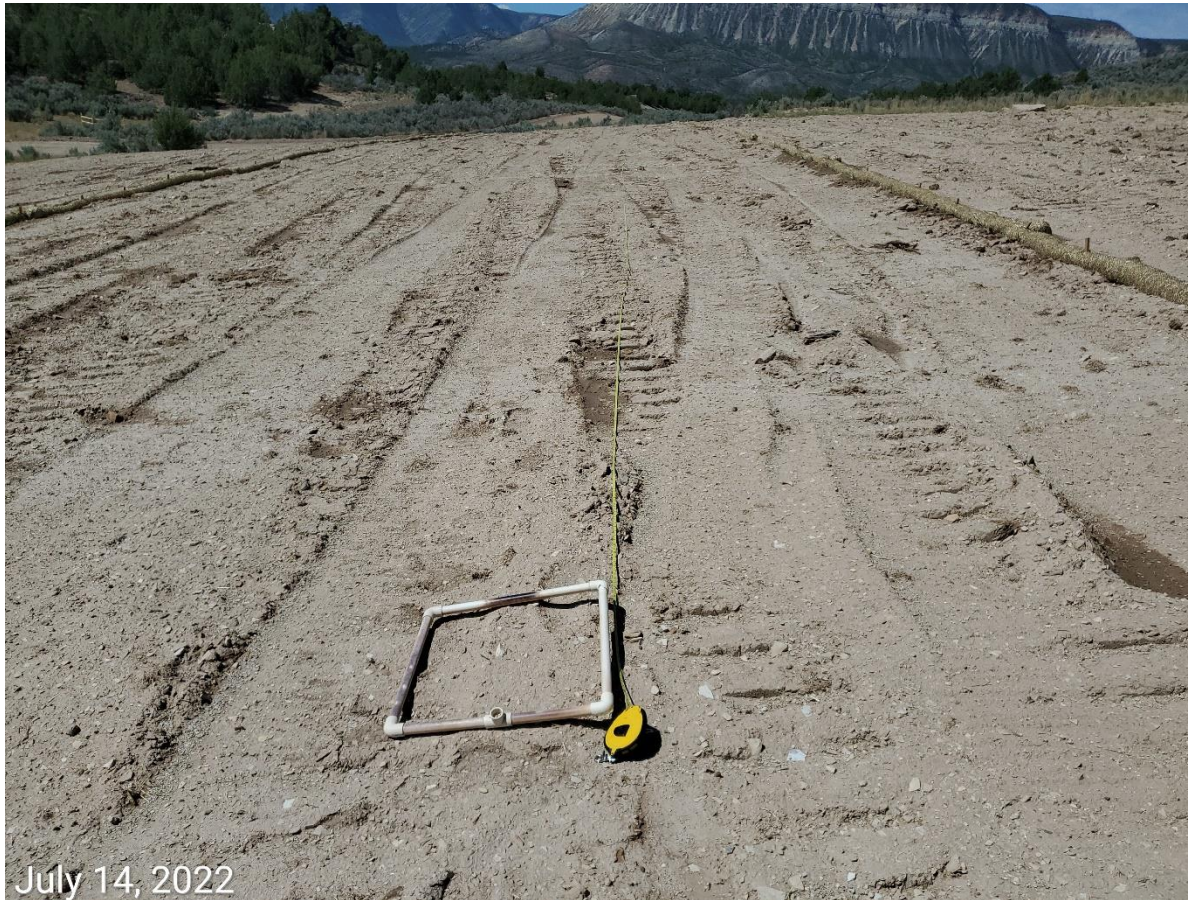
Photo 17: Photo shows the end point of the “Transect #3” transect (see “Transect Data Sheet”), on the “Spoils Pile” reclamation area, facing northeast. See additional comments under photo 6.

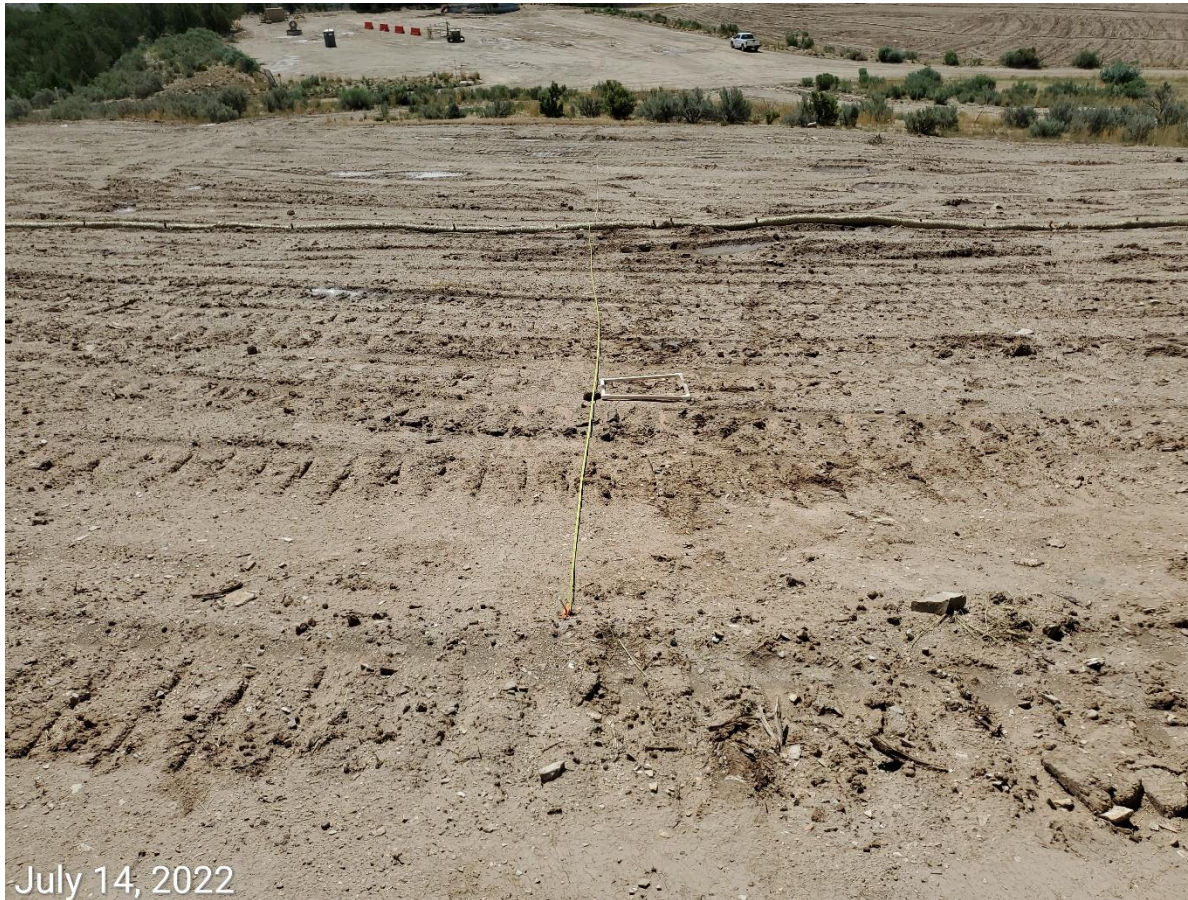
Photo 18: Photo shows starting point of the “Transect #4” transect (see “Transect Data Sheet”), at the “Topsoil Pile” reclamation area, facing southeast. See additional comments under photo 6.

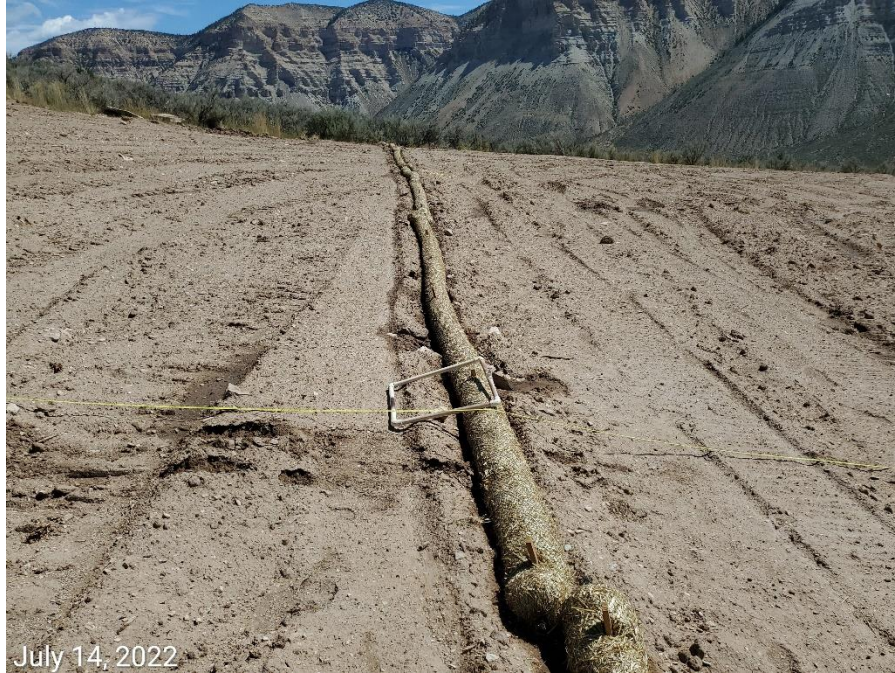
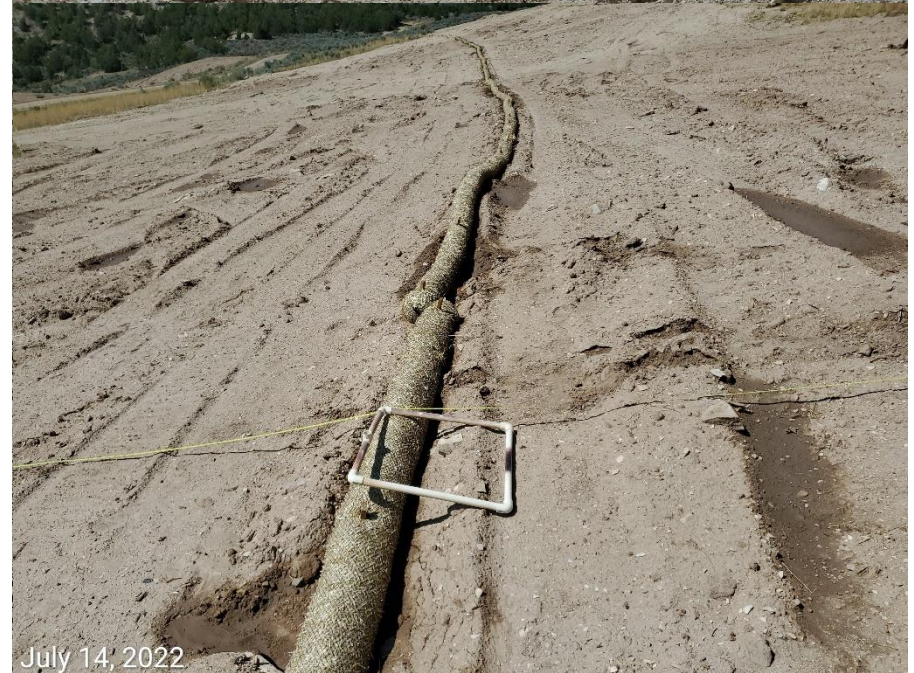
Photo 19: Photos show the “Topsoil Pile” reclamation areas, at the 50th point of Transect #4, facing northeast and southwest. See additional comments under photo 6.
