Inspection Photos and Issue Report

7/14/2022

Operator: CHEVRON USA INC #16700

Facility #424210 (Location #324350)

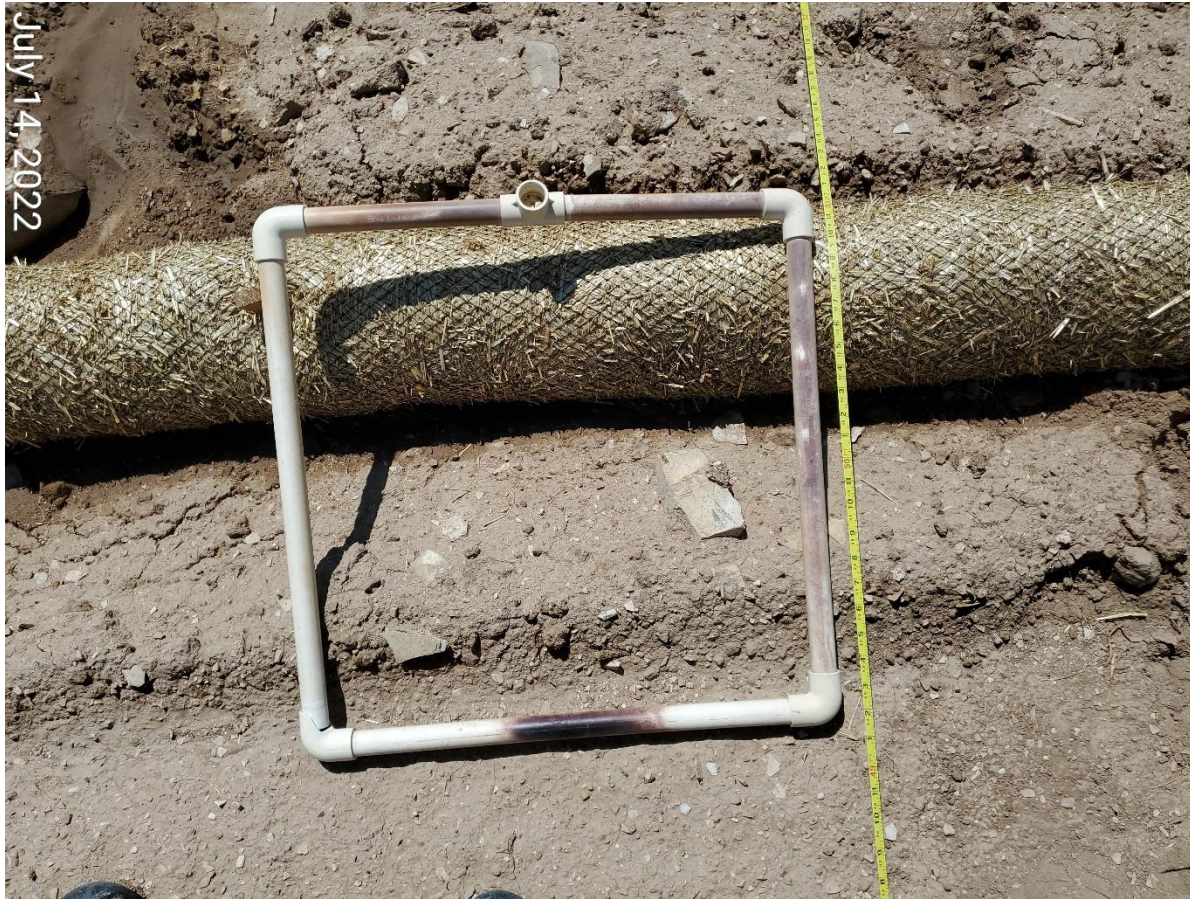
Additional Comment: Photos 6- 18 also show that the reclamation areas are bare and at risk to wind and water erosion; stormwater and erosion control measures are missing, or inadequate/insufficient per good engineering requirements; desirable plant germination was not observed- unable to find evidence that seeding activities were performed.

Photo 20: “Topsoil Pile” reclamation area’s surface at the 50th point of Transect #4. See additional comments under photo 6

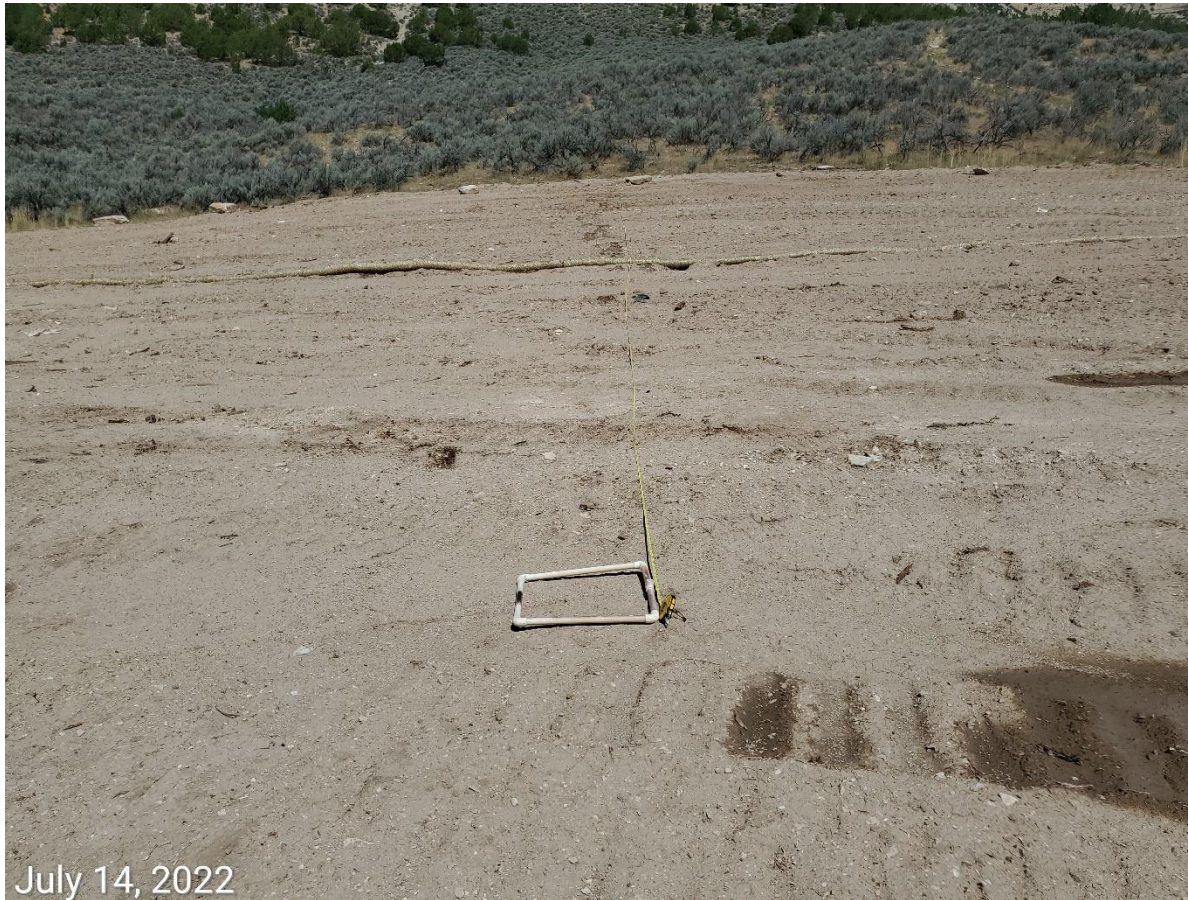
Photo 21: Photo shows the end point of the “Transect #4” transect (see “Transect Data Sheet”), on the “Topsoil Pile” reclamation area, facing northwest. See additional comments under photo 6.

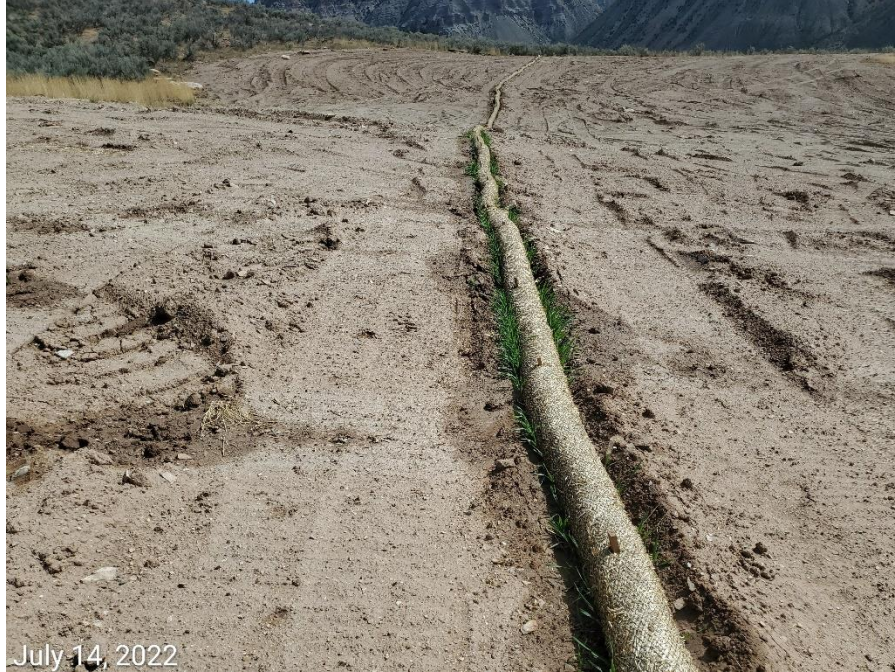
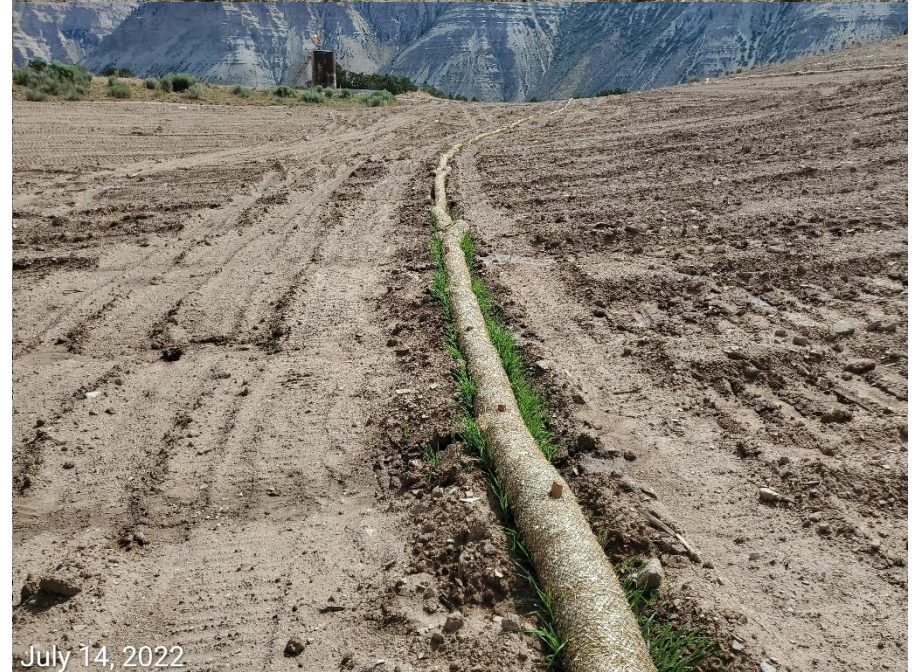
Photo 22: Photos example showing the only vegetation observed growing on the Location was an annual wheat species germinating from the straw wattles. Photos also examples showing wattles on the Location have not been installed per good engineering practices (trenched and backfilled)

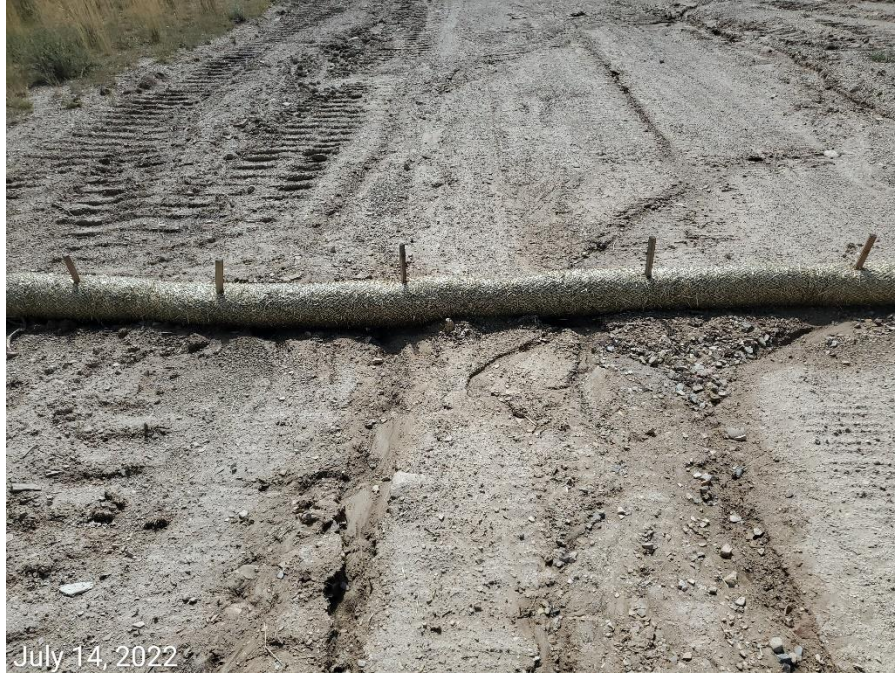
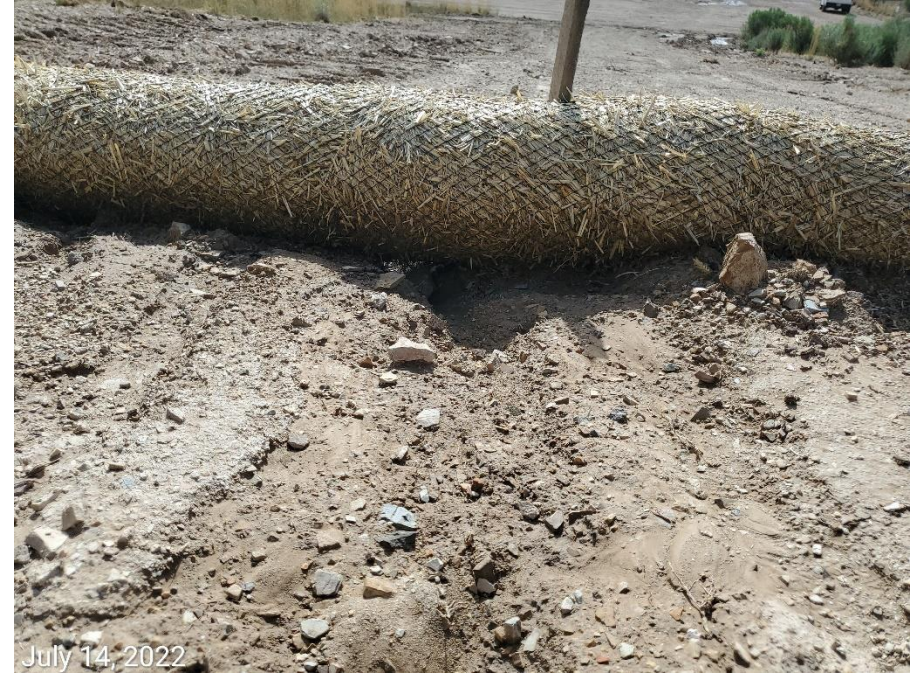
Photo 23: Photos examples showing wattles throughout the Reclamation areas have not been installed in accordance with good engineering practices; stormwater runoff is cutting under sections of the controls, resulting in stormwater erosion and degradation.

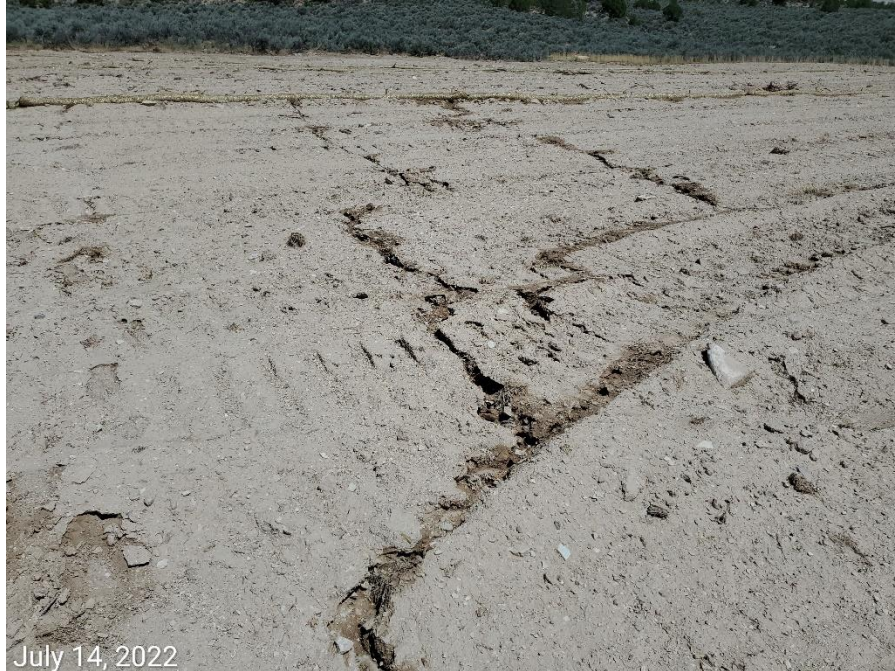
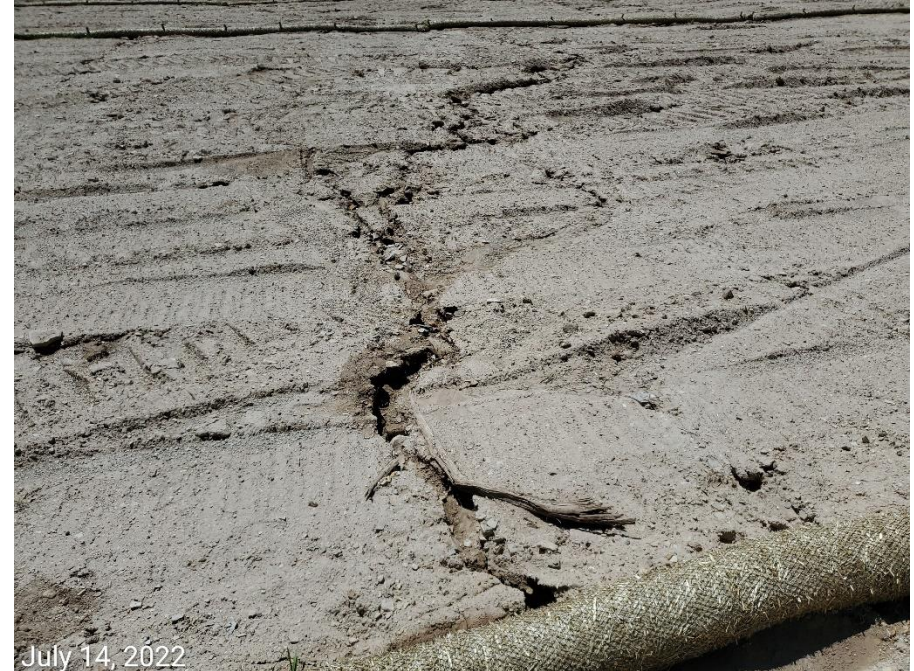
Photo 24: Photos provide examples showing that the reclamation areas are bare and at risk to wind and water erosion. Stormwater and erosion control measures over the ~9.5 acre reclamation area are missing or insufficient per good engineering requirements, to properly manage stormwater runoff in a manner that minimizes erosion, transport of sediment, and degradation.
