Inspection Photos

Location Name: TEP ROCKY MOUNTAIN LLC DOE-66S95W /21SESW

Location ID: 335230

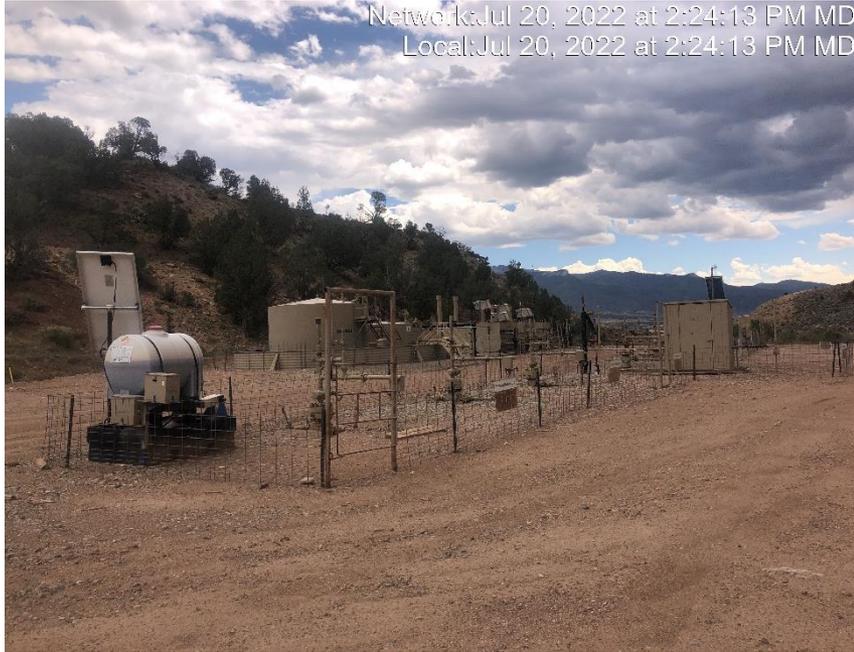
Photo #7221 from entrance to location.

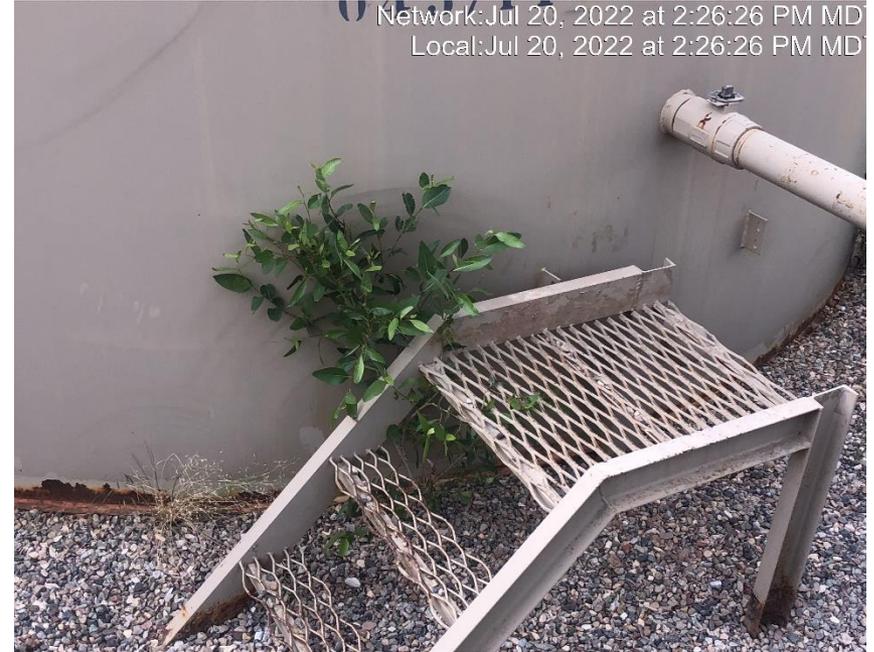
Photo #7223 Undesirable plant species in tank containment.

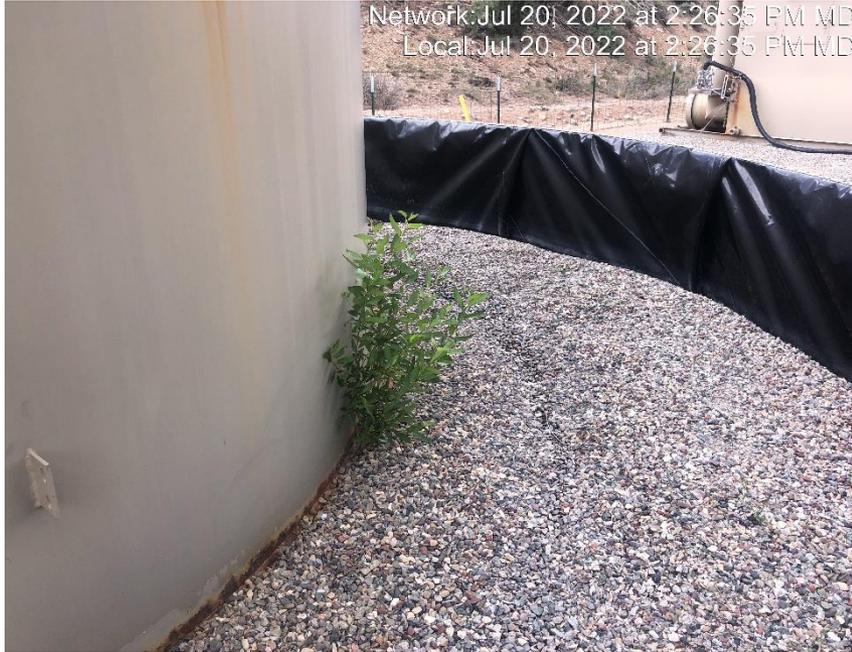
Photo #7224 Undesirable plant species in tank containment.

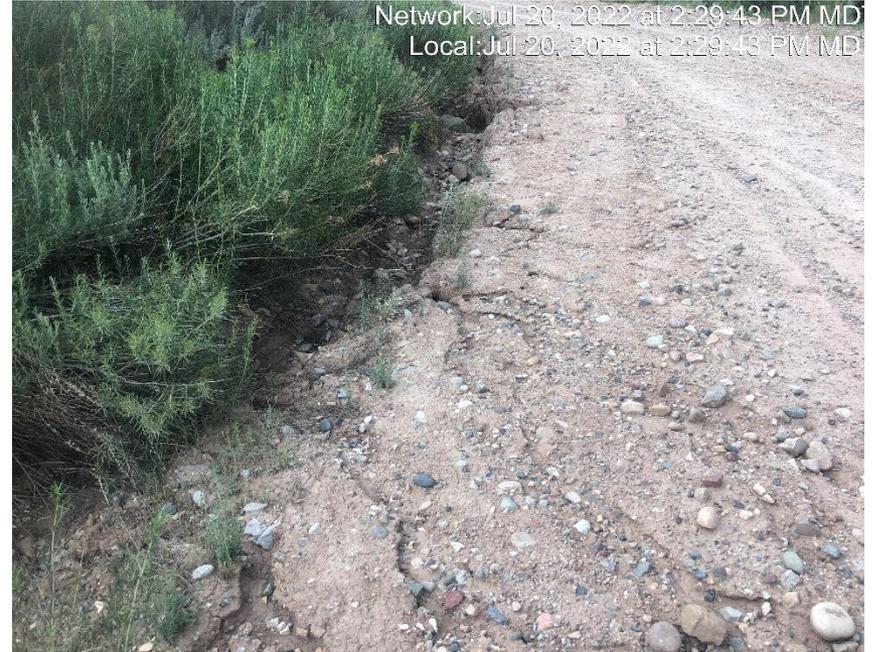
Photo #7226 Gully erosion occurring in access road ditch.

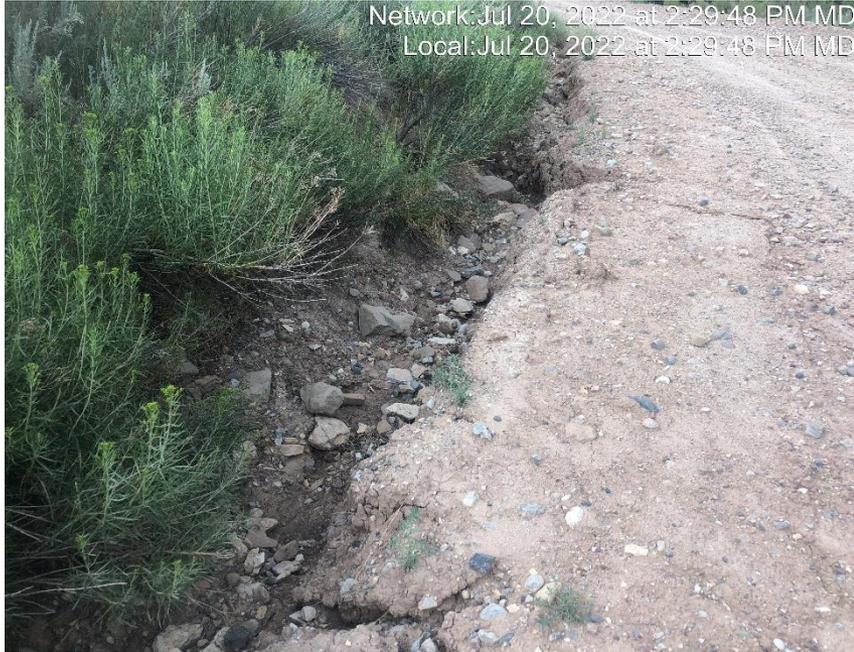
Photo #7227 Gully erosion occurring in access road ditch.

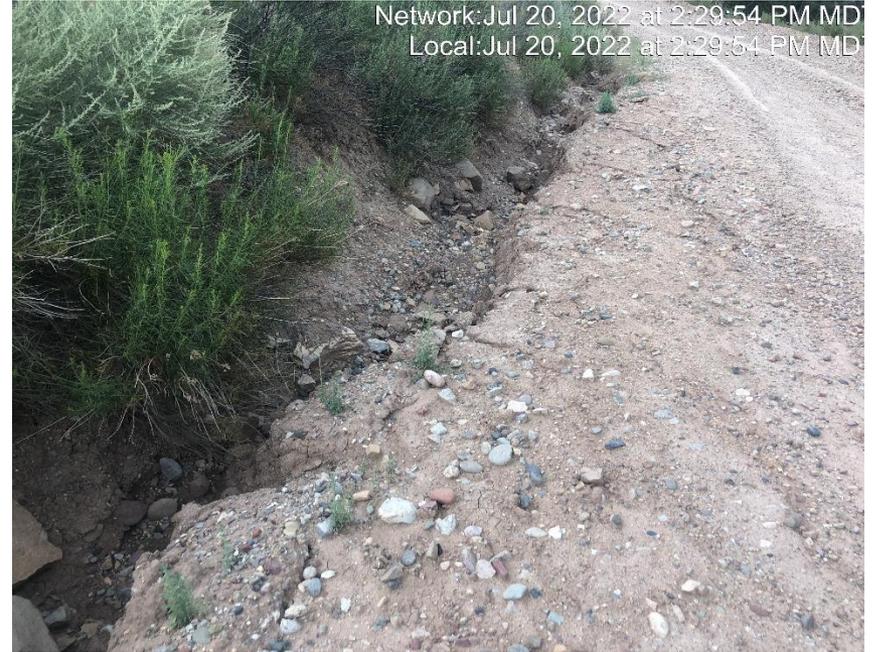
Photo #7228 Gully erosion occurring in access road ditch.

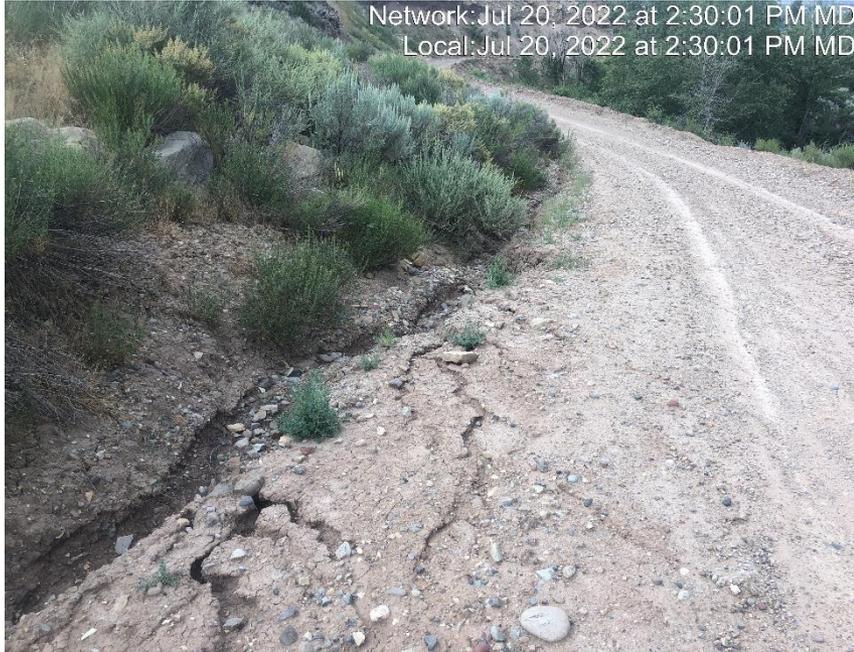
Photo #7229 No velocity checks located in ditch.

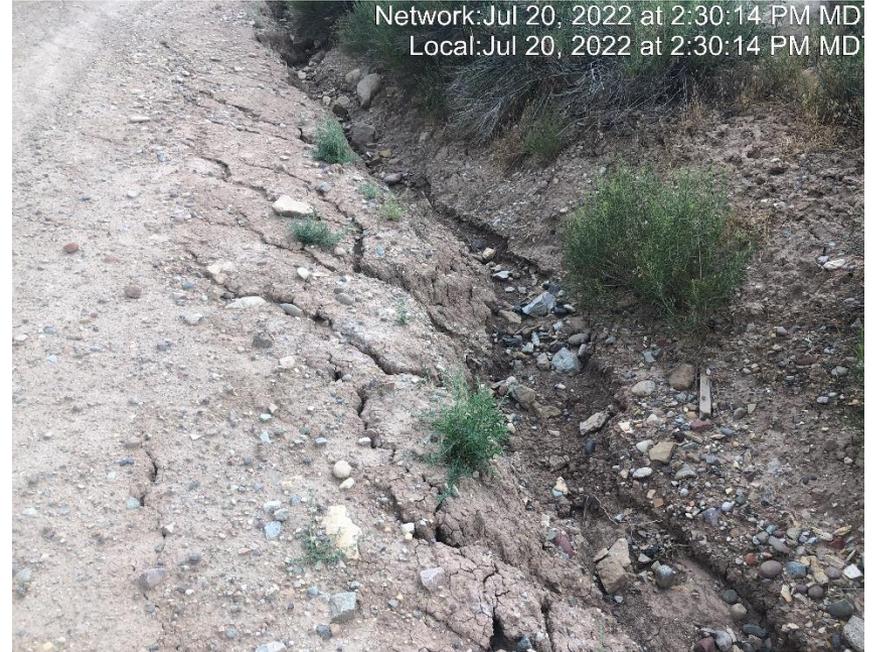
Photo #7231 No velocity checks located in ditch.
