# Inspection Photos

API: 121-10095

Operator: PETRON DEVELOPMENT COMPANY

Inspection Date: 7/21/2022

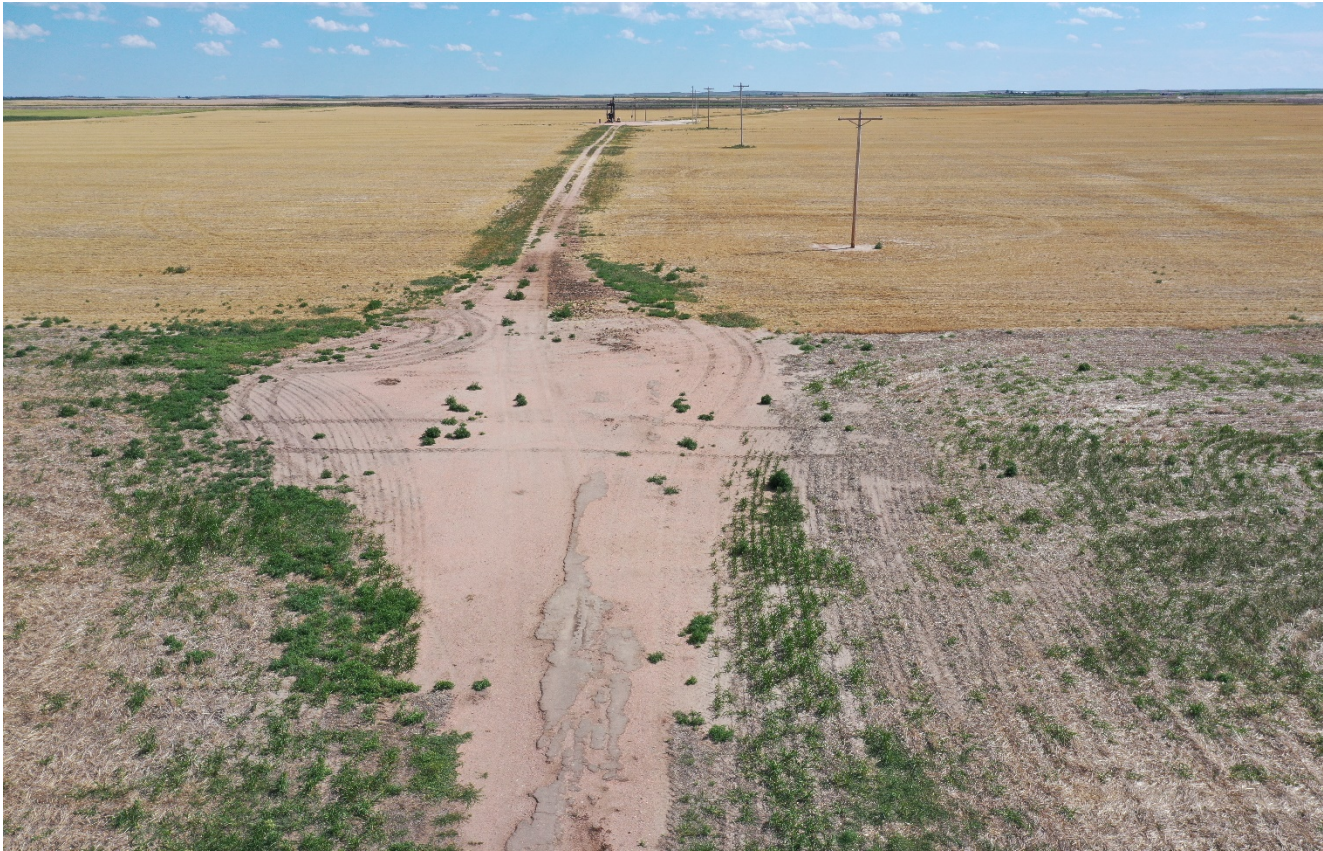
**Photo 1.** Drone aerial photo facing south toward the location. The access road travels thru the location to an active well site. The area out side of the road at the disturbed location has not been reclaimed. Previous corrective action was not completed.

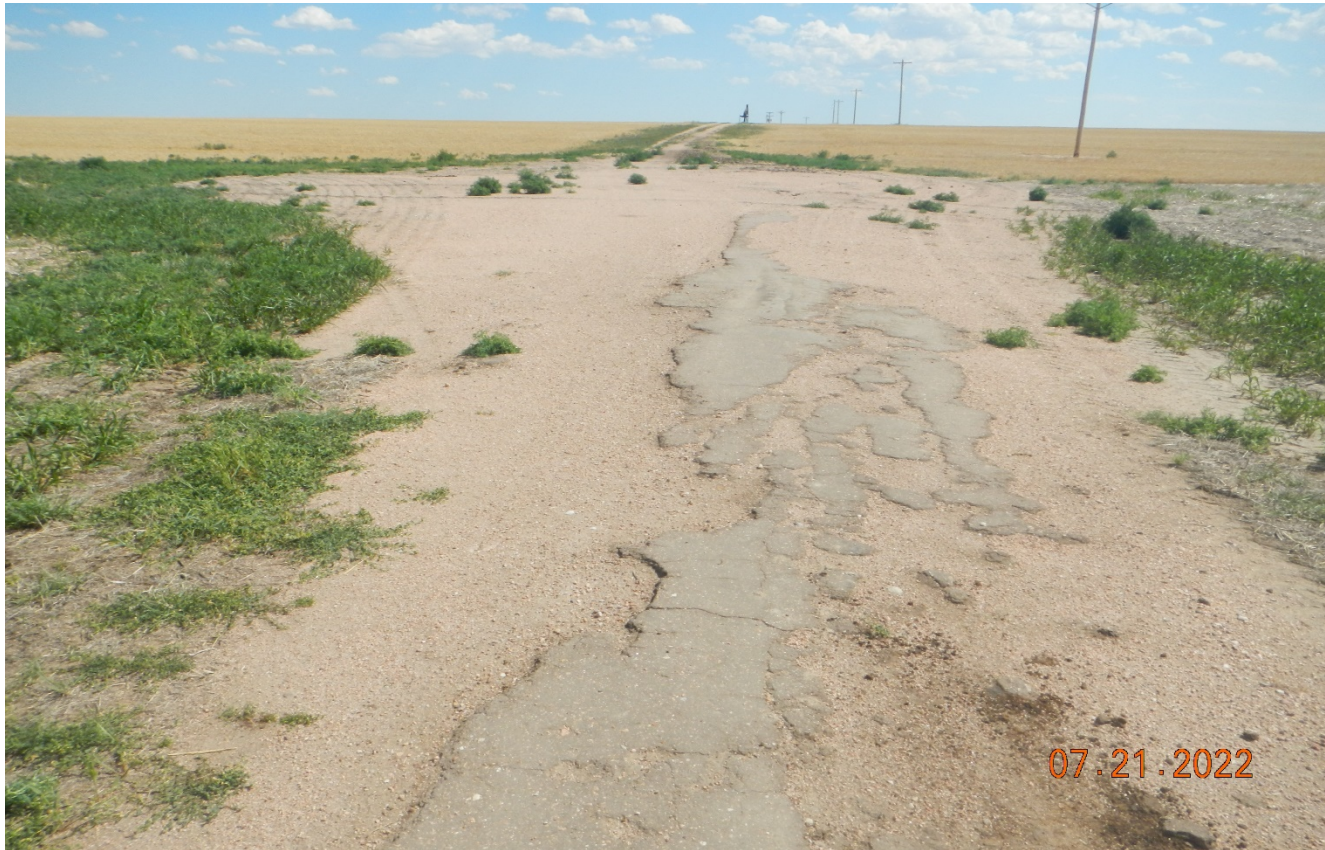
**Photo 2.** Facing south toward the location. The access road travels thru the location to an active well site. The area out side of the road at the disturbed location has not been reclaimed. Previous corrective action was not completed.

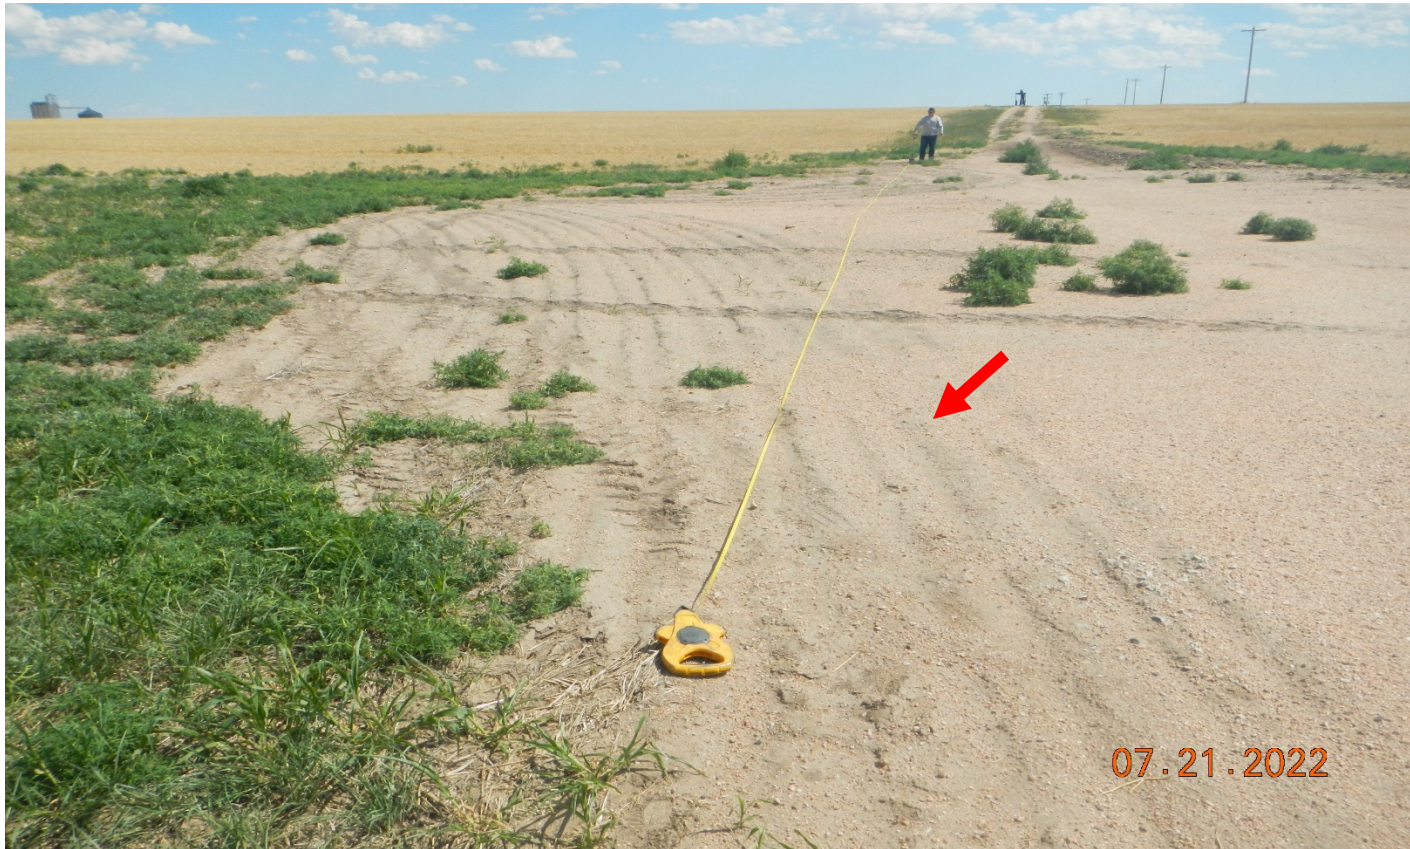
**Photo 3.** Facing south at the location which has not been reclaimed and remains bare of crop growth. A 100 ft. tape measure shows the length of disturbance which goes beyond 100 ft. The red arrow points to an area planted to millet which has failed to grow.

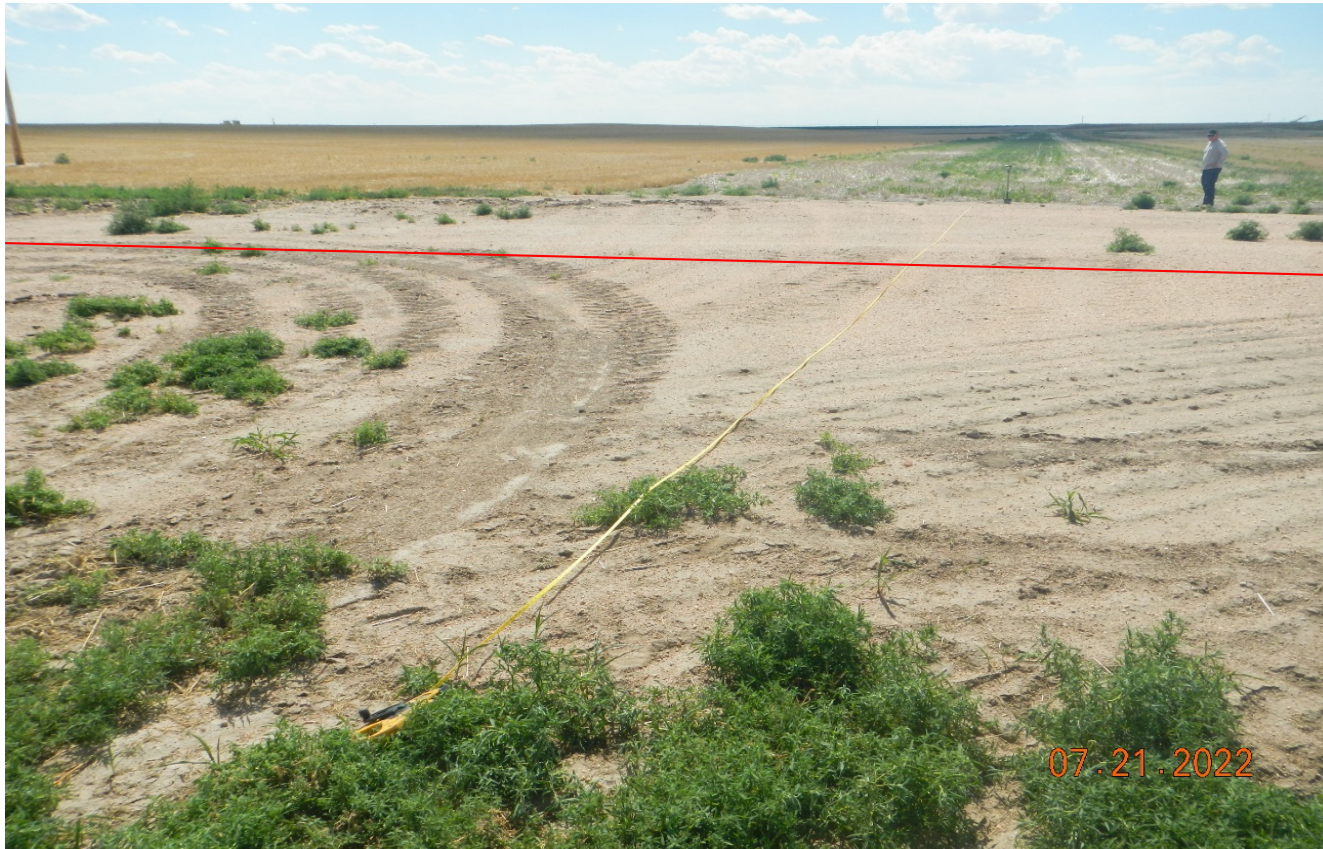
**Photo 4.** Facing west toward the location which remains with no crop growth. A 100 ft. tape measure shows the length of disturbance. The road travel thru the center location at the red line. There is approximately 50 ft. of disturbance with no crop growth at the west and east side of the access road.

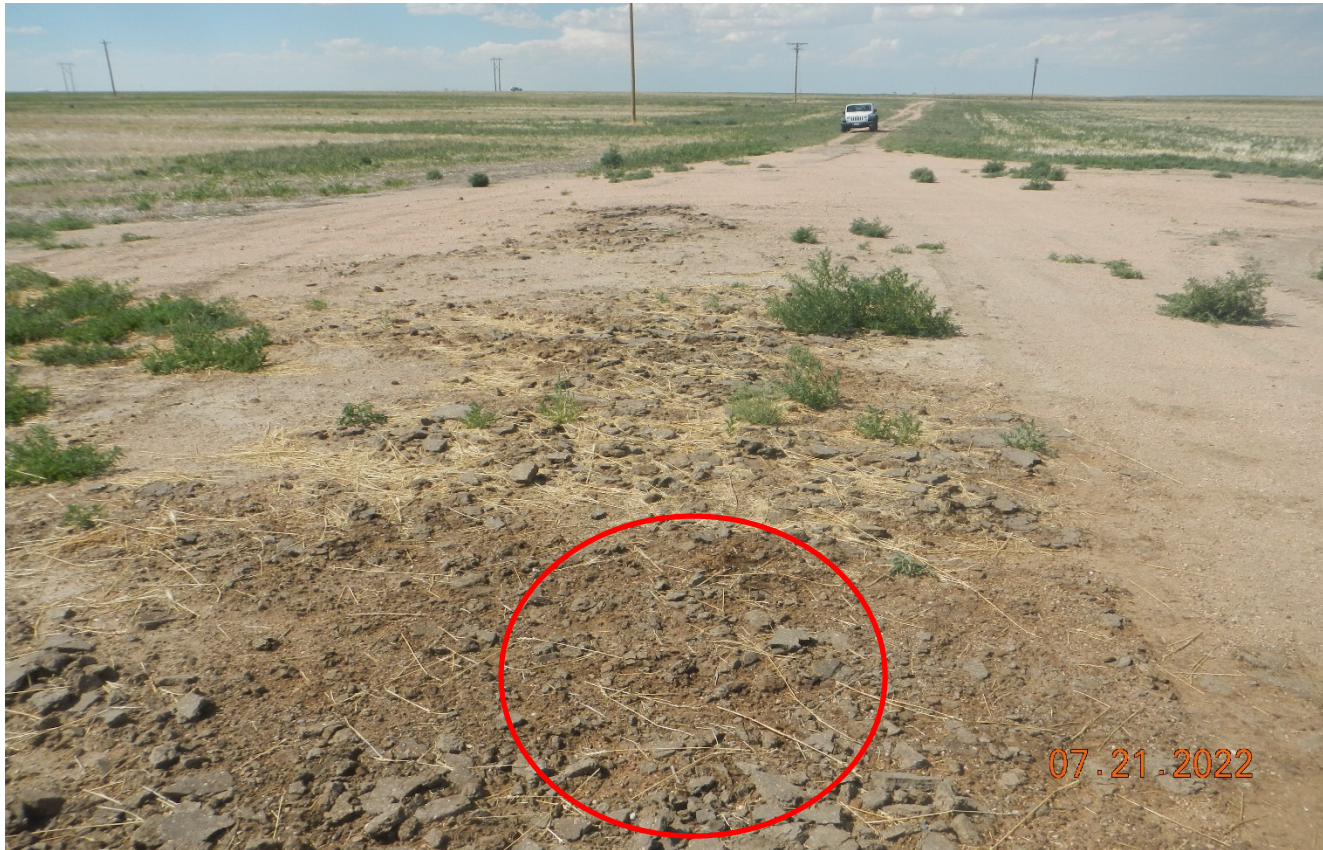
**Photo 5.** Facing north toward the location. The location is slightly elevated from the surrounding crop fields and there is asphalt debris that remains thru the location shown within red circle.

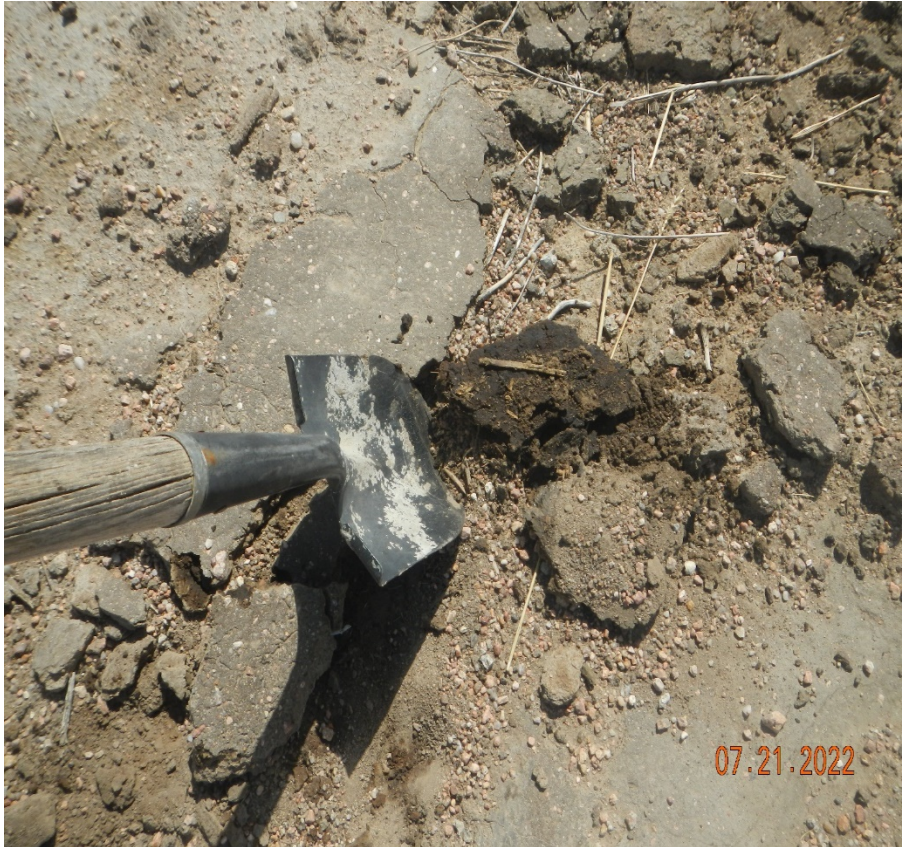
**Photo 6.** View of asphalt material found thru the location.

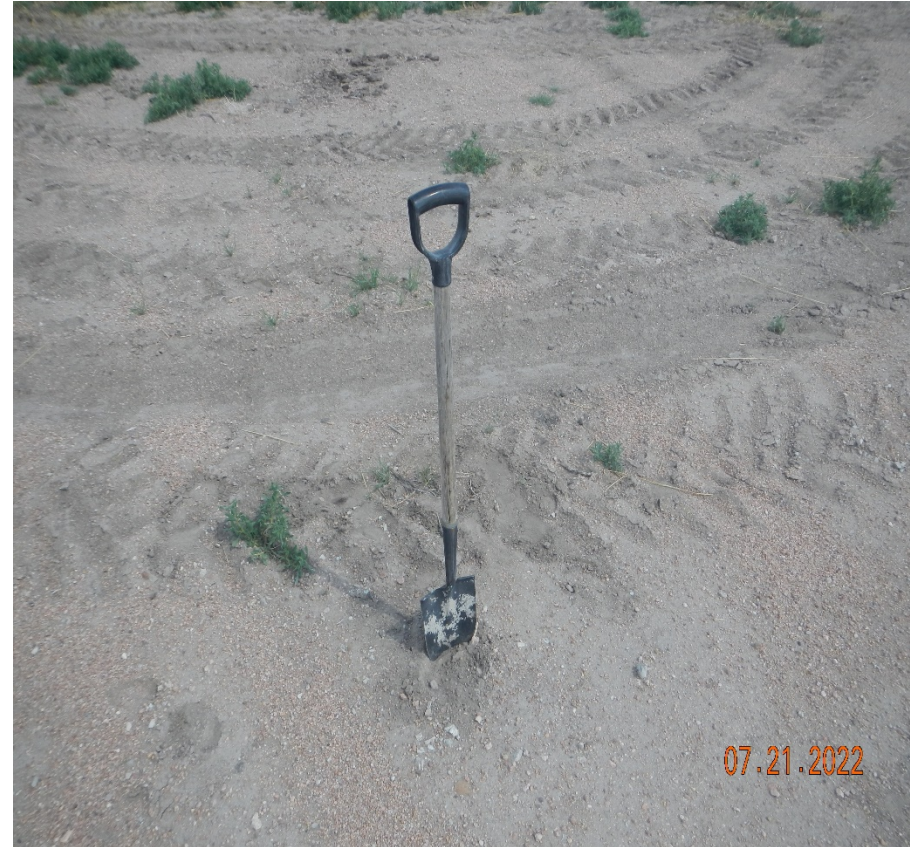
**Photo 7.** The soils throughout areas of the location are compacted. The shovel could not penetrate through the soil surface.

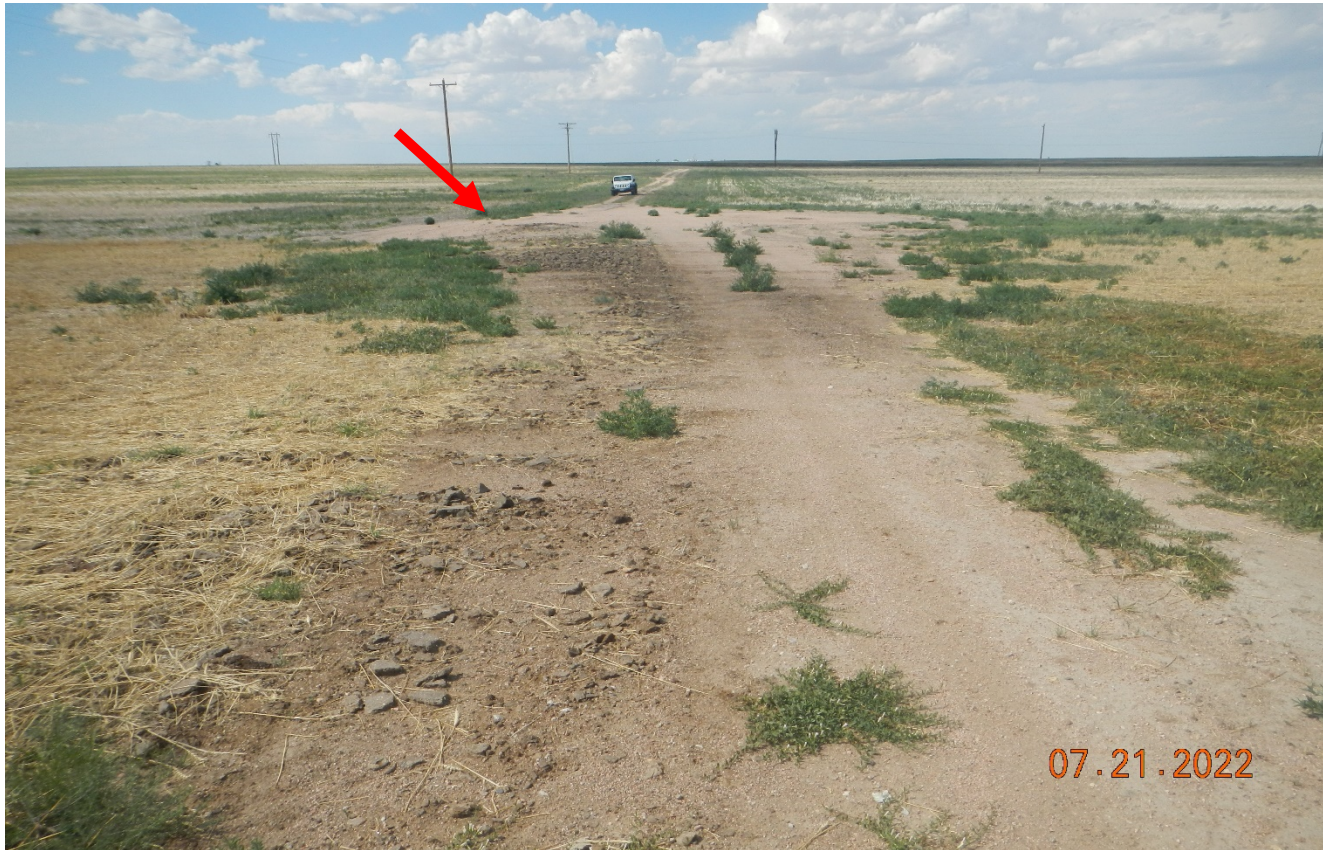
**Photo 8.** Facing north toward the location. The access road travels thru the location to an active well site. The area out side of the road at the disturbed location has not been reclaimed.
