Inspection Photos
Location Name: Thacker 1
Location ID: 32931

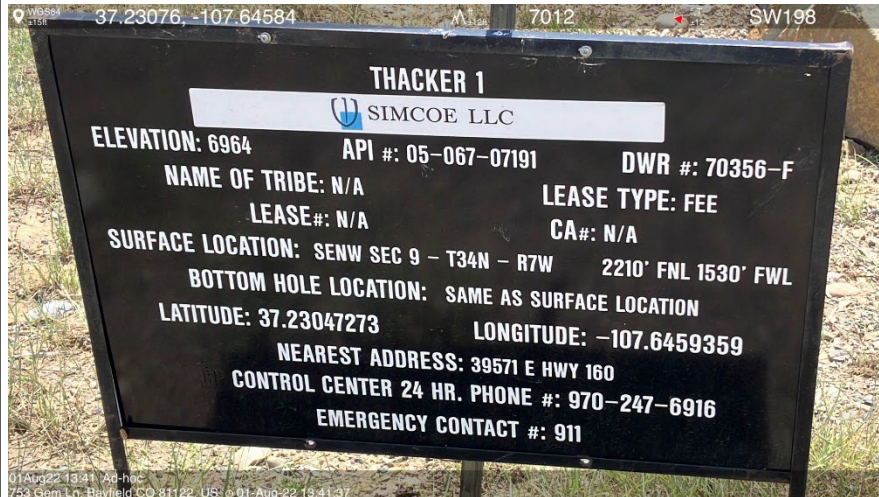
IMG 01
Well sign

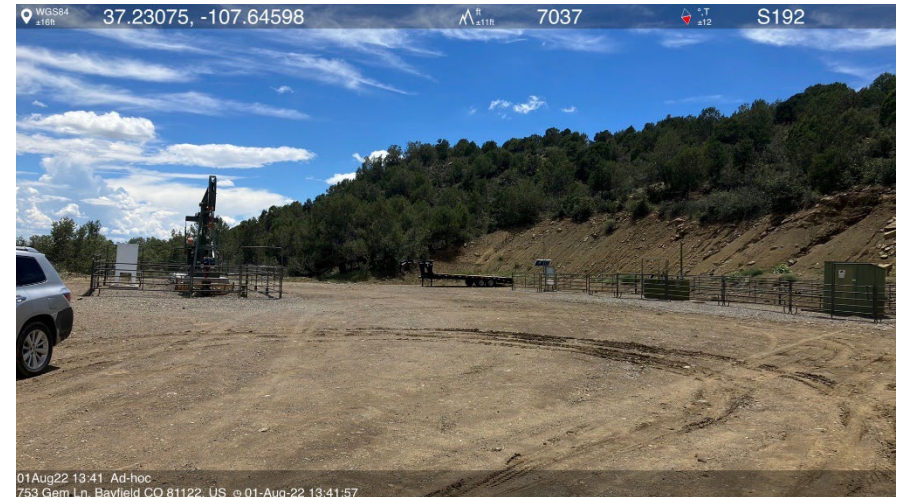
IMG 02
Location overview

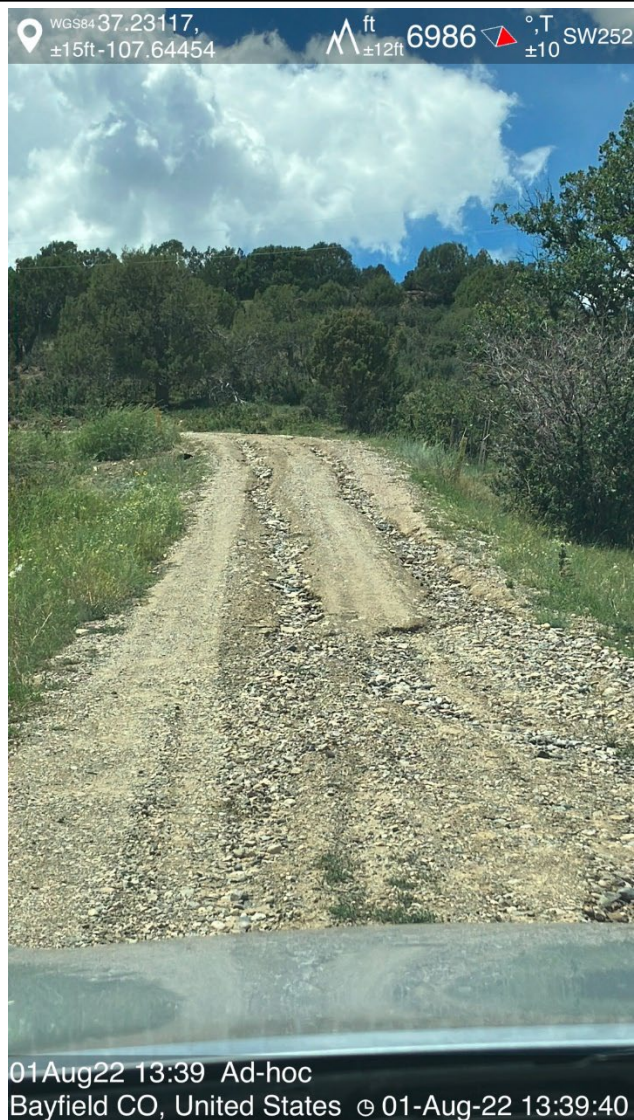
IMG 03

Ruts beginning to develop in access road

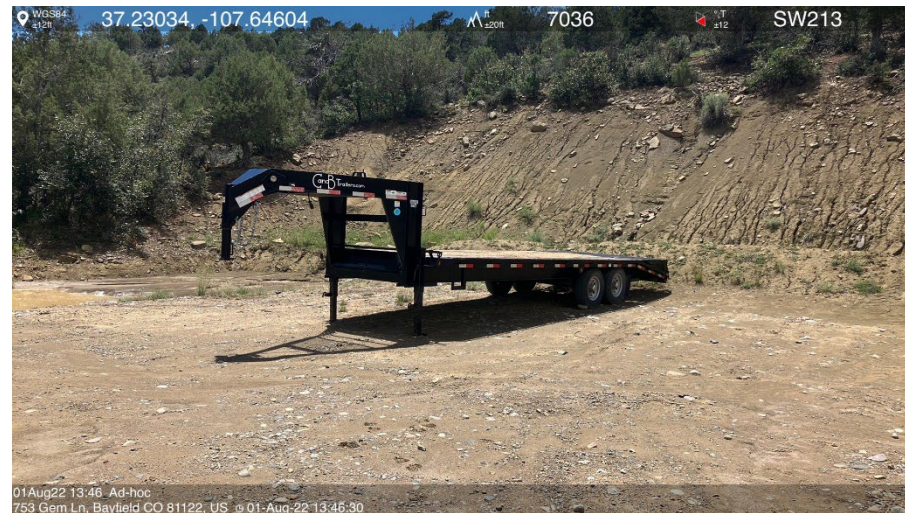
IMG 04

Trailer on location
