Inspection Photos  
Location Name: Le Platt A 1  
Location ID: 325938

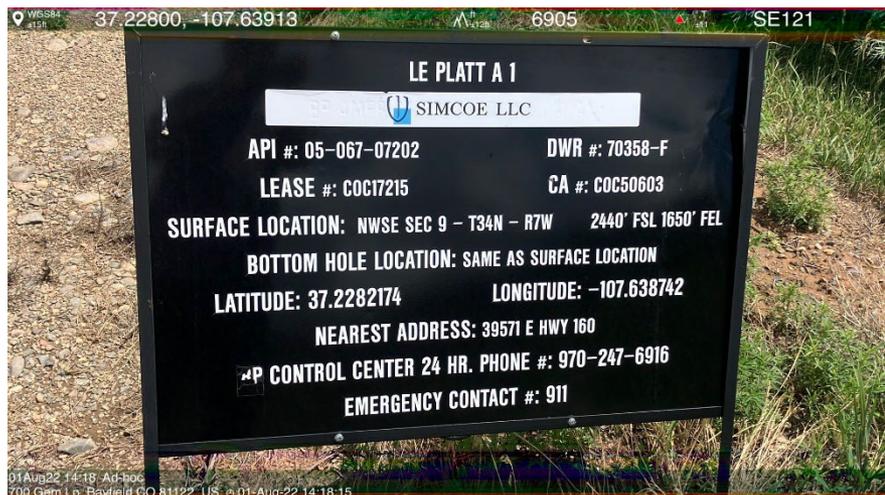
IMG 01  
Well sign

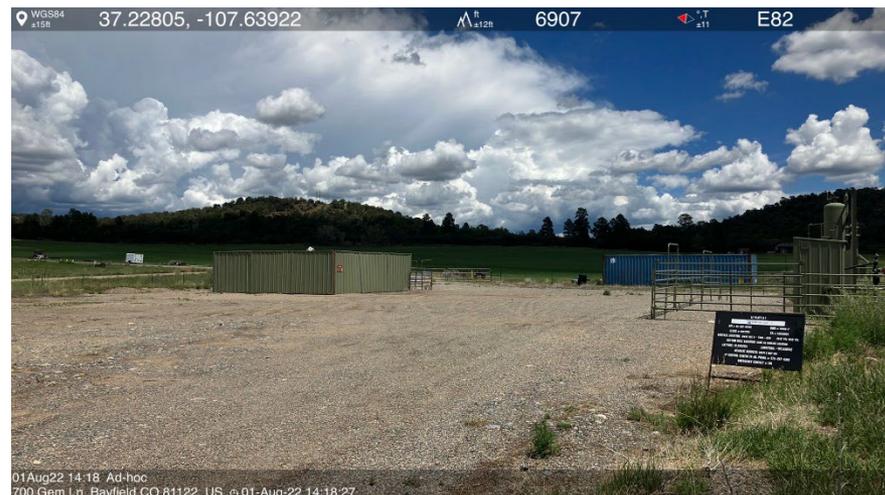
IMG 02  
Location overview

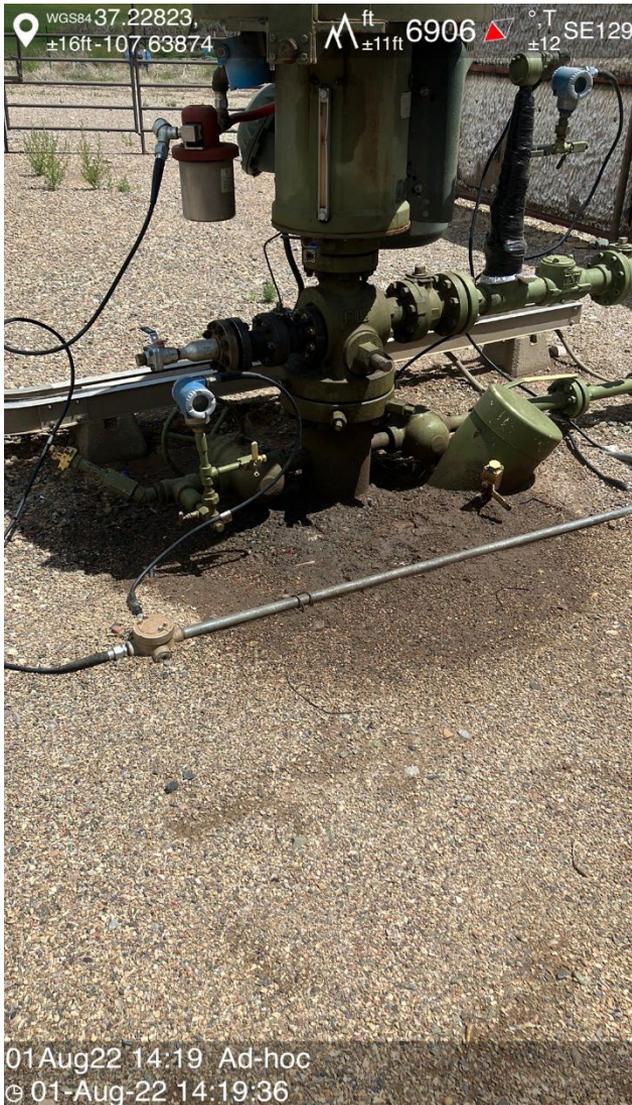
**IMG 03**

**Lube oil has impacted surface material**

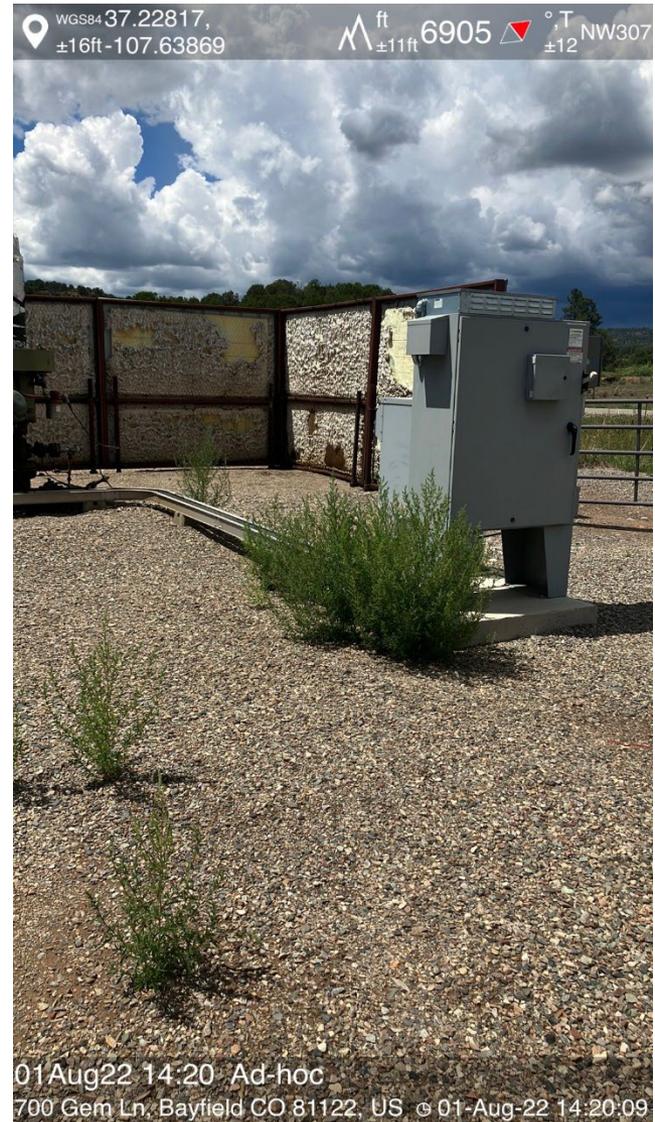
**IMG 04**

**Weeds beginning to encroach on wellhead**
