Inspection Photos

API: 071-07085

Operator: EVERGREEN NATURAL RESOURCES

Inspection Date: 8/3/2022

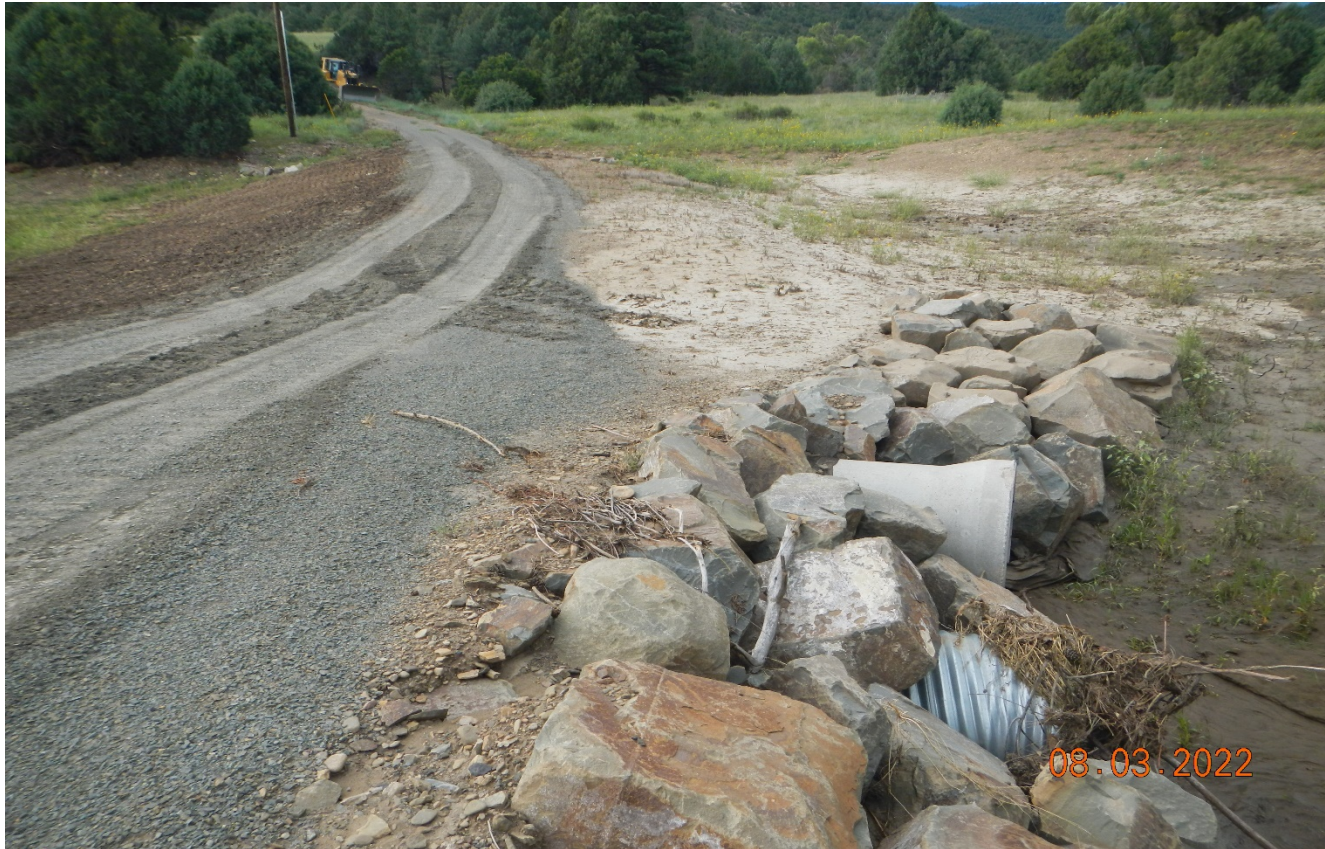
Photo 1. Facing south toward the access road stream crossing. It appears a recent storm event had overtopped the crossing. The two culverts are not sufficient to handle storm events. Previous corrective action not completed.

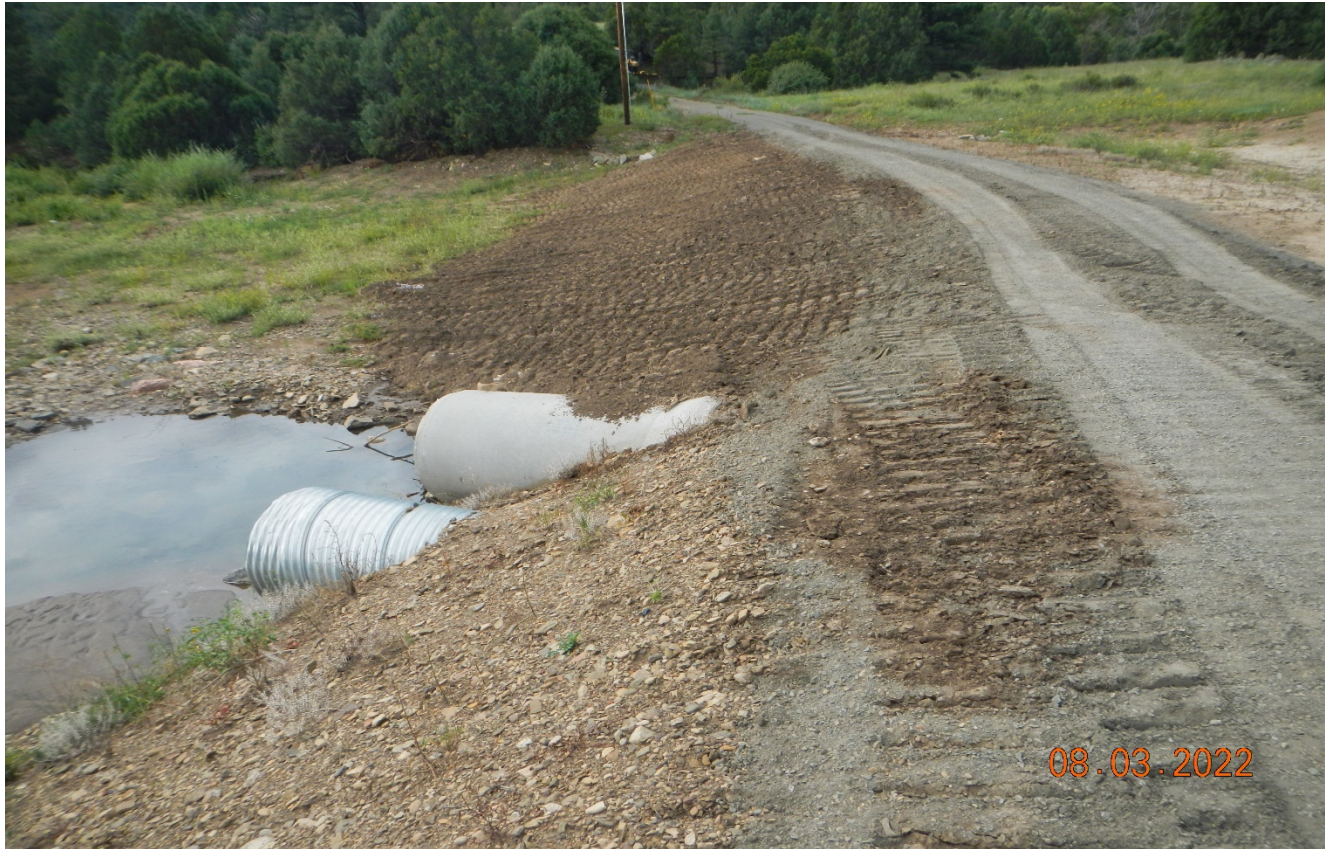
Photo 2. Facing south toward the access road stream crossing outlet side. There is no bank stabilization at the outlet side. Recent dozer work was performed in this area.

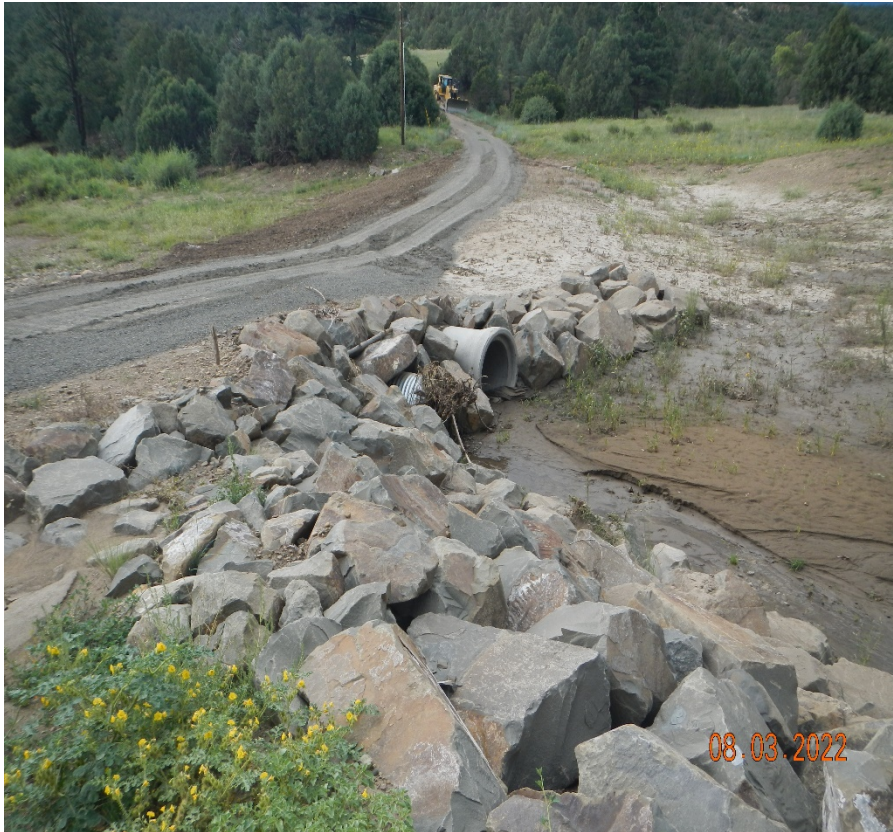
Photo 3. There are two culverts installed at the stream crossing. This appears to be inadequate as the prior cement culvert shown in the photo on the right had 3 large culverts.

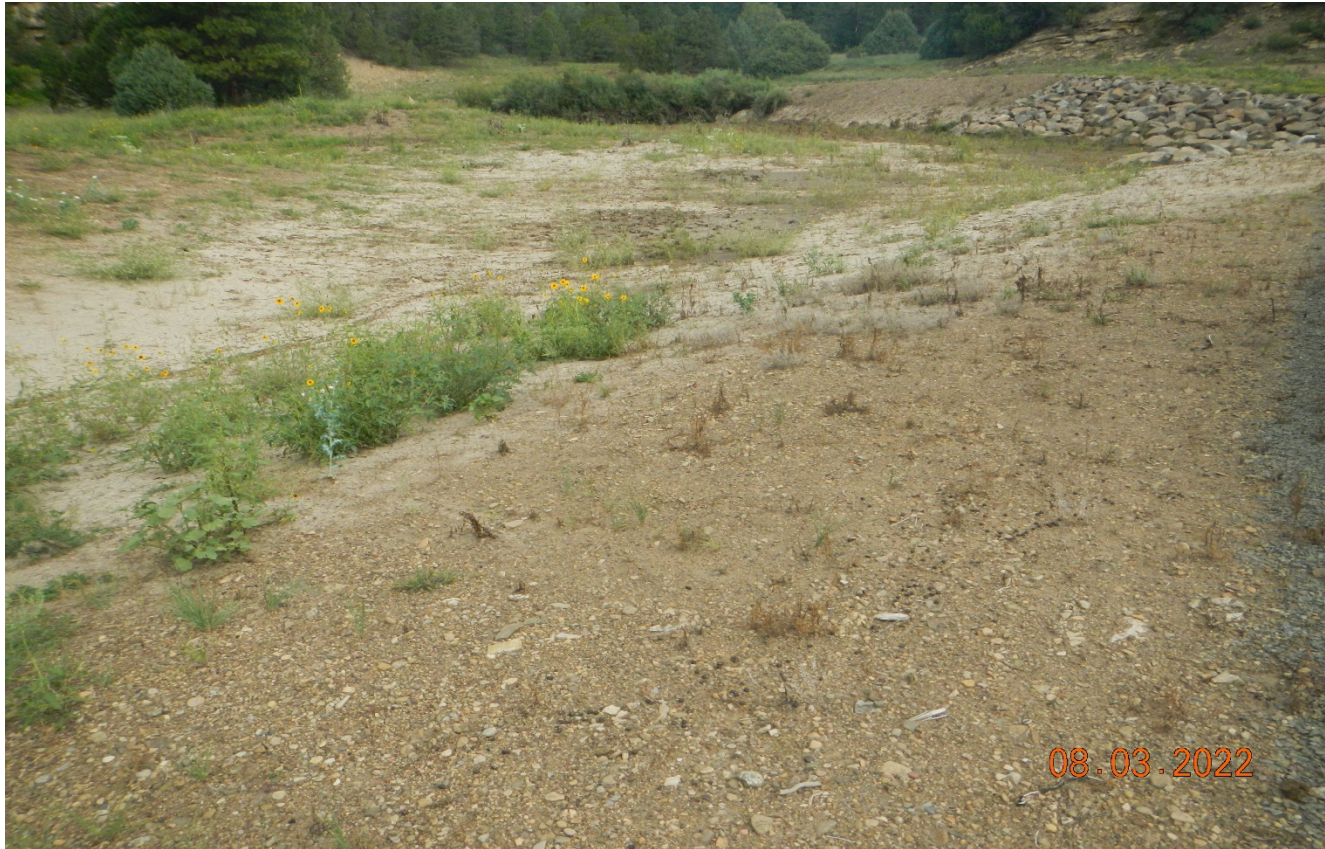
Photo 4. Facing northwest along the side of the access road. All disturbed areas along the road side need to be seeded and stabilized. Previous corrective action not completed.

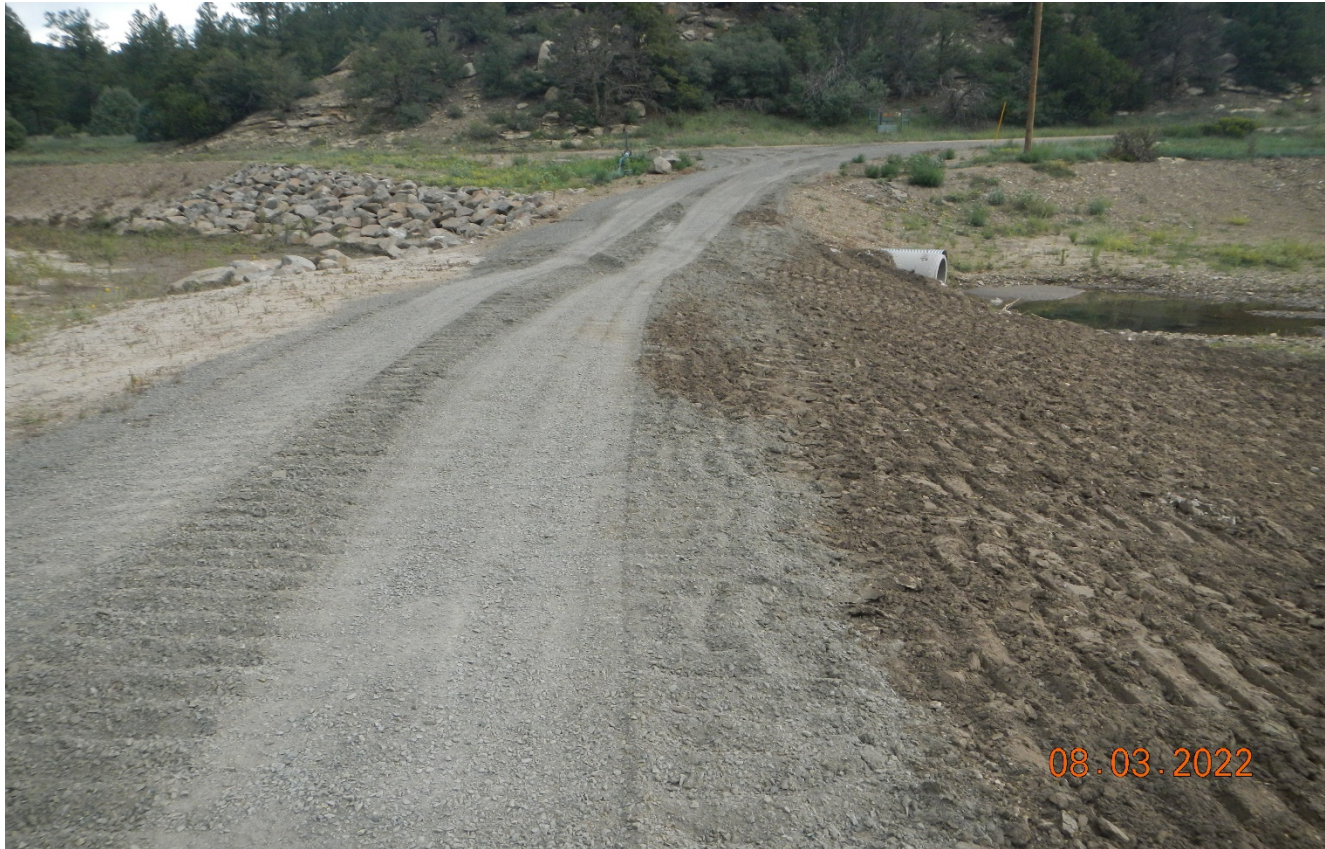
Photo 5. Facing northwest along the side of the access road. All disturbed areas along the road side need to be seeded and stabilized.
