Inspection Photos

August 8, 2022

Location Name: Honea 19-05

Inspection Document #: 702800552

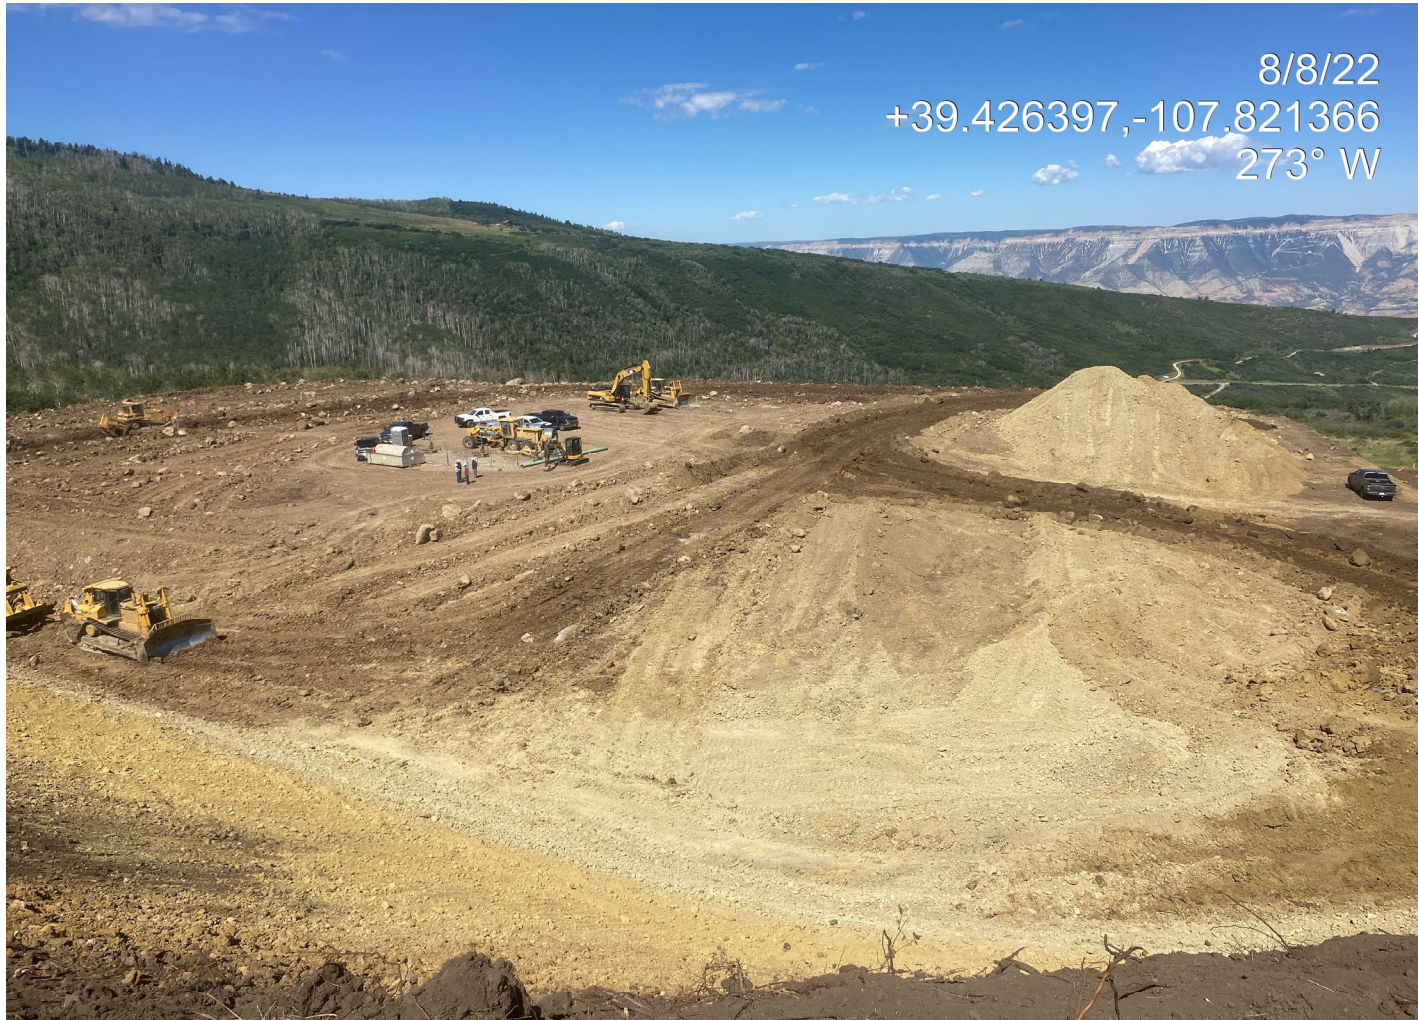
Photo 1. Photo taken from the east shows an overview of the Location.

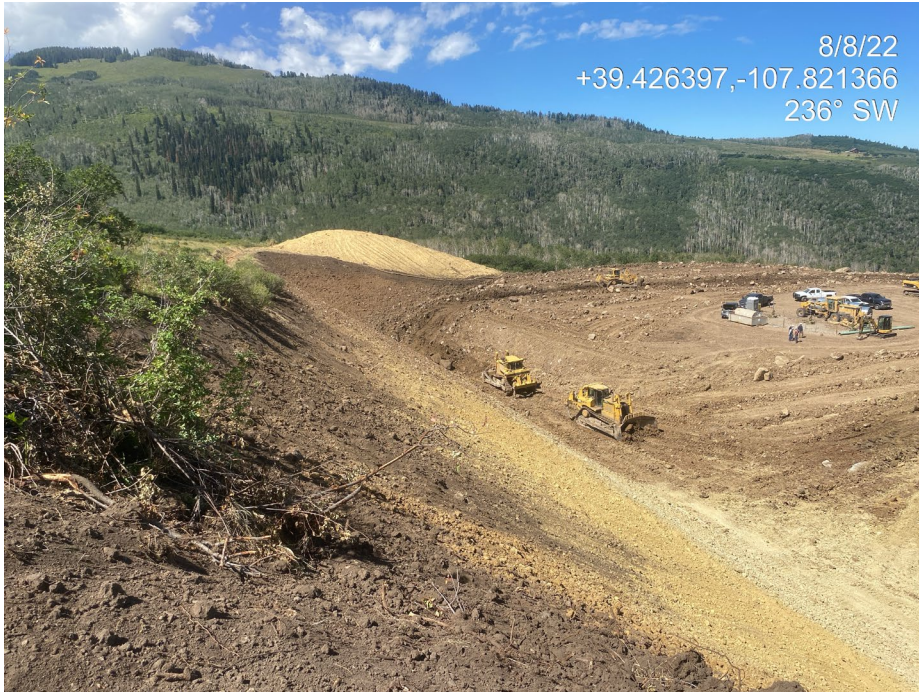
Photo 2. Photo taken from the east shows an overview of the western portion of the Location. Photo also shows the cut slope is unstabilized. Upon completion of construction, slopes must be stabilized.

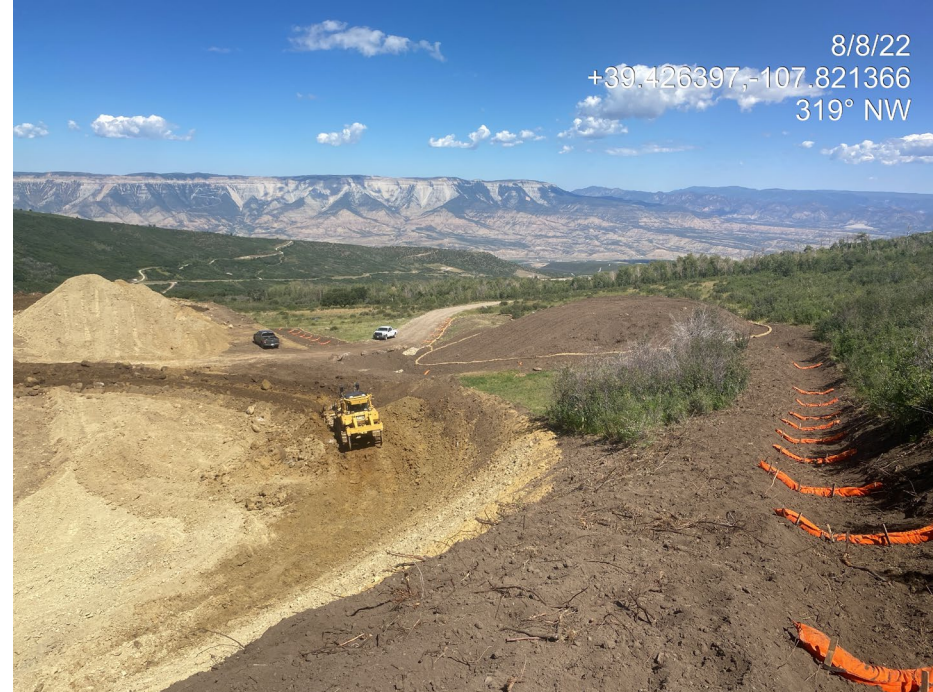
Photo 3. Photo taken from the east shows an overview of the eastern portion of the Location.

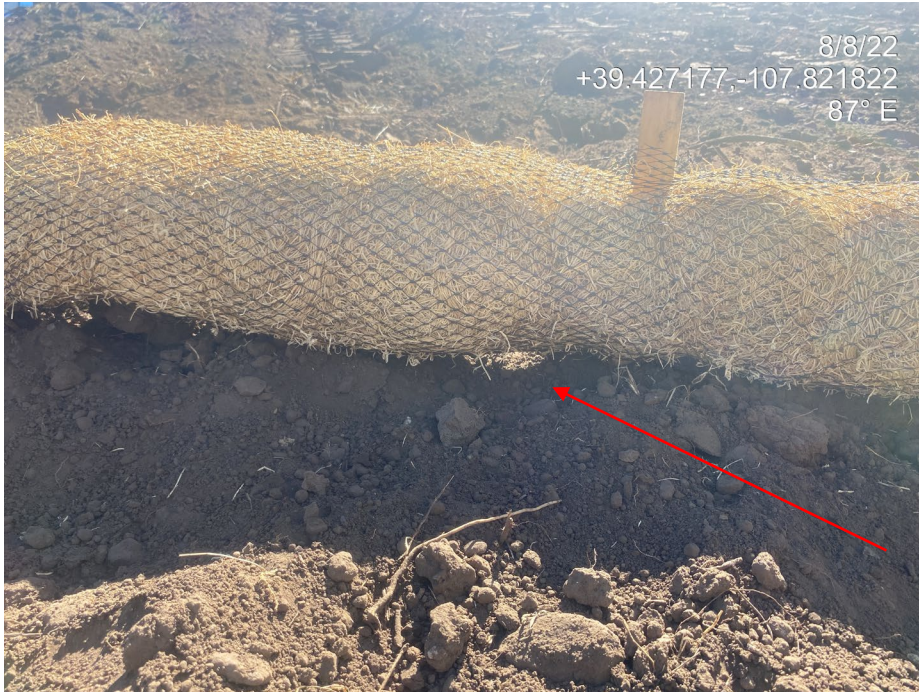
Photo 4. Photo taken from the northeast shows a straw wattle installed around the perimeter of the topsoil stockpile has not been properly installed. The wattle has not been trenched and backfilled.

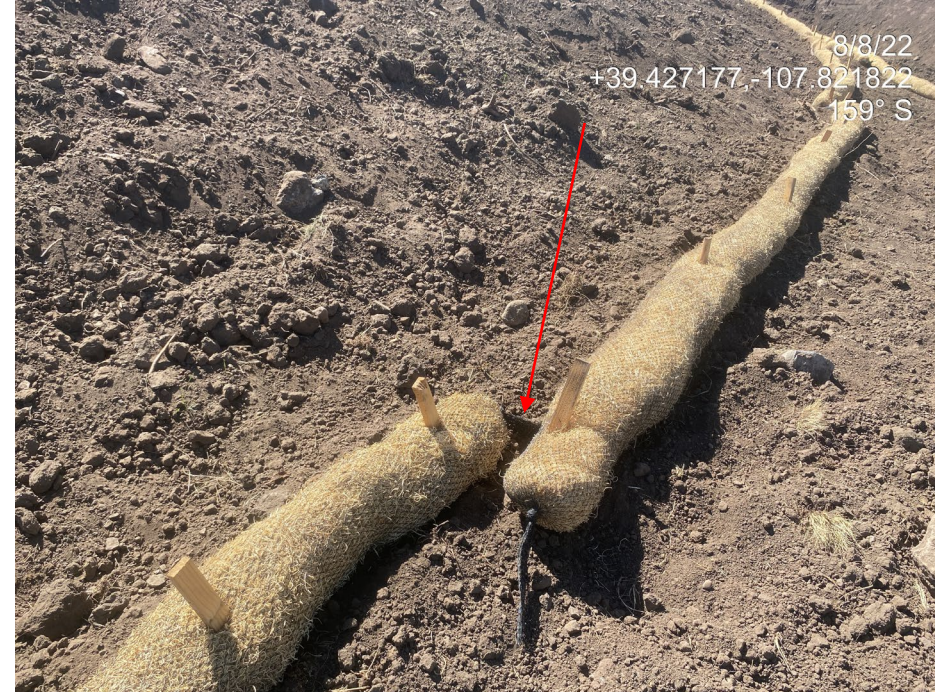
Photo 5. Photo taken from the northeast shows a straw wattle installed around the perimeter of the topsoil stockpile. Adjacent wattles have not been properly installed and wattles have not been trenched and backfilled.

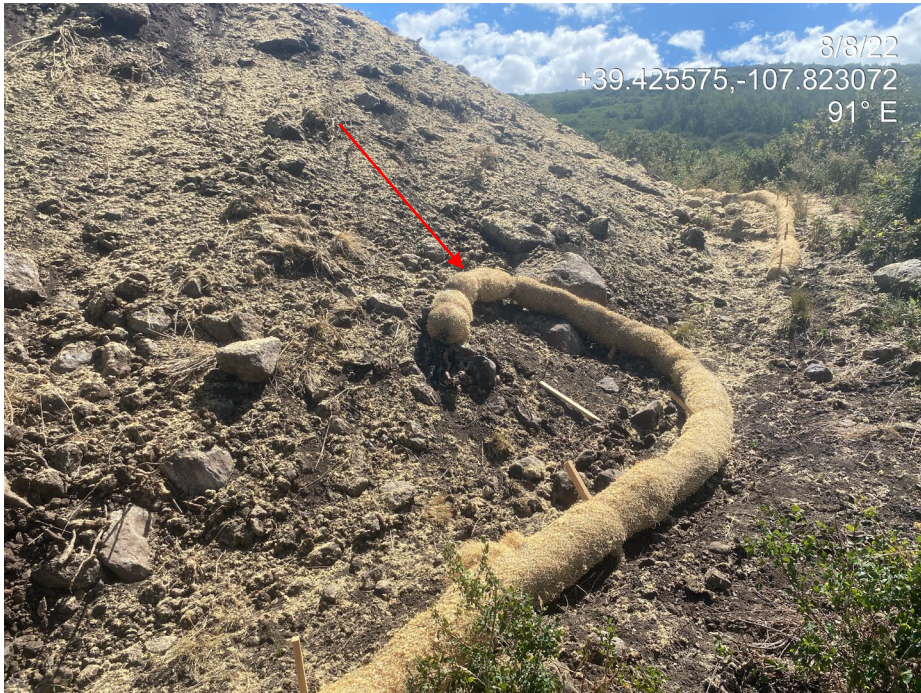
Photo 6. Photo taken from the south shows a straw wattle installed around the perimeter of the topsoil stockpile is in disrepair and is not in proper functioning condition to protect the stockpile. Downslope sections of the wattle were not trenched and backfilled.

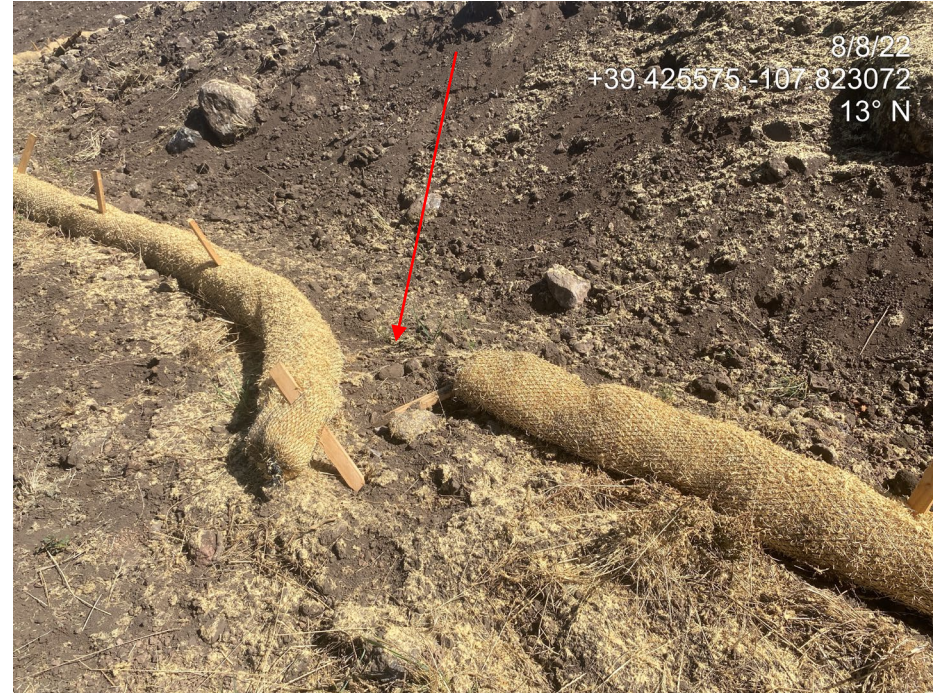
Photo 7. Refer to Photo 6 comment.

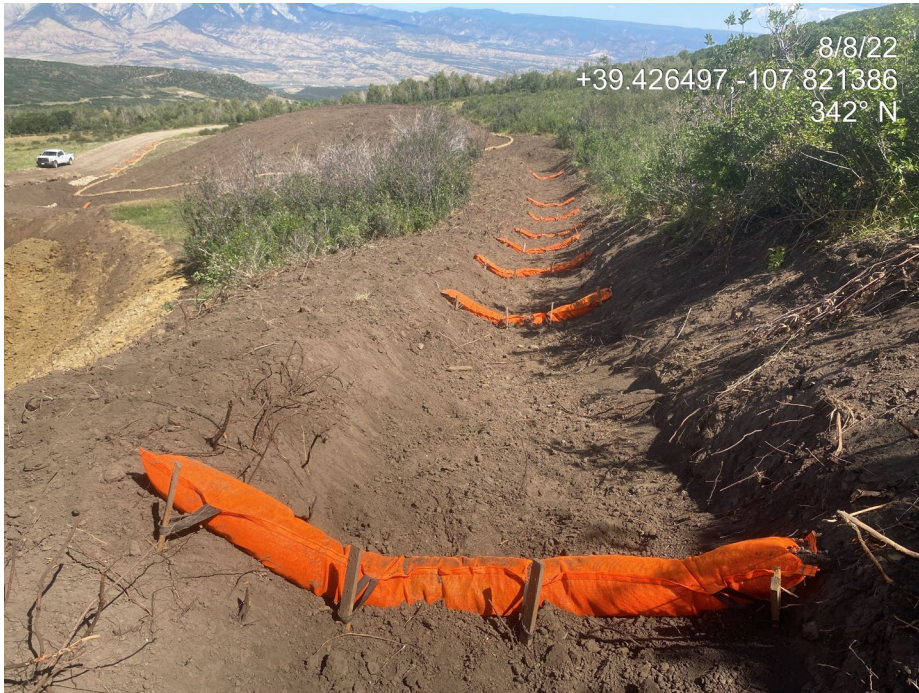
Photo 8. Photo taken from the east of the Location shows the perimeter stormwater diversion ditch. The channel shape has been properly constructed however, soil in the ditch is loose and unconsolidated, acting as a pollutant source. Velocity checks have been installed within the ditch.

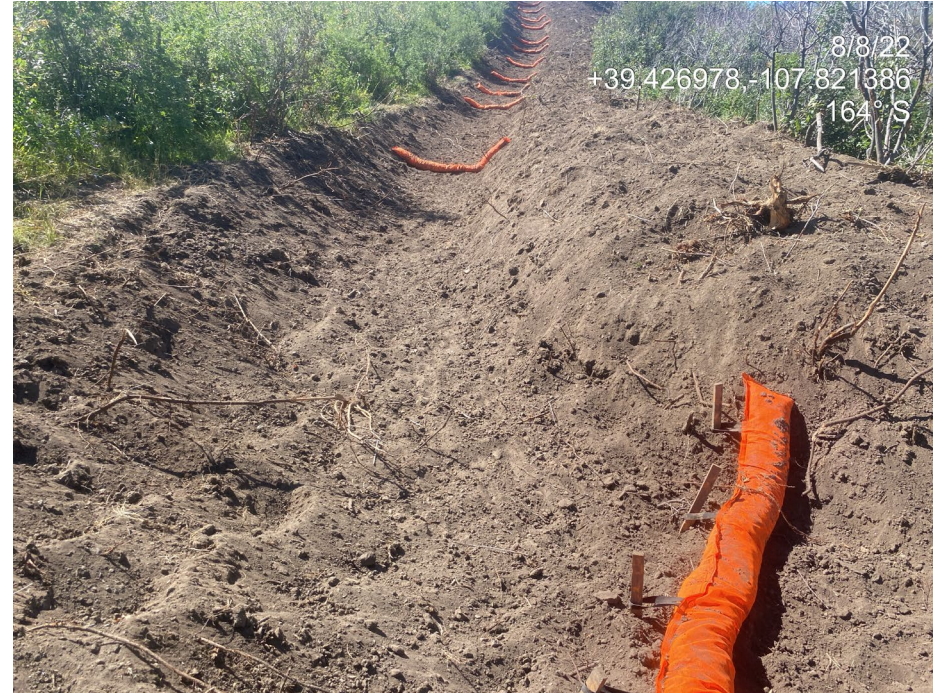
Photo 9. Refer to Photo 8 comments.

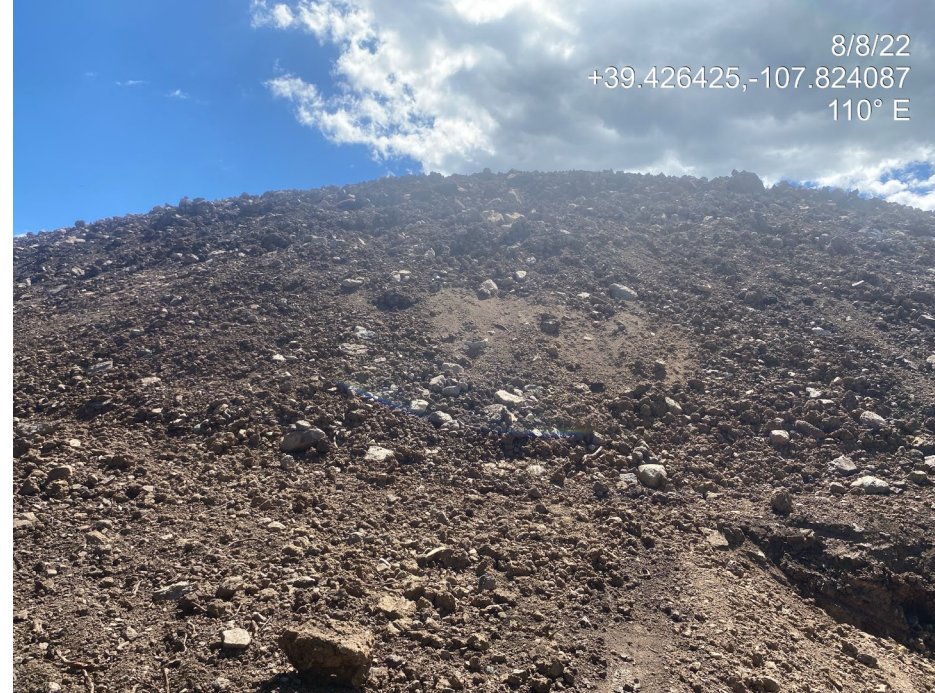
8/8/22
+39.426425, -107.824087
110° E

Photo 11. Photo taken from the west of the Location shows soils of the fill slope are unstabilized. Upon completion of construction, slopes must be stabilized.

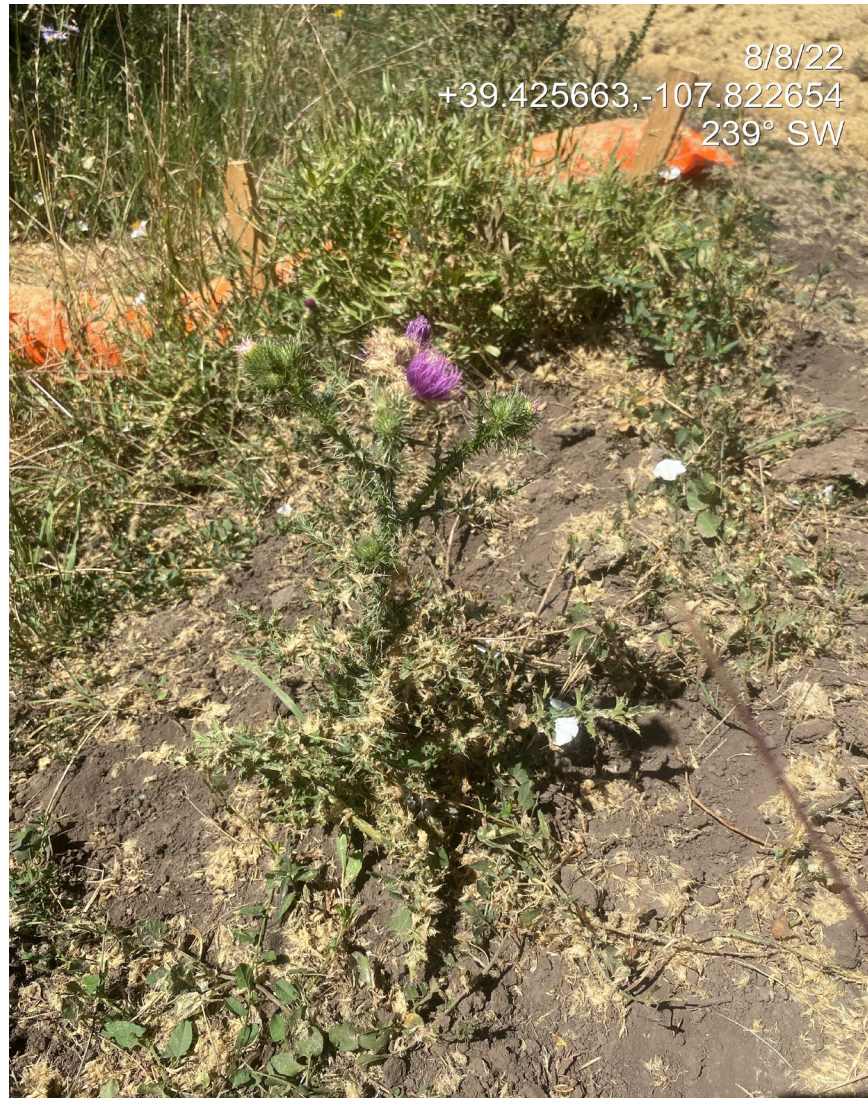
8/8/22
+39.425663,-107.822654
239° SW

Photo 12. Photo taken from the southeast shows plumeless thistle, a CO List B Noxious Weed found occasionally throughout the perimeter of the Location.
