Inspection Photos

API: 061-06023

Operator: WESTERN OPERATING COMPANY

Inspection Date: 8/10/2022

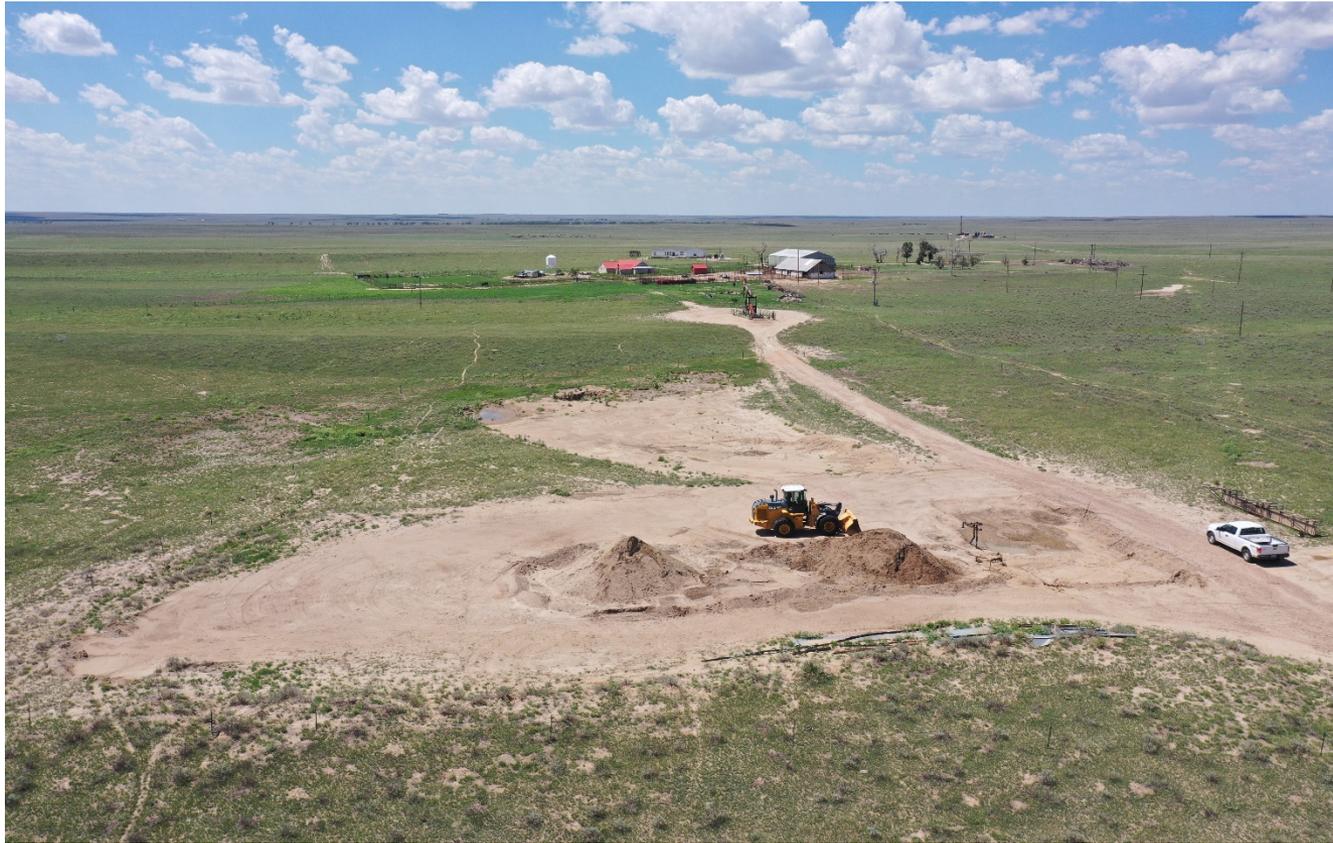
Photo 1. Drone aerial photo facing west toward the battery and wellsite. There is a remediation project in process.

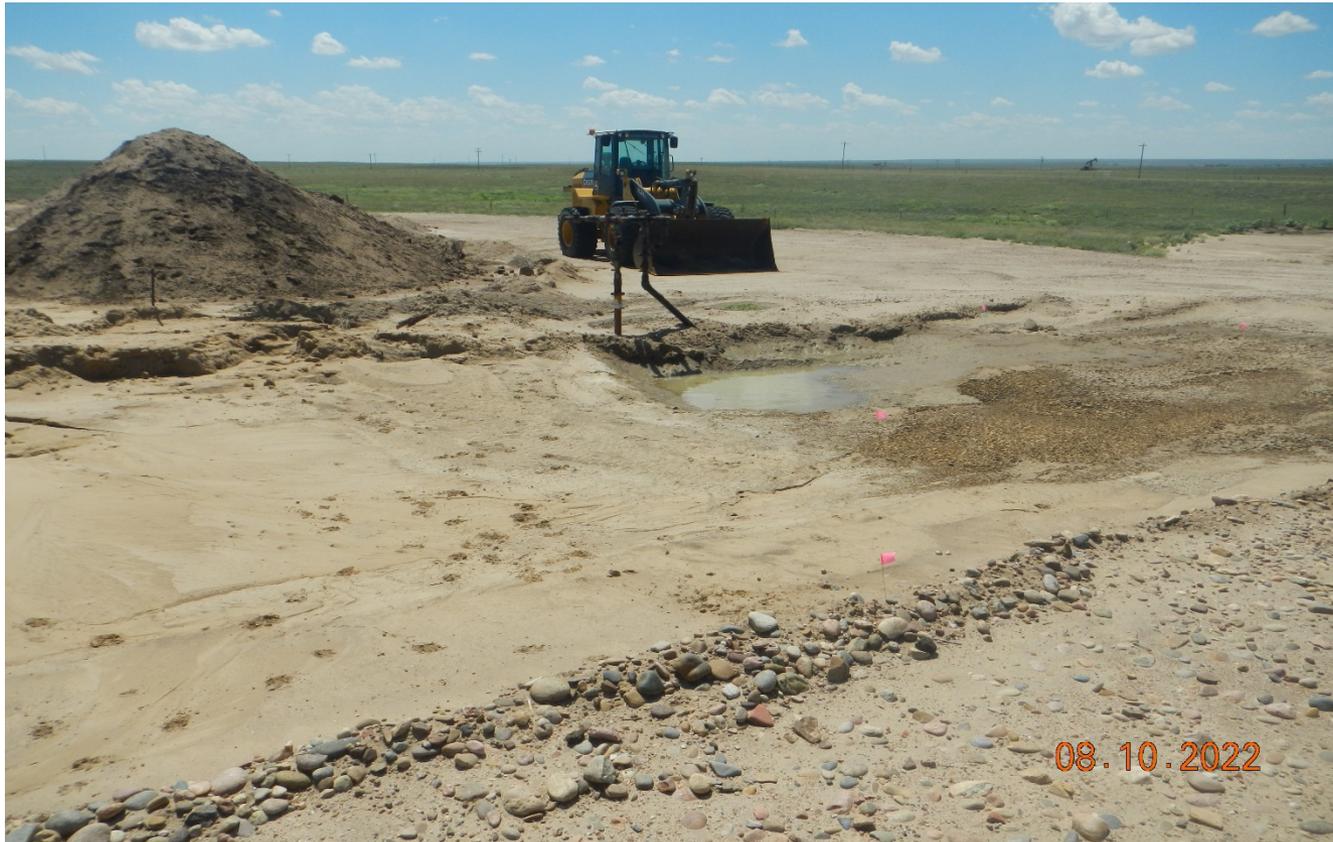
Photo 2. Facing southwest toward the tank battery facility. The tank was removed and soils have been excavated in this area. Remediation project: 20712

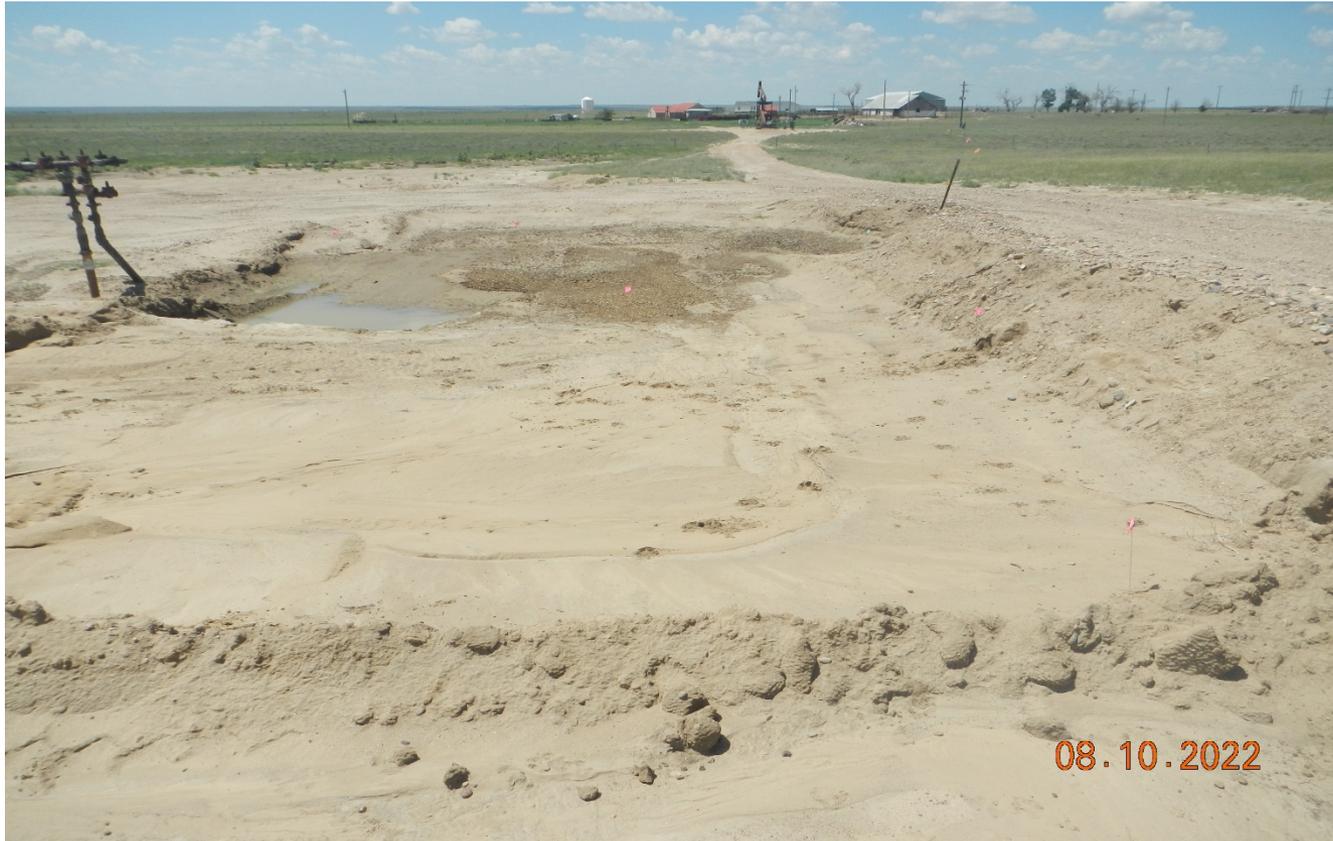
Photo 3. Facing west toward the tank battery facility. The tank was removed and soils have been excavated in this area. Remediation project: 20712

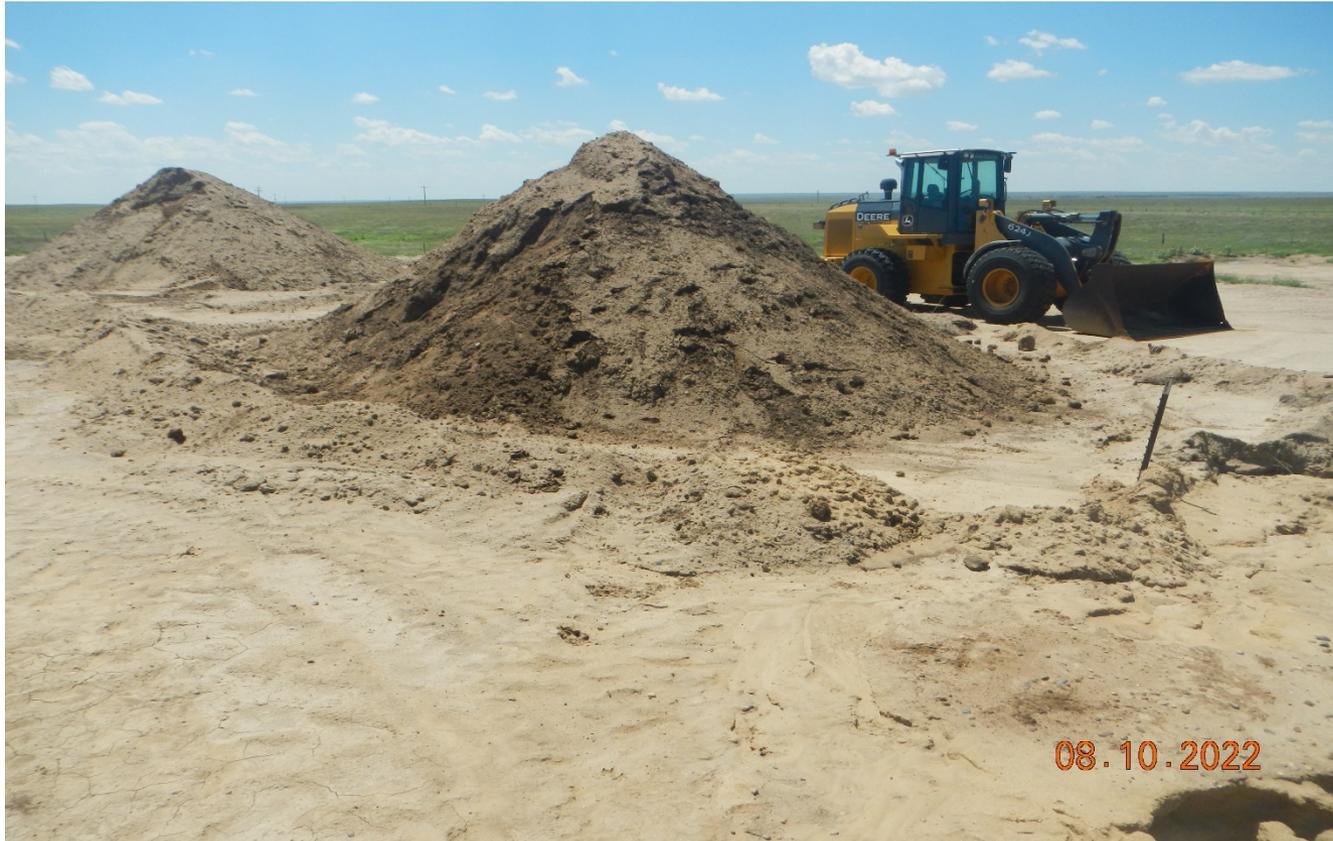
Photo 4. There are soil piles stored at the battery site. There appears to be oil contaminated soil present in the soil pile on the right.

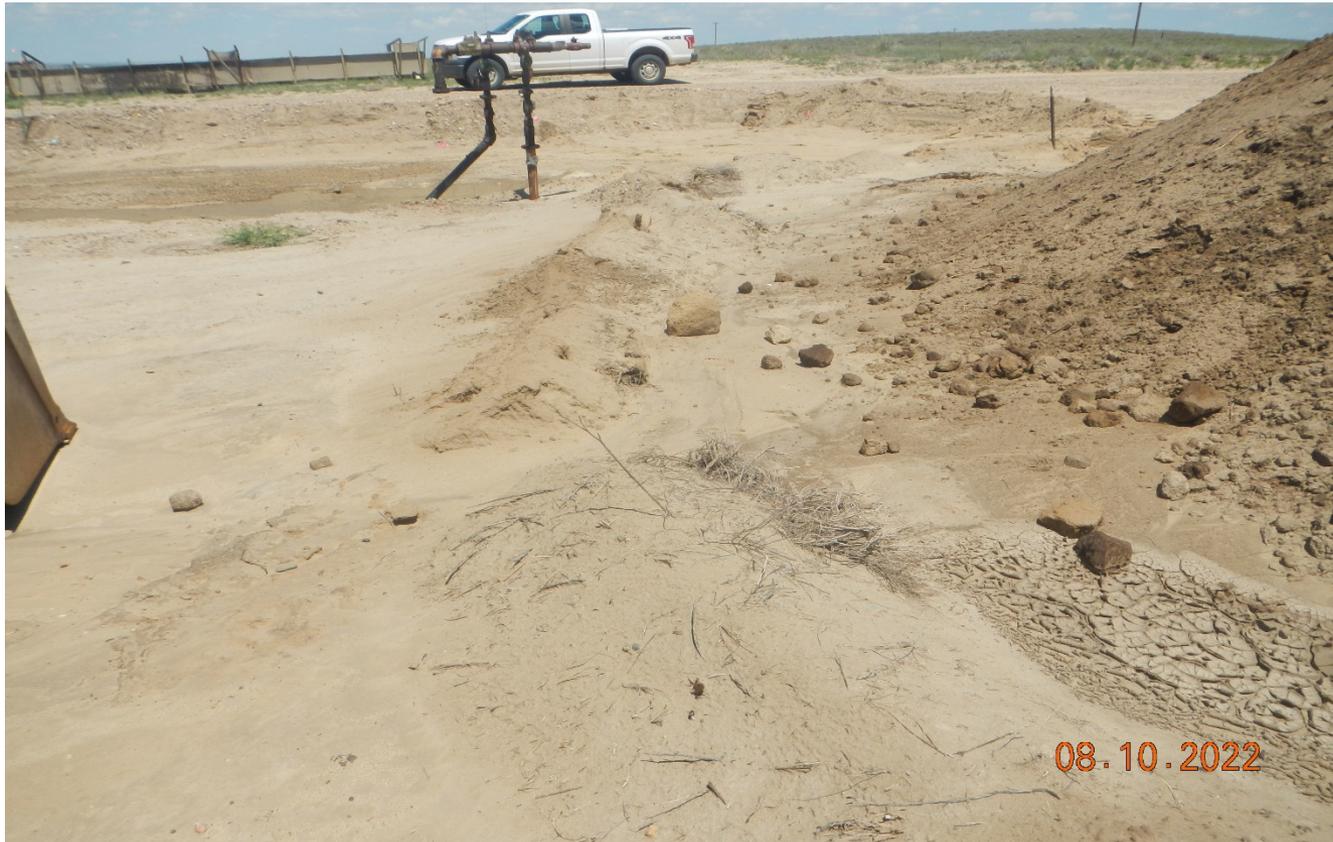
Photo 5. The berms around the soil piles are insufficient and need to be properly constructed and compacted.

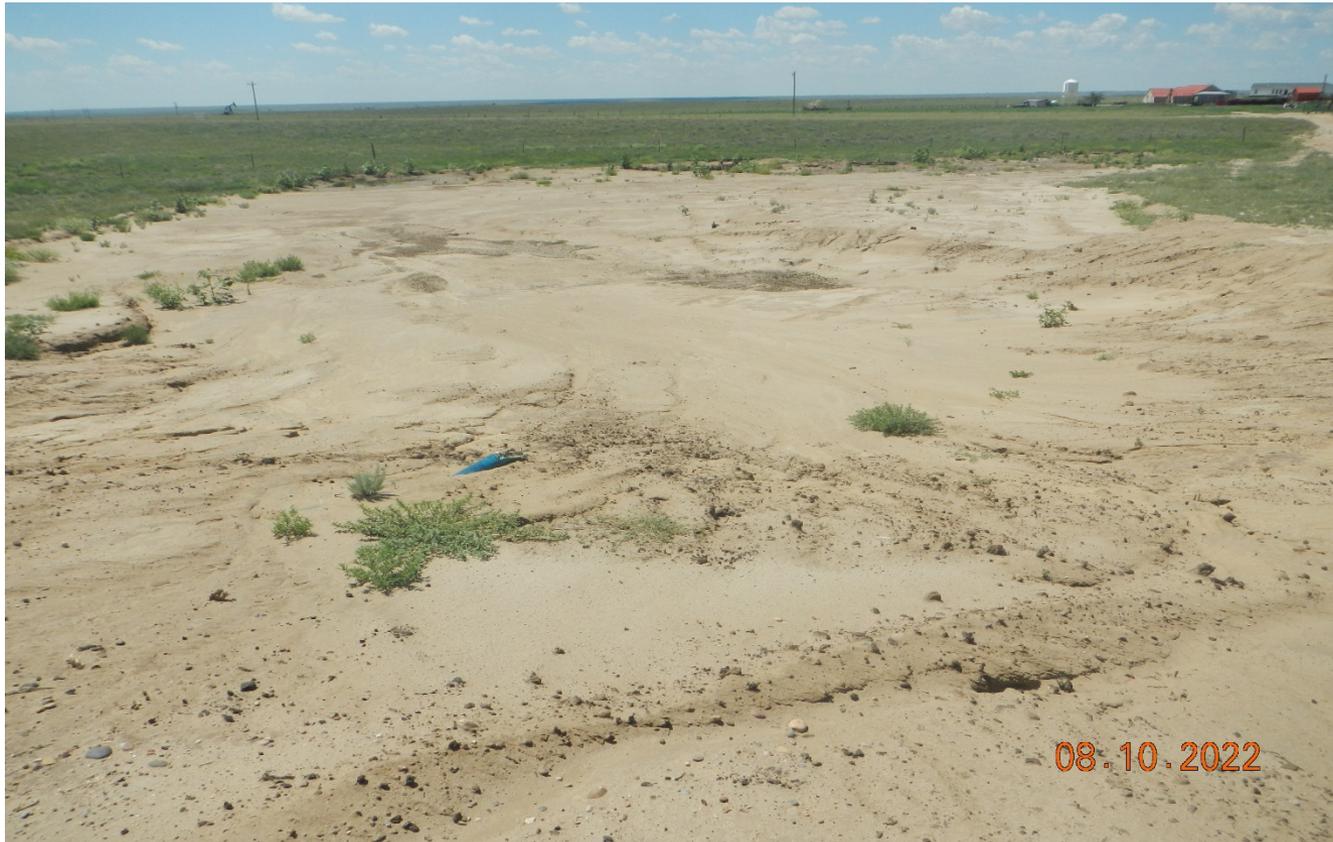
Photo 6. Facing west toward the area where the spill occurred. Remediation project: 20712. Some areas have been excavated more than other areas.

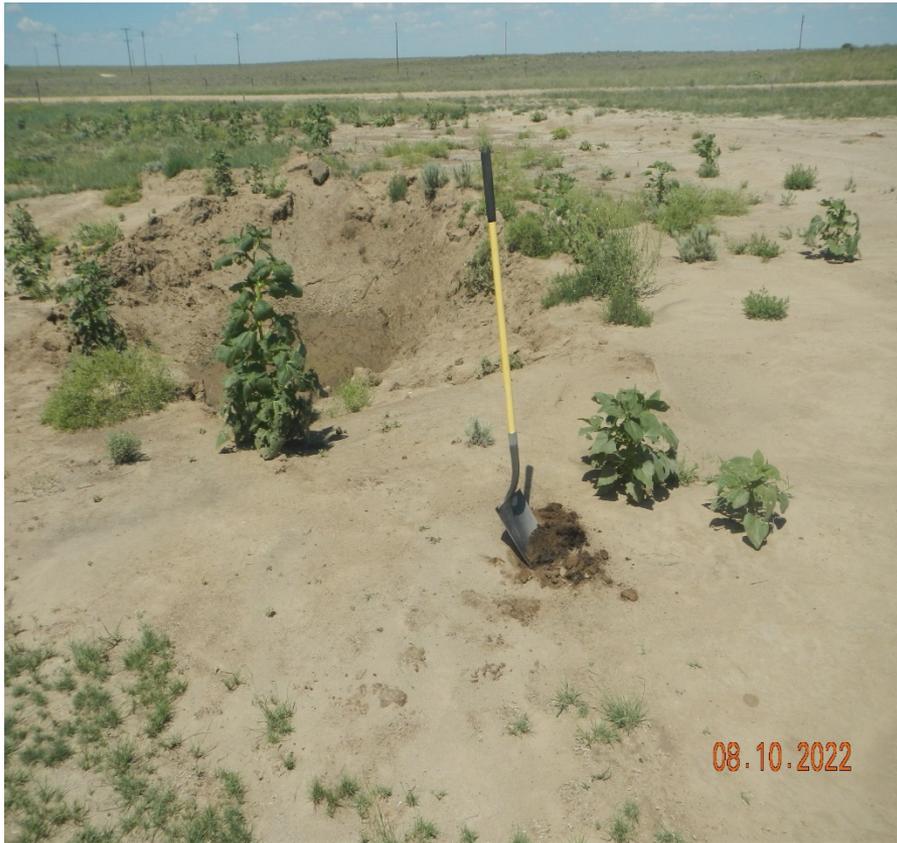
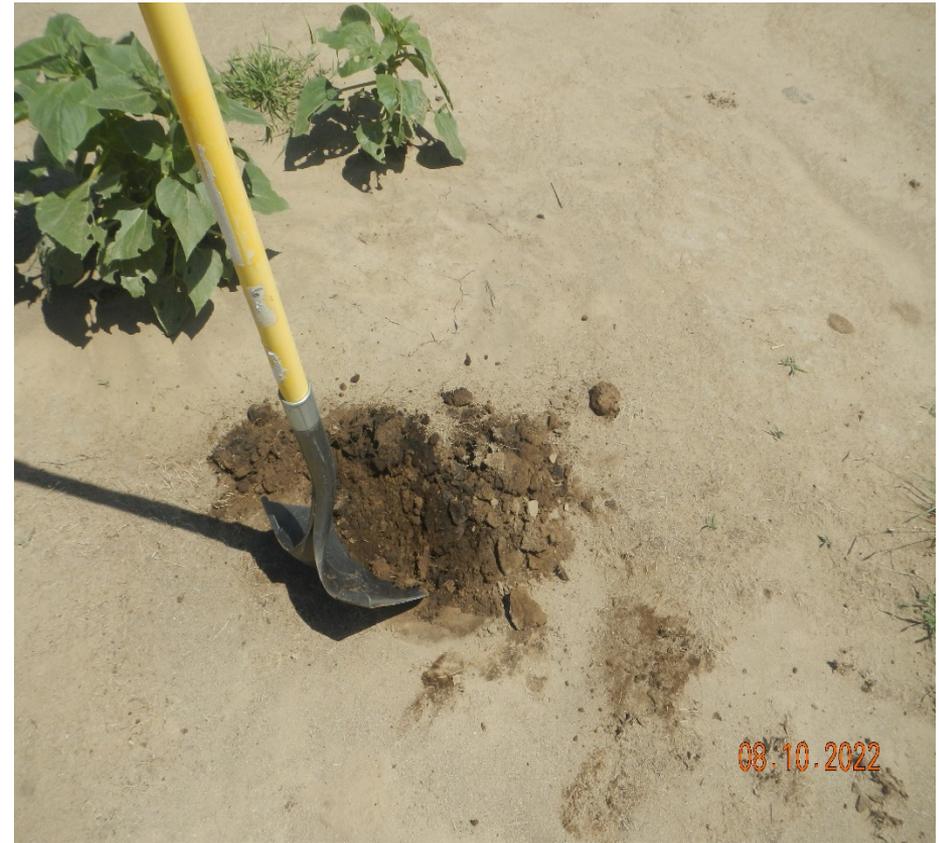
Photo 7. Located at the western side of the spill area. There is an excavated hole on this area approximately 12'x12'6". There are still areas of oil stained soils at the surface.

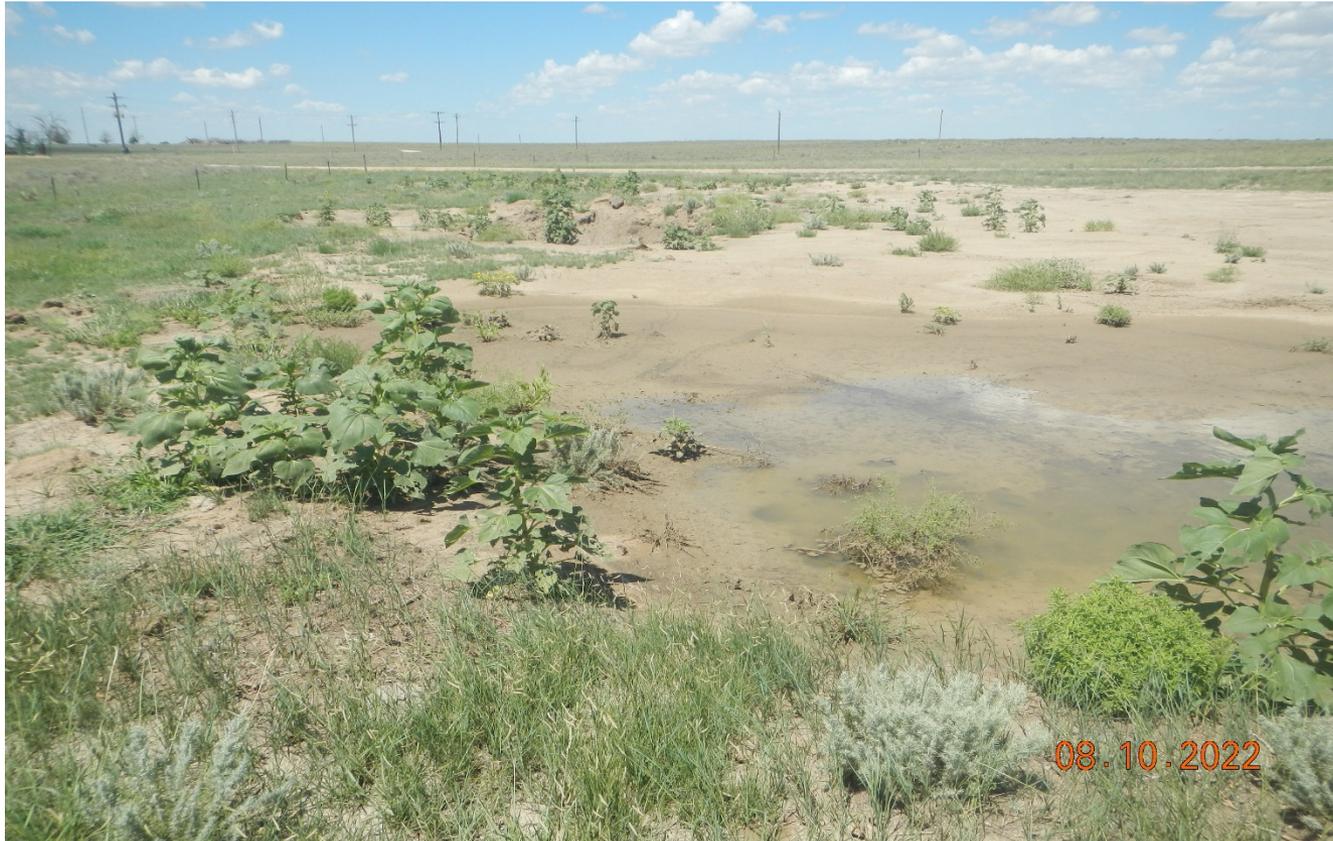
Photo 8. Facing northwest at the down gradient side of the spill area. There are no stormwater controls to prevent sediment movement off site. BMP's must be installed to prevent erosion.

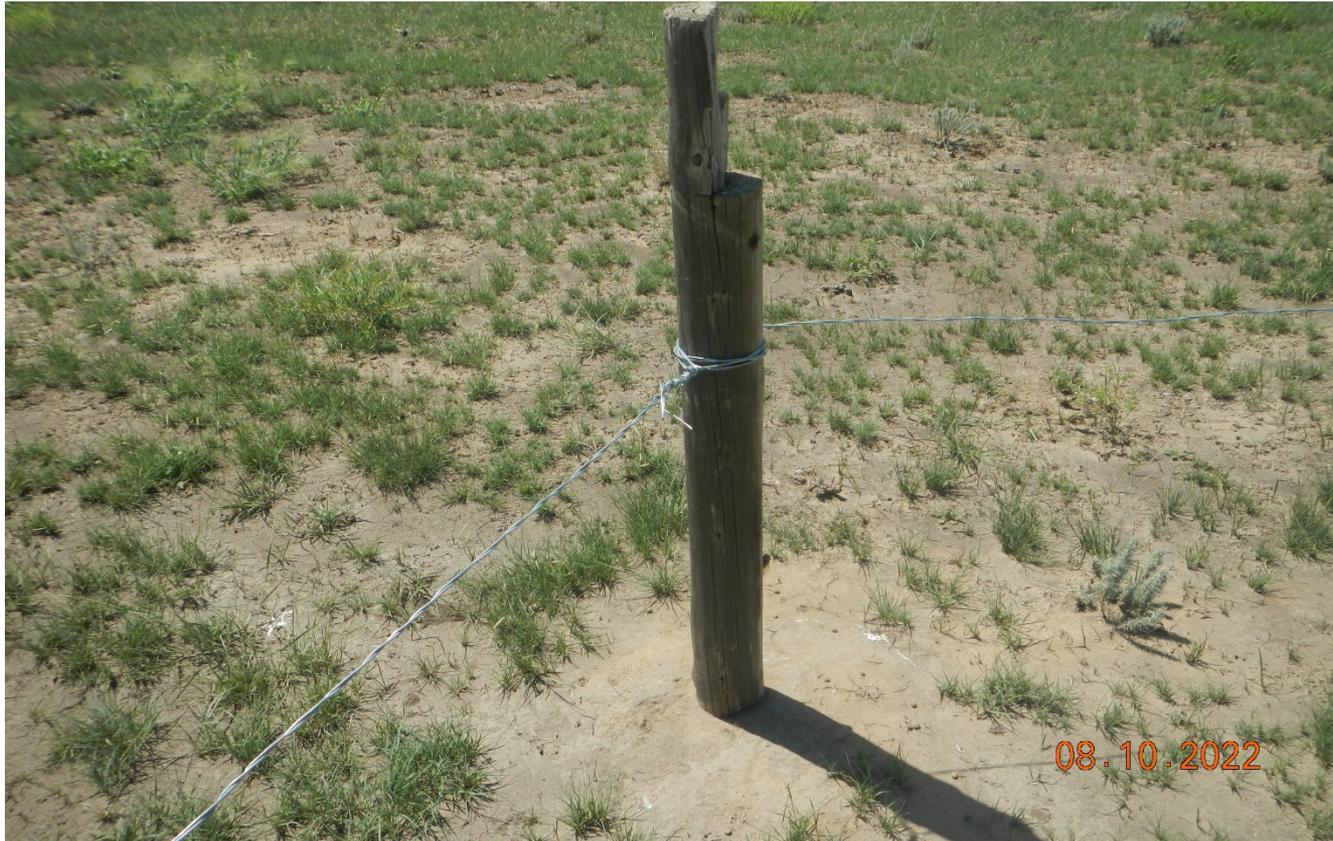
Photo 9. The one wire electric fence is inadequate to prevent livestock entry. The electric wire to the post will make the electric wire deficient.

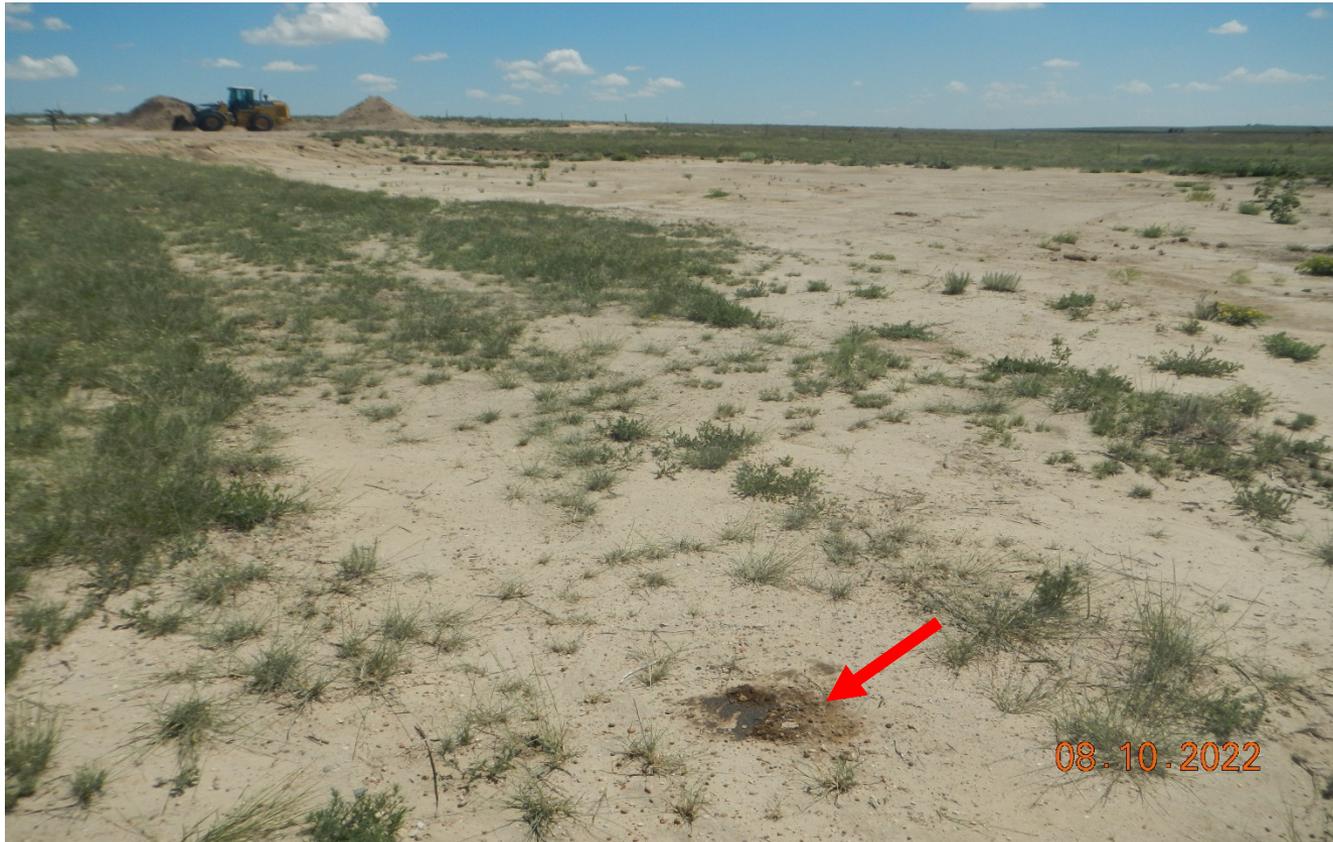
Photo 10. Facing southeast toward the remediation area. There are still areas of oil stained soil shown at red arrow. No stormwater controls are installed to prevent sediment movement offsite.

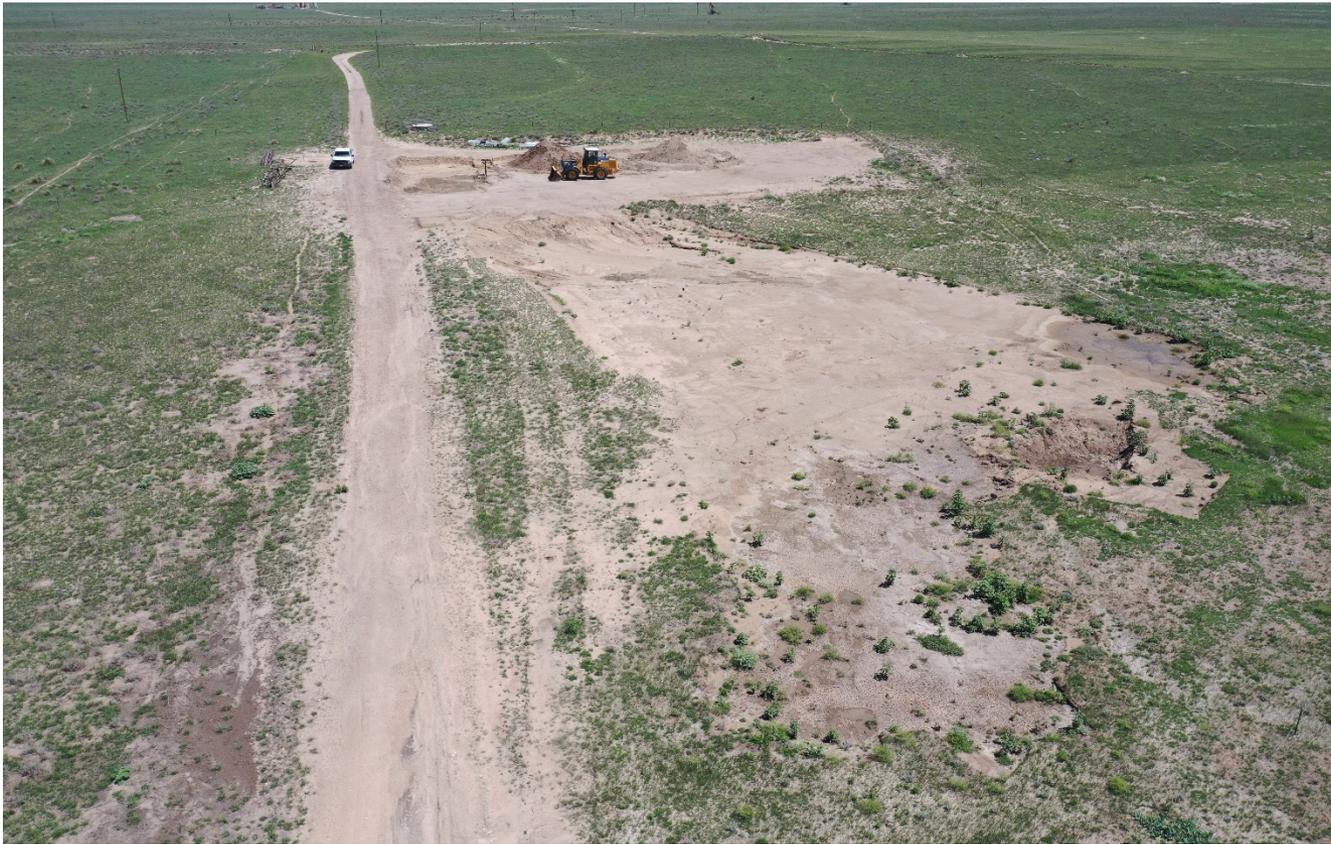
Photo 11. Drone aerial photo facing east toward the battery and remediation project.
