# Inspection Photos

API: 061-05138

Operator: WESTERN OPERATING COMPANY

Inspection Date: 8/10/2022

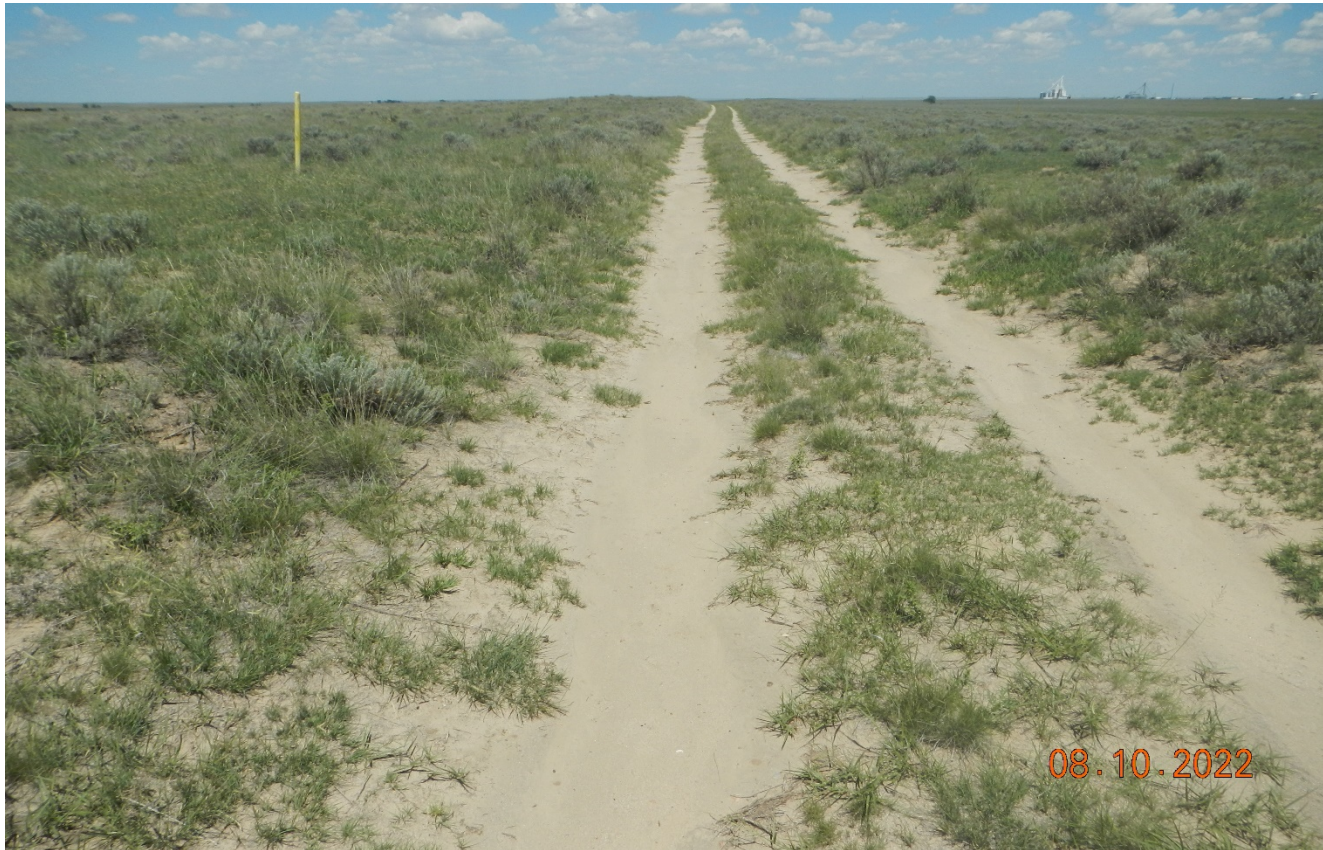
**Photo 1.** Facing north along the access road which has not been recontoured and reclaimed. Previous corrective action not completed.

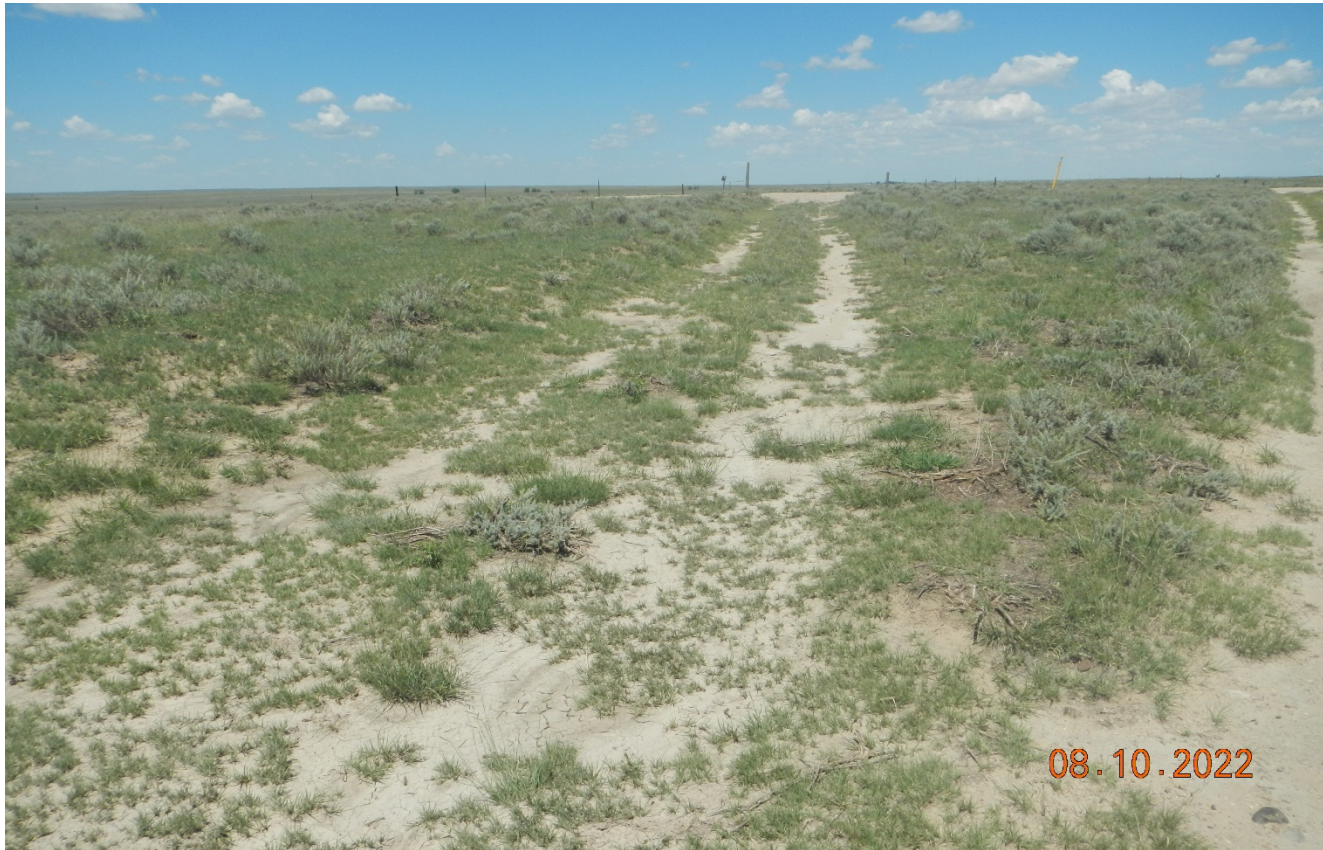
**Photo 2.** Facing northwest toward the former tank battery site located 300' southwest of the well site. The access road has not been reclaimed.

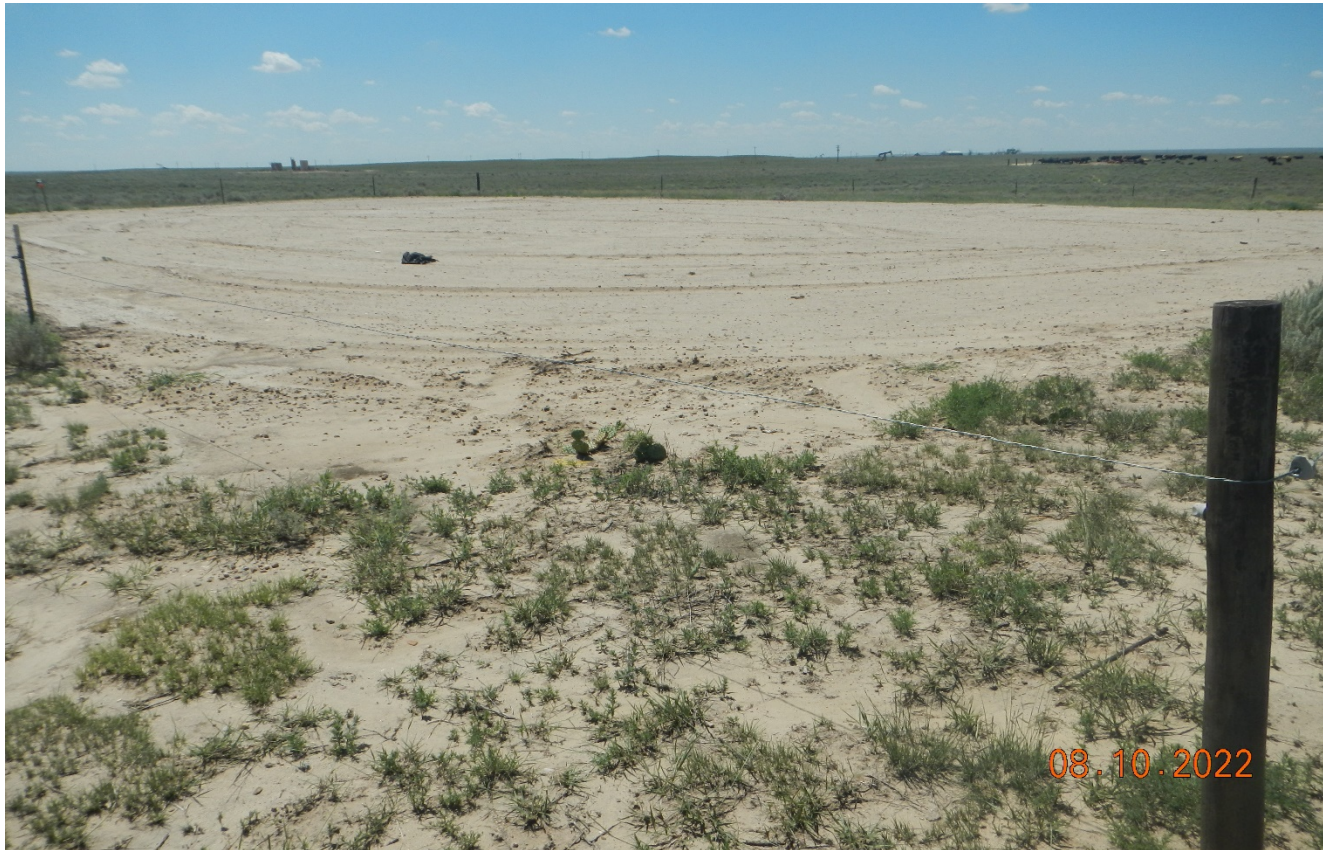
**Photo 3.** Facing southwest toward the former tank battery site located 300' southwest of the well site. This area has been recontoured and pipe risers have been removed.

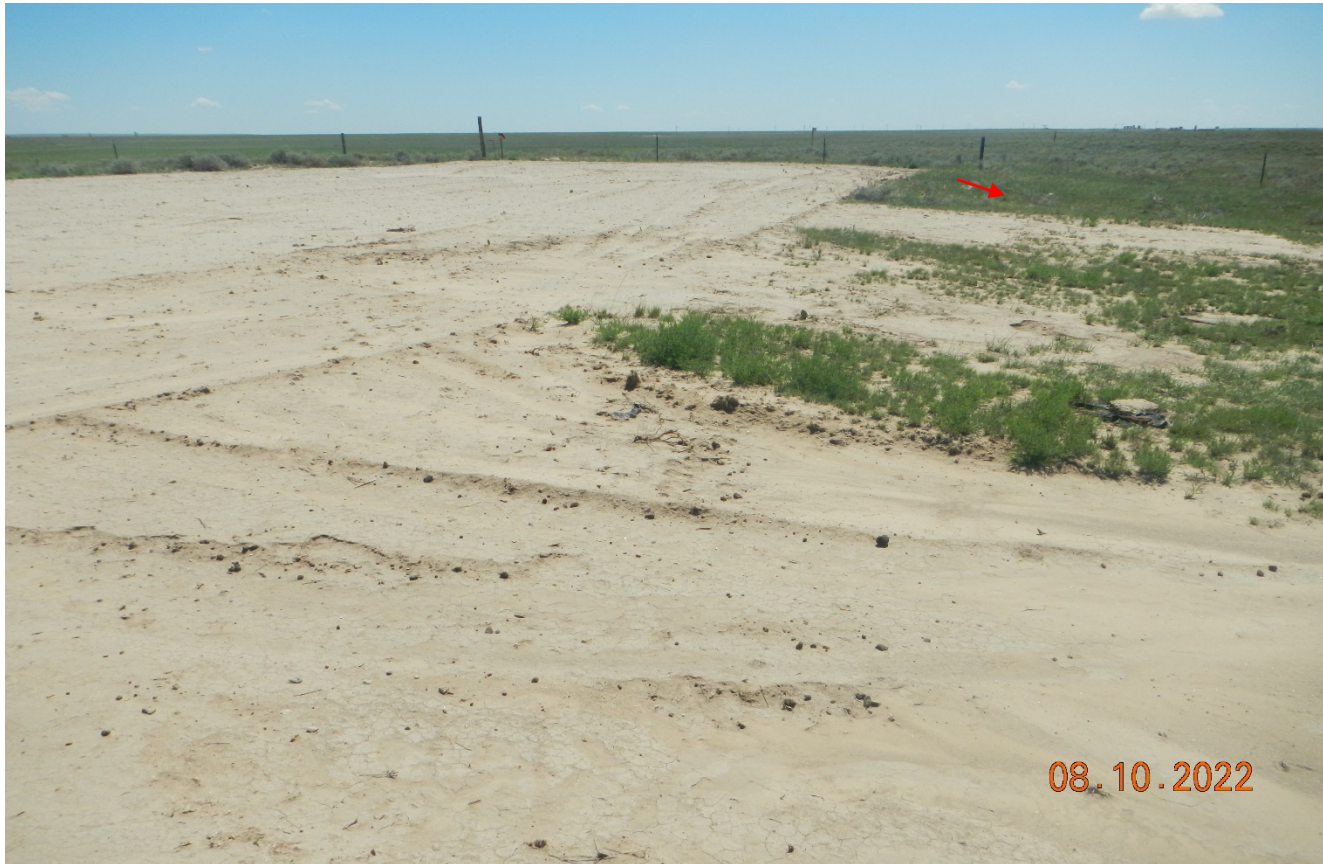
**Photo 4.** Facing south at the recontoured battery site. There are no stormwater controls installed down gradient and bare soils are susceptible to erosion.

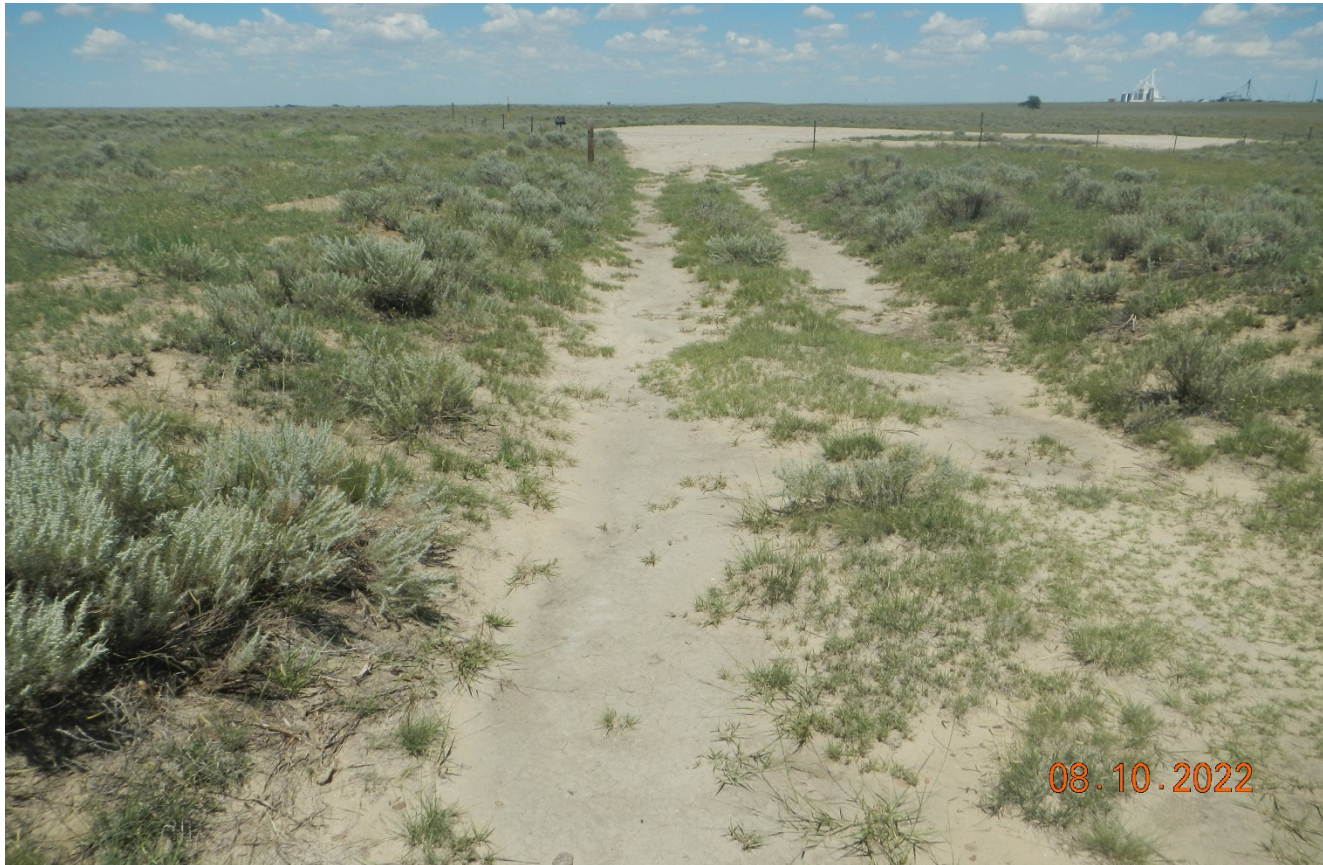
**Photo 5.** Facing north toward the well site. The access road has not been reclaimed.

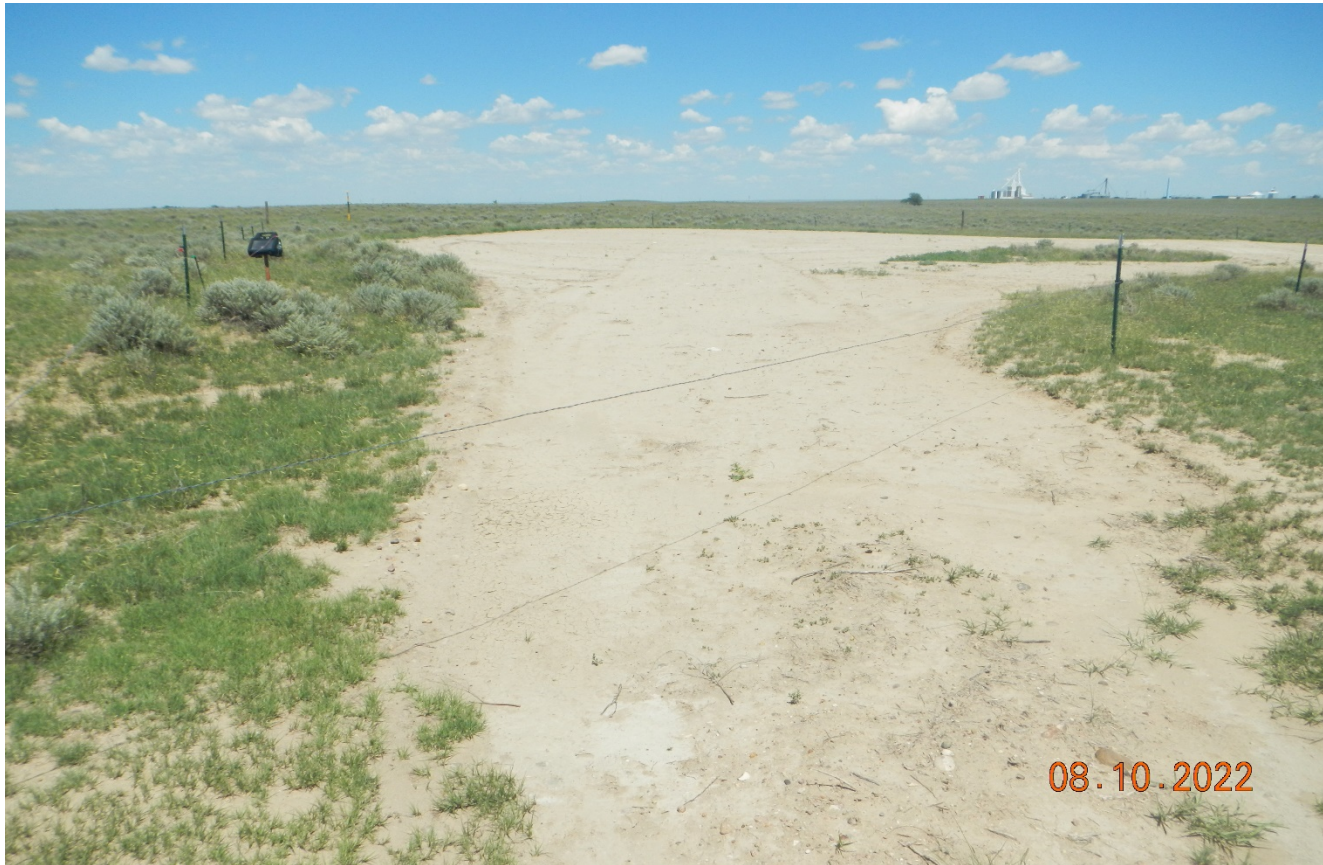
**Photo 6.** Facing northeast toward the abandoned well site. This area has not been reclaimed. Bare soils that are not stabilized and are susceptible to erosion. This area has been recontoured and decompacted.
