# Inspection Photos

API: 061-06020

Operator: WESTERN OPERATING COMPANY

Inspection Date: 8/10/2022

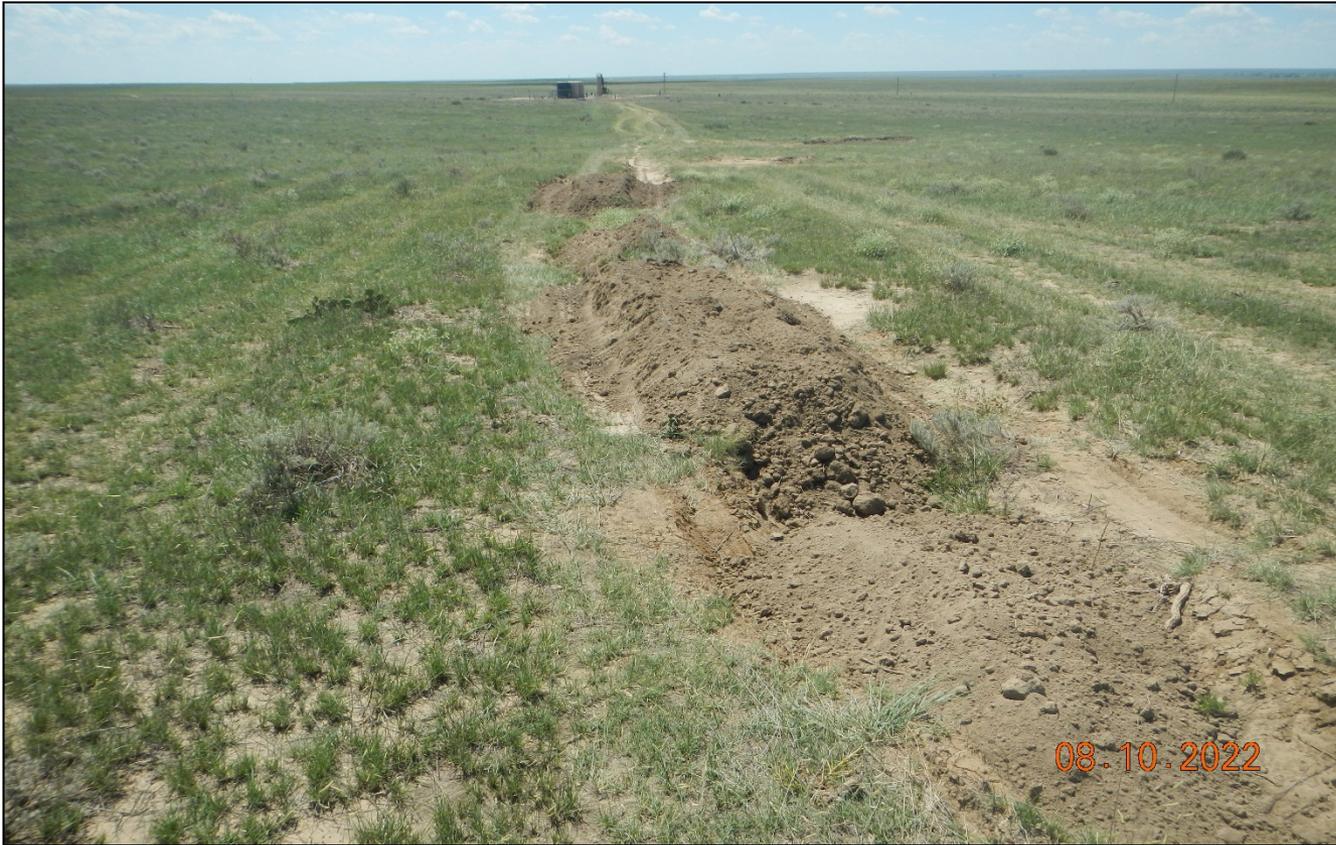
**Photo 1.** Facing west traveling to the location There has been recent topsoil hauled in along the flowline area. The wellsite is shown at top of photo.

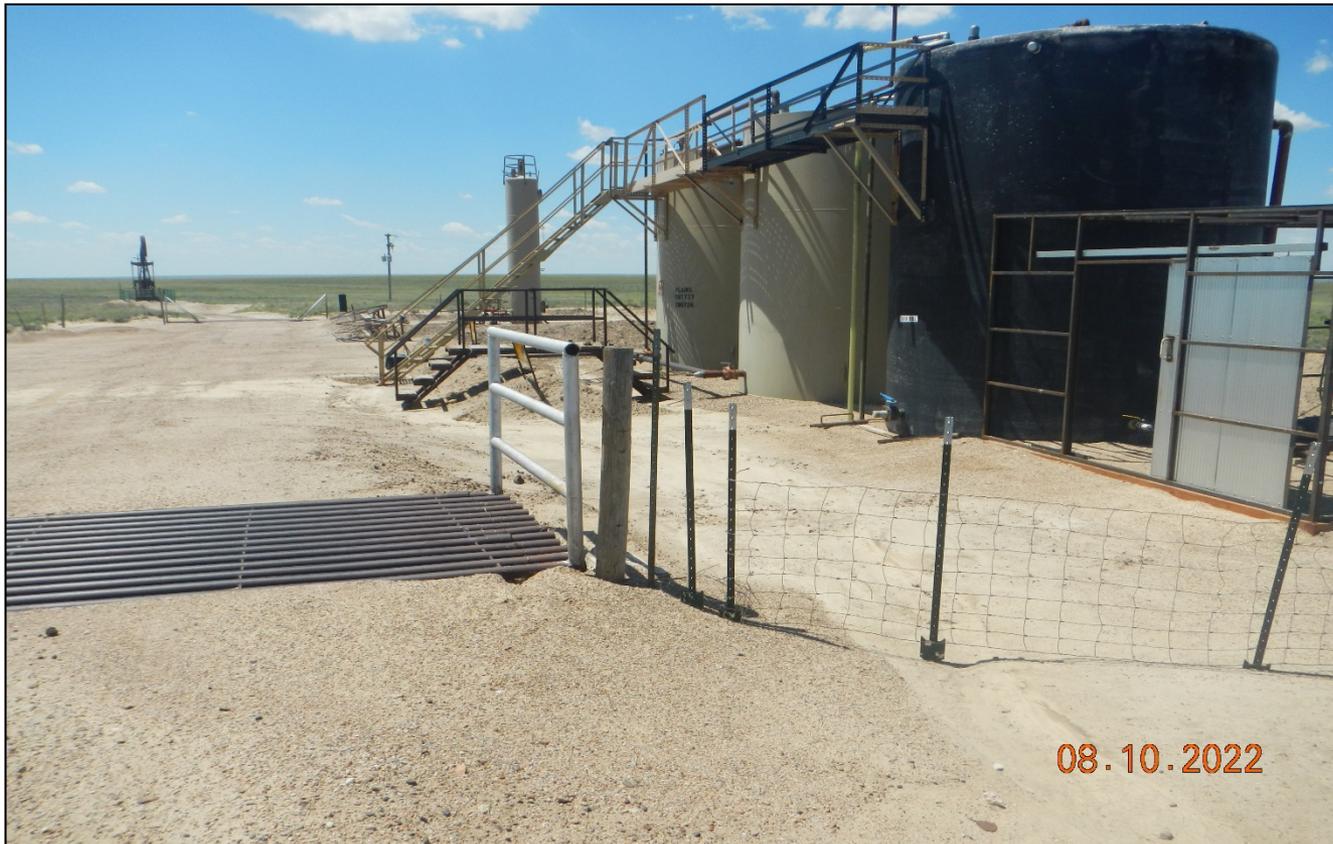
**Photo 2.** Facing west toward the tank battery.

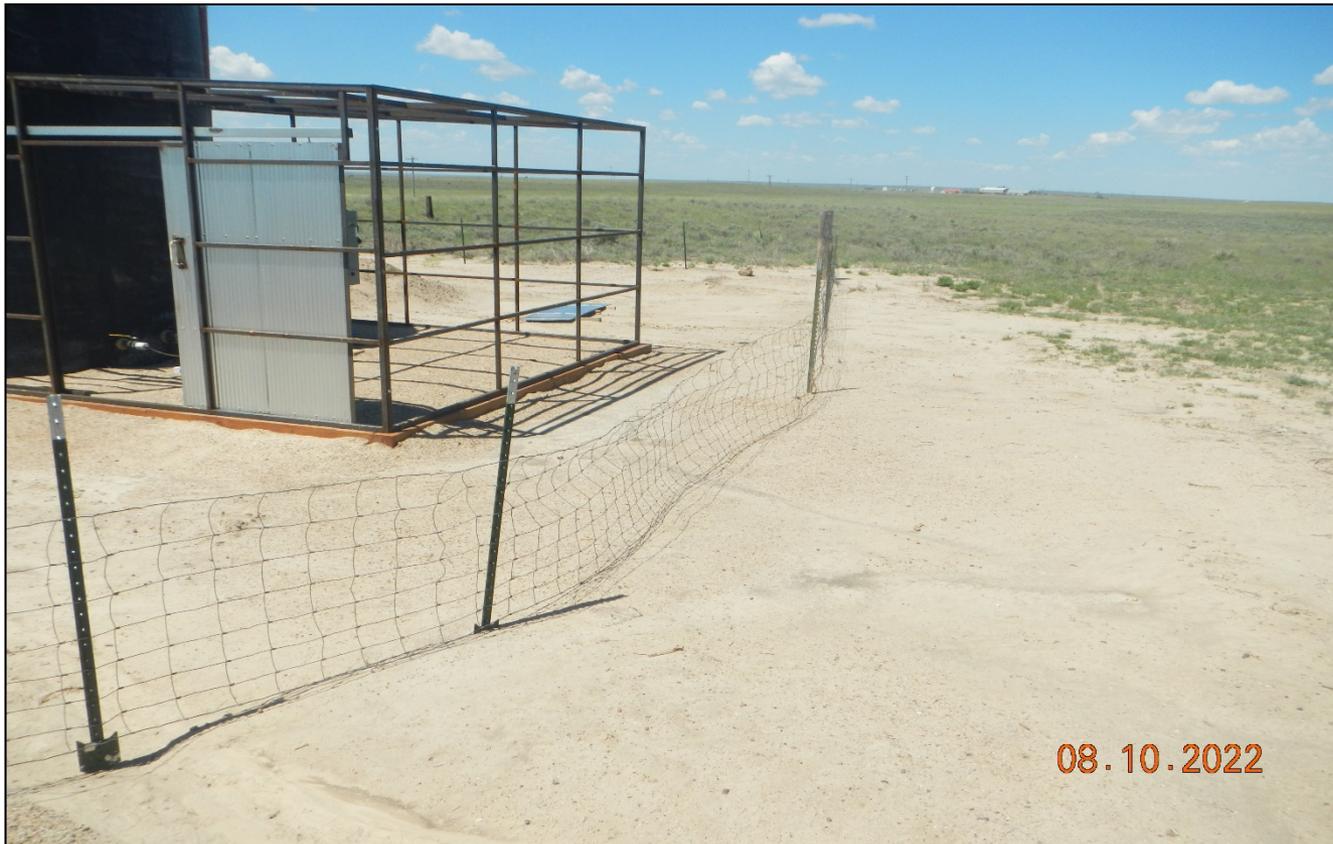
**Photo 3.** The fence at the tank battery is inadequate and needs maintenance.

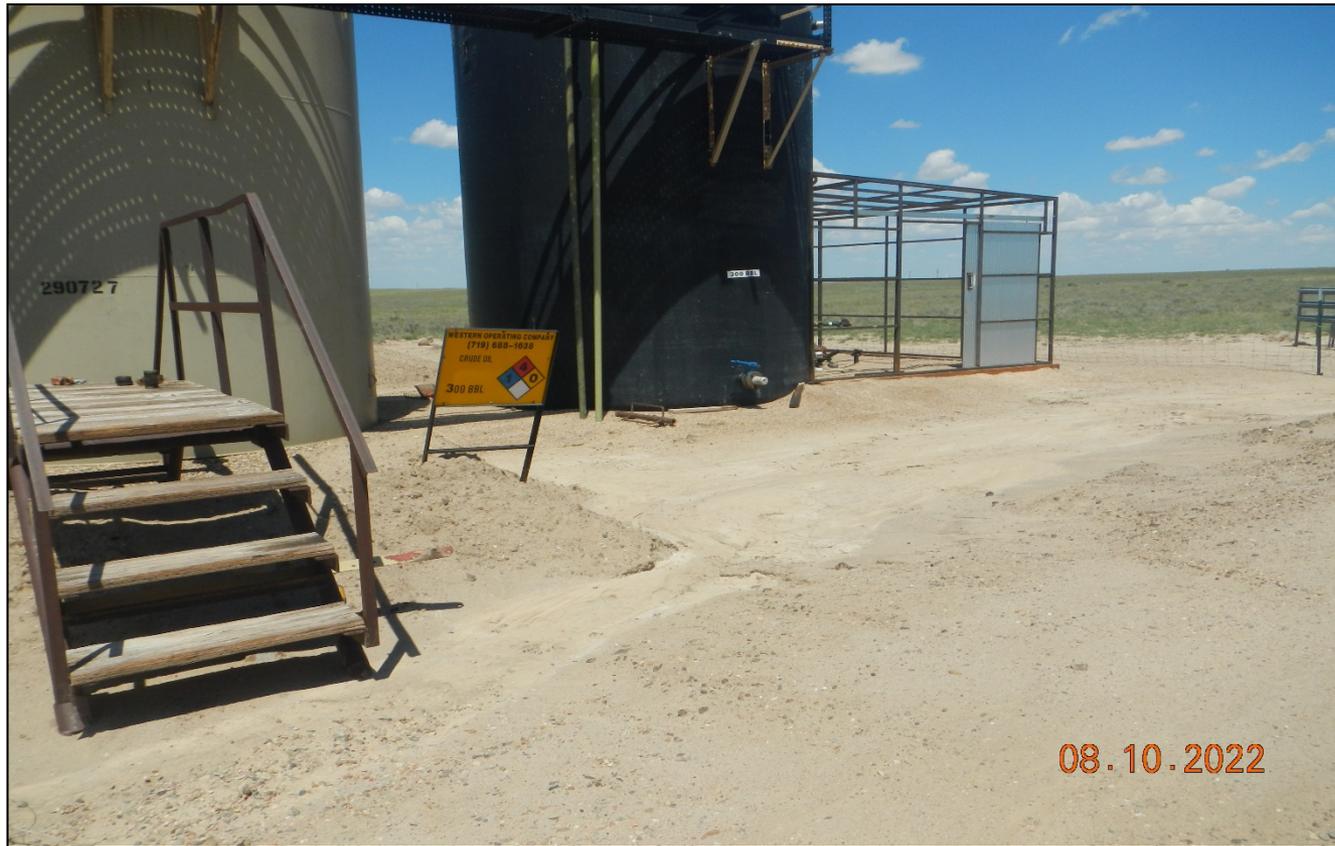
**Photo 4.** There is incomplete secondary containment at the tank battery.

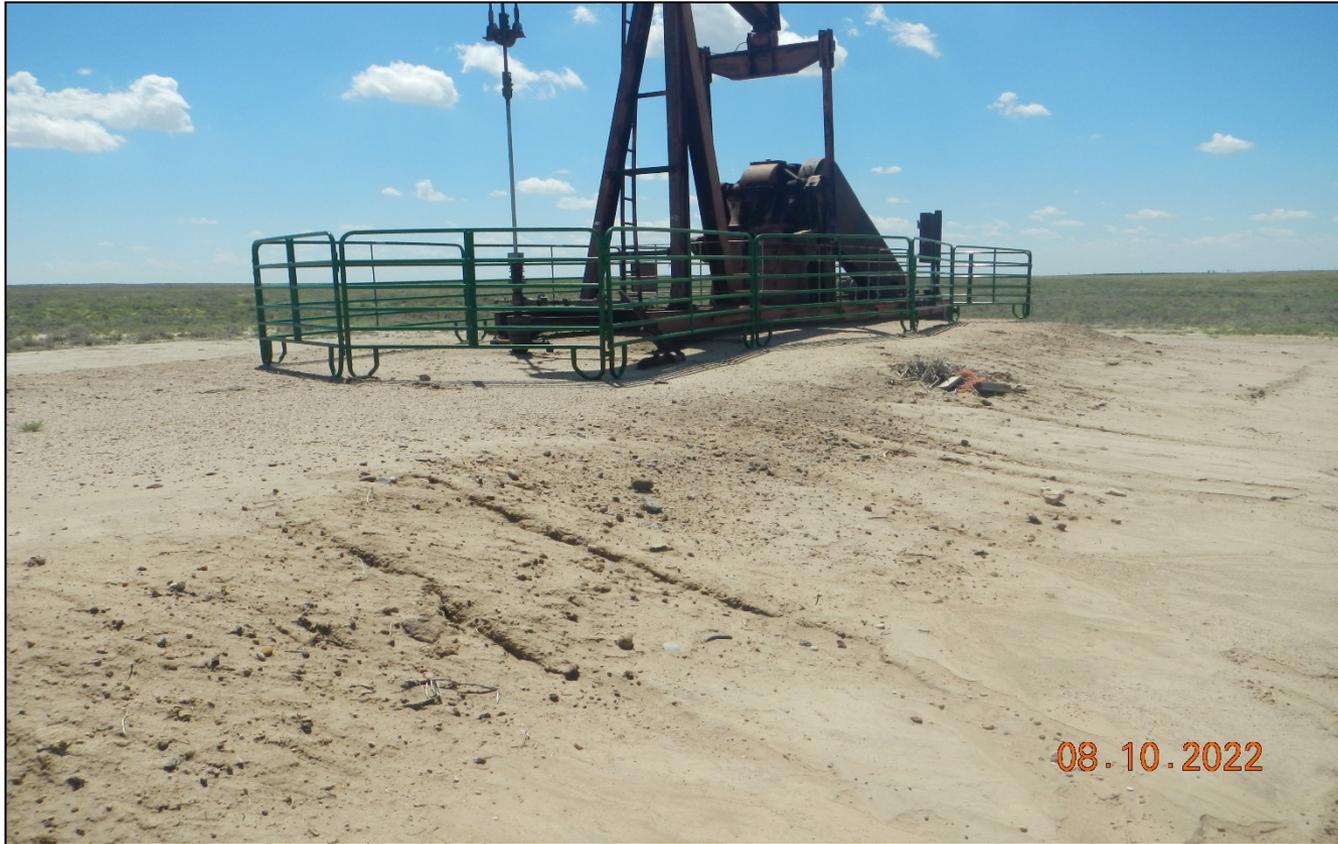
**Photo 5.** Facing toward the pumpjack. There is stormwater runoff transporting sediment offsite.

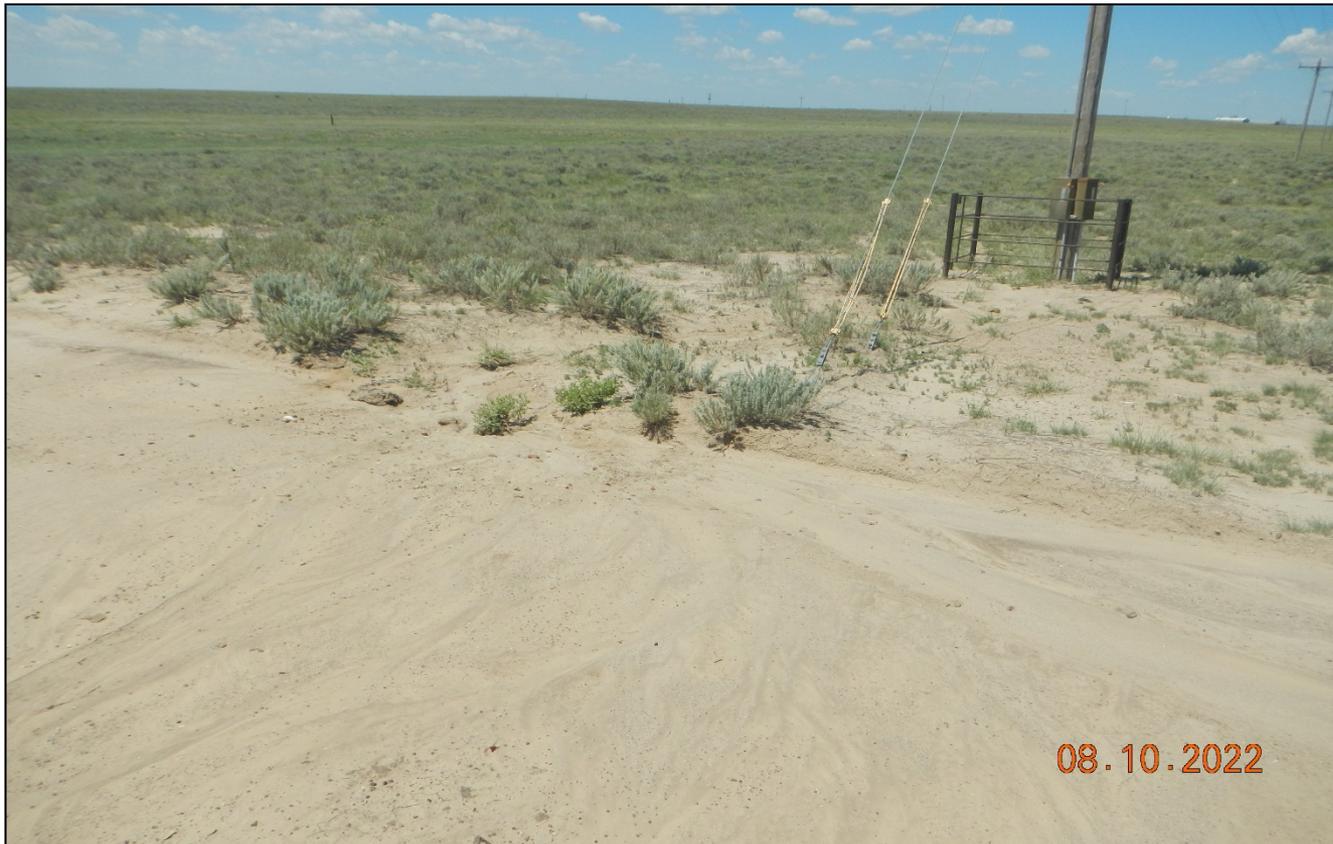
**Photo 6.** There are signs of sediment movement offsite. BMP's need to be installed.
