Inspection Photos
482698

Inspection Date: 8/8/2022
All Photos taken by Kris Neidel

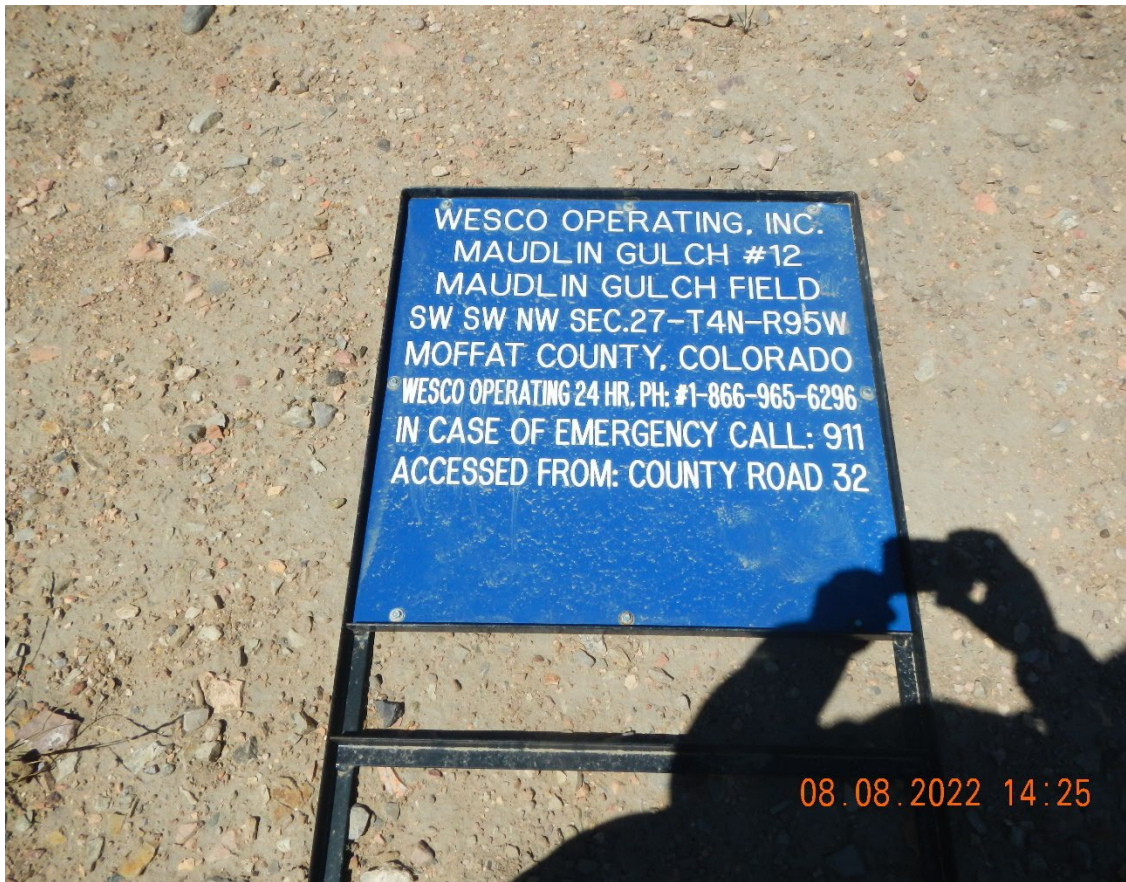
Photo #1 Sign at wellhead.

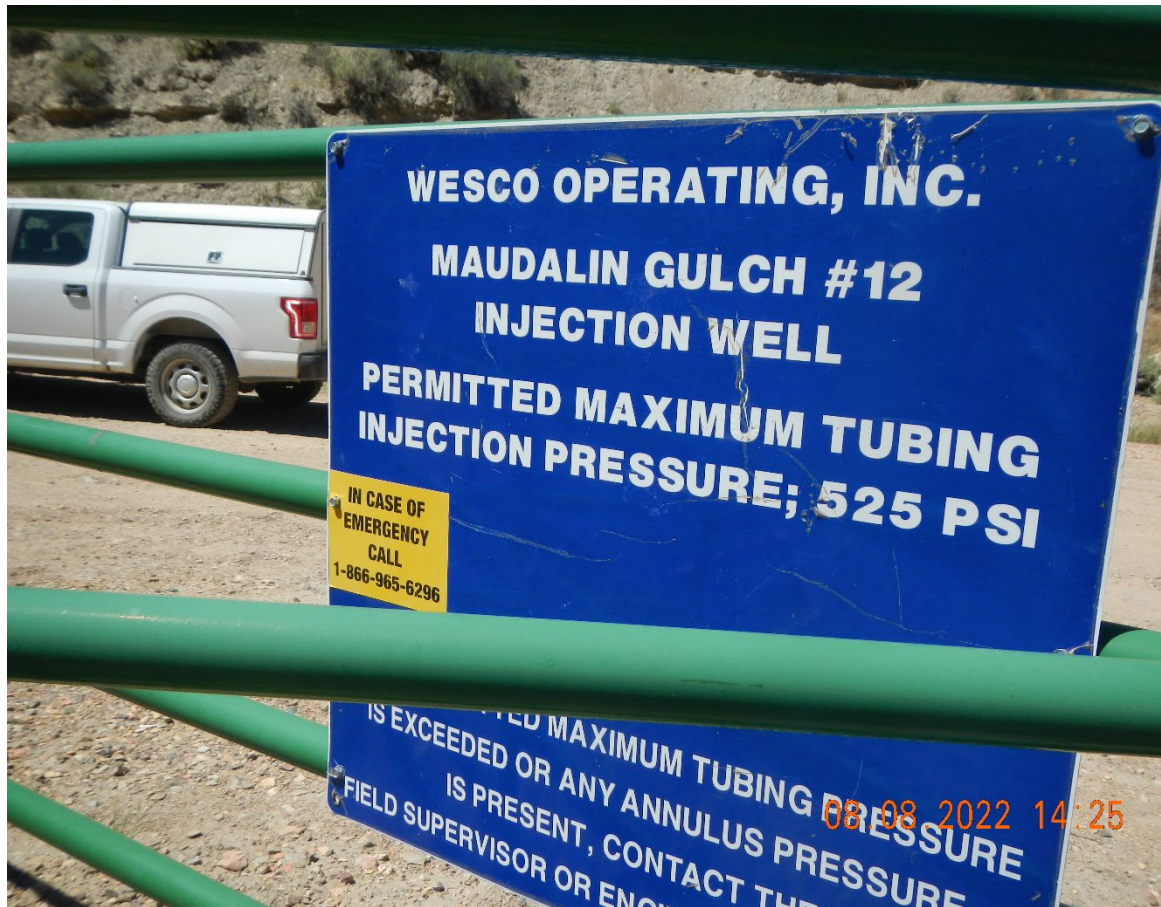
Photo #2 sign near wellhead.

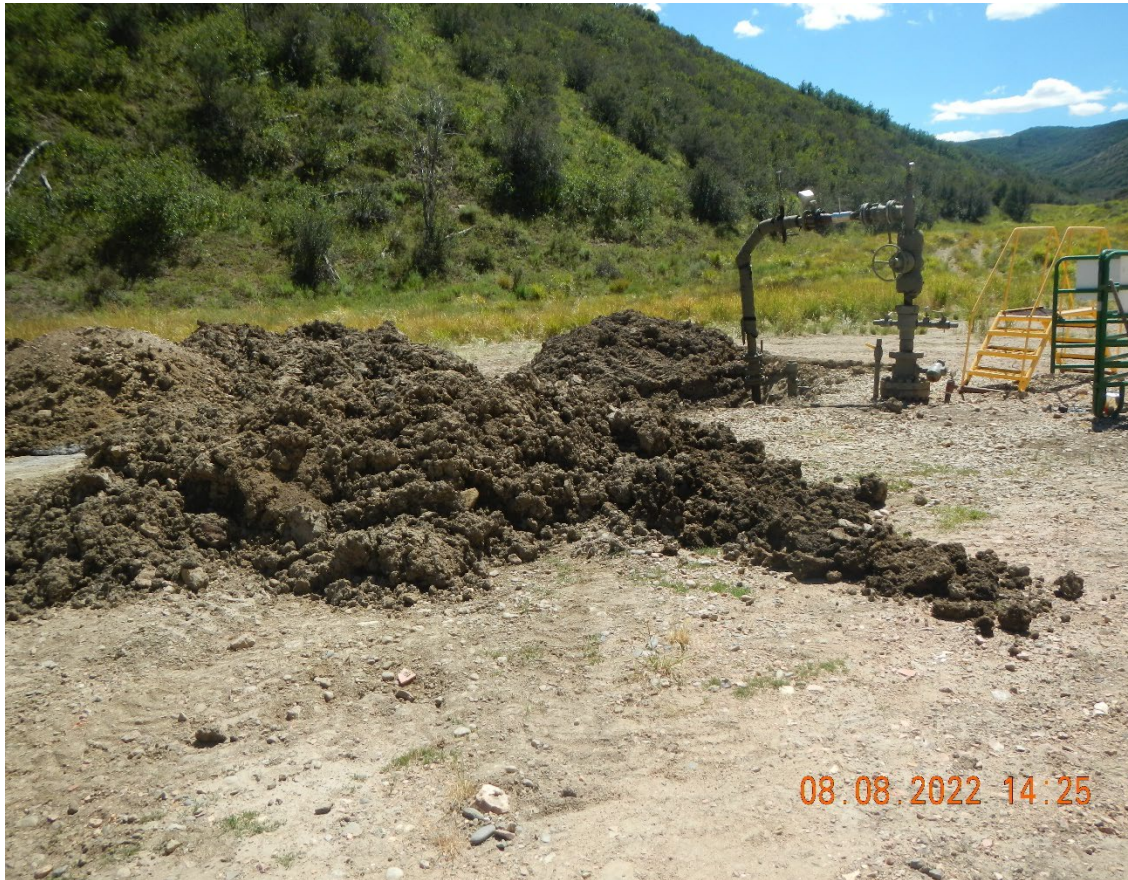
Photo #3 overview of wellhead and excavated soil.

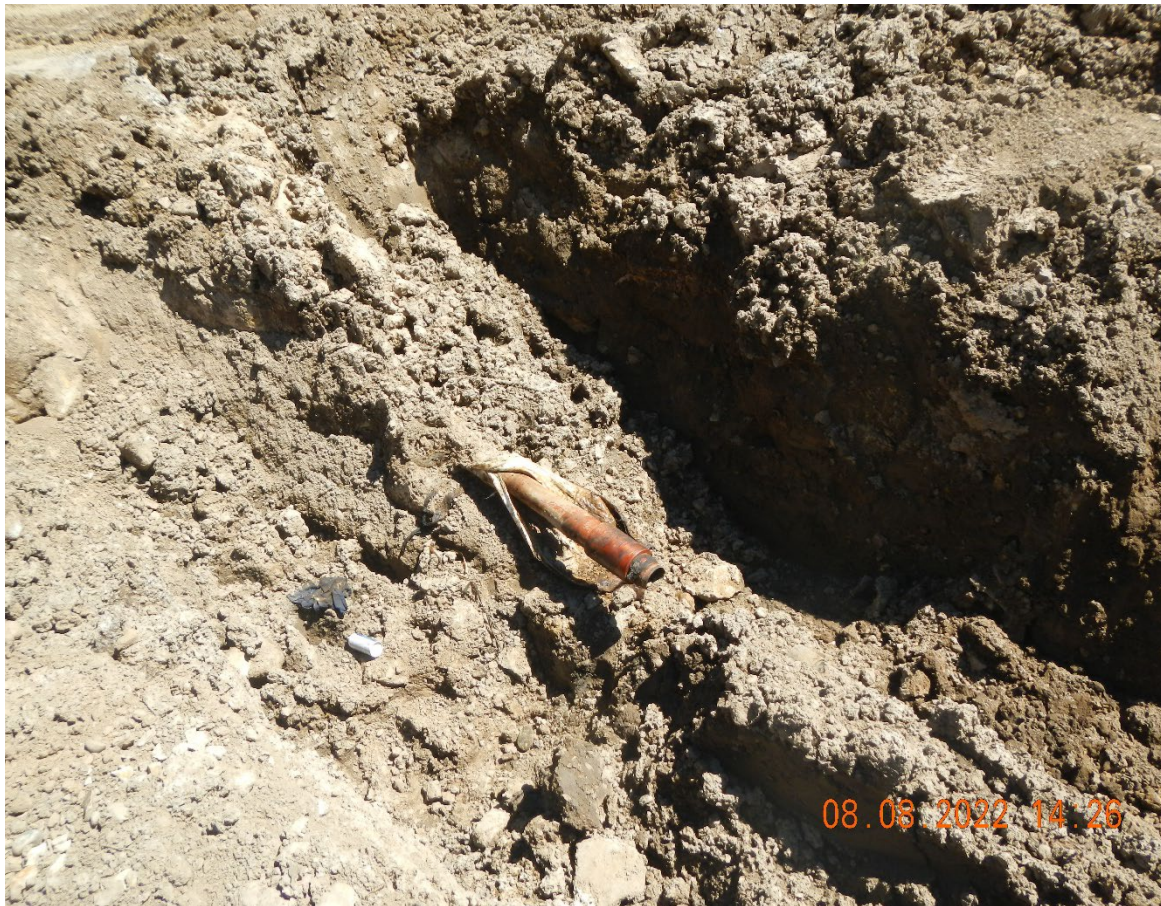
Photo #4 supply flowline from injection pump. It was told to COGCC that this was the point of failure, where line transitions from fiberglass to steel, at collar.

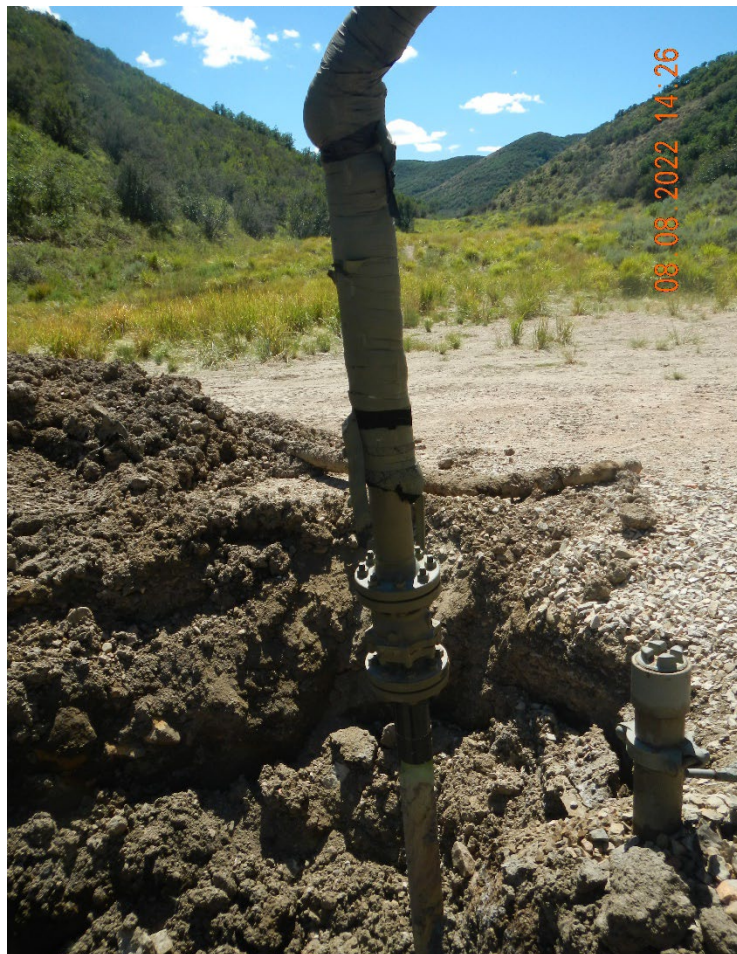
Photo #5 flowline

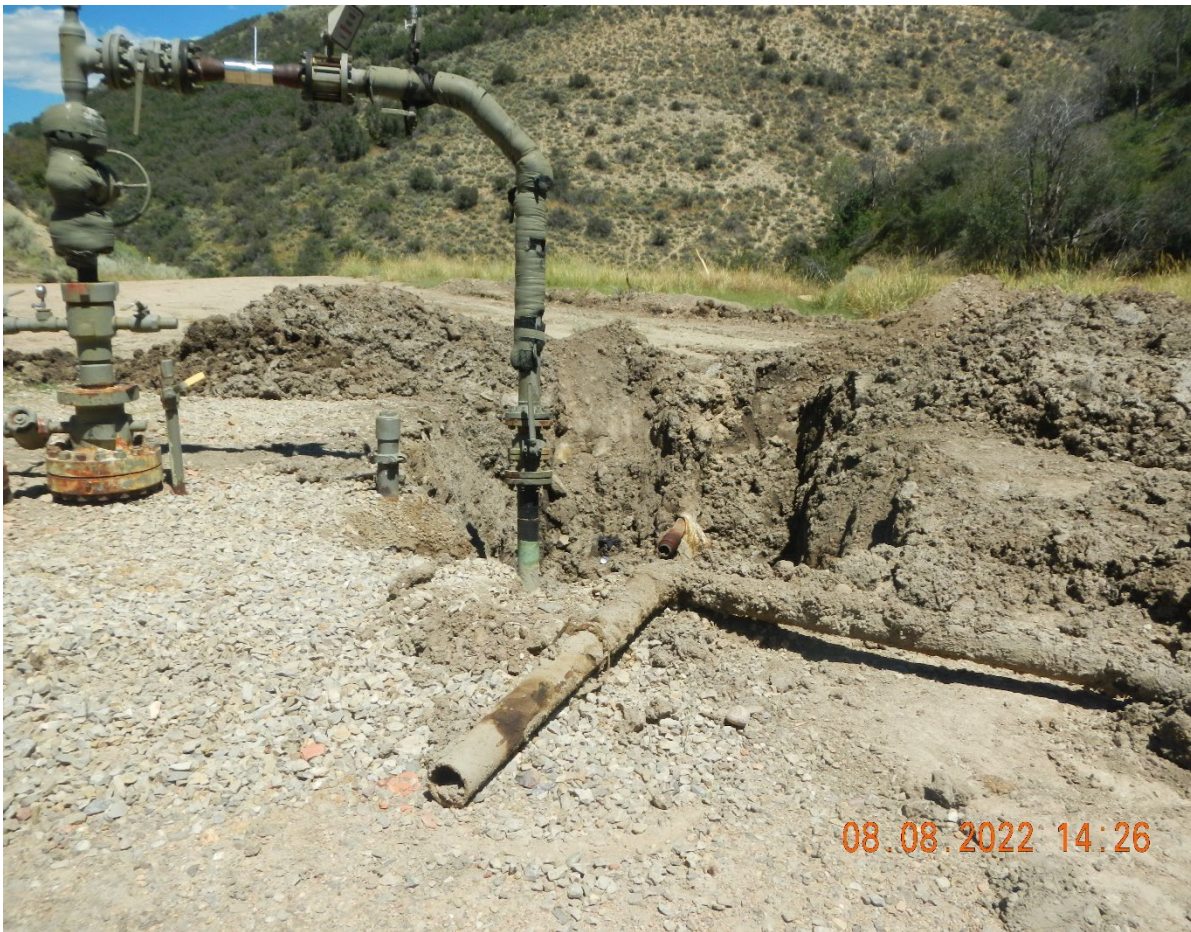
Photo #6 excavation at flowline near injection well.

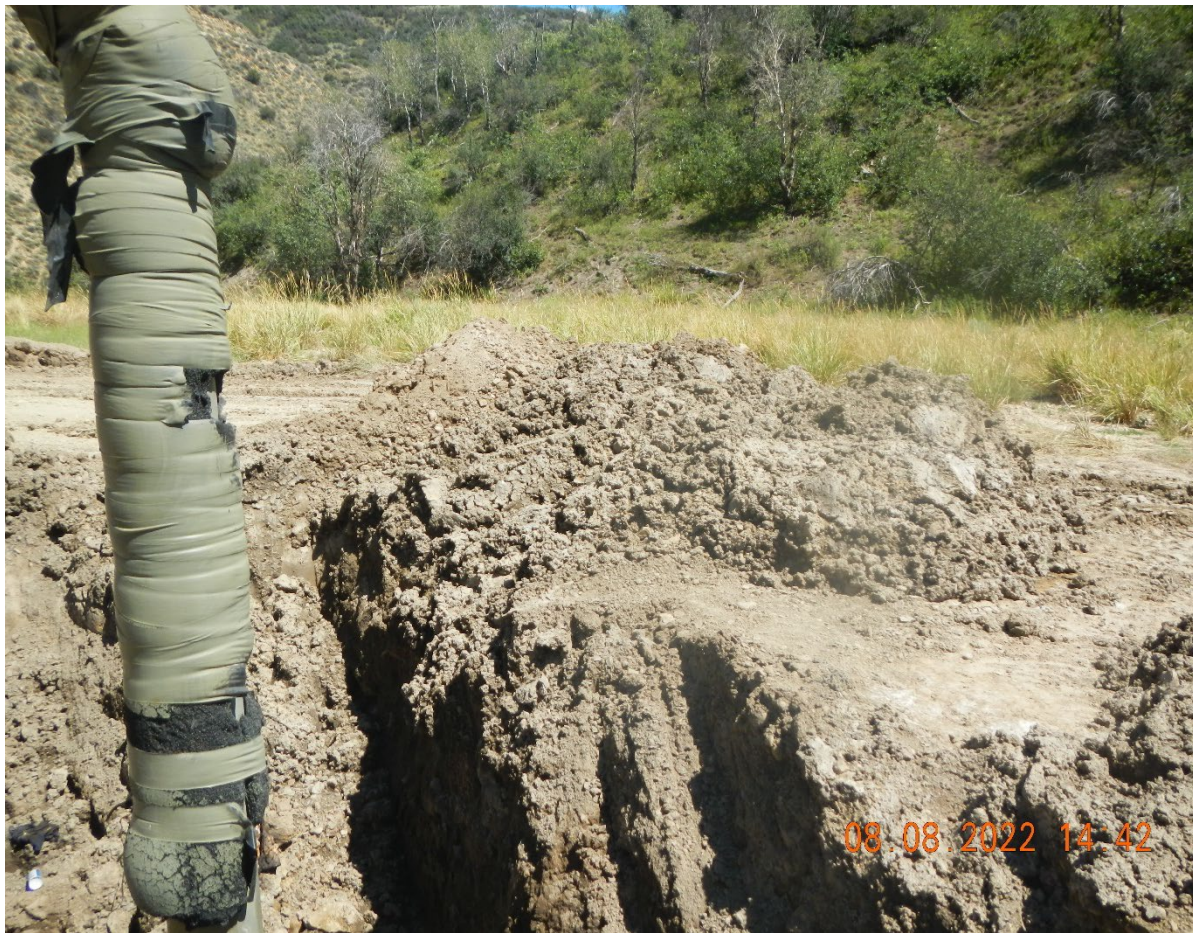
Photo #7 pipe on left of photo was coming out of the ground to well.

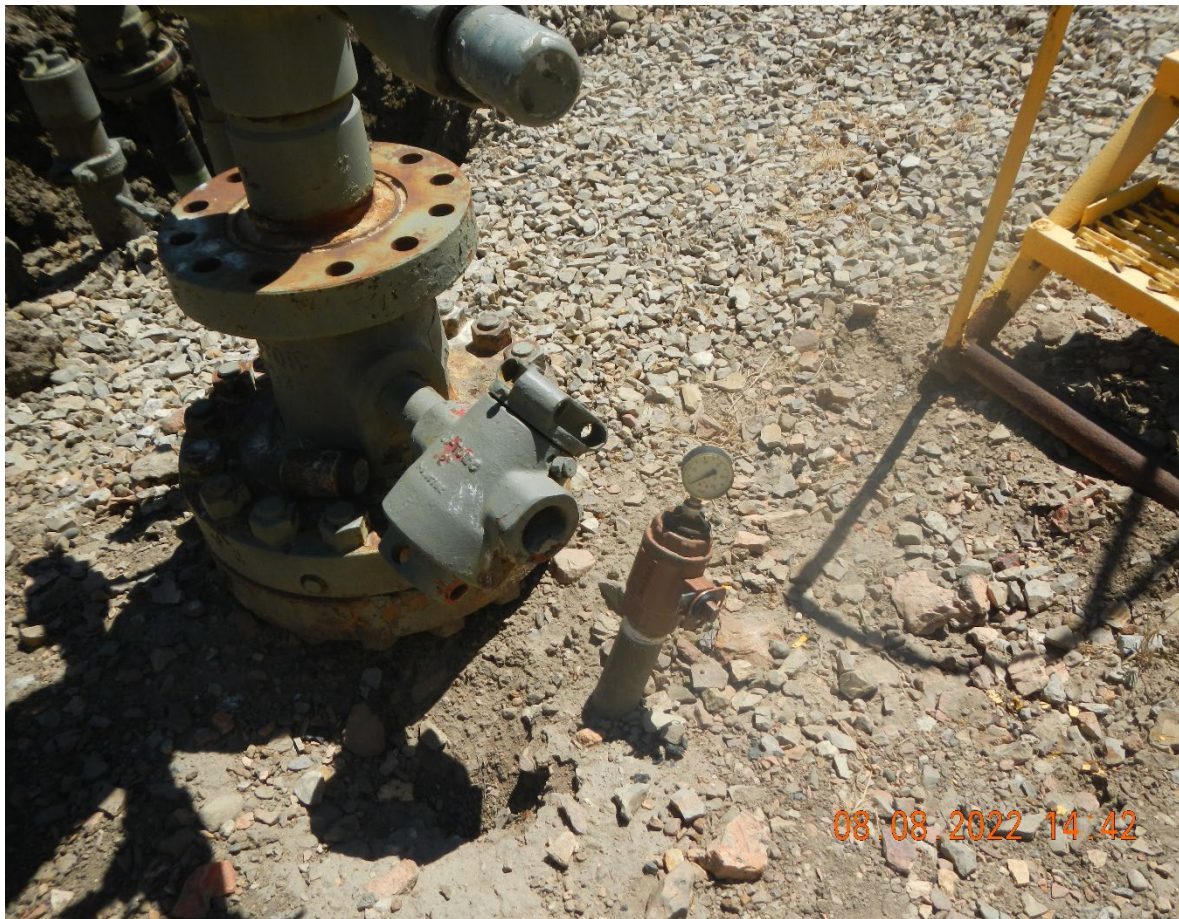
Photo #8 Bradenhead access
