Inspection Photos

API: 05-071-07960

Operator: PRESCO INC

Inspection Date: 8/15/2022

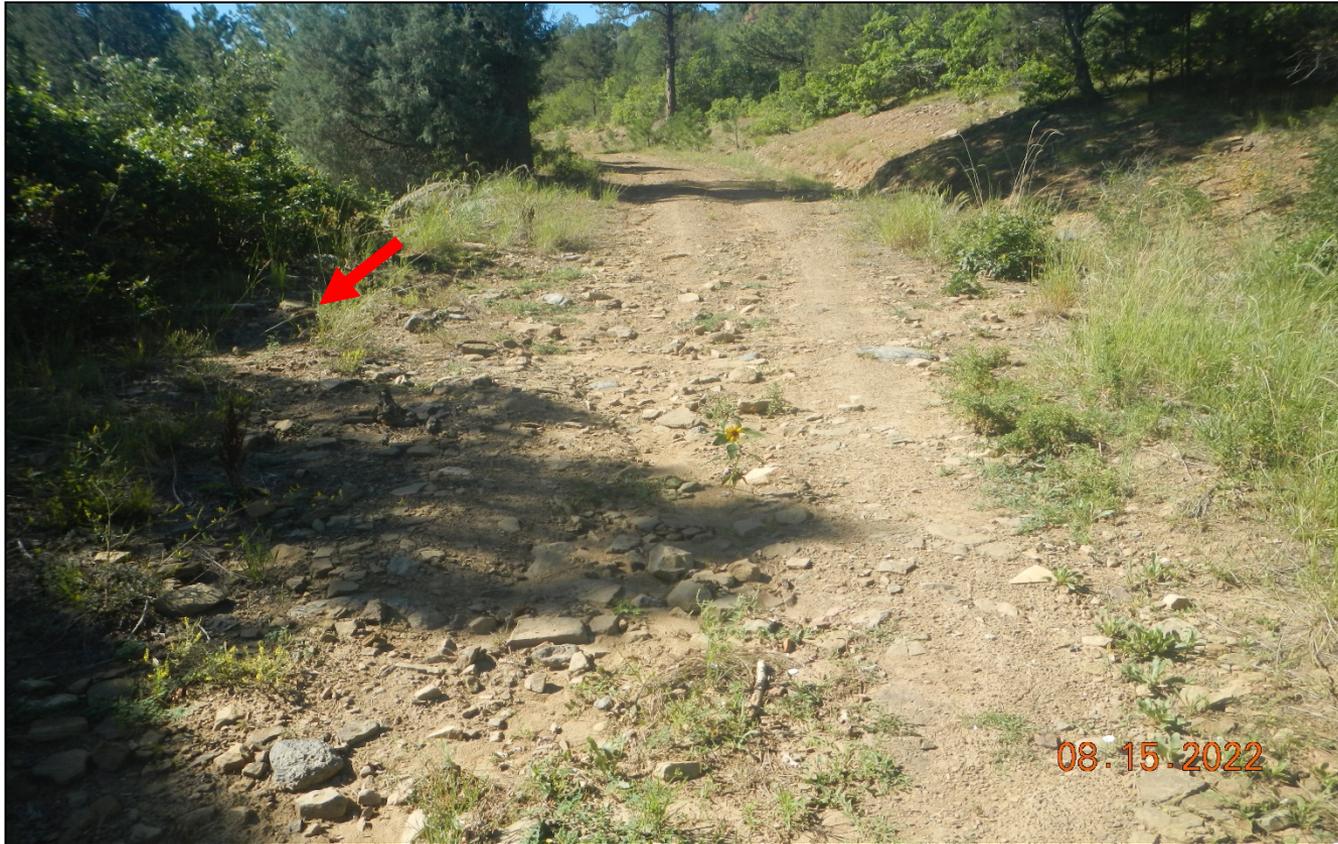
Photo 1. Facing south along the access road. There is a culvert that is filled in with sediment causing stormwater to flow down the road causing erosion.
Lat/Long:37.08200, -104.51180.

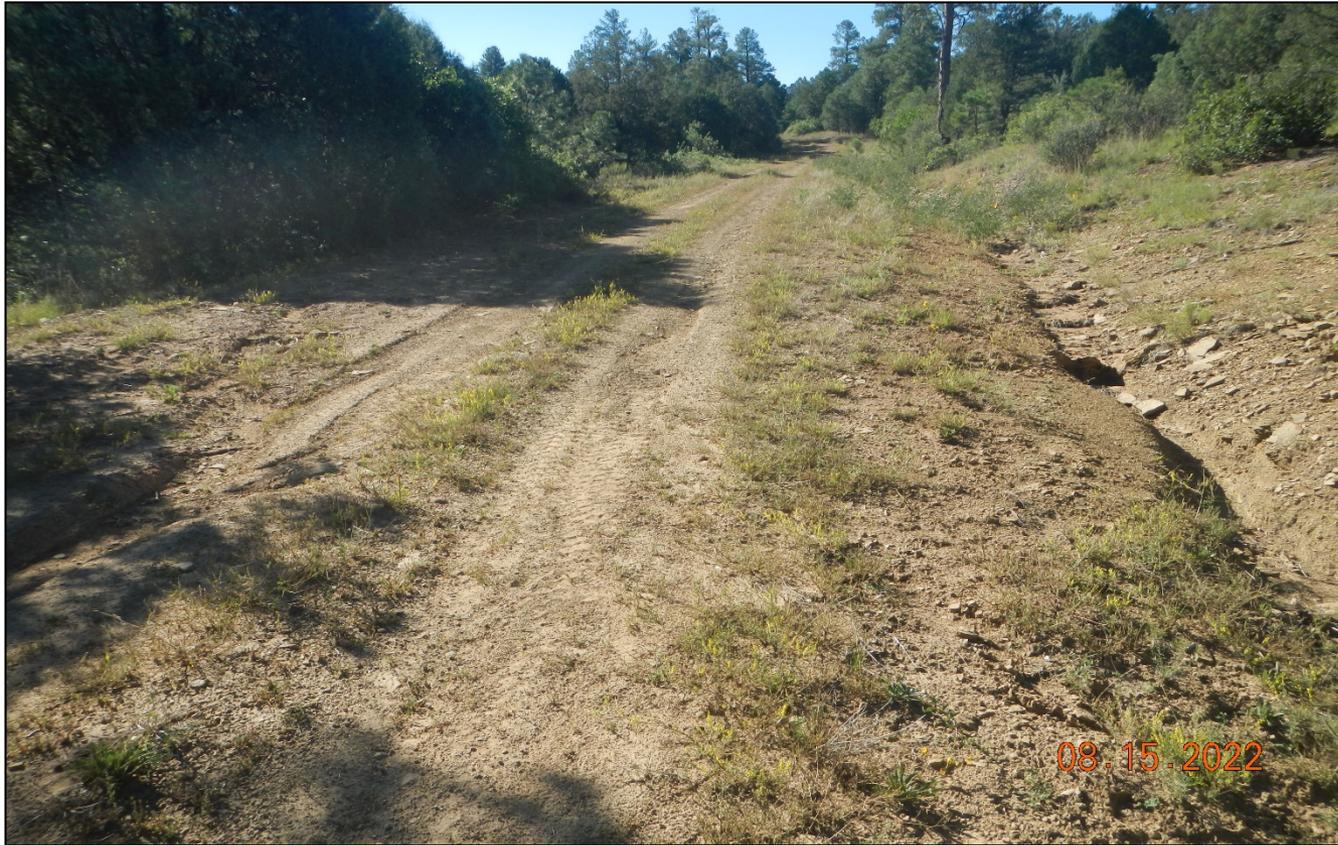
Photo 2. Facing south along the access road.

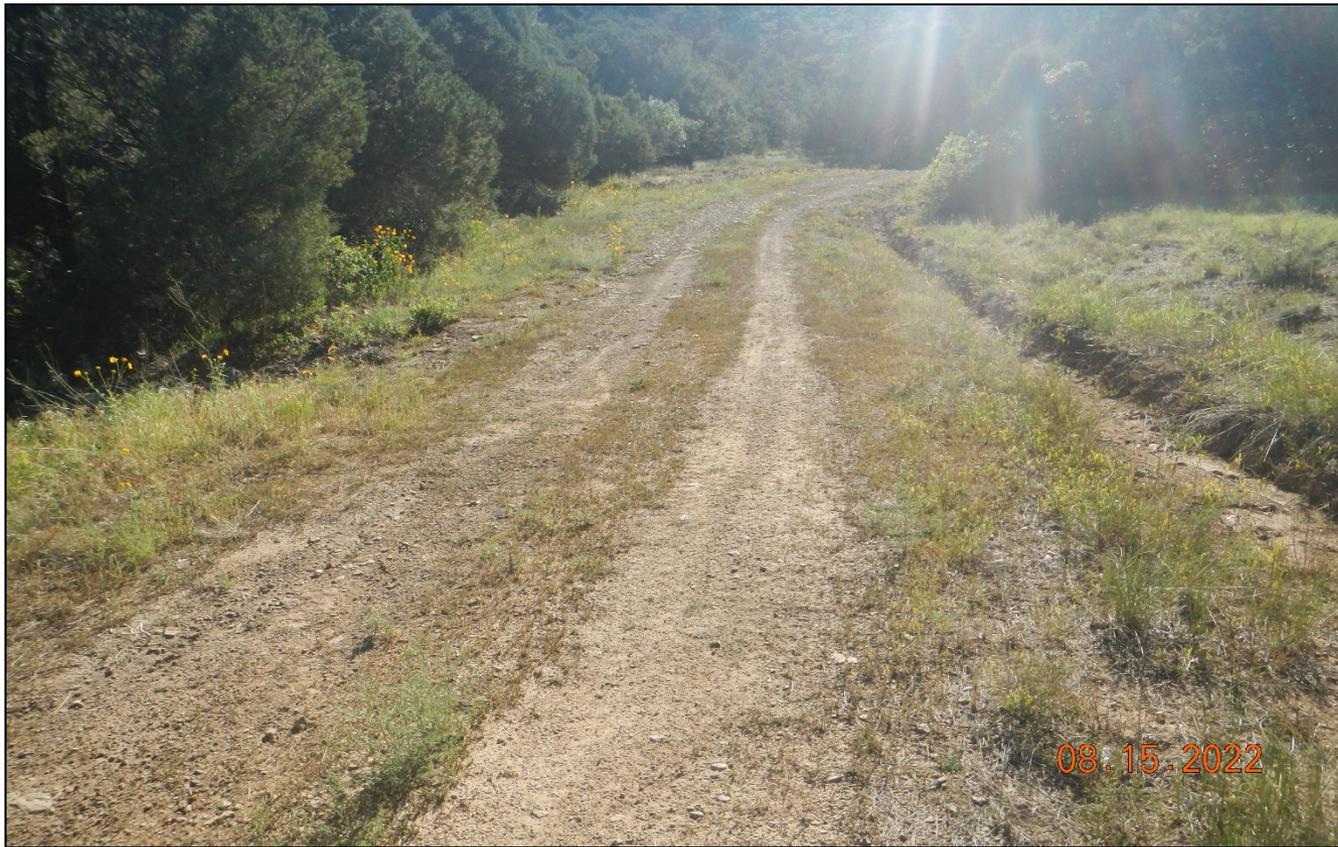
Photo 3. Facing east along the road.

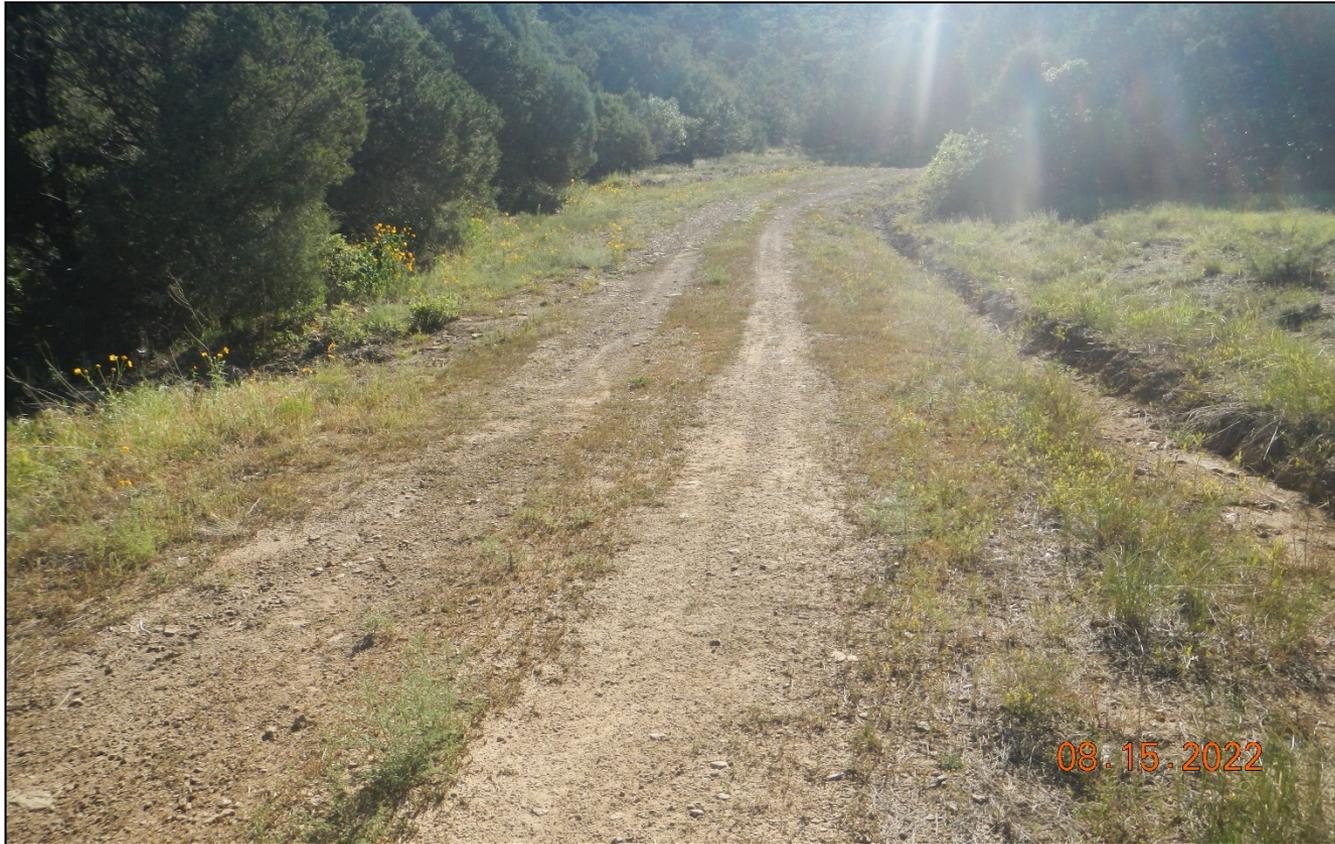
Photo 4. This runoff ditch was not properly installed. The disturbance along the side of the road will need to be seeded and stabilized.

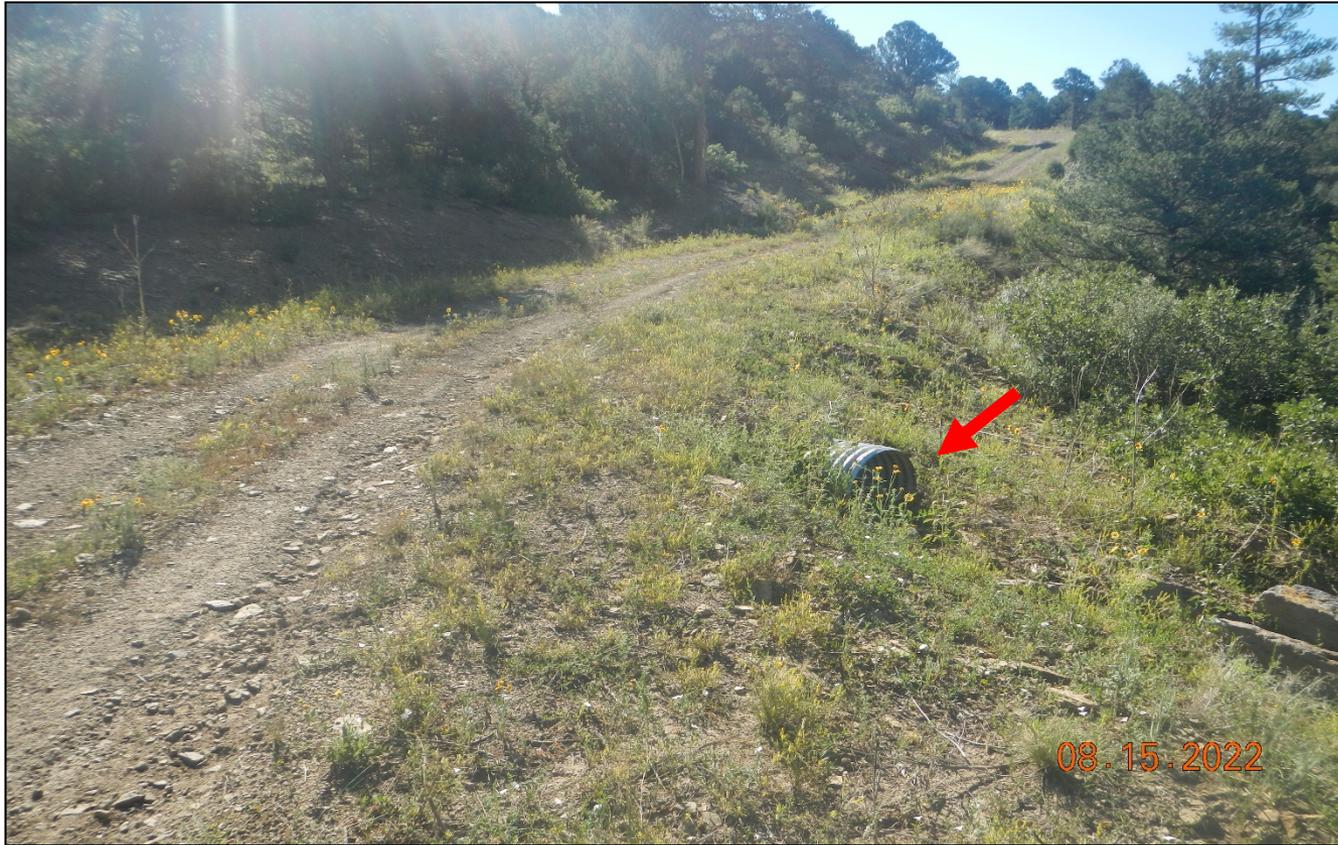
Photo 5. Facing southeast along the road. There are culverts installed along the road. The culvert outlet shown at red arrow has rip/rap outlet protection.

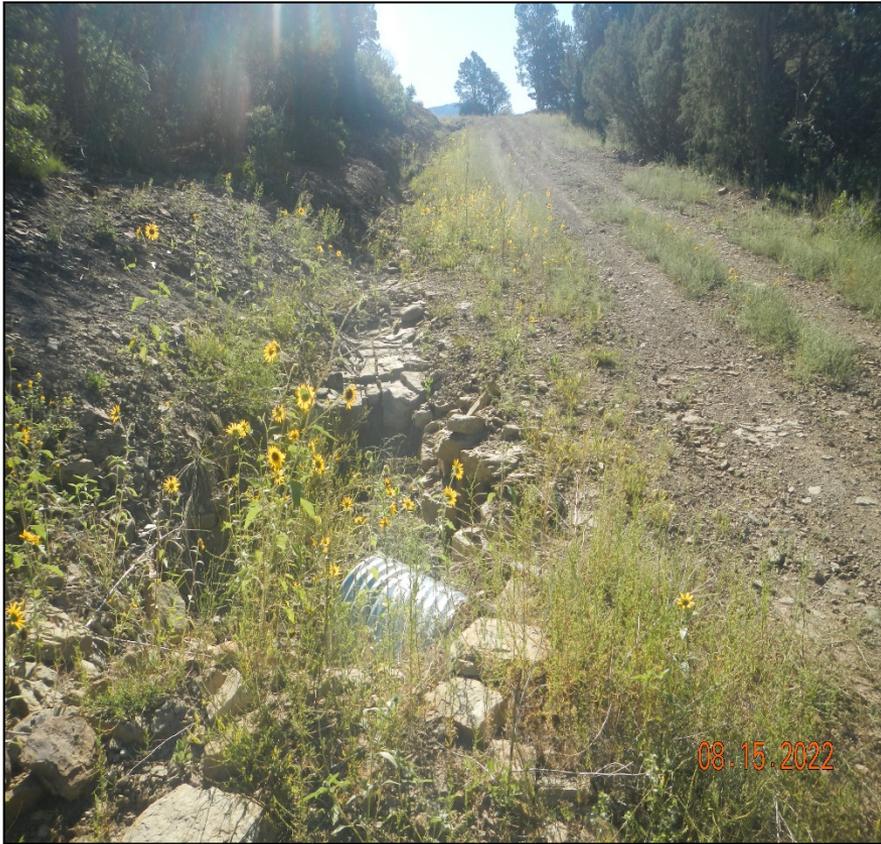
Photo 6. There are culverts installed along the road ascending this hillside.

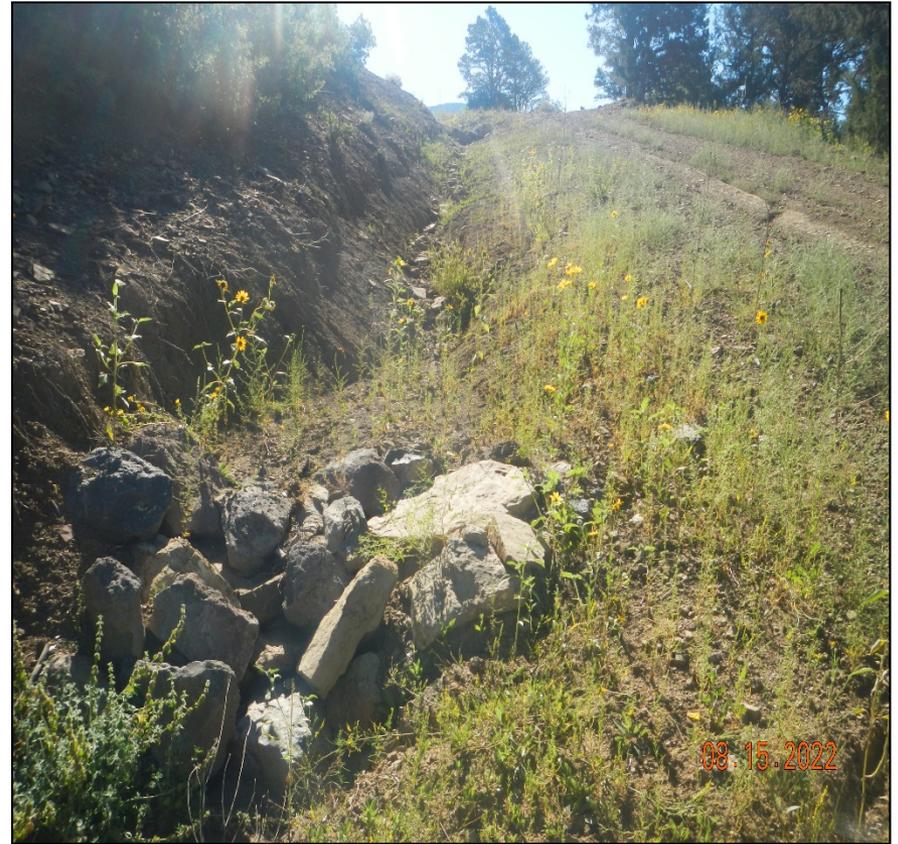
Photo 7. There are multiple rock rip/rap check dams installed along the roadside.

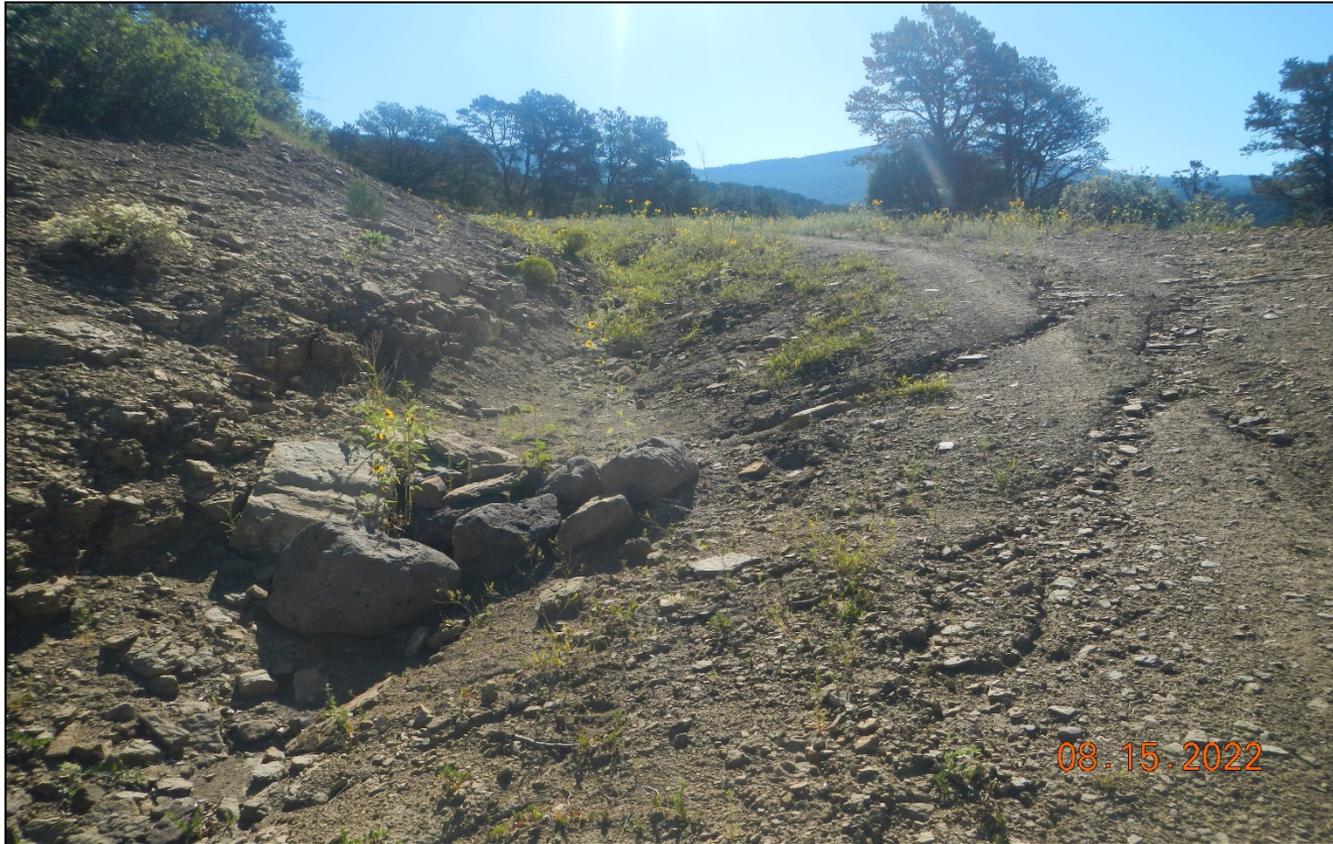
Photo 8. This rock check dam at the curve need to be installed from side to side so stormwater does not flow around the check dam. Lat/Long:37.07425,-104.50717

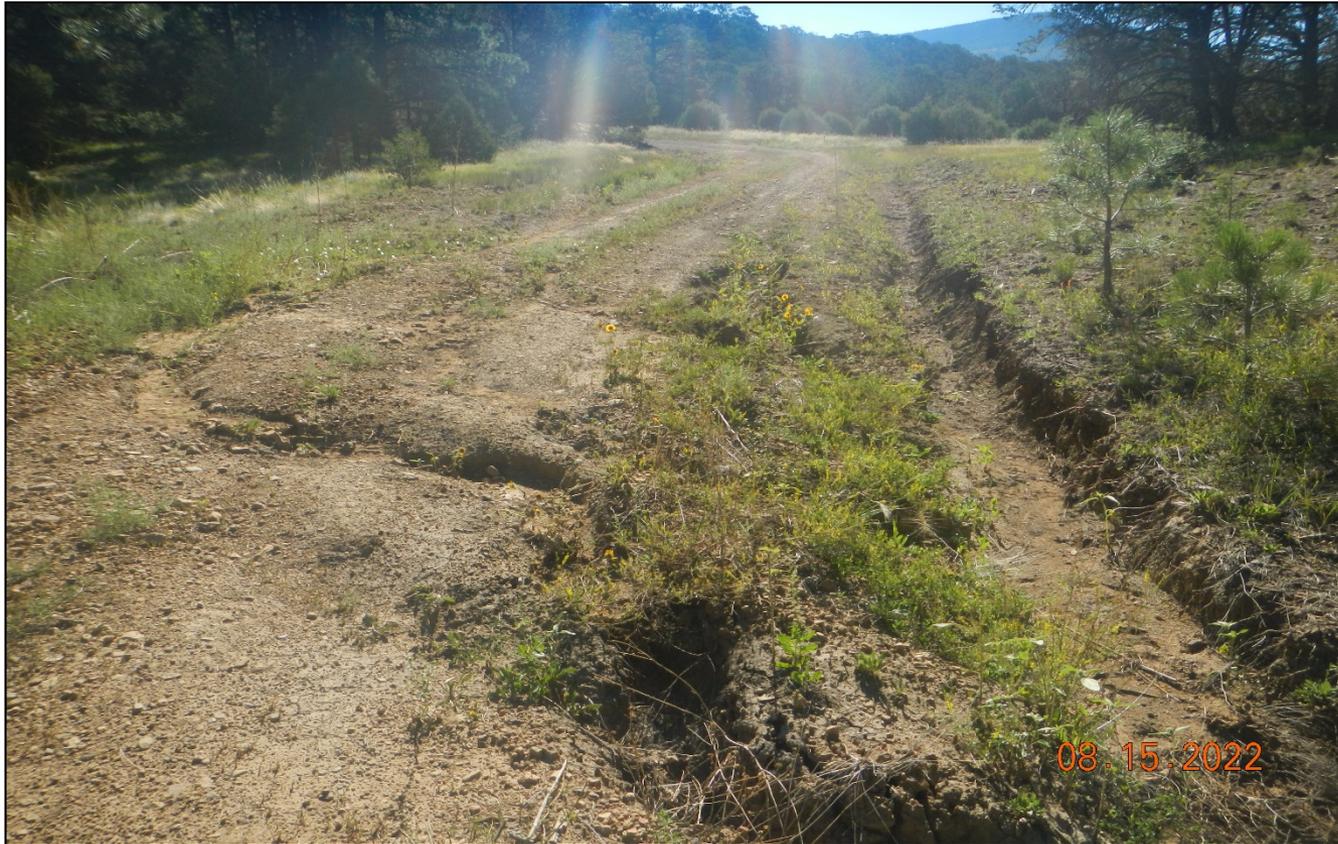
Photo 9. Facing east along the access road. There is erosion of the road in this area that needs to be repaired. There are stormwater divers further up the road that have filled in with sediment causing stormwater to flow down the road to this area. Lat/Long:37.07559,-104.50439

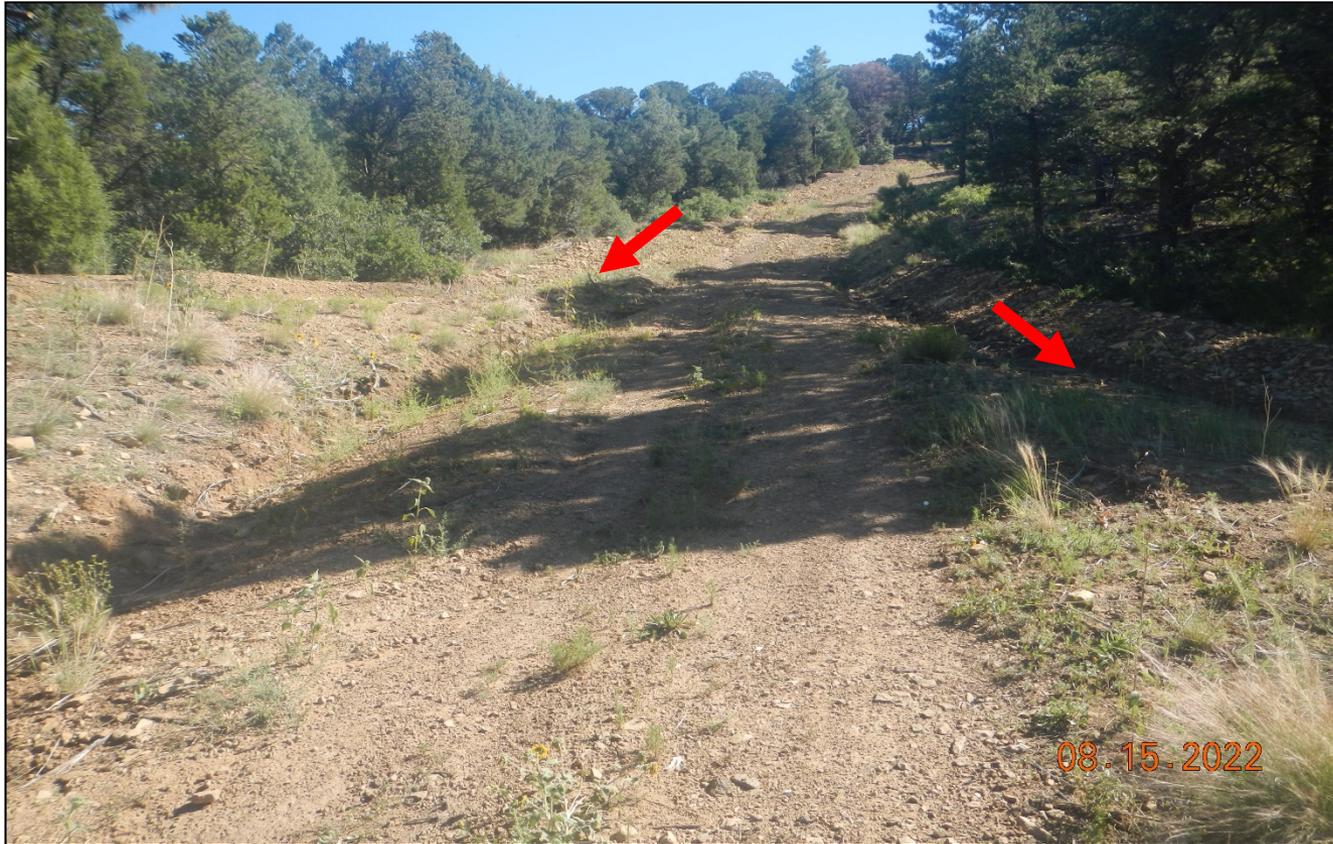
Photo 10. Facing northeast along the access road ascending the hill. The stormwater diversions in this area (red arrows) have filled in with sediment causing stormwater to flow back onto and down the road causing erosion shown in previous photo.
Lat/Long:37.07585,-104.50347

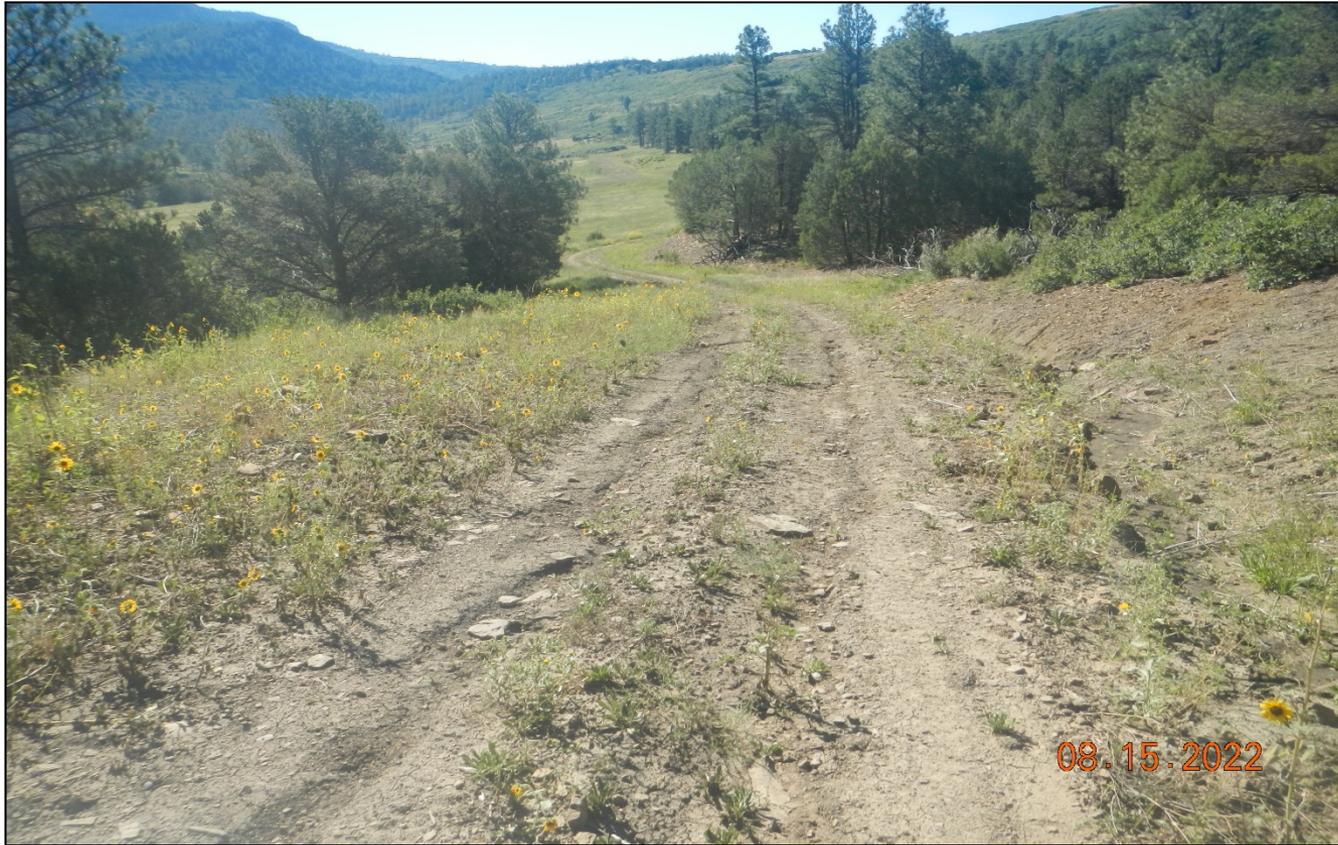
Photo 11. Facing southeast along the access road.

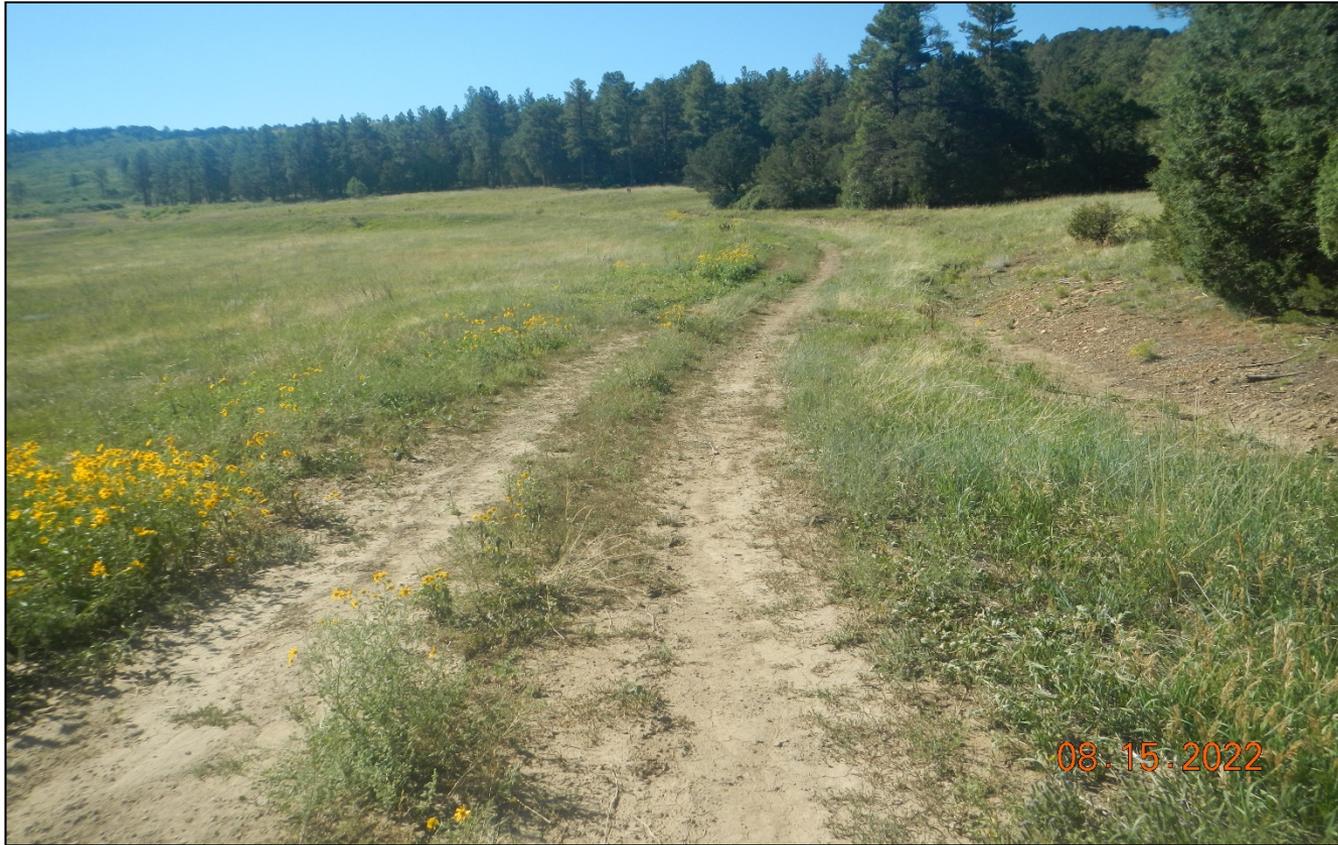
Photo 12. Facing southeast along the access road near the location..

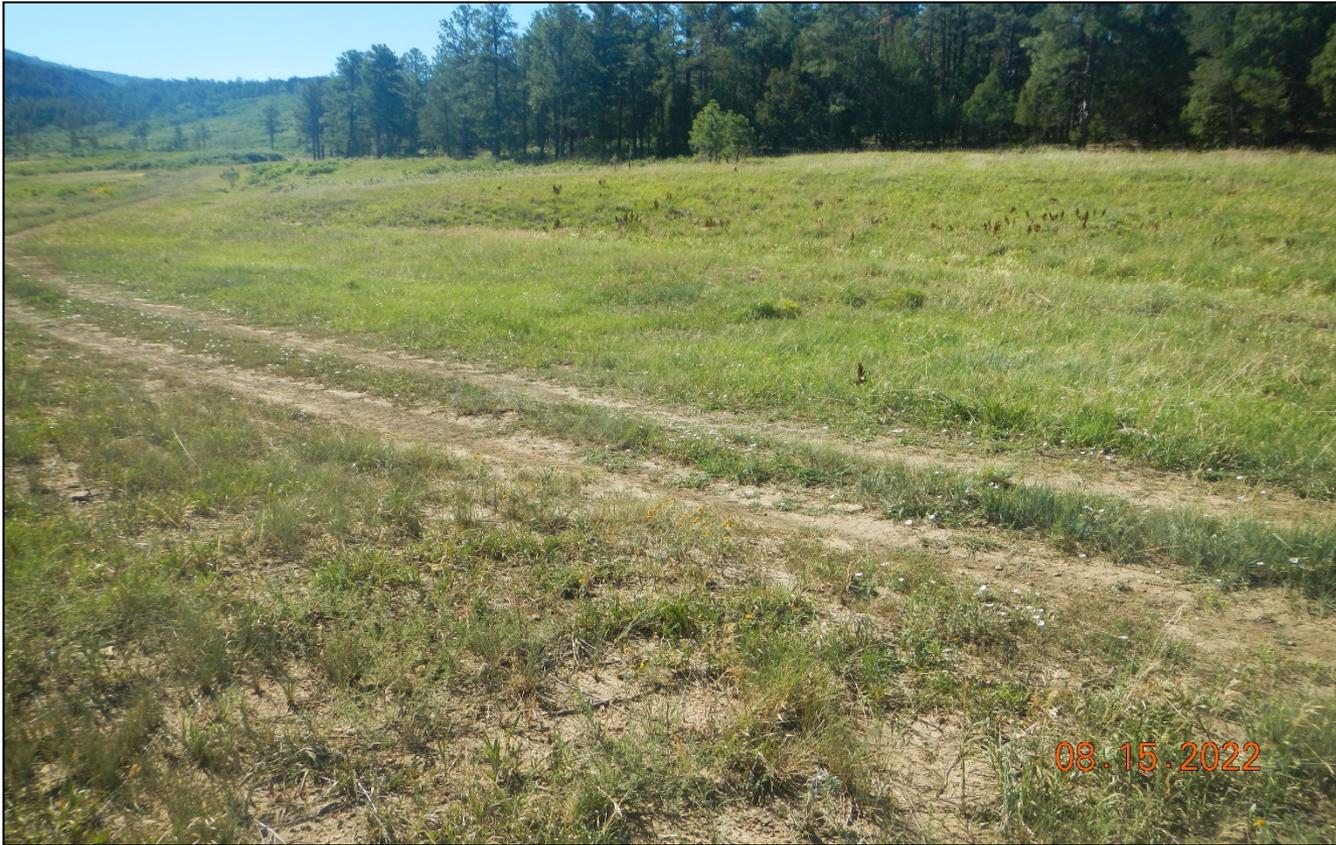
Photo 13. Facing southeast toward the location. The road continues past the location.

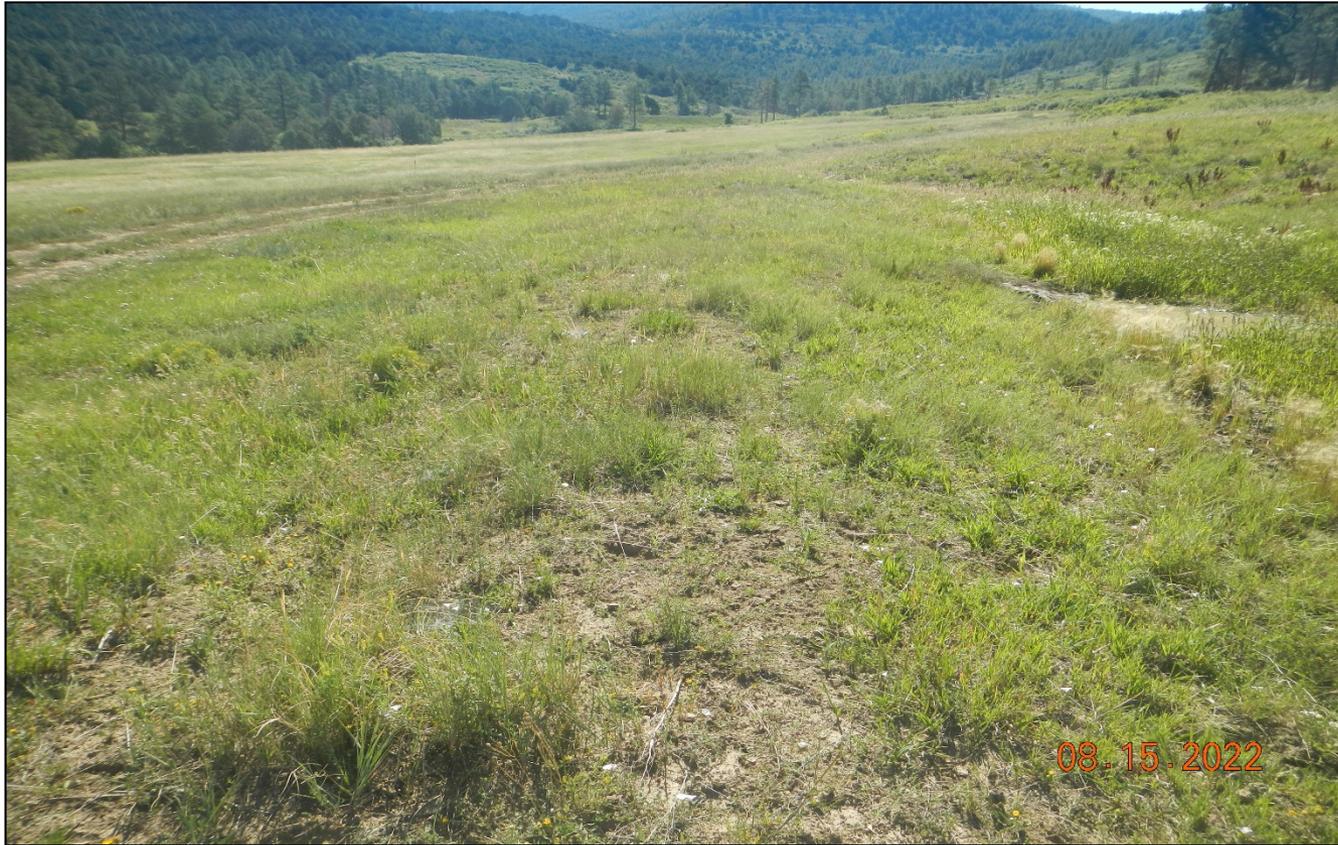
Photo 14. Facing east at the location. Perennial vegetation has re-established at the location.
