Inspection Photos Location ID:312083

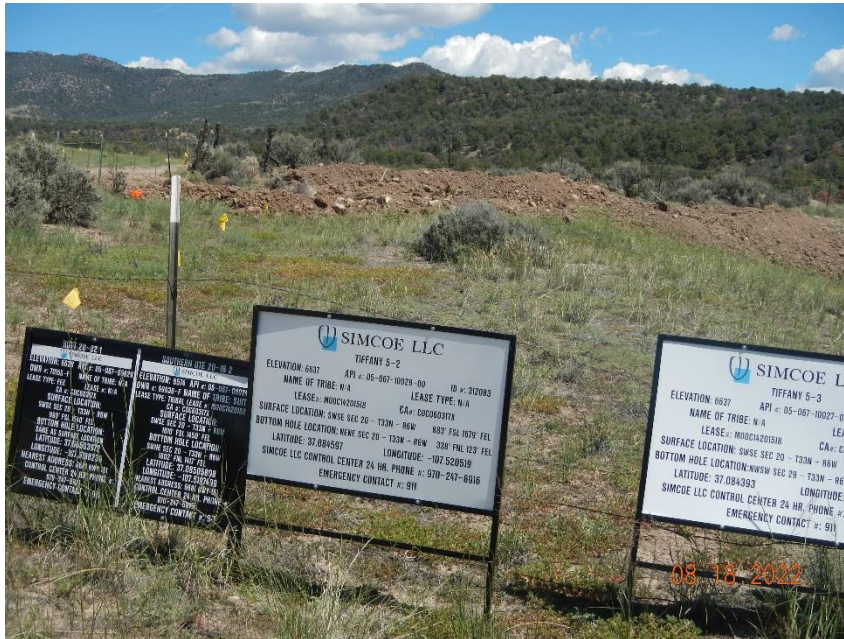
Well signs, including signs for PA wells

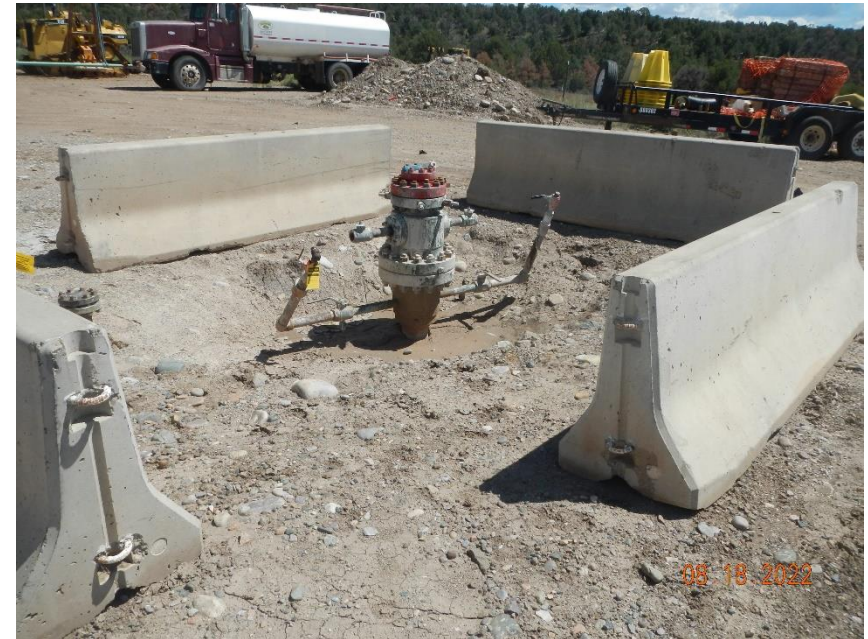
Hott 20-2 1 well not cut and capped

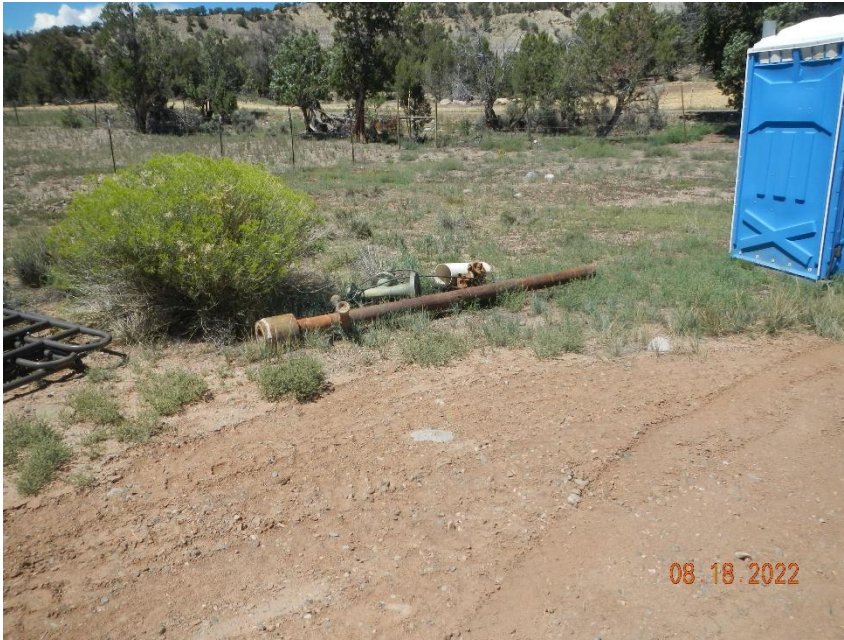
Monument and parts stored in revegetation area. Portable toilet with no BMPs such as anchoring to prevent blow over or spill prevention.

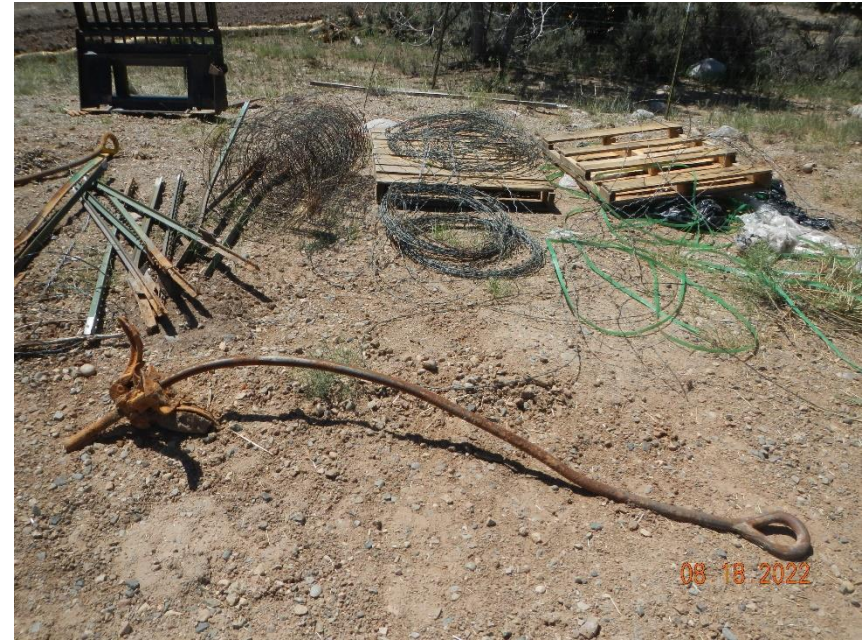
Trash and debris

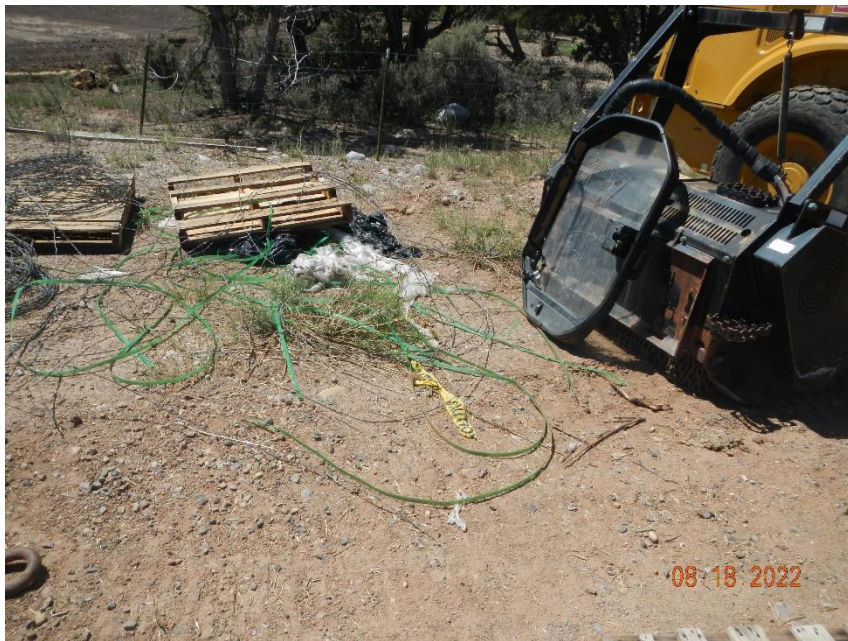
Close up of trash/debris and fencing

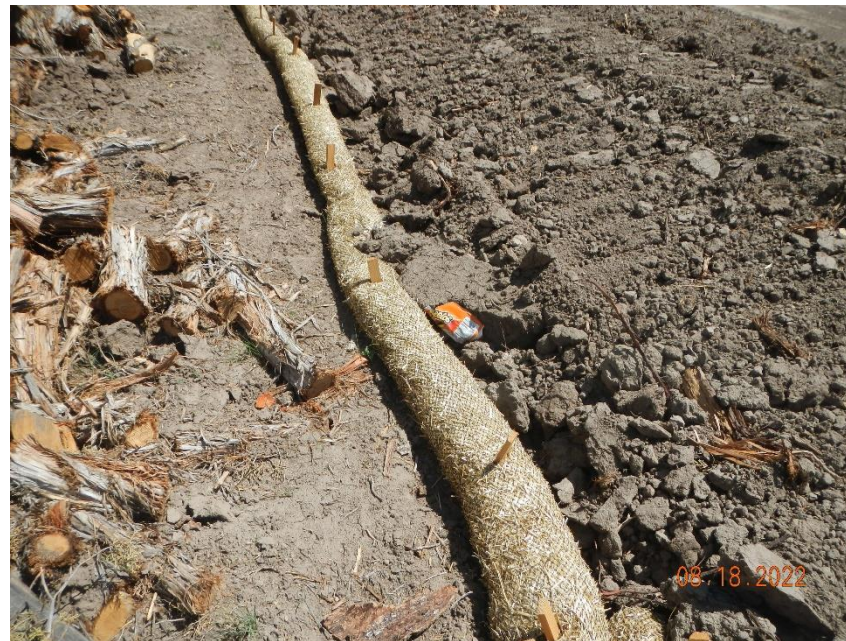
Wood debris and food wrapper

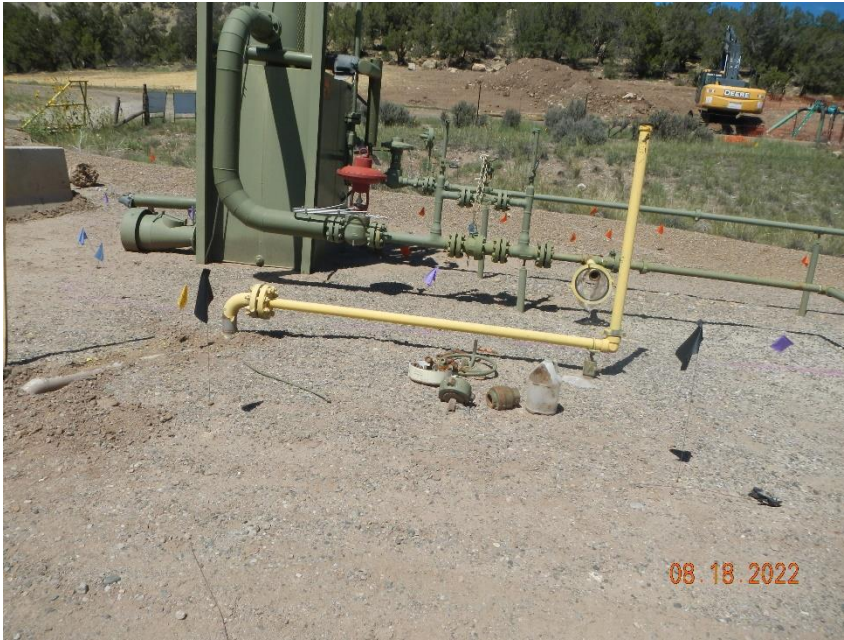
Production equipment from PA well not removed, unused parts

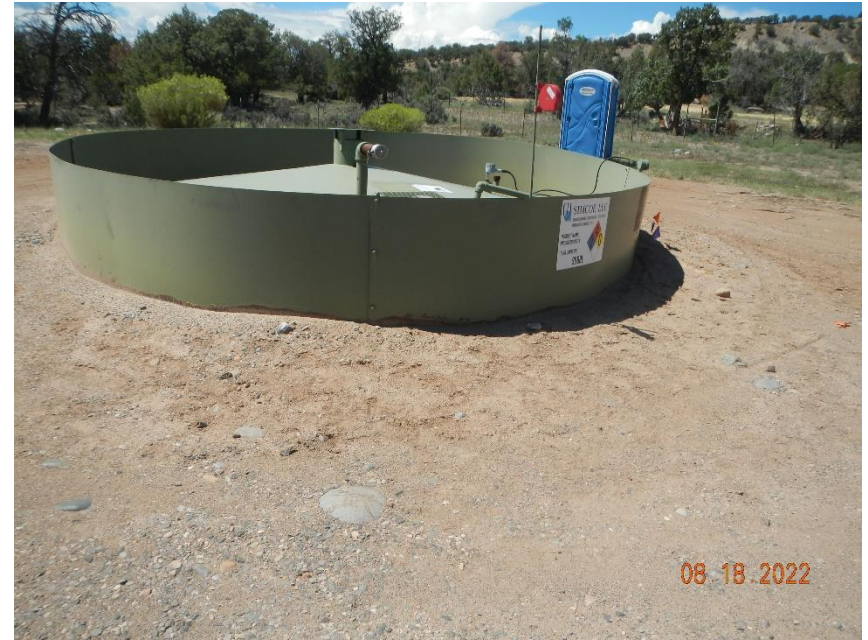
Produced water tank

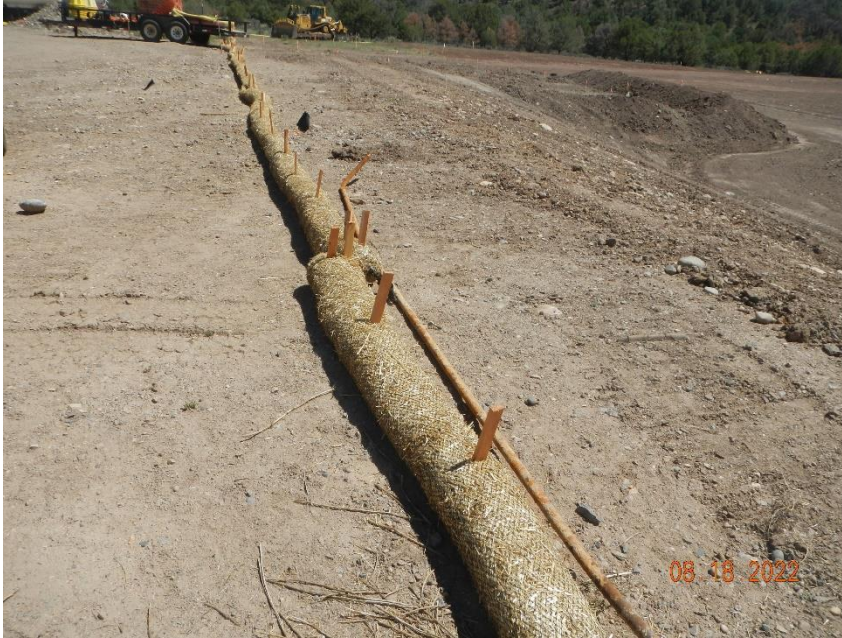
Vertically staked wattles, not trenched in on north side of new disturbance

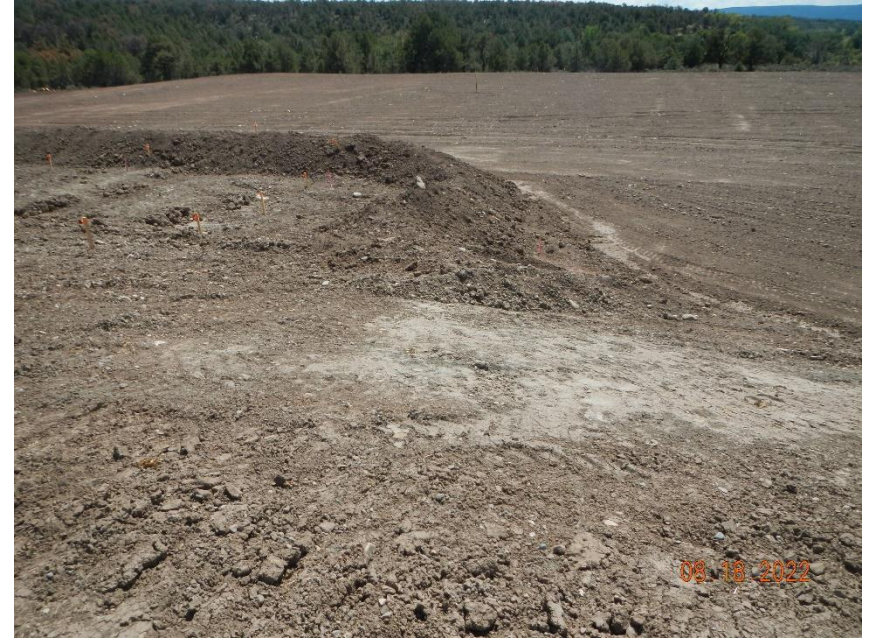
Looking south from PA well at new construction on different grade from original pad

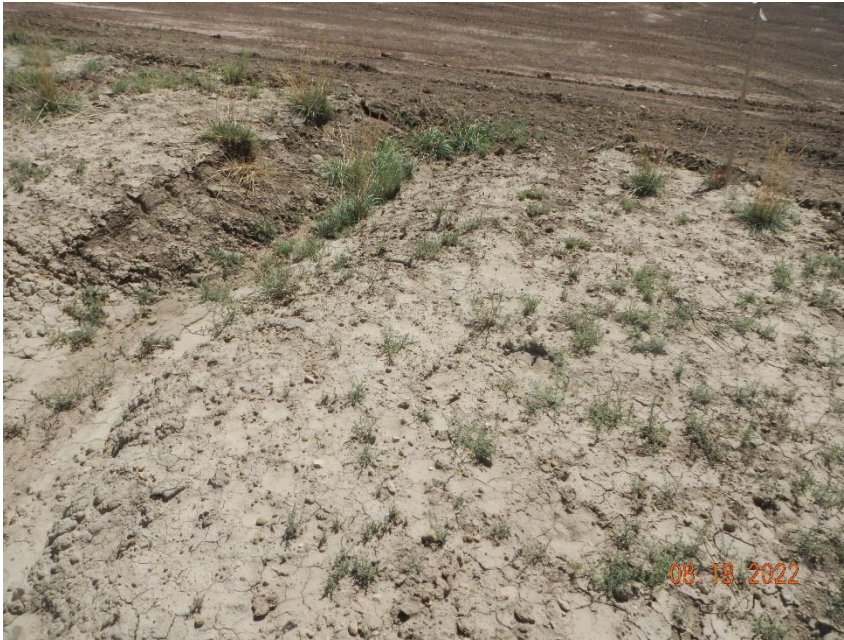
Erosion channel that will run onto new disturbance

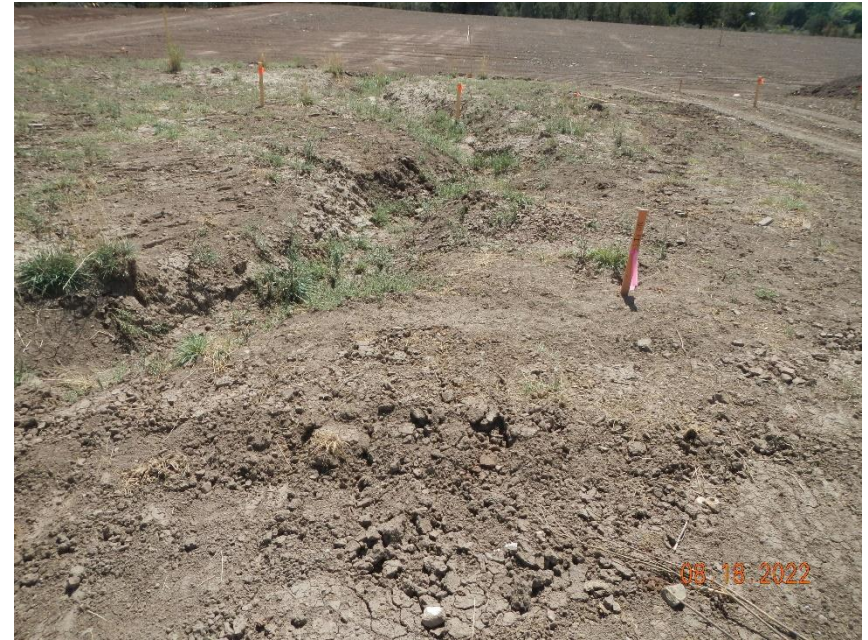
Erosion channel with no BMPs

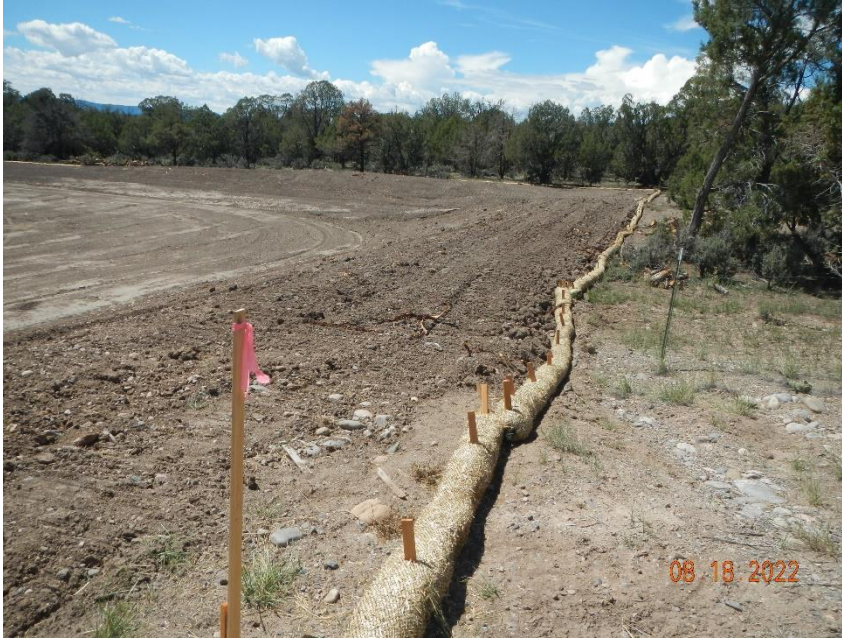
Wattle installation on south side of disturbance

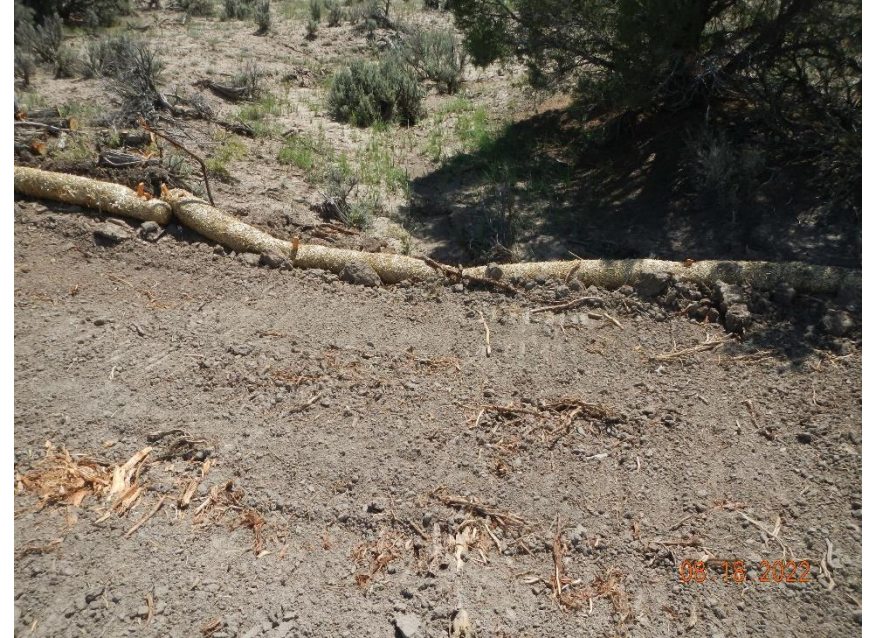
BMPs installation appears inadequate to control run-off on south side of new disturbance

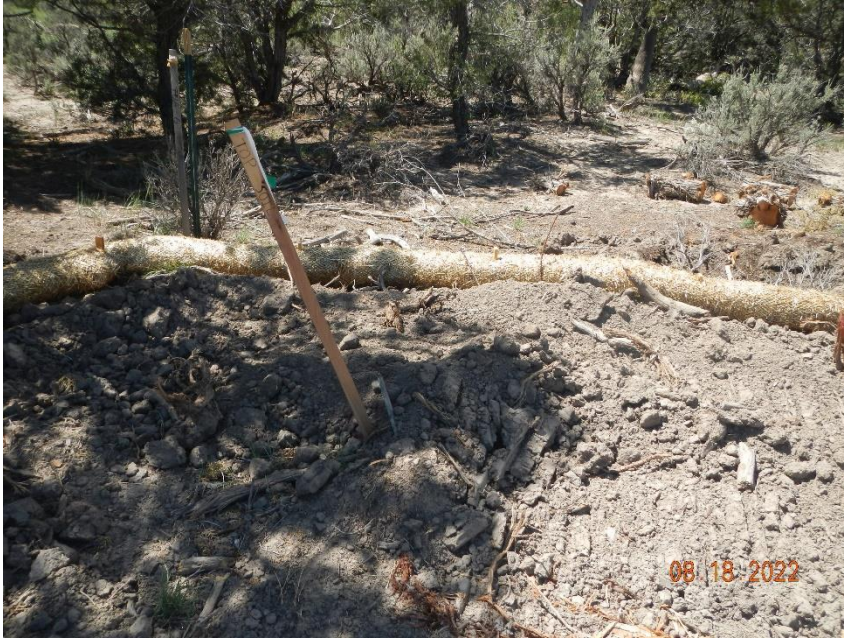
Stake in SE corner labeled with “top soil”

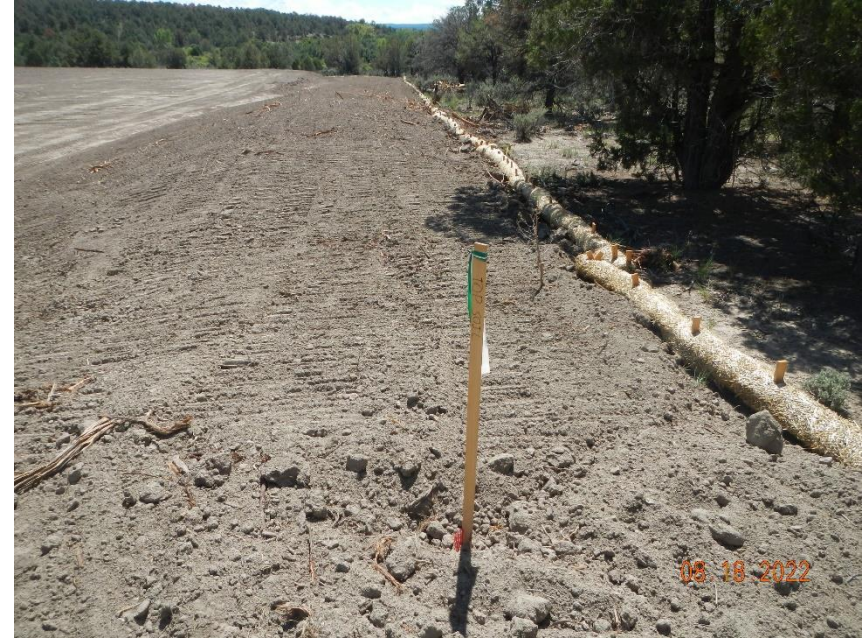
Stake in NE corner labeled “top soil” and what appears to be top soil storage in a board flattened area on perimeter of new disturbance arewa

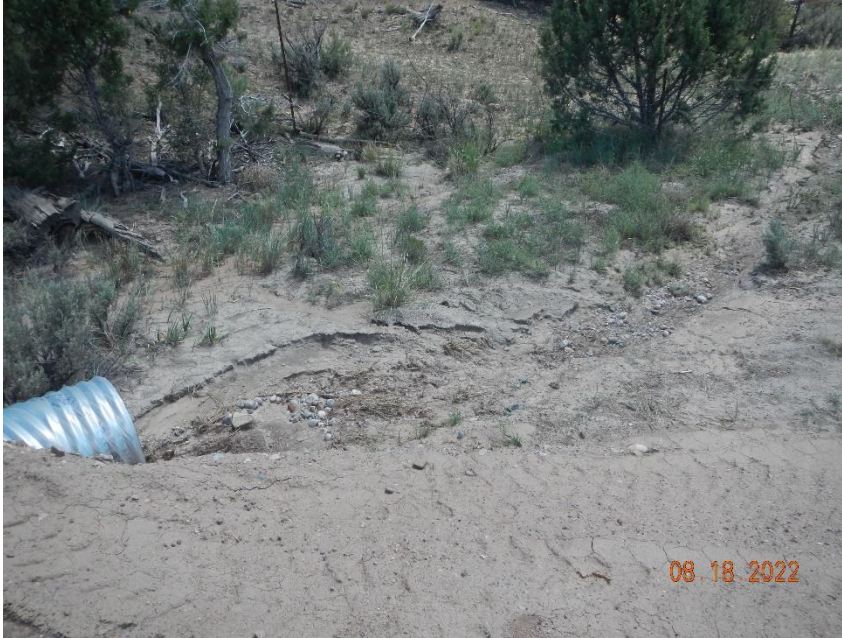
Stormwater erosion at culvert on access road, no outlet protection BMPs

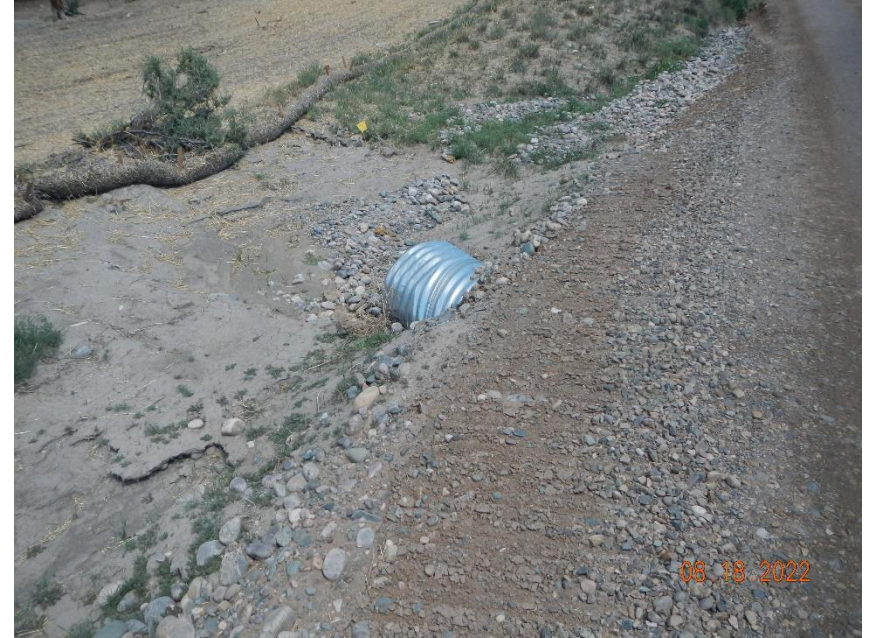
Erosion at culvert on access not inlet protection

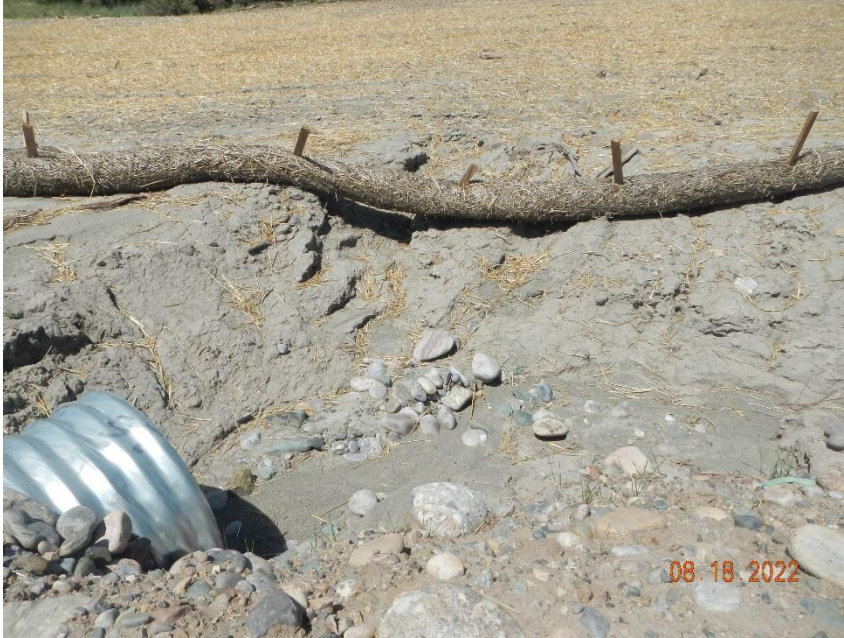
Erosion at culvert inlet on access road, improperly installed/maintained straw wattles

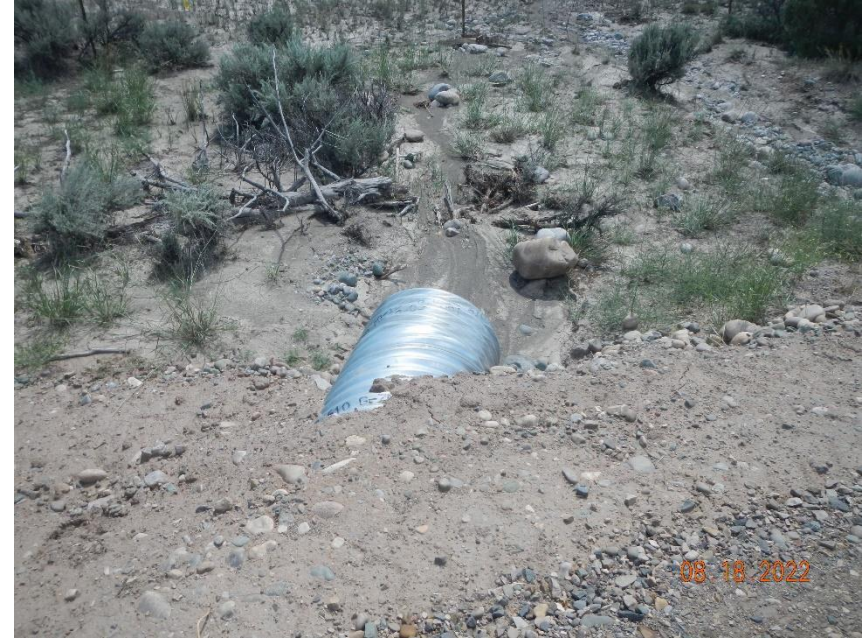
Erosion at culvert outlet on access

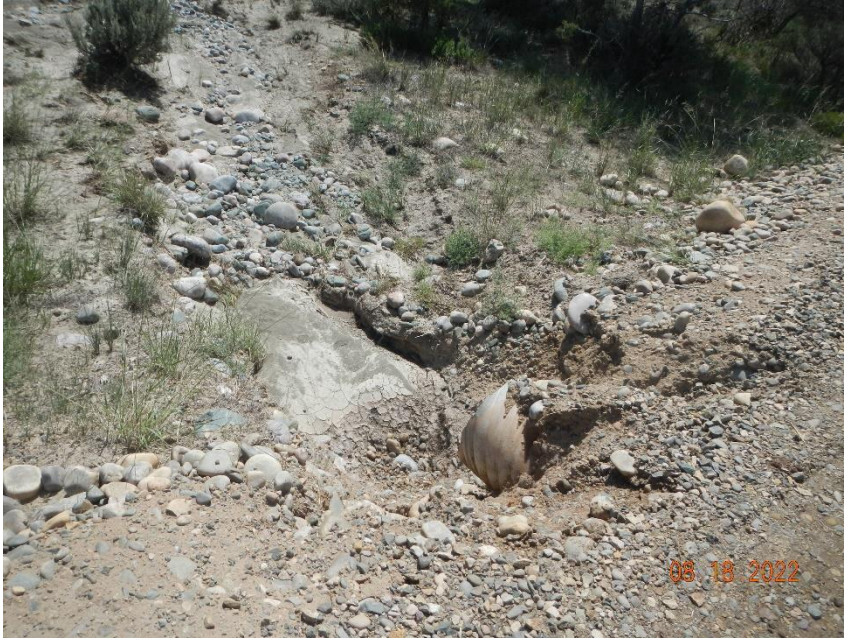
Erosion at culvert outlet on access

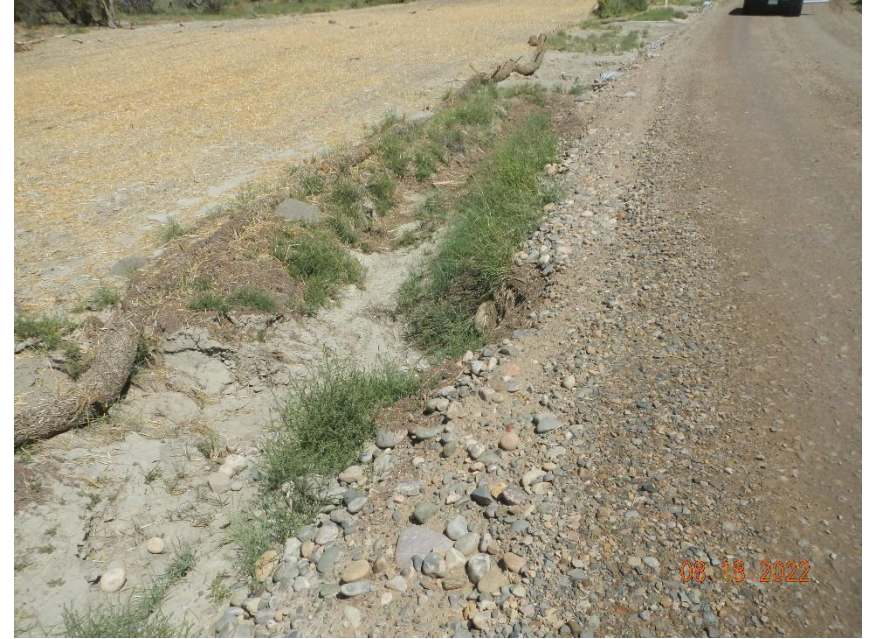
Erosion along access and improperly installed/maintained straw wattles
