KP Kauffman - COGCC Inspection Photos
Location: Rogers #1 Consolidation Flowline
Spill ID #482755 Date 08/24/2022

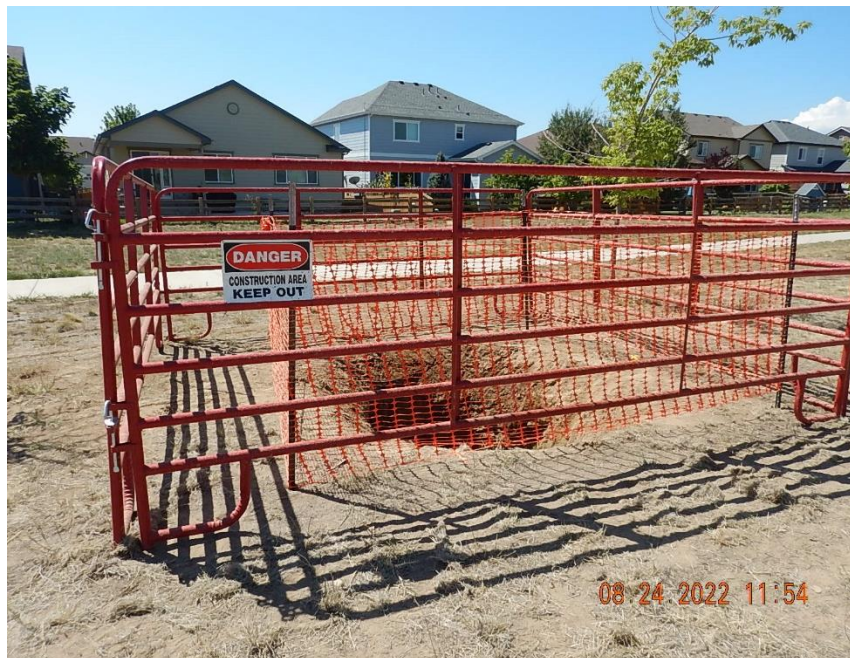
Rogers #1 flowline excavation at release point ; view south.

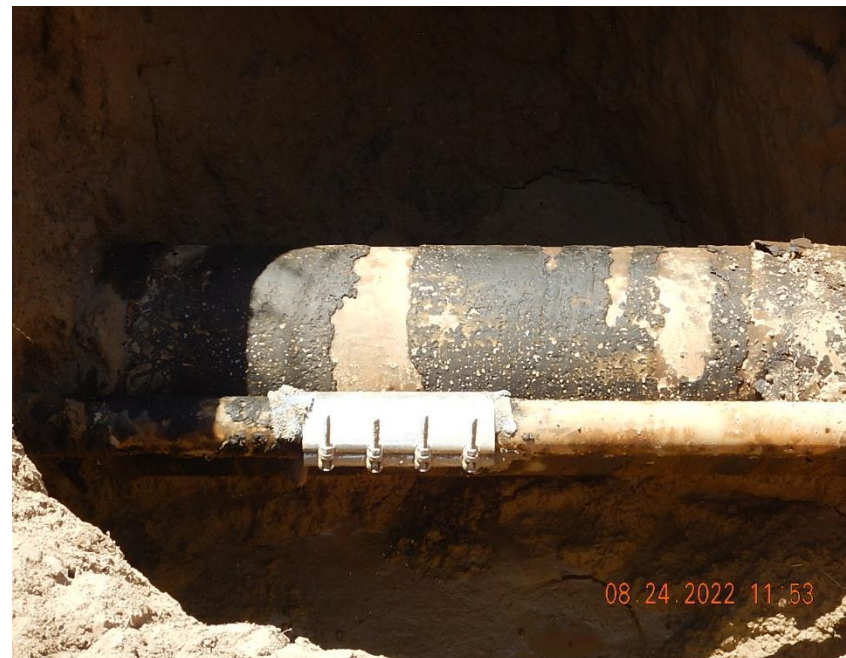
View of flowlines exposed in excavation at release point; (1) 4" carbon steel flowline (being repaired) with a bolted clamp over hole in line; (1) 16"-18" CS OLF (consolidation).

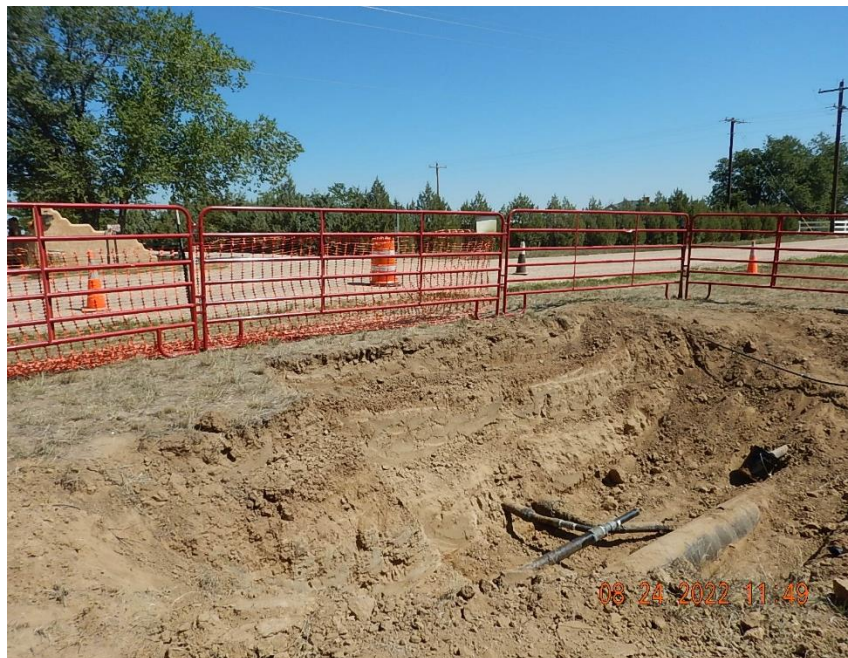
View of flowlines exposed in west bellhole excavation during repairs; view NE along WCR 14.5

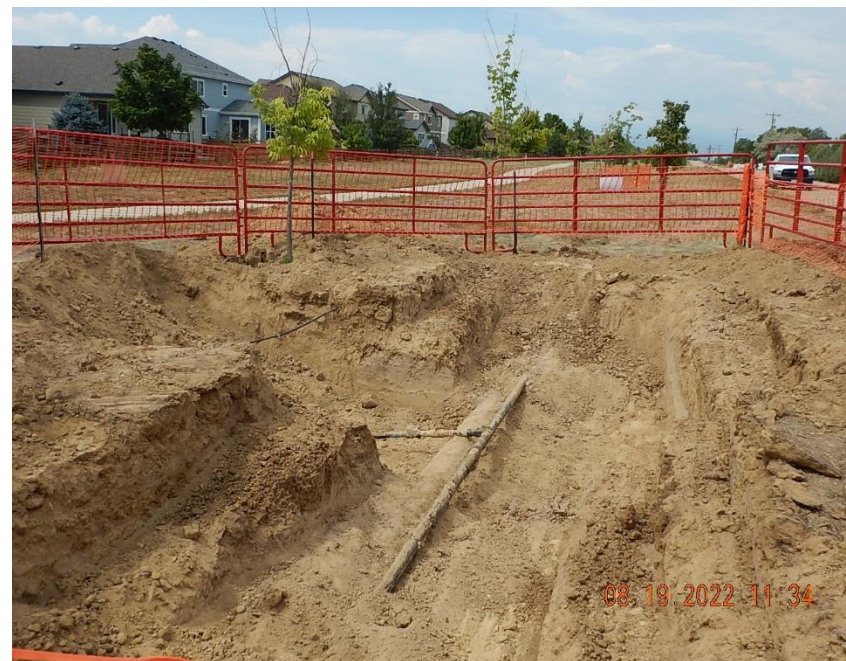
View of flowlines exposed in east bellhole excavation during repairs; view W along WCR 14.5
