Inspection Photos
Location Name: Xavier 1
Location ID: 325411

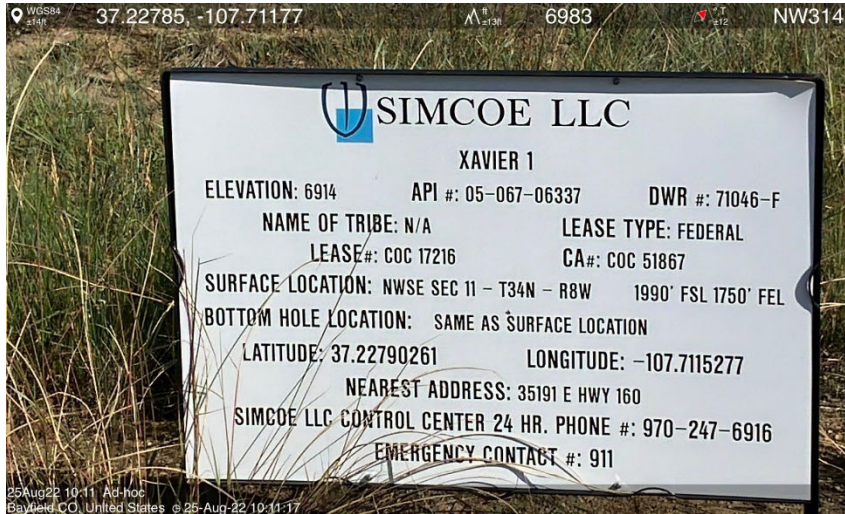
IMG 01
Well sign

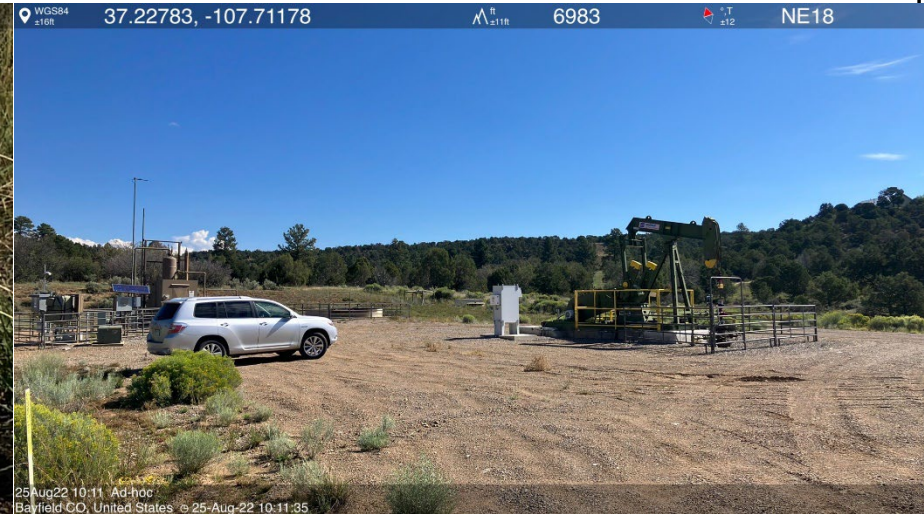
IMG 02
Location overview

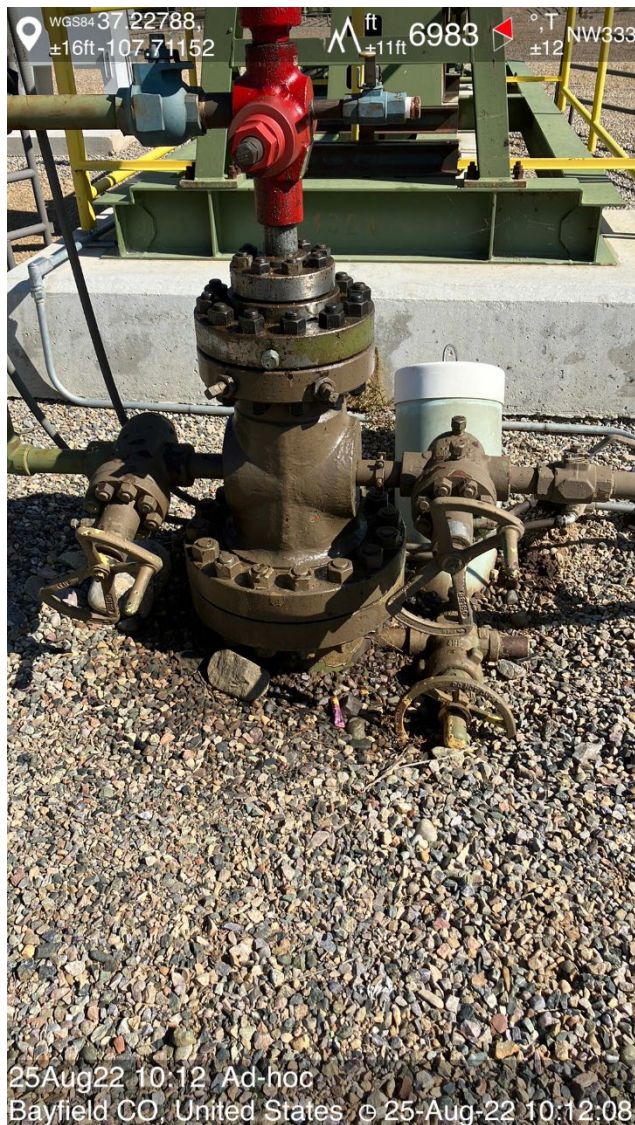
IMG 03
Lube oil

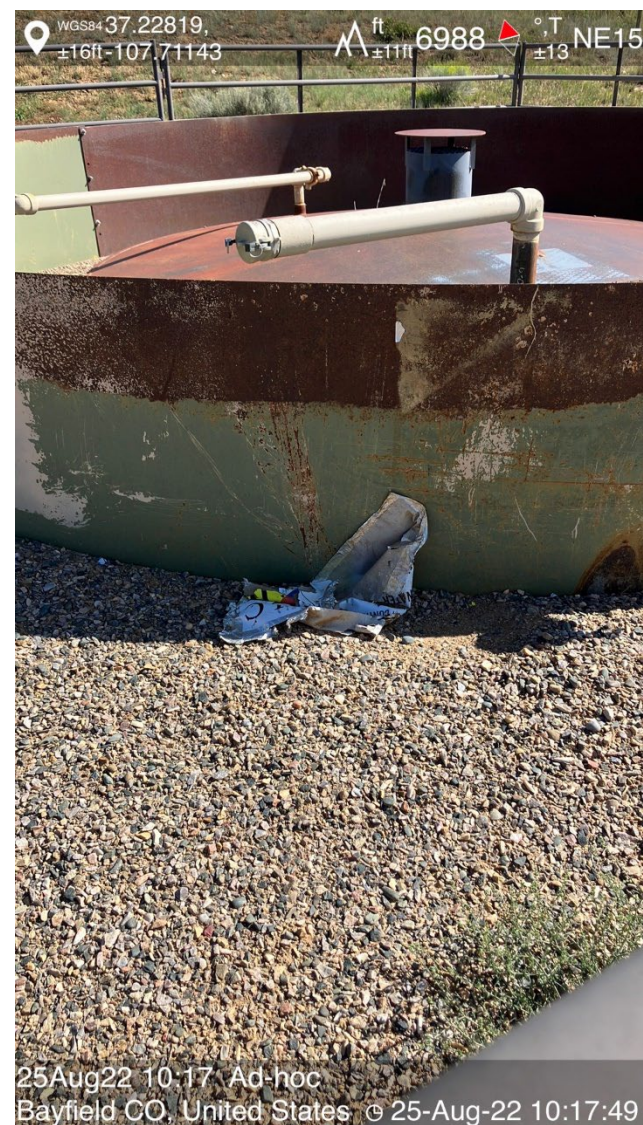
IMG 04
Tank sign

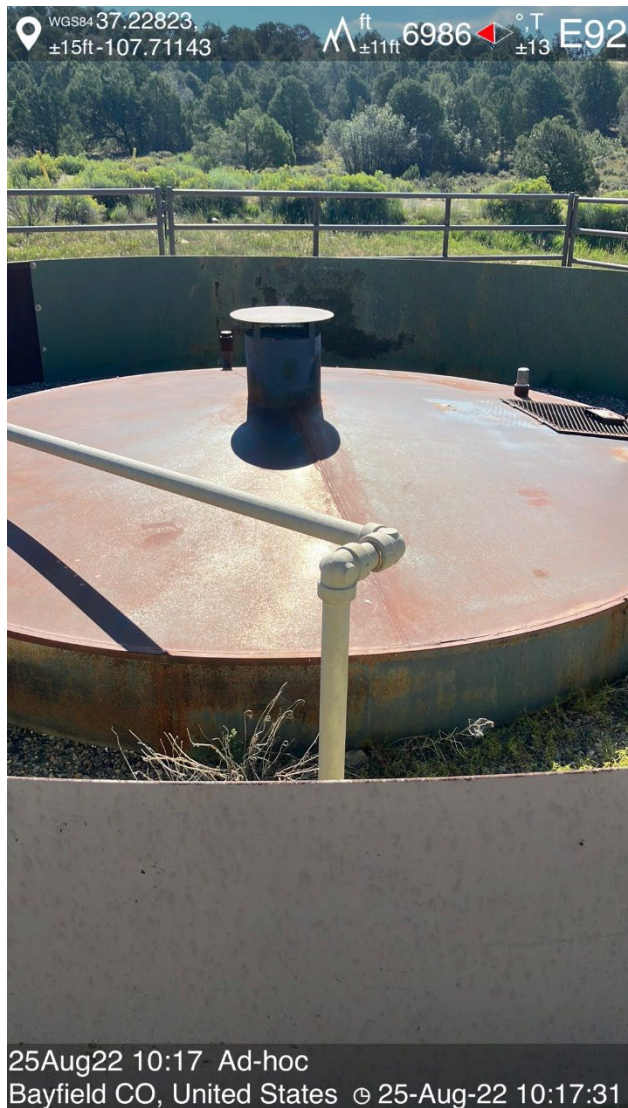
IMG 05

Deteriorating paint

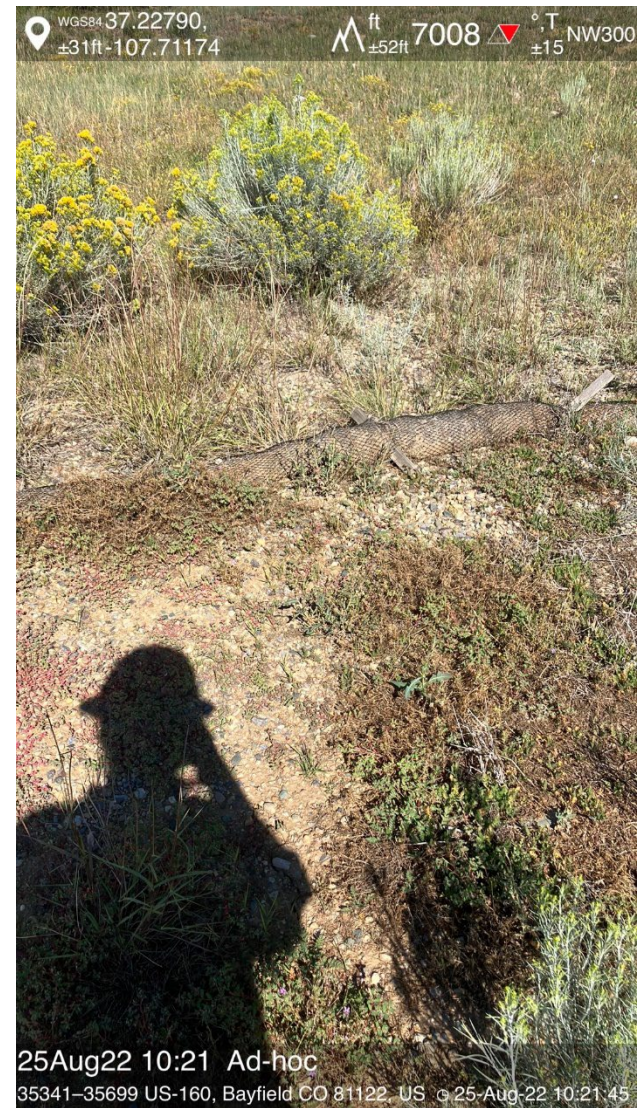
IMG 06

Wattles beginning to deteriorate
