Inspection Photos and Issue Report

Operator: PRE RESOURCES INC #10241

Location #322302

Garfield County, CO

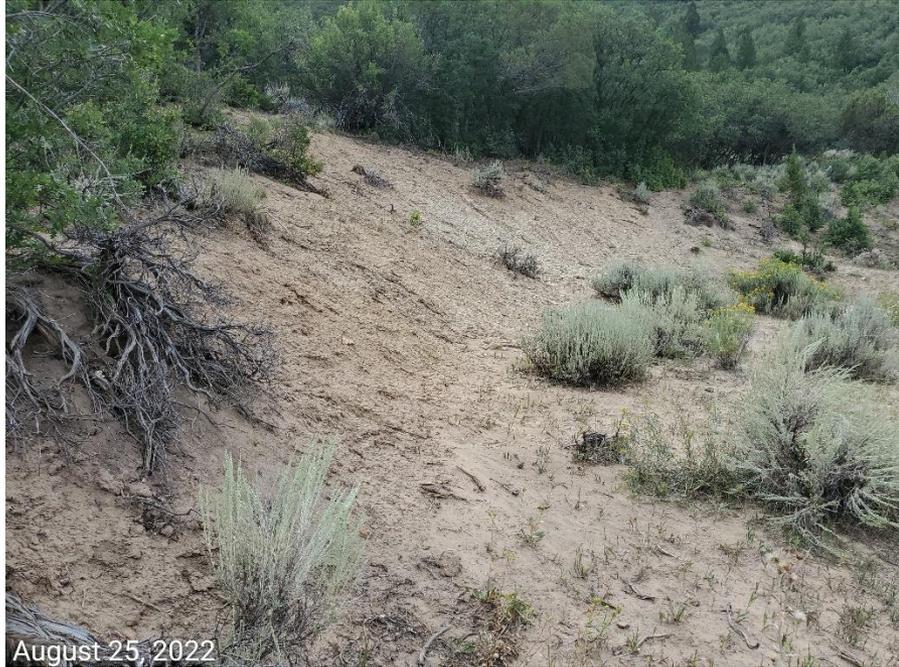
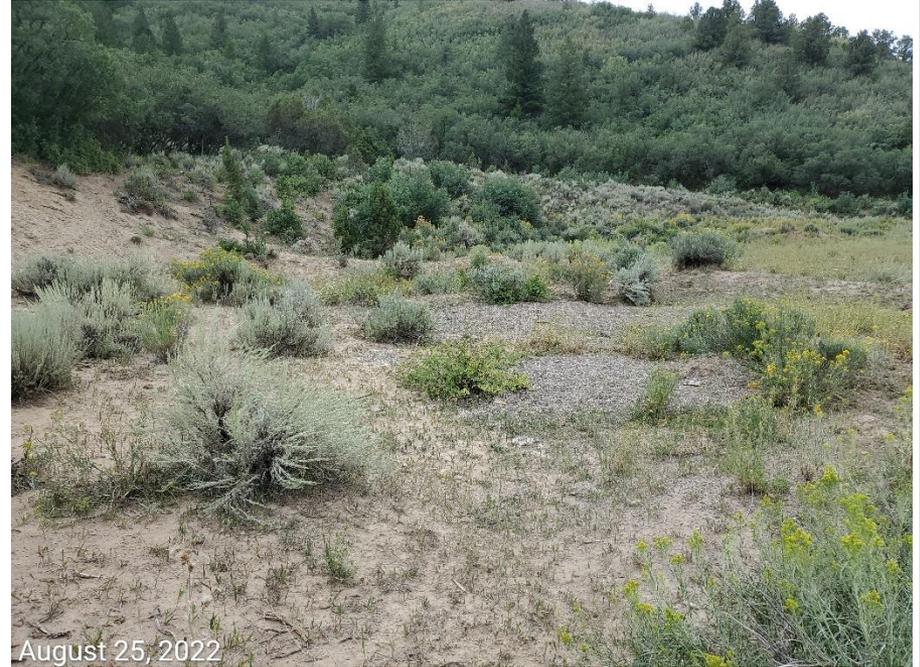
Photo 1: Photos 1-2 taken from the north end of the Location. Photos provide an overview of the Location from southeast, south, southwest to west. Photos shows final reclamation including recontouring/regrading and revegetation activities have not been conducted.

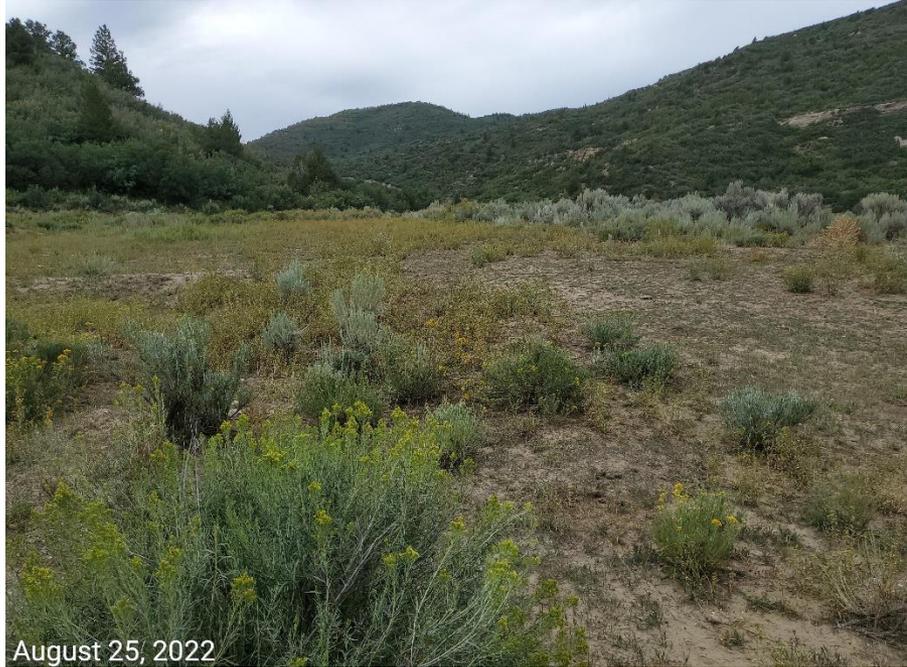
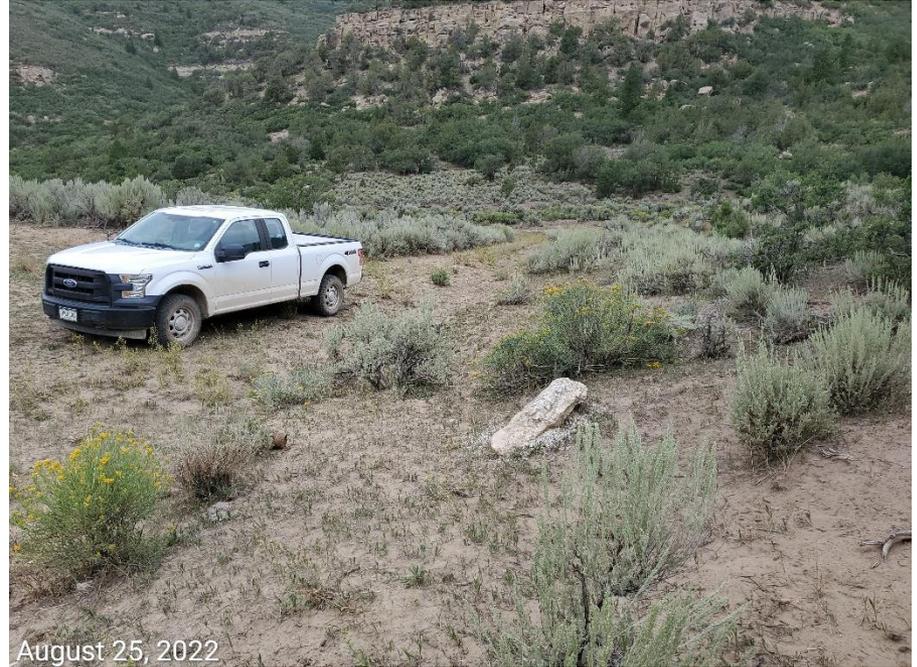
Photo 2: See comments under photo 1.

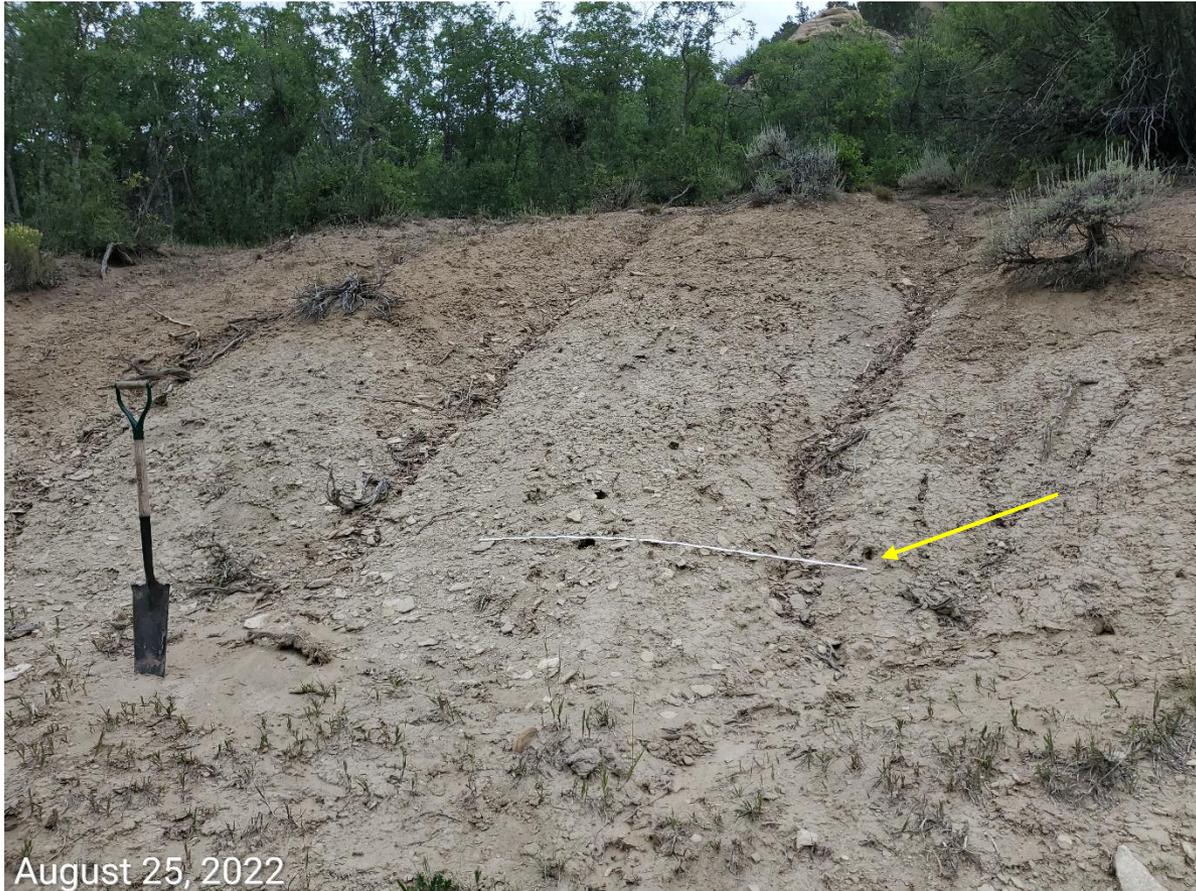
Photo 3: Photo taken from the cut slopes on the northeast end of the Location. Photo shows slopes have not been reclaimed; BMPs to minimize erosion and degradation are missing or insufficient on Location; gully erosion and sediment transport evident. 6.5' measuring stick for reference.

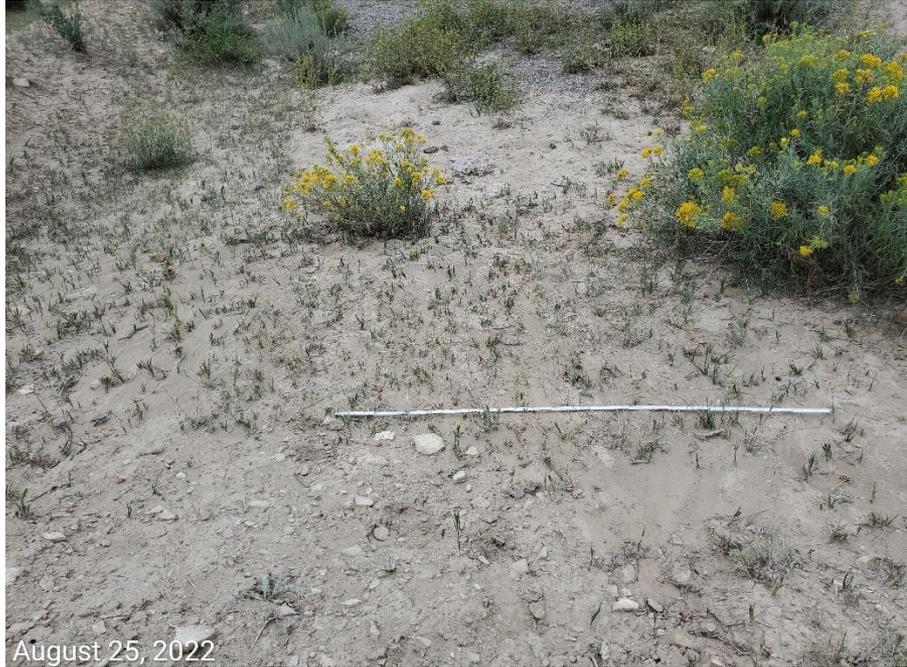
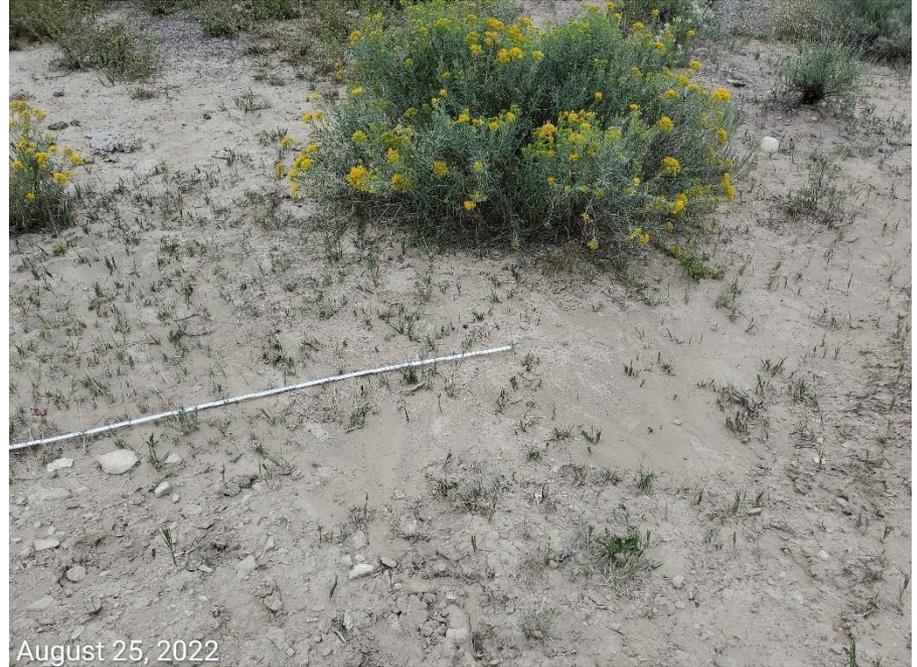
Photo 4: Continued from photo 3. Photo taken from the base of the cut slopes. Photo shows sediment deposition resulting from erosion degradation at the cut slopes.

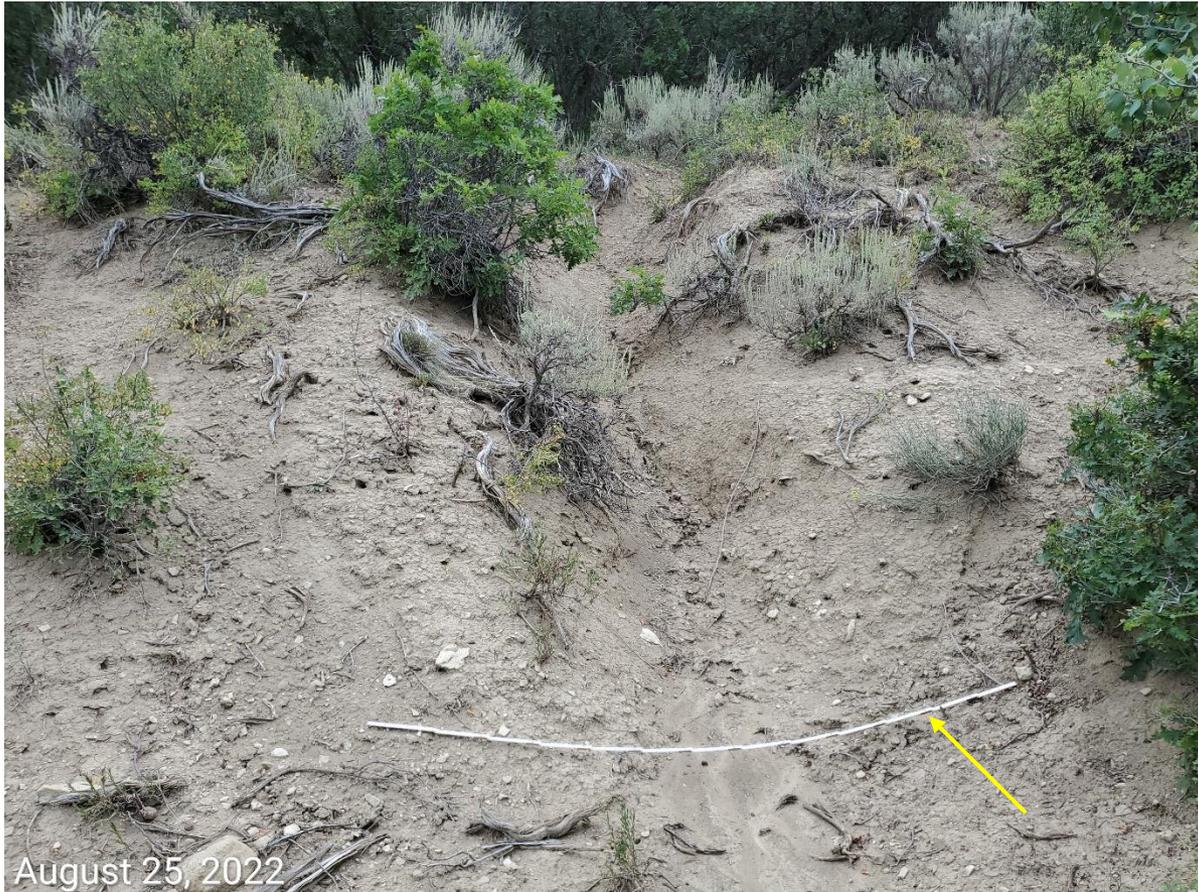
Photo 5: Photo shows gully erosion degradation observed at the cut slopes on the east end of the Location. 6.5' measuring stick for reference.

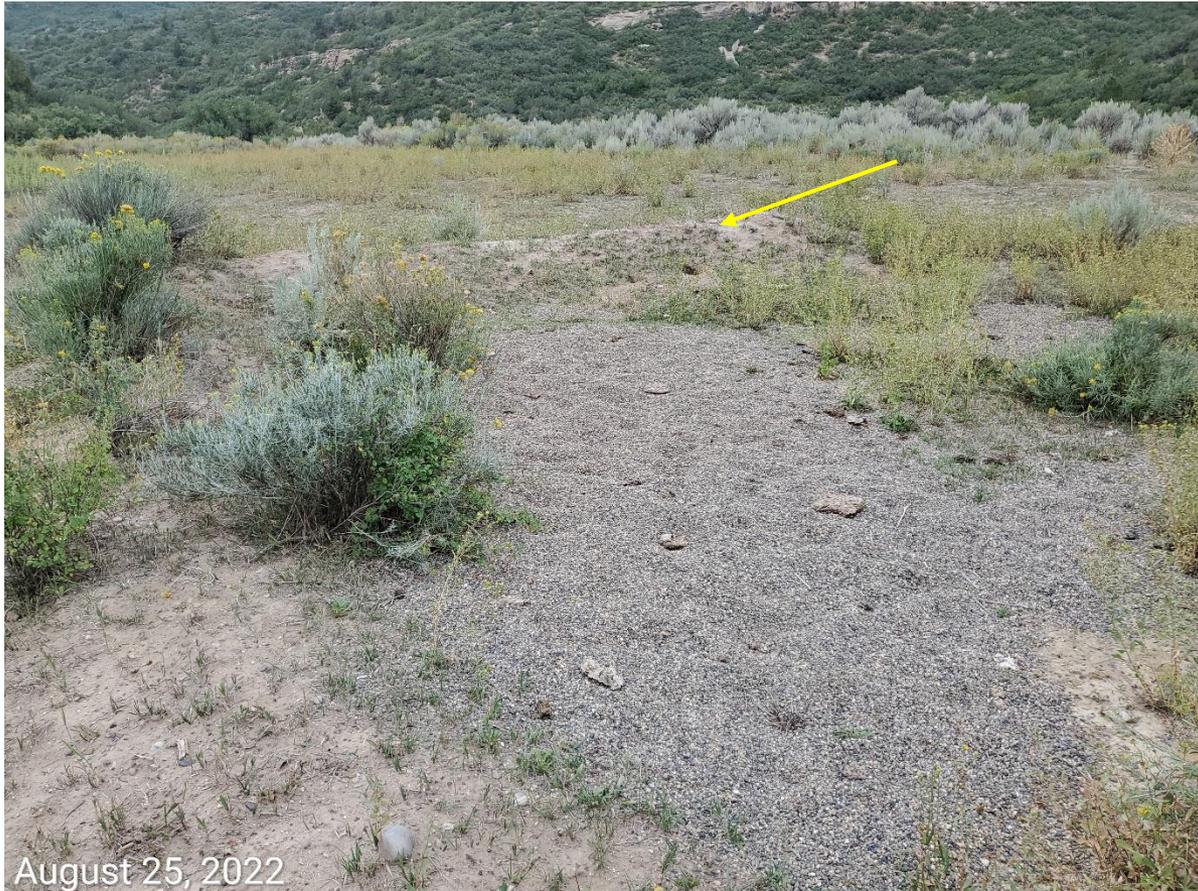
Photo 6: Photo taken from the north east end of the Location, facing southwest. Photo shows gravel, as well as a secondary containment berm remaining on the Location.

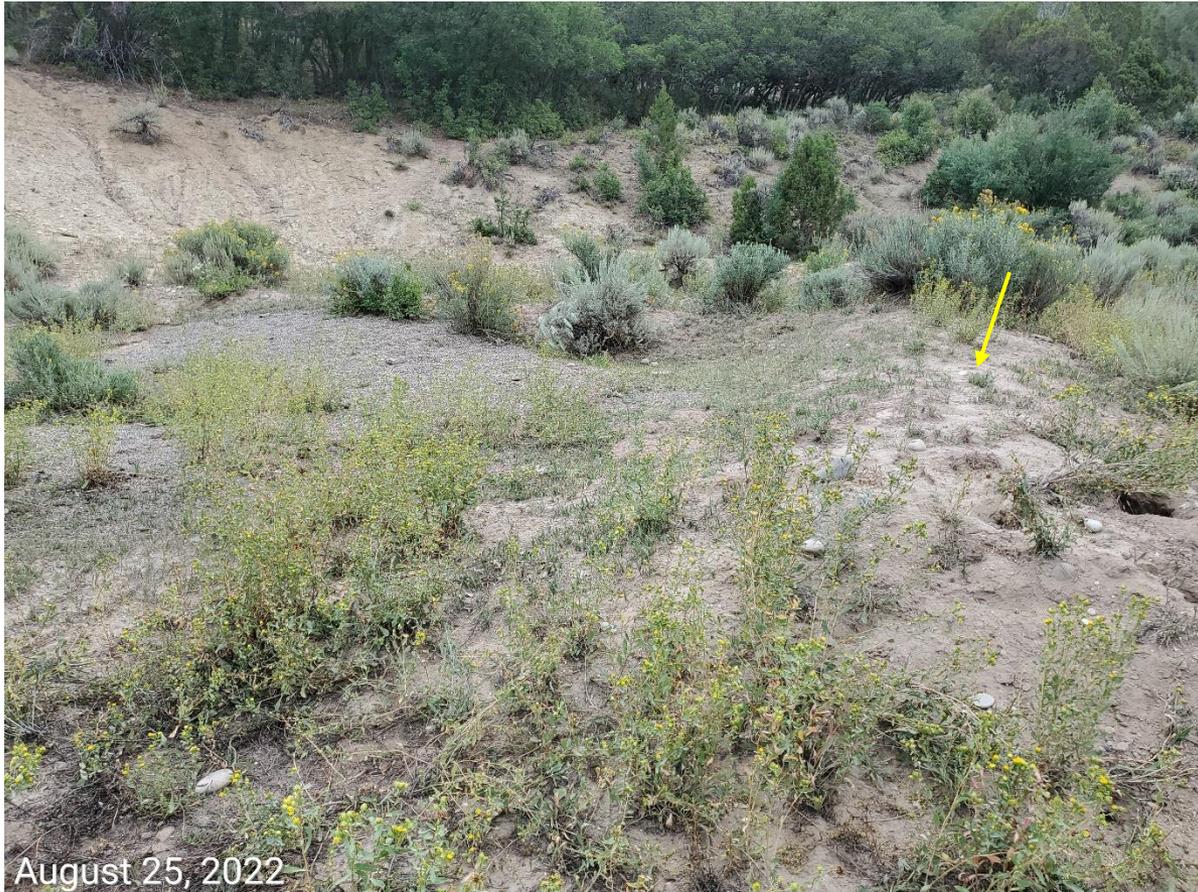
Photo 7: Continue from photo 6. Photo shows gravel, as well as a secondary containment berm remaining on the Location.

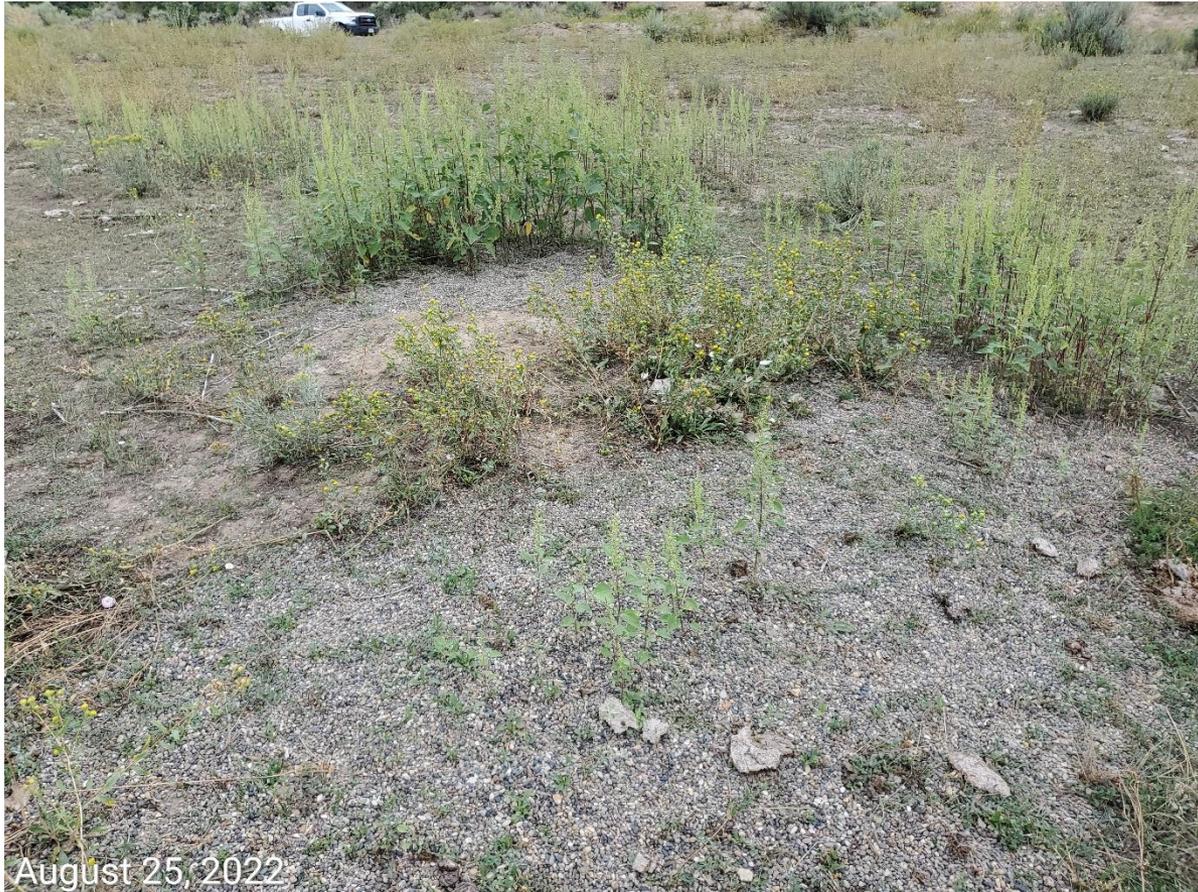
Photo 8: Gravel remaining at the well site. Photo also shows vegetation on the Location remains predominantly Undesirable Weedy, as well as Noxious Plant species.

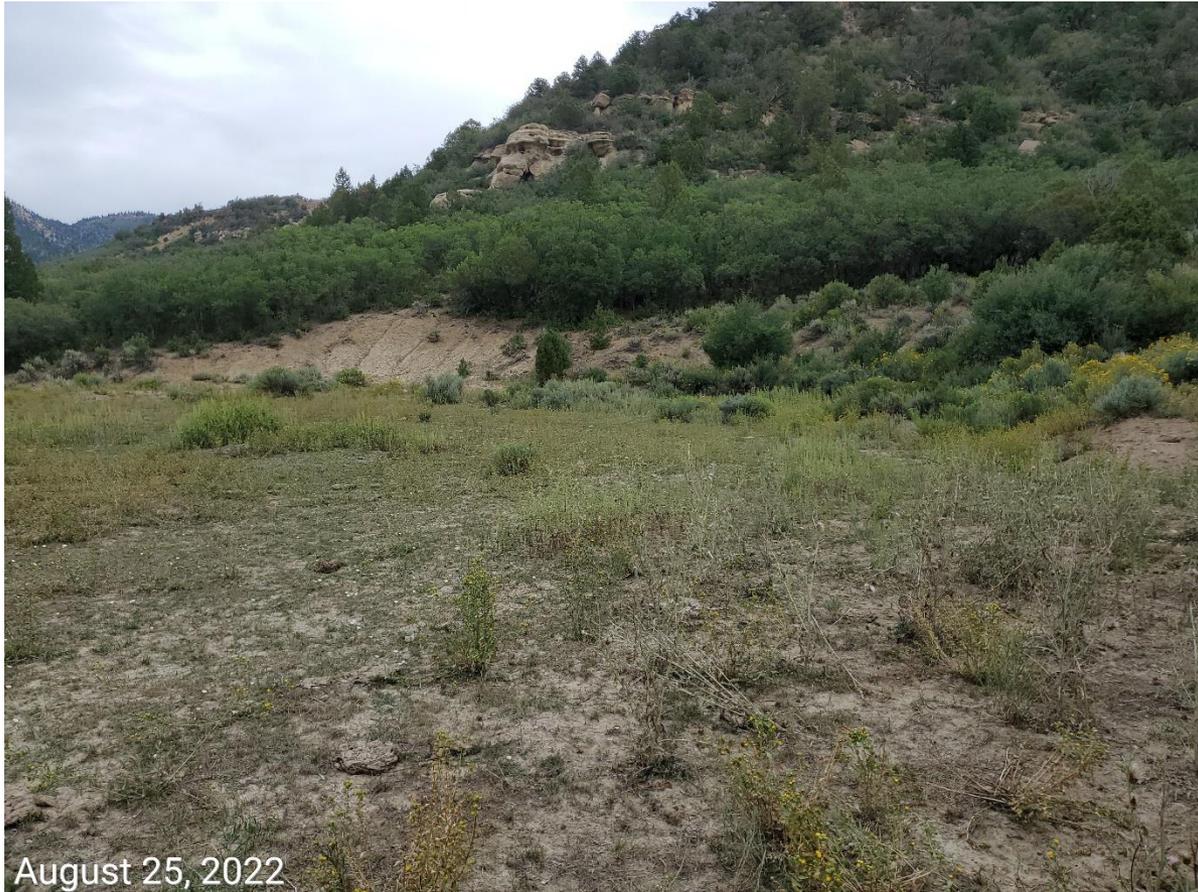
Photo 9: Photo of cut slopes on Location.

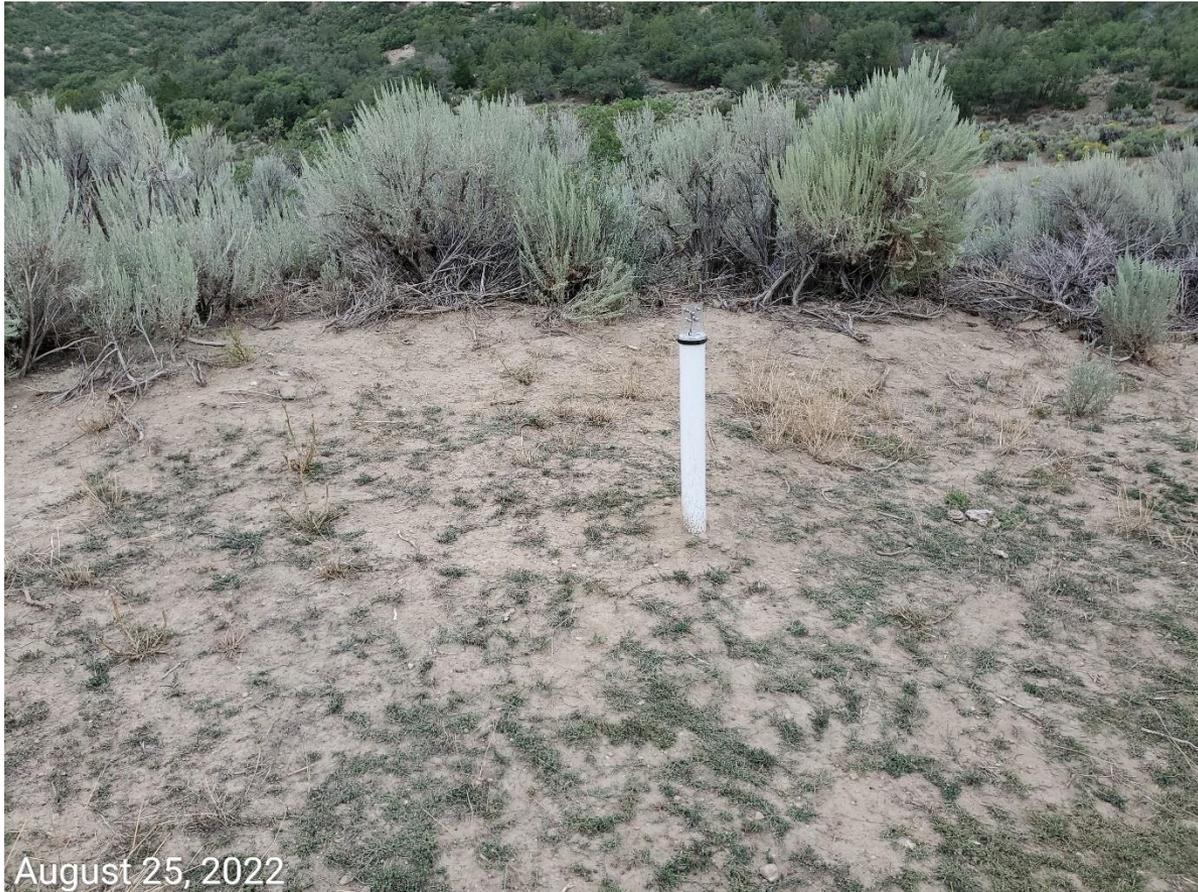
Photo 10: Pipe with wires remaining on the northwest end of the Location.

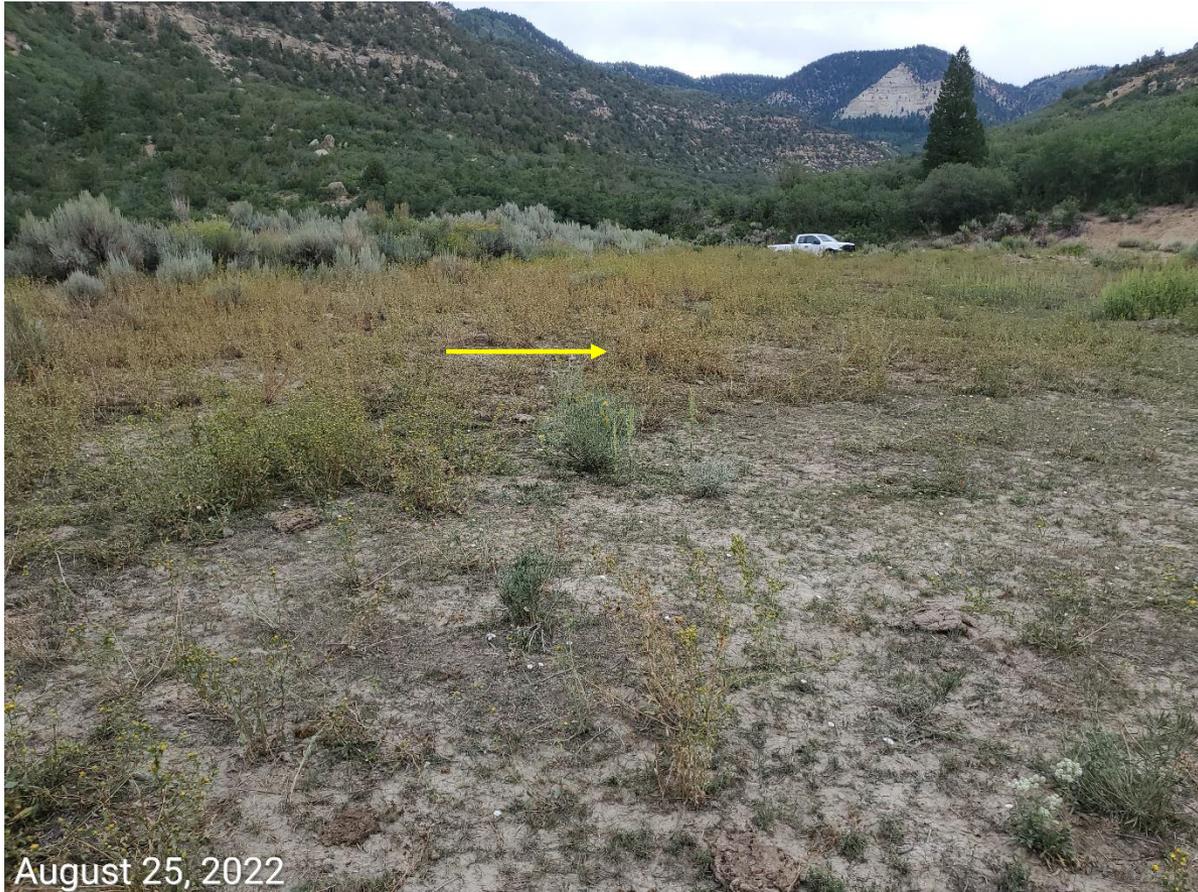
Photo 11: Photo example showing vegetation on Location; vegetation predominantly undesirable weedy plant species, including noxious weeds such as bindweed. Other Undesirable species observed include Amaranth, and Curlycup gumweed (brownish-yellow plant dominating background on the pad, arrow).

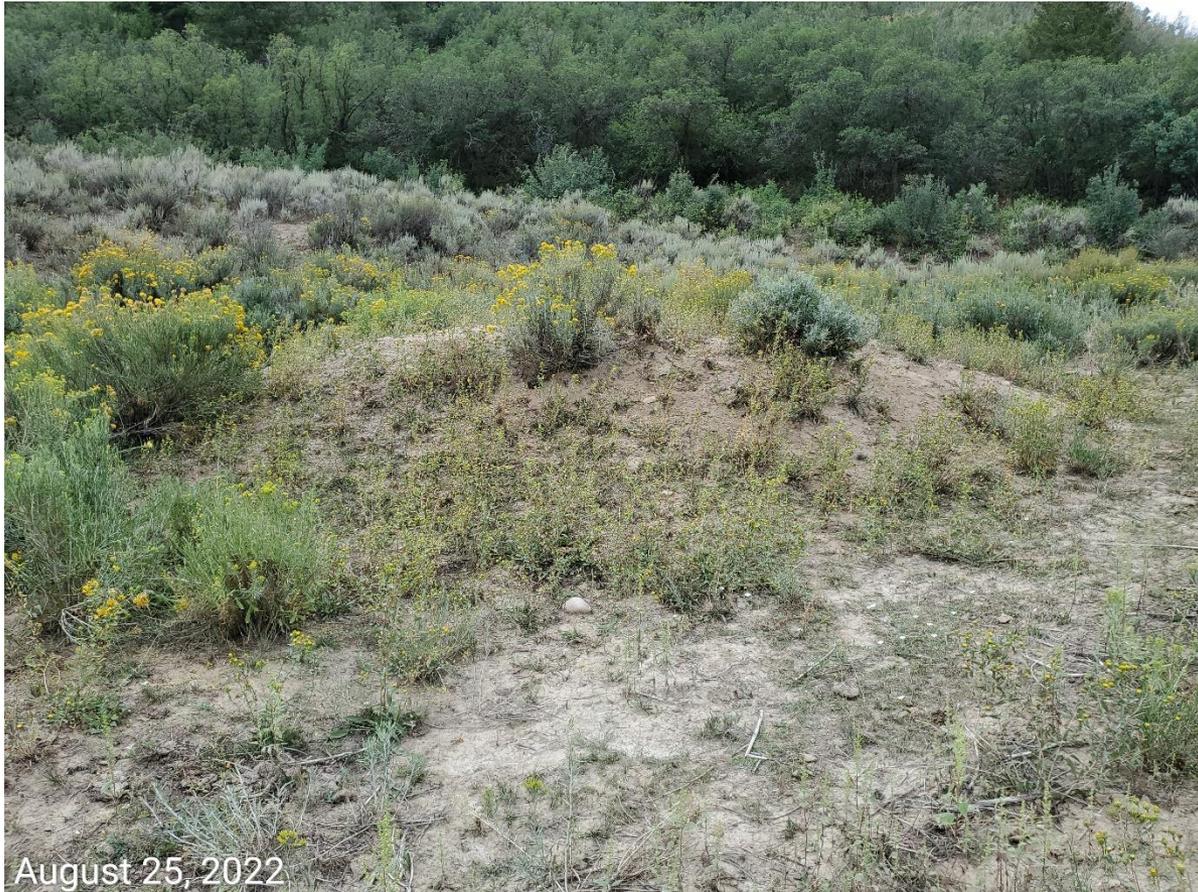
Photo 12: Photo shows soil stockpile observed remaining on the southeast end of the Location.

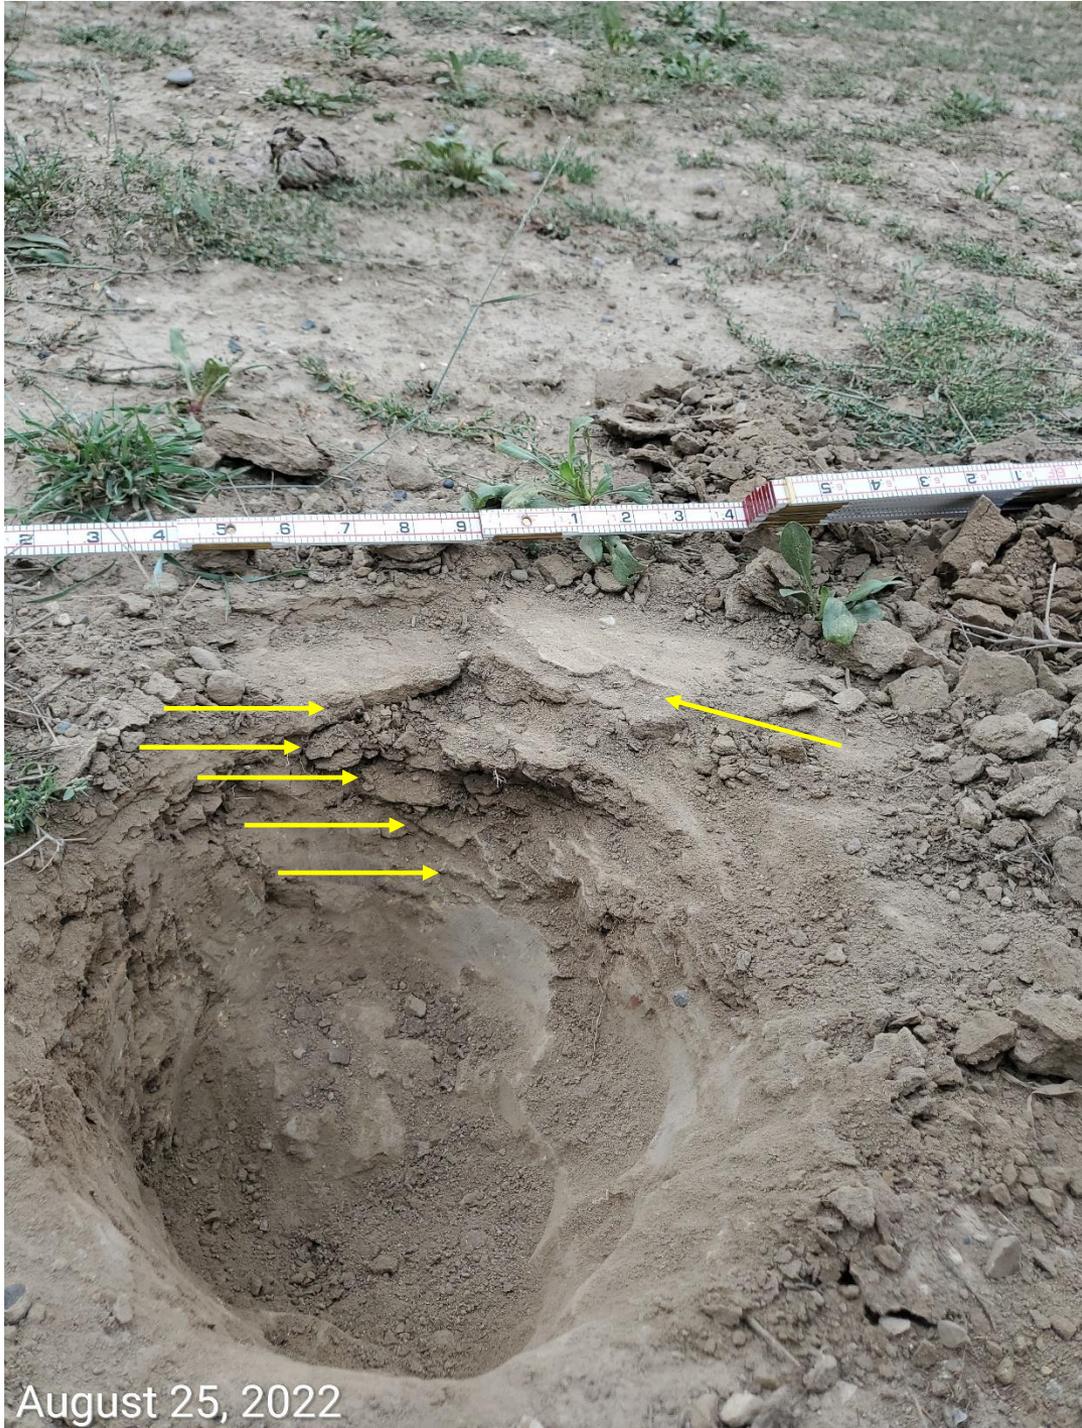
Photo 13: Photo shows compaction test pit taken from the Location. Photo shows zones of compaction evident below subsurface, including “platy” soil structures (arrow)- these structures are thin, flat plates of soil that lie horizontally and are usually found in compacted soils.

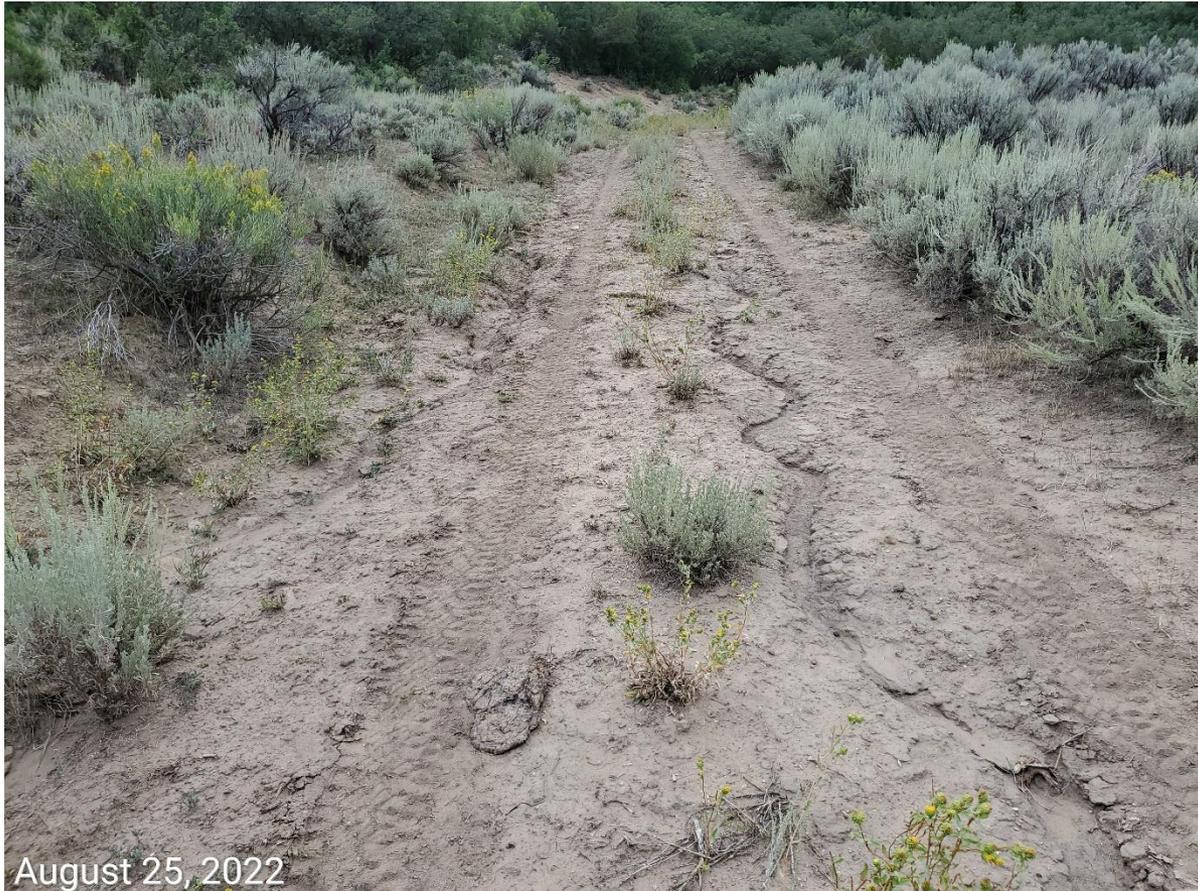
Photo 14: Photo taken from the access road. Photo shows access road has not been reclaimed. Photo also show erosion degradation occurring at road.
