Inspection Photos  
Location Name: Dowler 1B  
Location ID: 307008

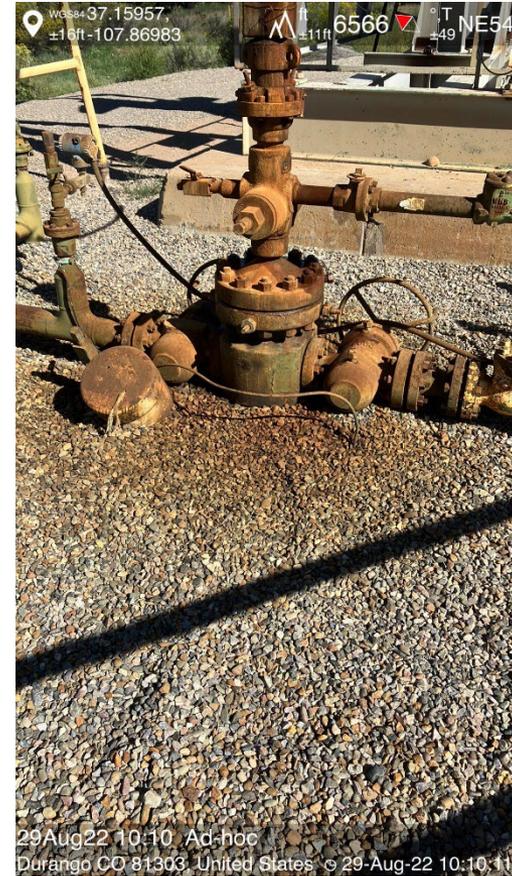
IMG 02  
Impacted material

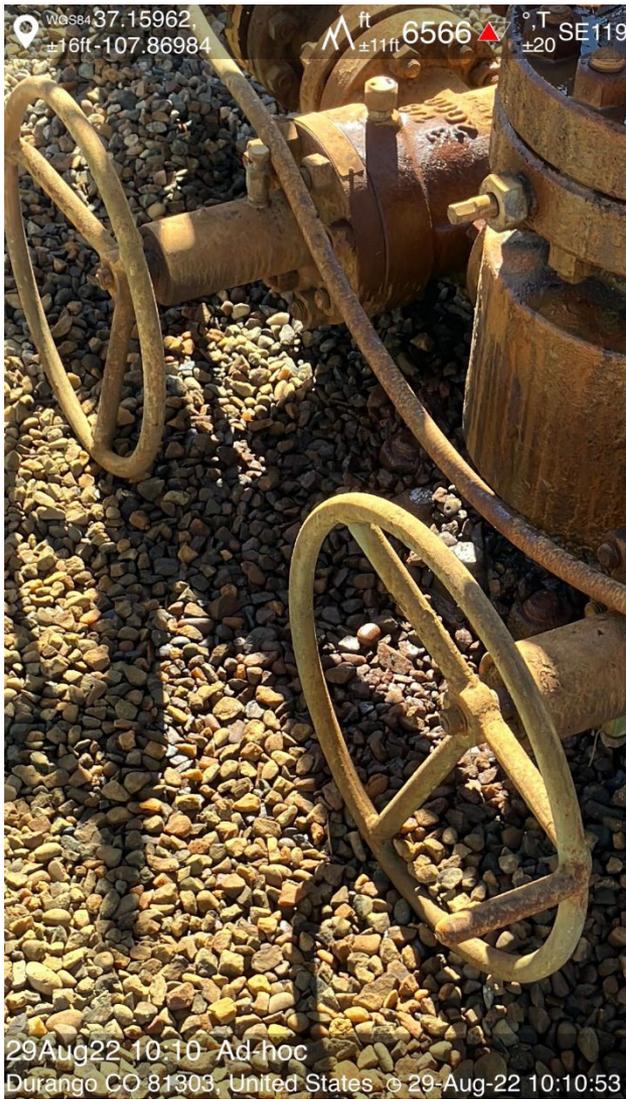
**IMG 03**  
**Impacted material**

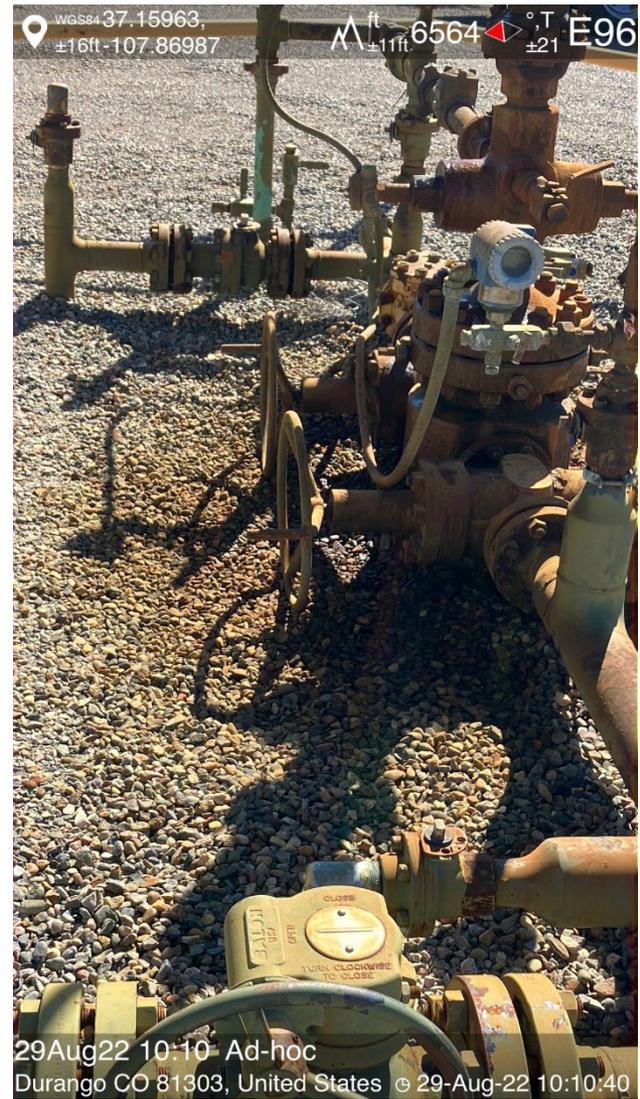
**IMG 04**  
**Impacted material**

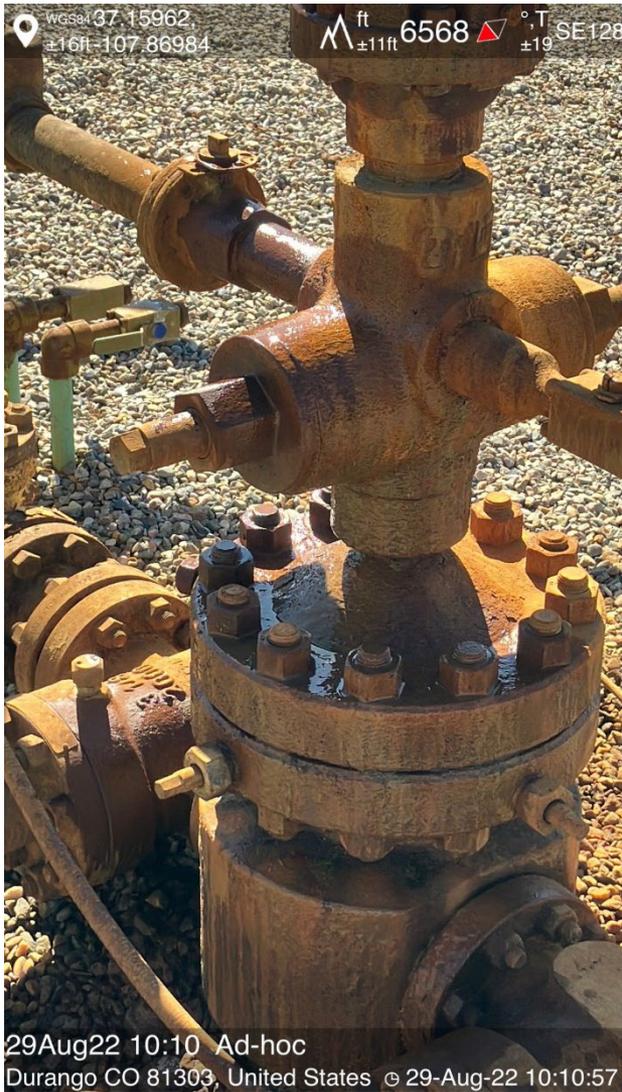
**IMG 05**

**Lube oil/produced water**
