GMT Exploration Company LLC, Irwin 6-65 23-11 10 HN  
039-06722  
Inspection #688313004  
8/25/2022  
Flowback Inspection

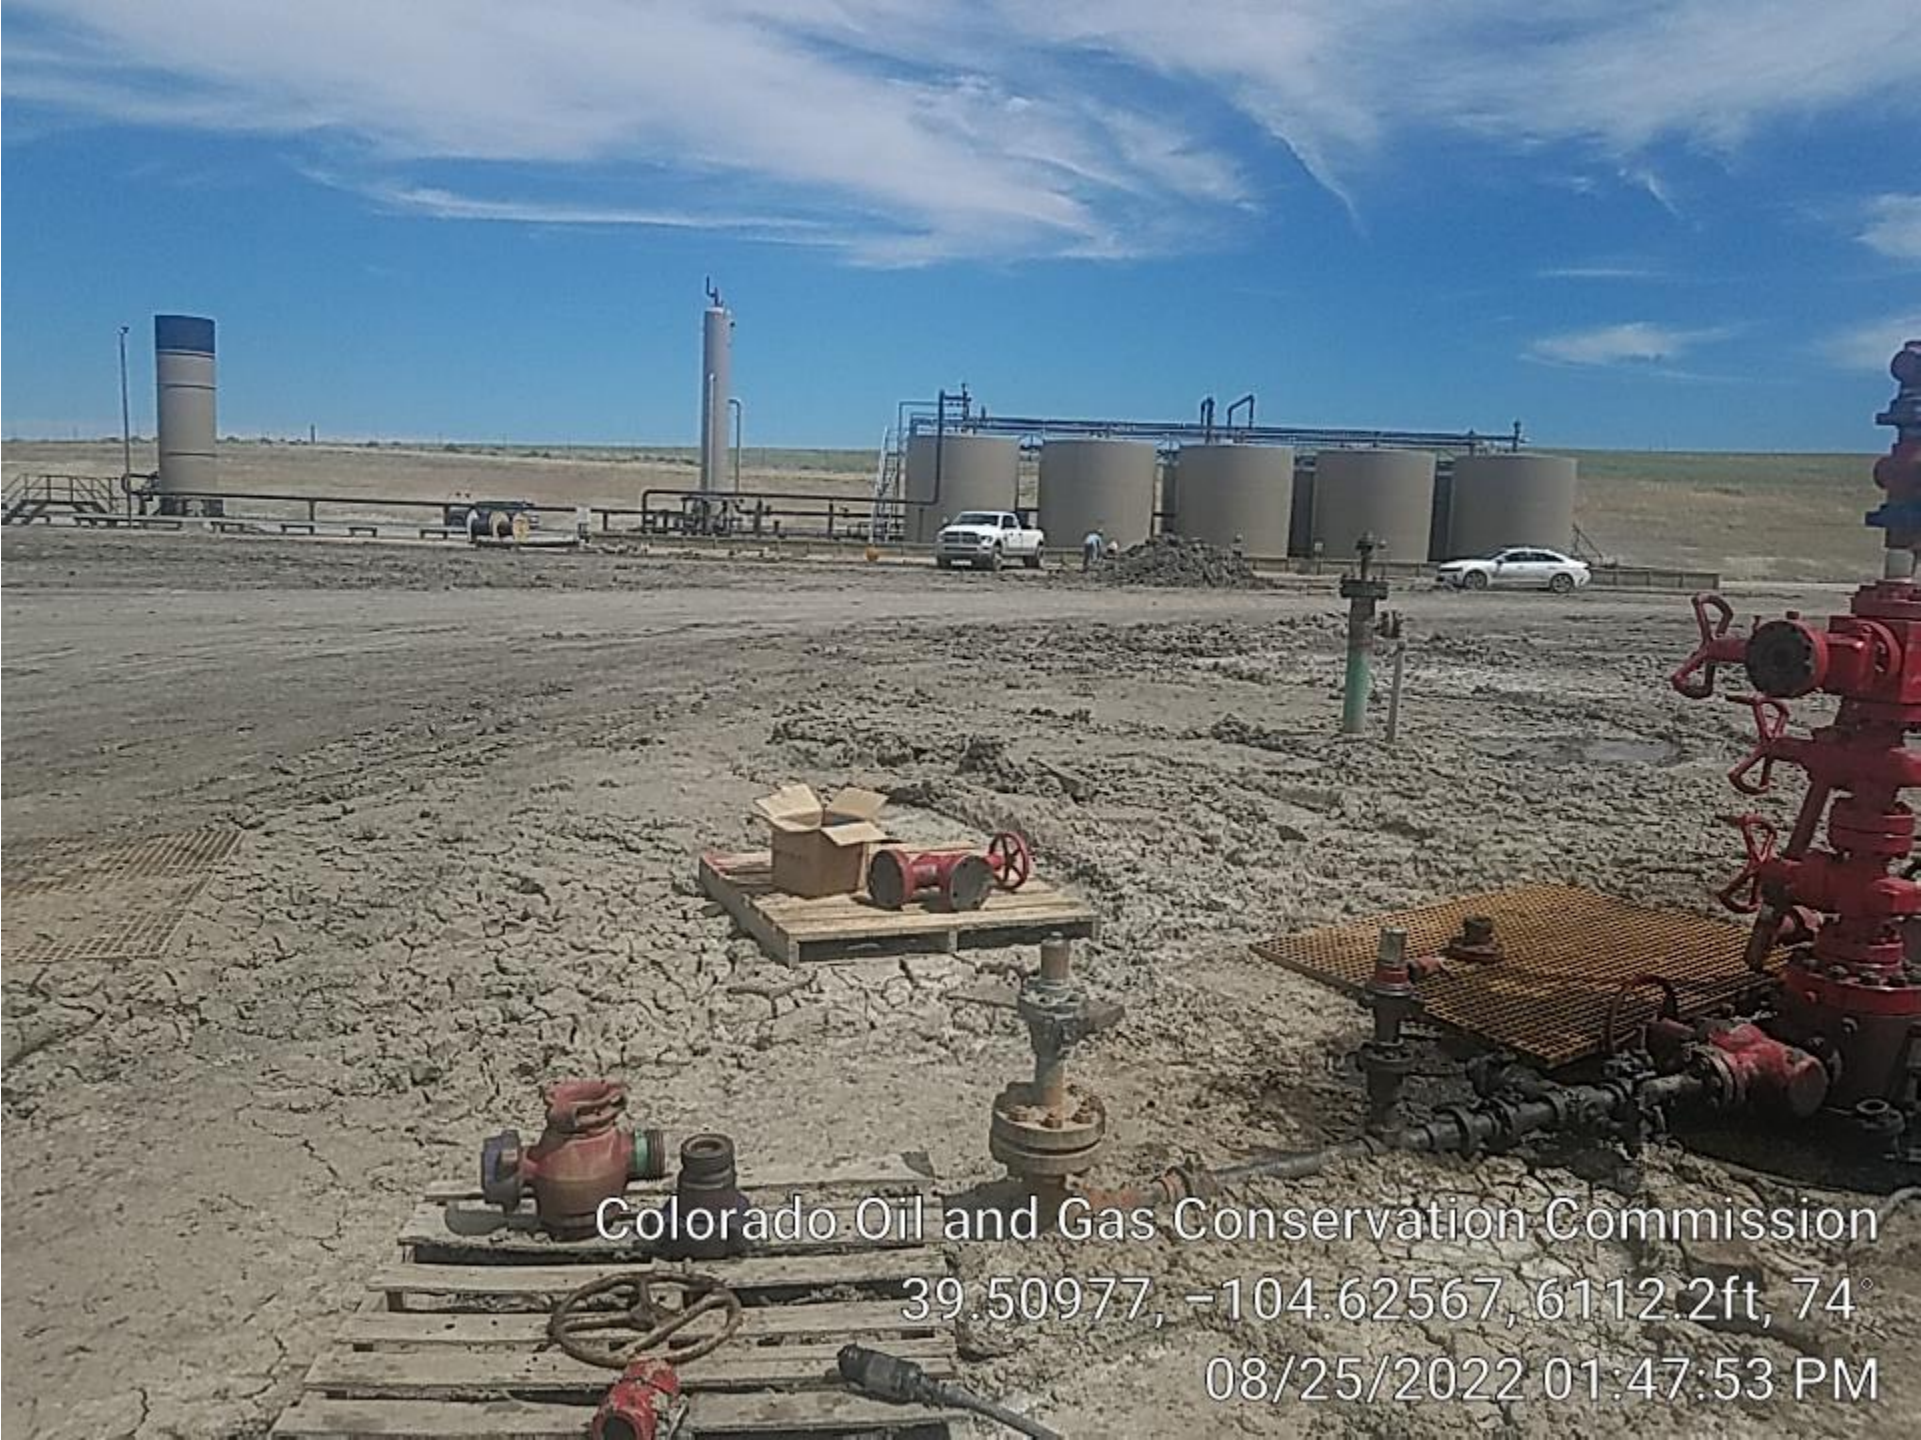
Production facility under construction on the pad.

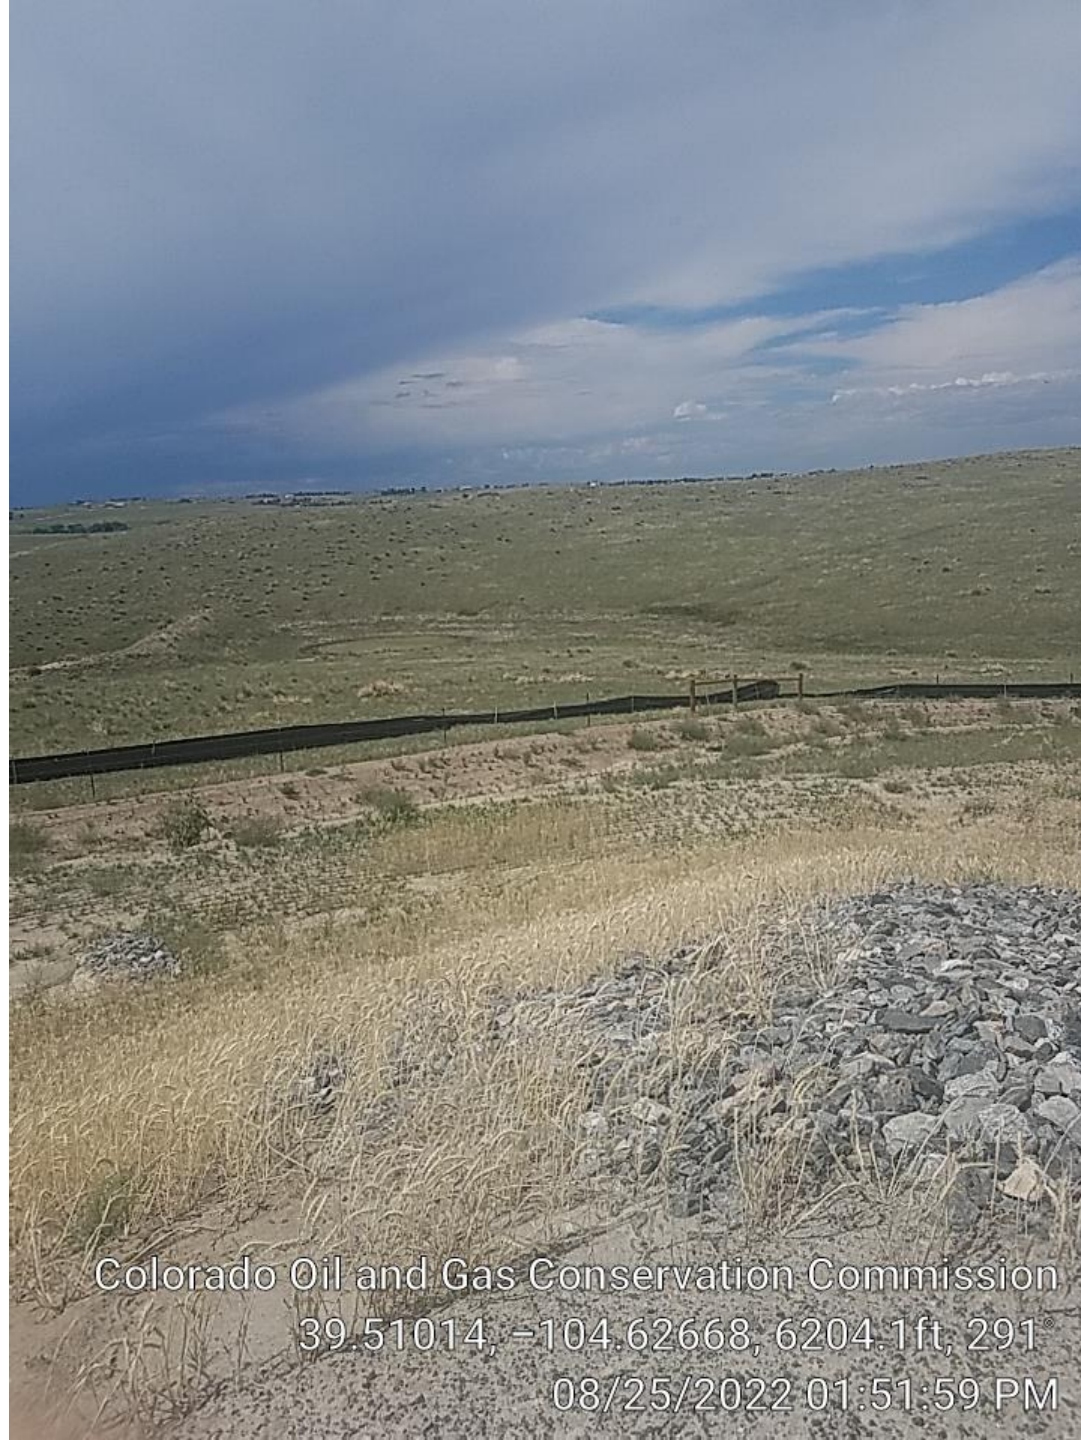
Silt/frog fence is  
down.
