Construction and Stormwater Inspection

Operator: NOBLE ENERGY INC- #100322

Location ID: 459556

Inspection Photos
Location Name: C29-04 /Pad
Location ID: 459556

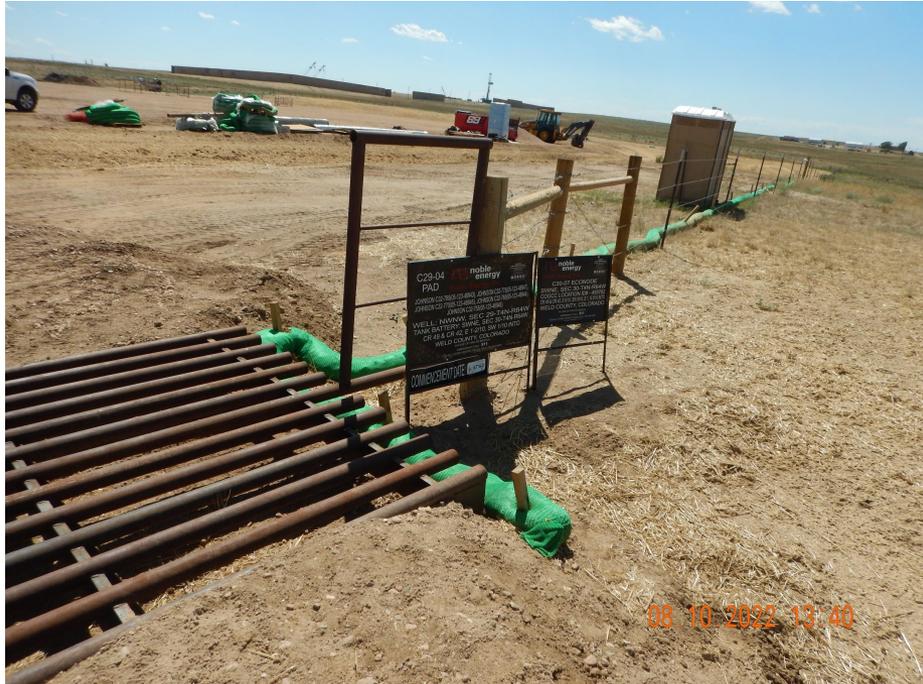
Photo 1. Photo taken from the entrance of location, facing Southwest. Photo illustrates a cattle guard which would also serve as a VTC device BMP. Also, filtrex has been installed around the entire perimeter of location.

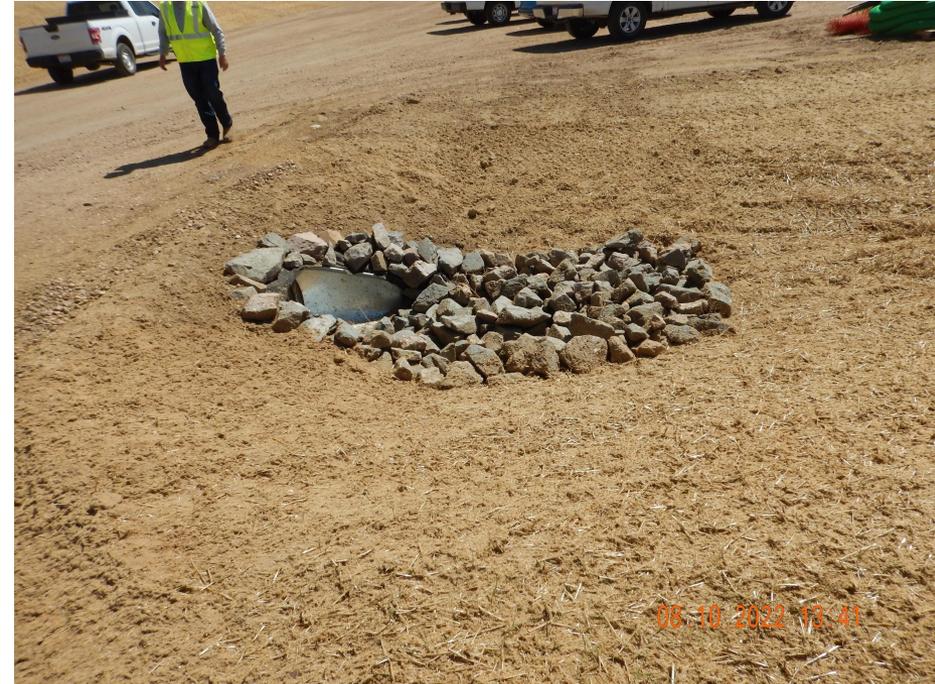
Photo 2. Photo taken from the entrance of location, facing South. Photo illustrates the stabilized outlet of the culvert which is directed to a sediment basin.

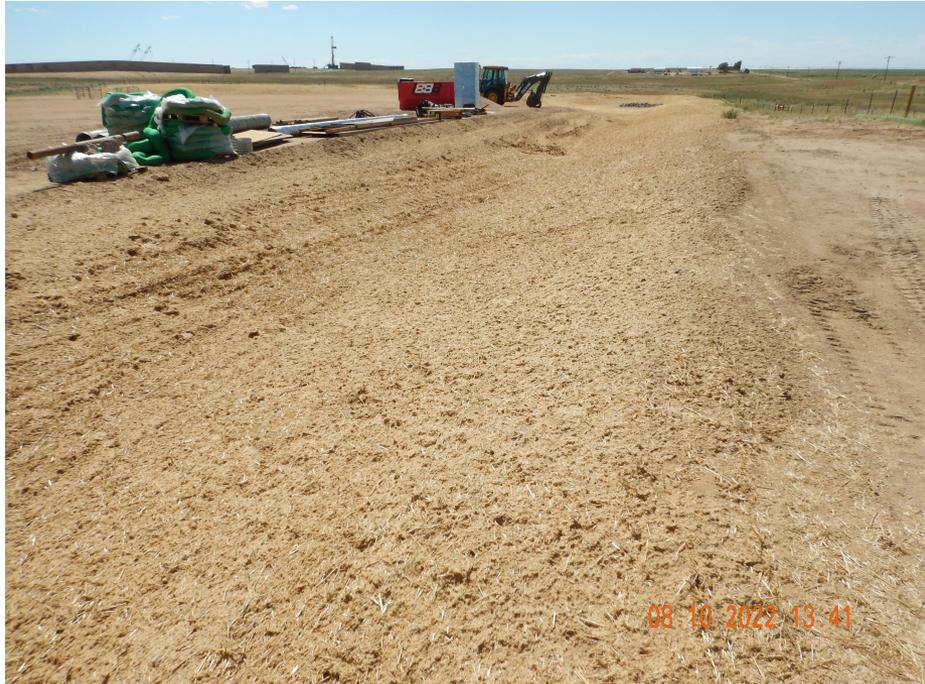
Photo 3. Photo taken from the northeastern location, facing West. Photo illustrates the eastern sediment basin area which has been seeded, straw crimped with mulch and tackifier applied.

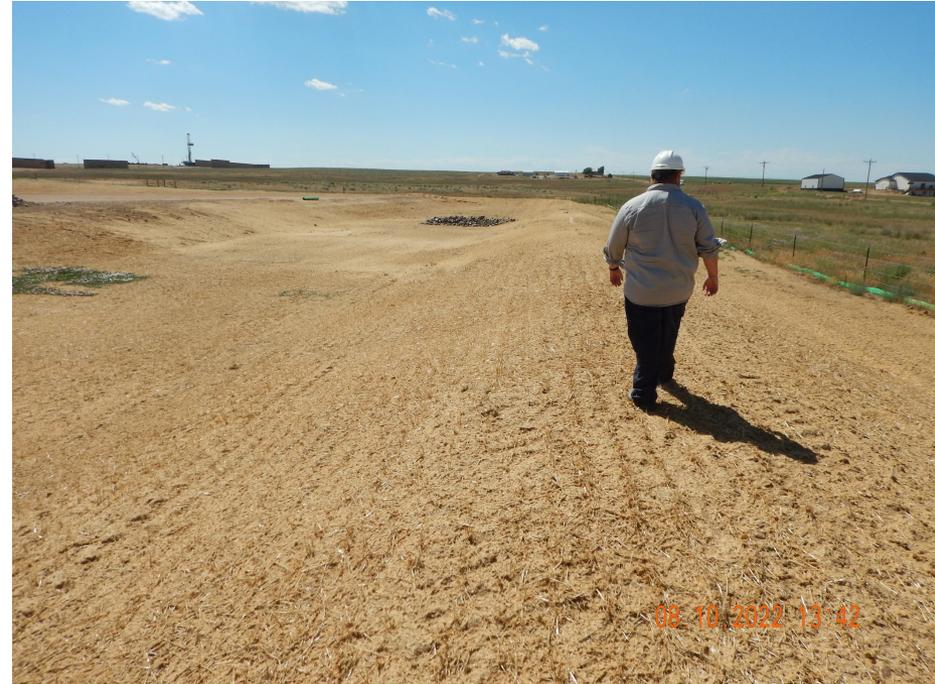
Photo 4. Photo taken from the northern location, facing West. See comments under Photo 3.

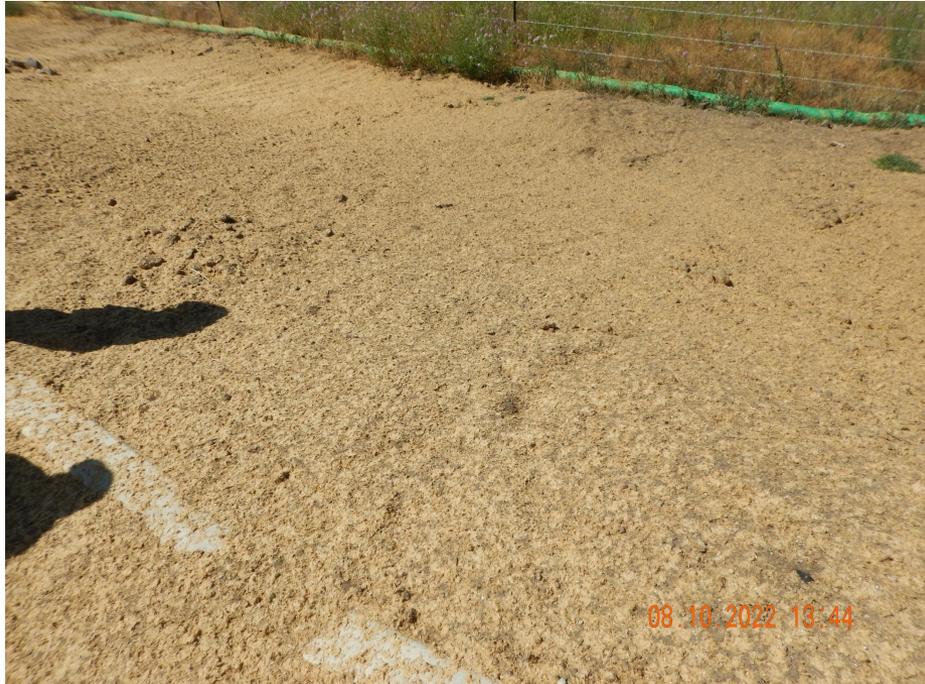
Photo 5. Photo taken from the weir of the outlet structure, facing Northwest. Photo illustrates the riprap material has been buried.

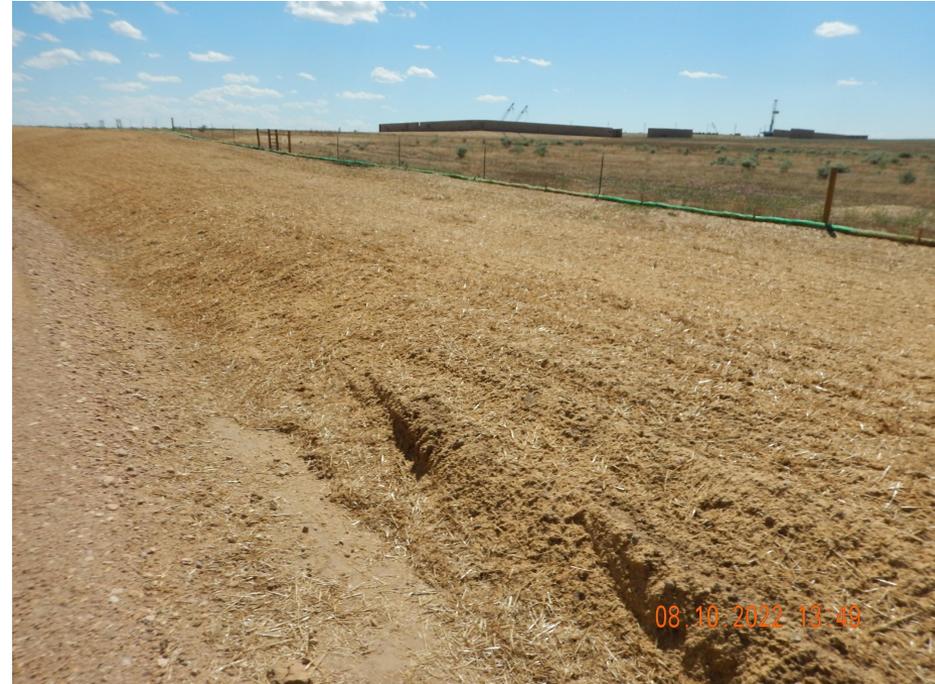
Photo 6. Photo taken from the western location, facing Southwest. See comments under Photo 3.

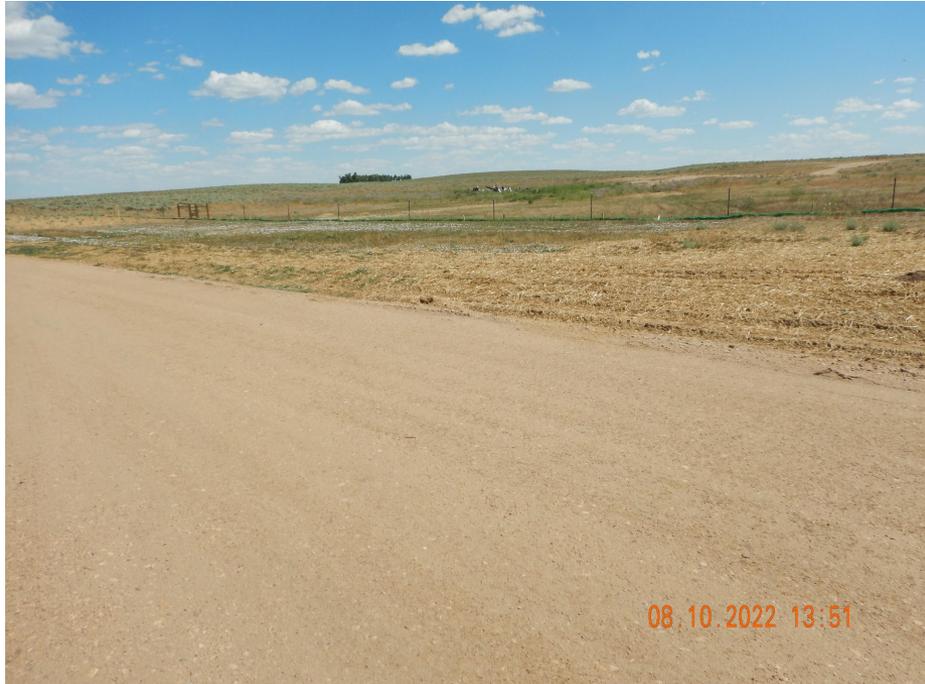
Photo 7. Photo taken from the southwestern location, facing Southeast. See comments under Photo 3.

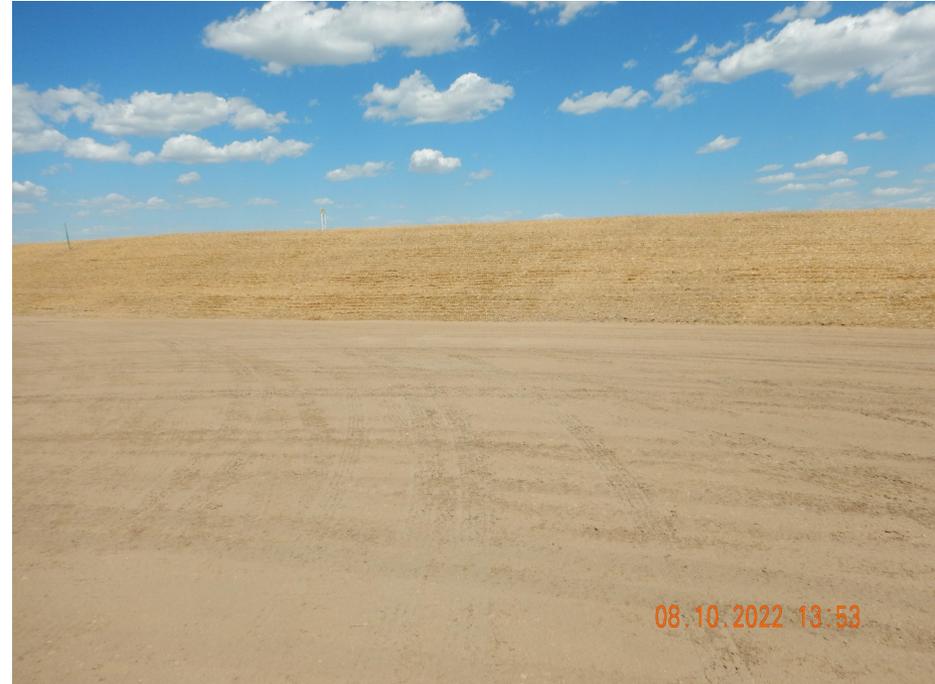
Photo 8. Photo taken from the eastern location, facing East. Photo illustrates the topsoil stockpile which has been stabilized with seeding, straw crimped with mulch and tackifier applied.
