# Inspection Photos and Issue Report

8/30/2022

Operator: CAERUS PICEANCE LLC

Location #416157

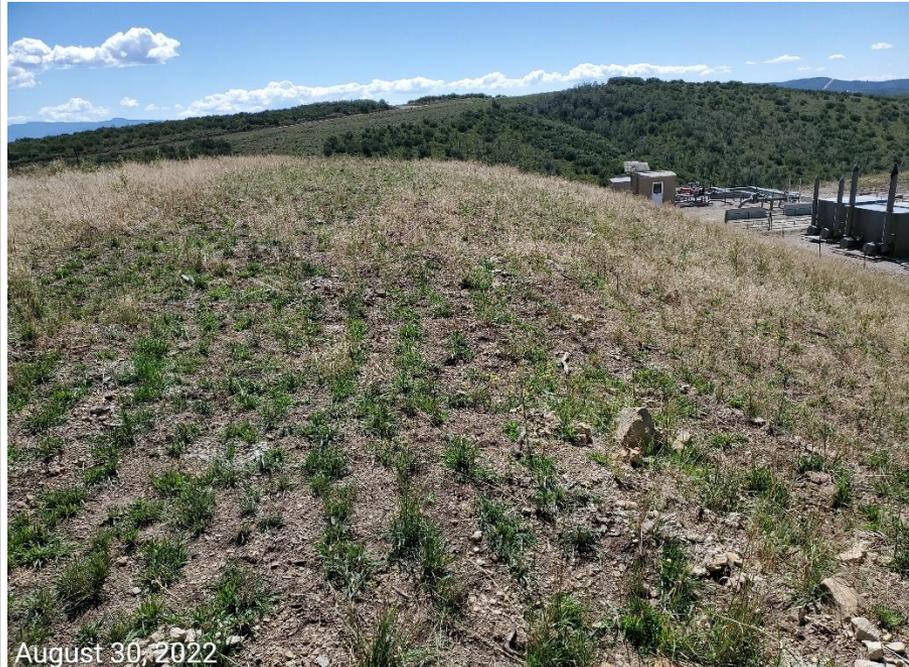
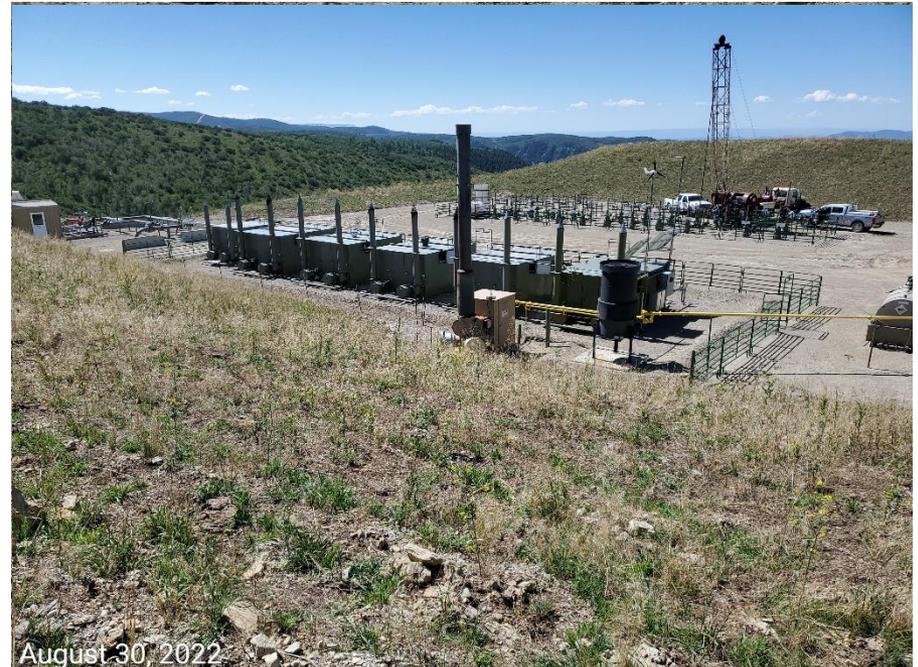
**Photo 1:** Photos taken from the interim areas on the northeast end of the Location. Photos 1-2 provide an overview of the Location from southeast, south, west to northwest.

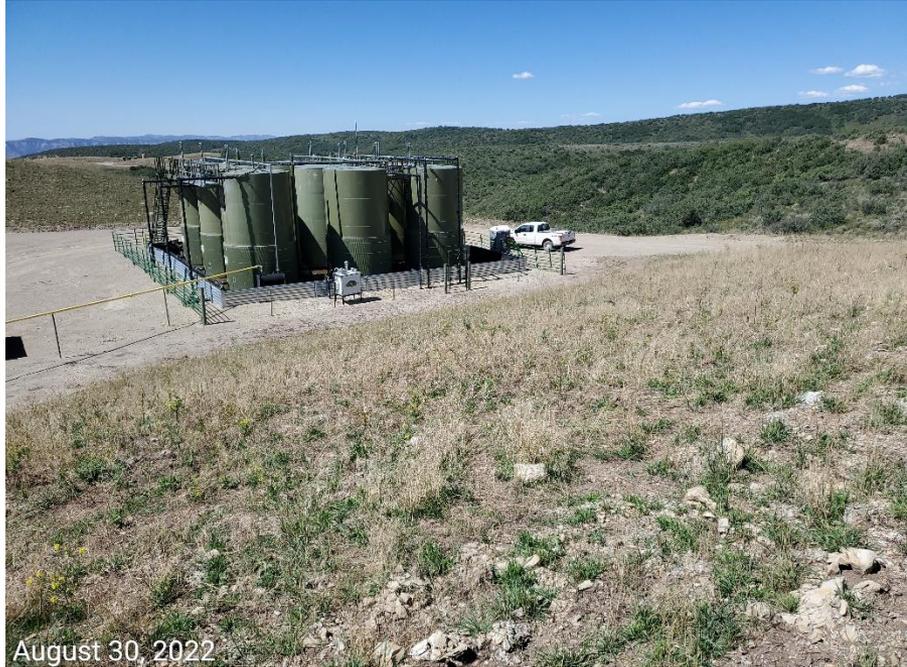
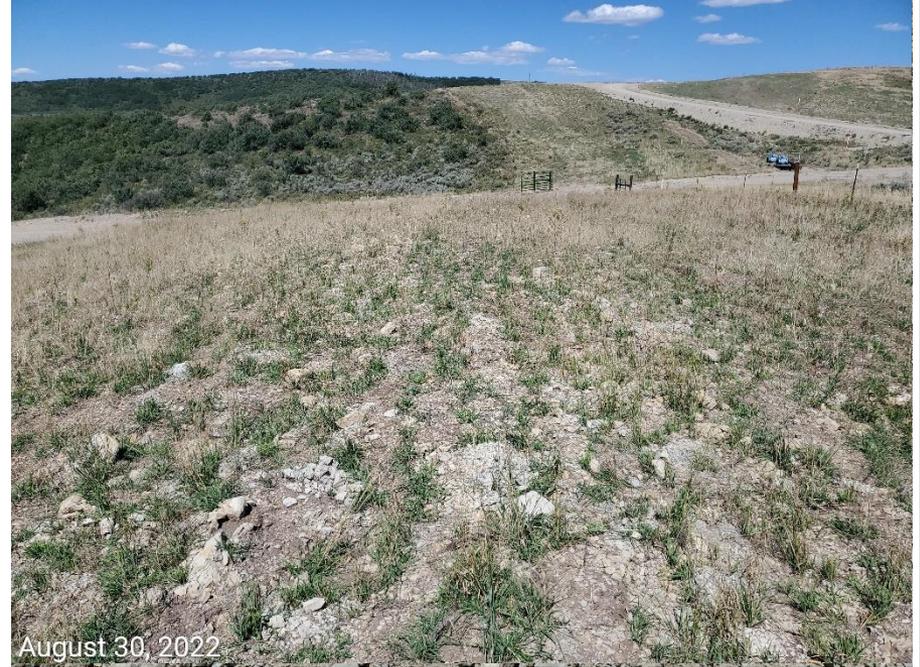
**Photo 2:** See comments under photo 1.

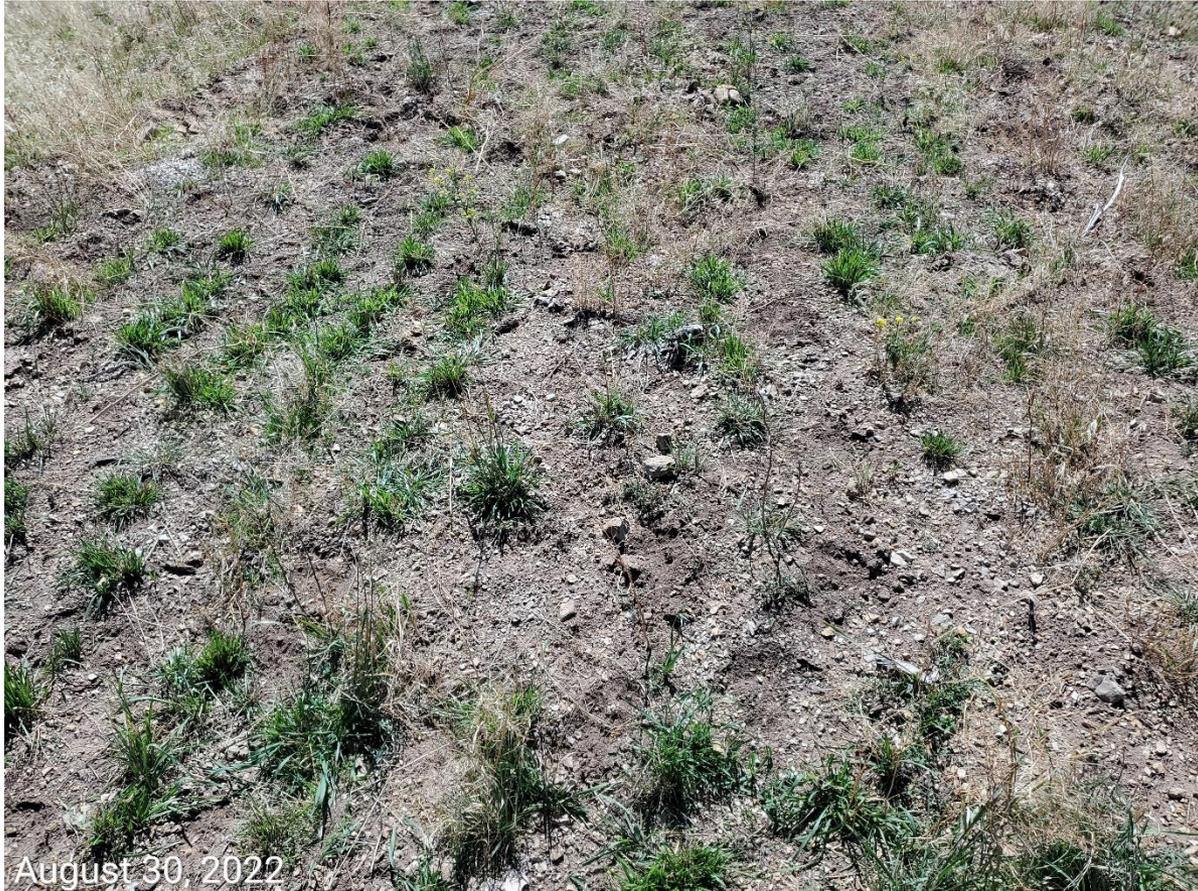
**Photo 3:** Photo example showing vegetation on the interim areas; areas appear to be progressing towards COGCC uniform revegetative standards.

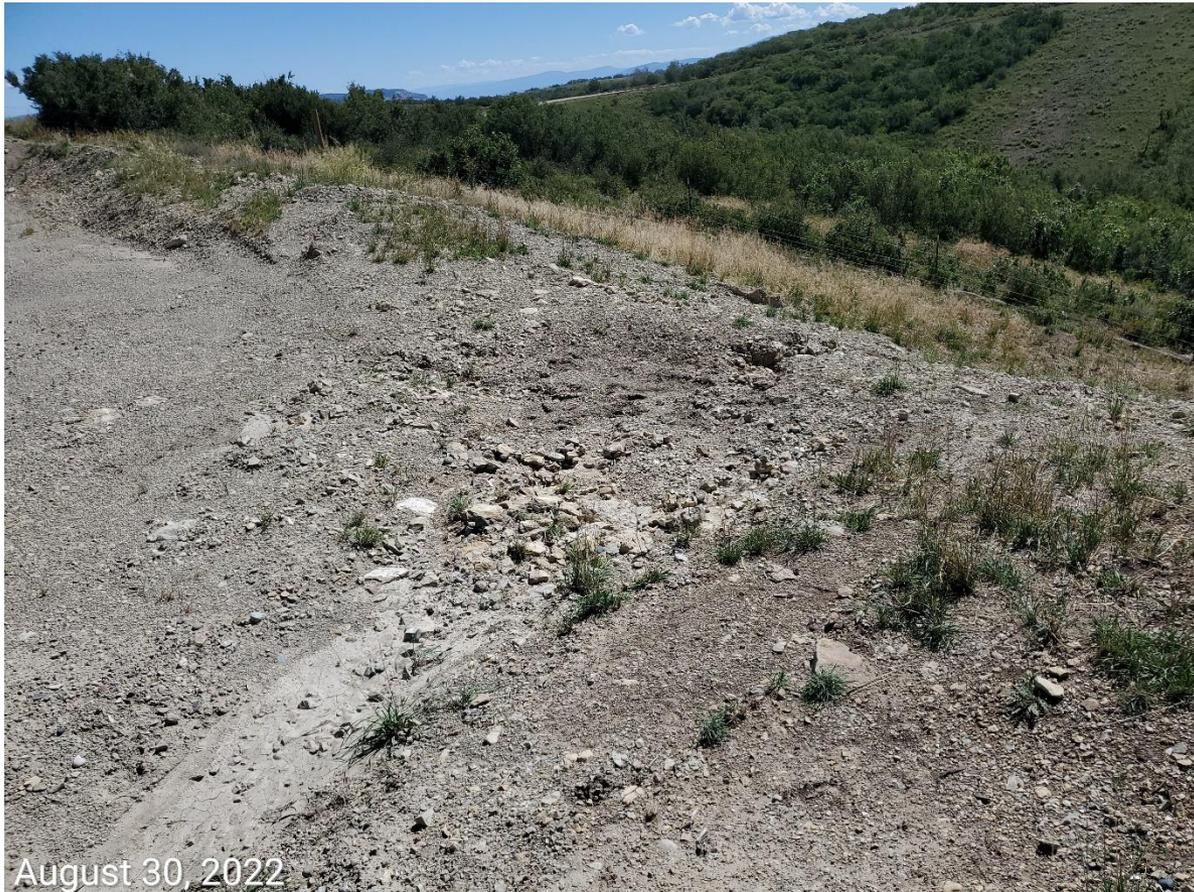
**Photo 4:** Photo taken from the east end of the Location. Photo shows point where stormwater discharges from the pad.

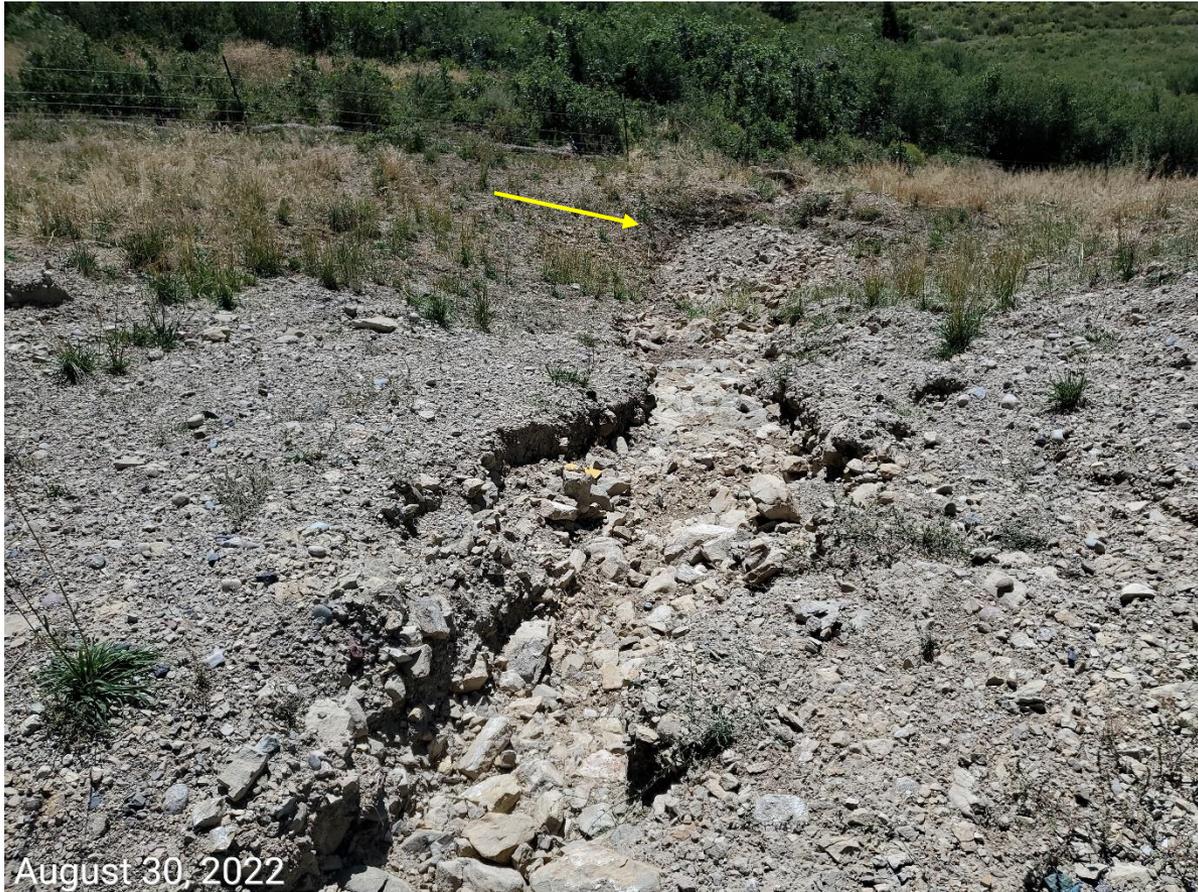
**Photo 5:** Continue from photo 4. Photo shows sediment trap (arrow). Photo shows outlet from the pad (inlet to the trap) has not been installed or maintained per good engineering practices, resulting in erosion (gully) degradation. Slopes require stabilization and additional reclamation.

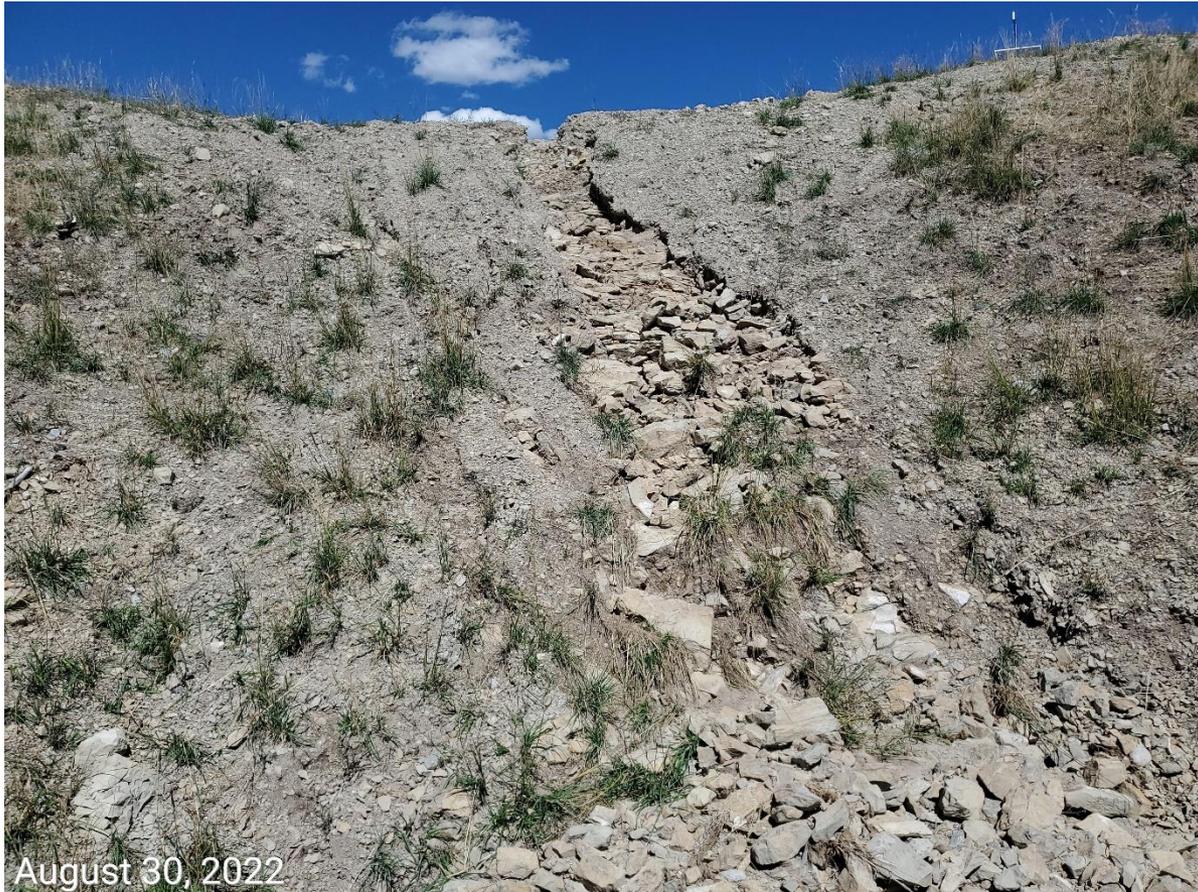
**Photo 6:** Photo shows erosion degradation above the eastern sediment trap, due to stormwater runoff from the pad; outlet from the pad (inlet to the trap) has not been installed or maintained per good engineering practices, resulting in erosion (gully) degradation. Slopes require stabilization and additional reclamation.

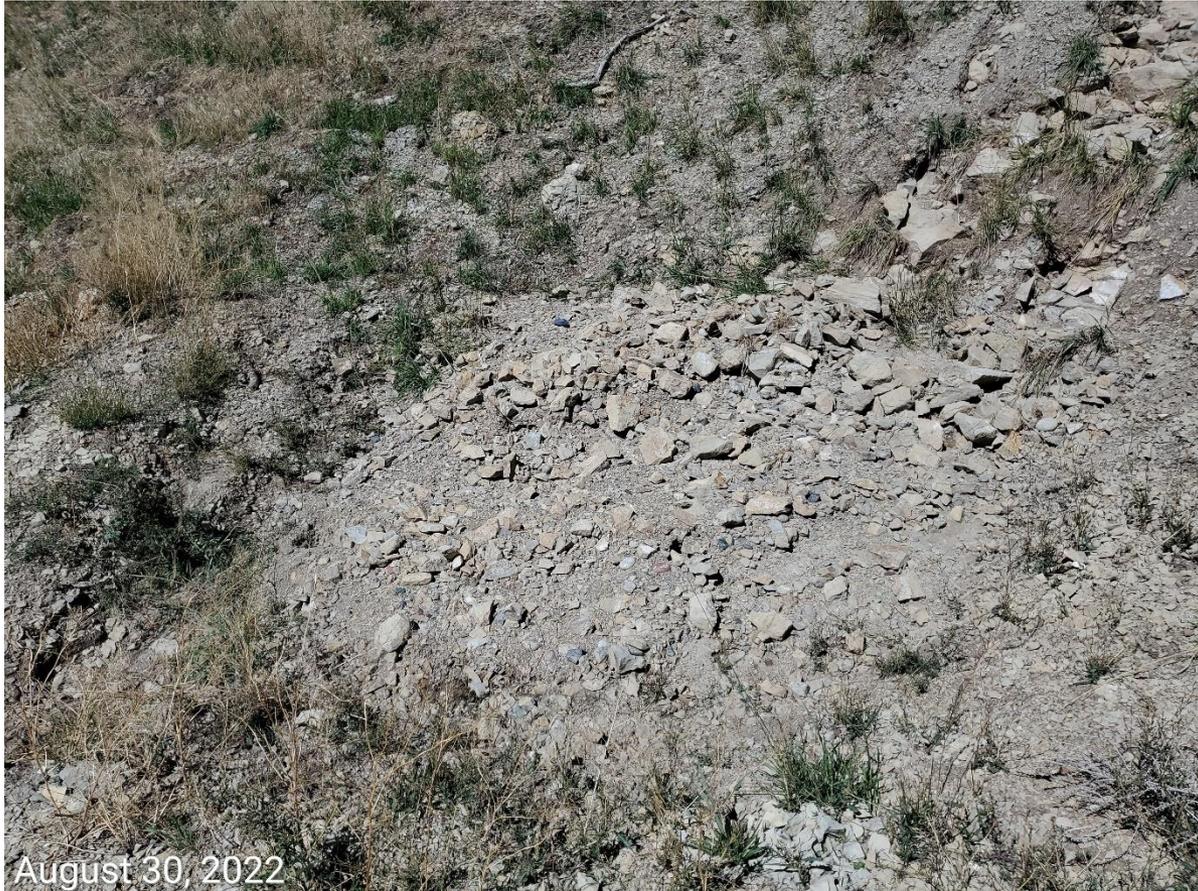
**Photo 7:** Photo shows sediment trap below the pad on the east end of the Location. BMPs has not been installed or maintained per good engineering practices; sediment trap does not appear to be adequate is size, and has not been constructed with a properly engineered inlet and outlet; trap has filled with sediment; runoff from the pad has resulted in erosion degradation to the slopes above and below the trap.

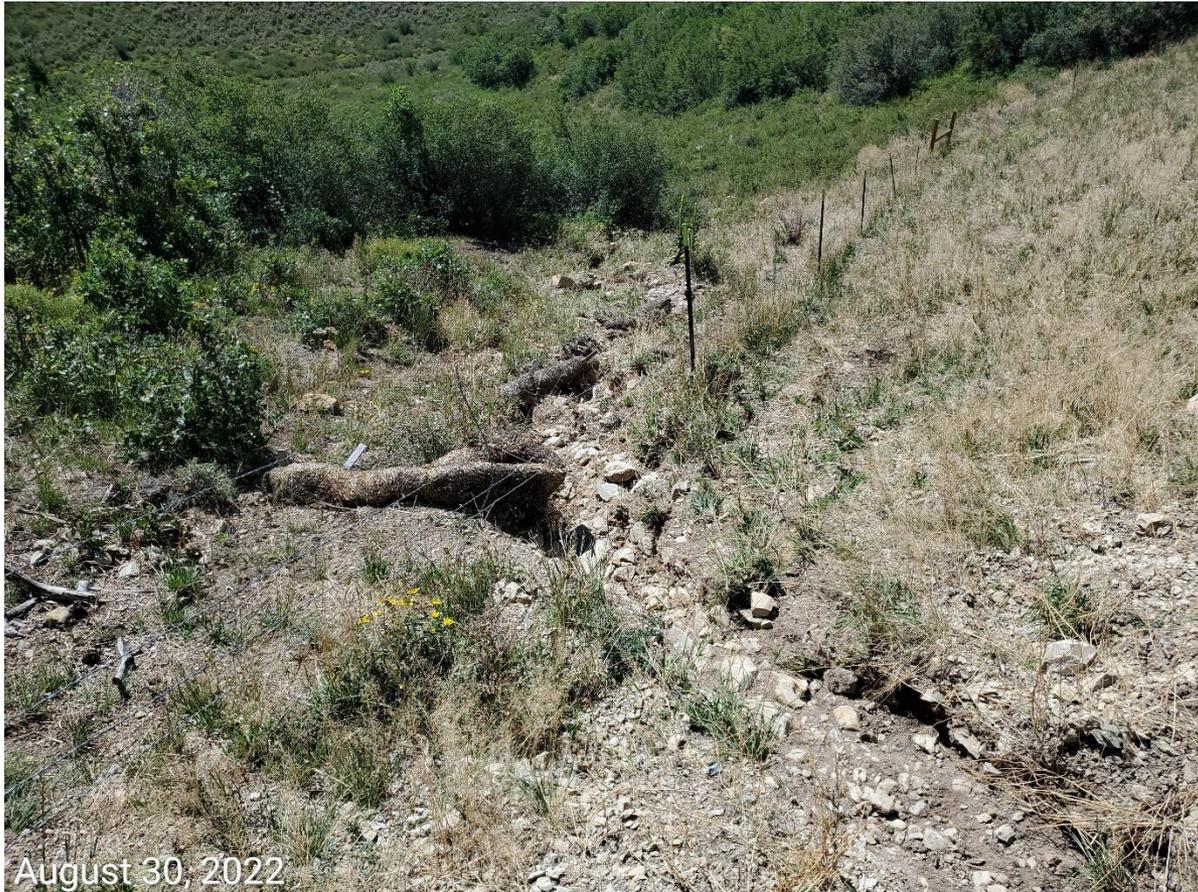
**Photo 8:** Photo shows off-site areas below the sediment trap on the east end of the Location; BMPs to manage runoff in such a manner as to minimize erosion, degradation and offsite sediment transport are inadequate. Photo also shows erosion logs along the perimeter have not been maintained, and are considered “debris”. Fence in photo is the edge of the Location’s disturbance area. Disturbed areas require stabilization and reclamation.

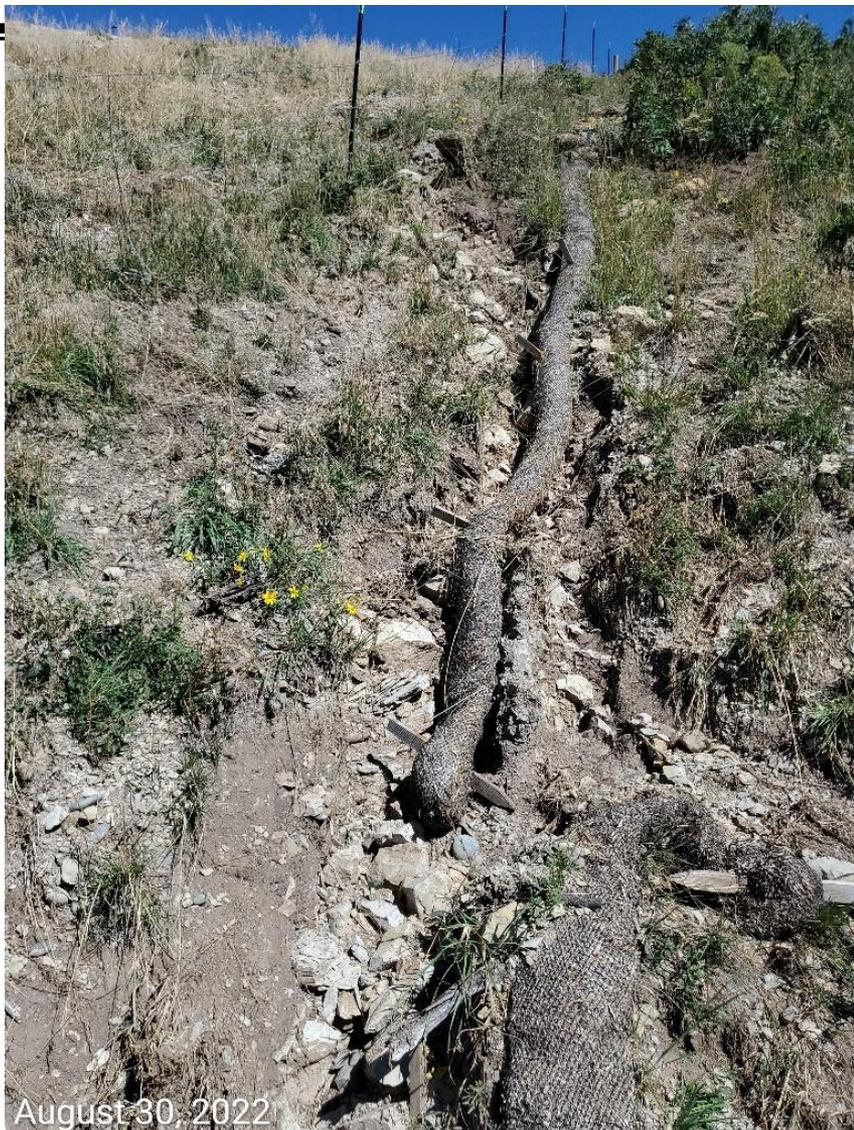
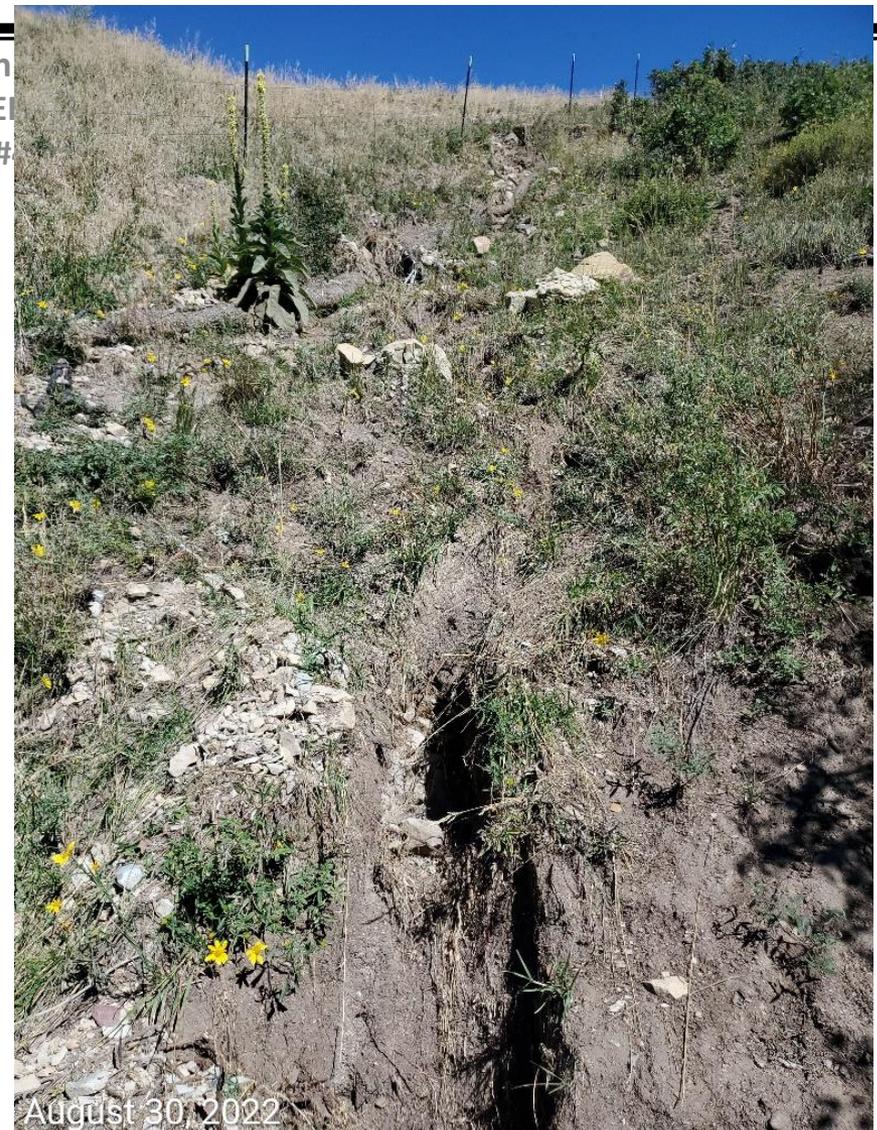
**Photo 9:** Continued from photo 8. Photo shows off-site areas below the eastern sediment trap, and the Location; BMPs to manage runoff in such a manner as to minimize erosion, degradation and offsite sediment transport are inadequate. Disturbed areas require stabilization and reclamation.

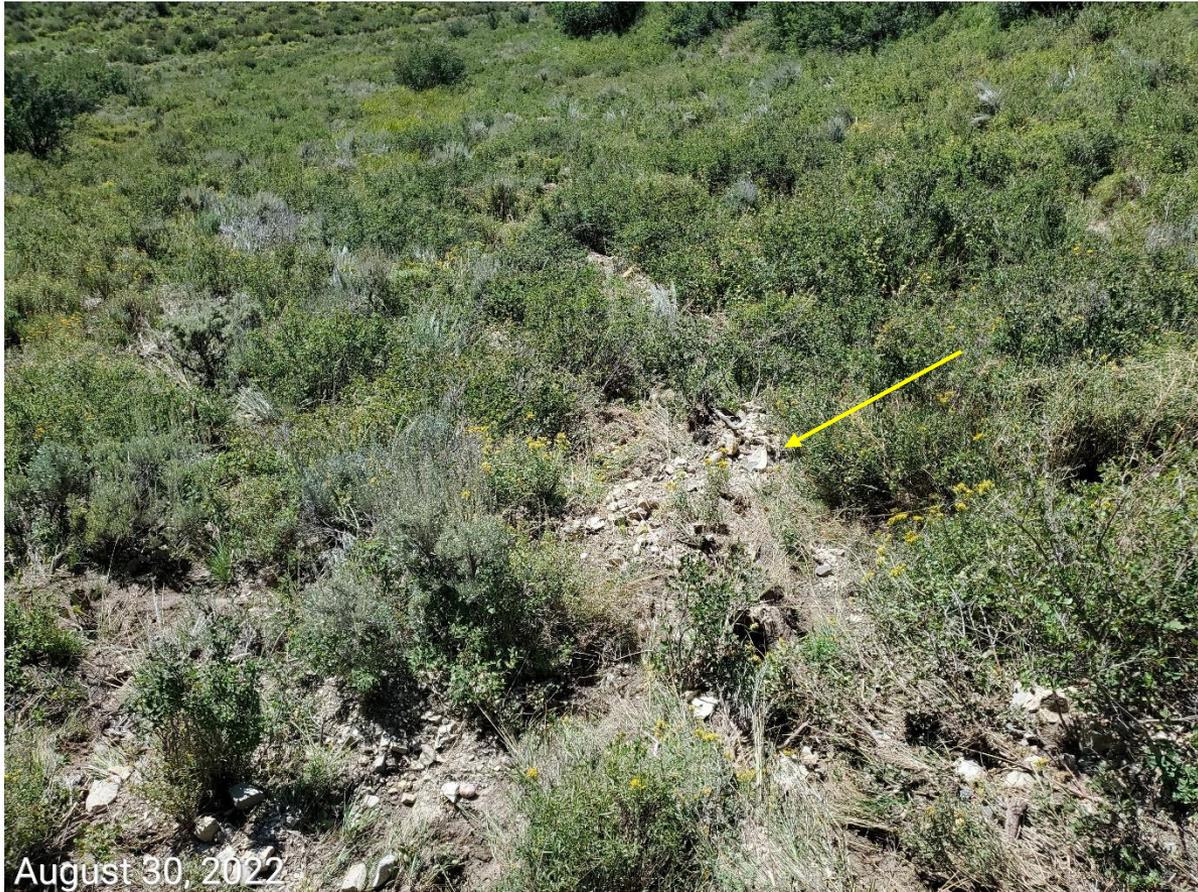
**Photo 10:** Photo taken from drainage area east of the Location. Photo shows off-site sediment deposition due to runoff from the Location (arrow). Disturbed areas require stabilization and reclamation.

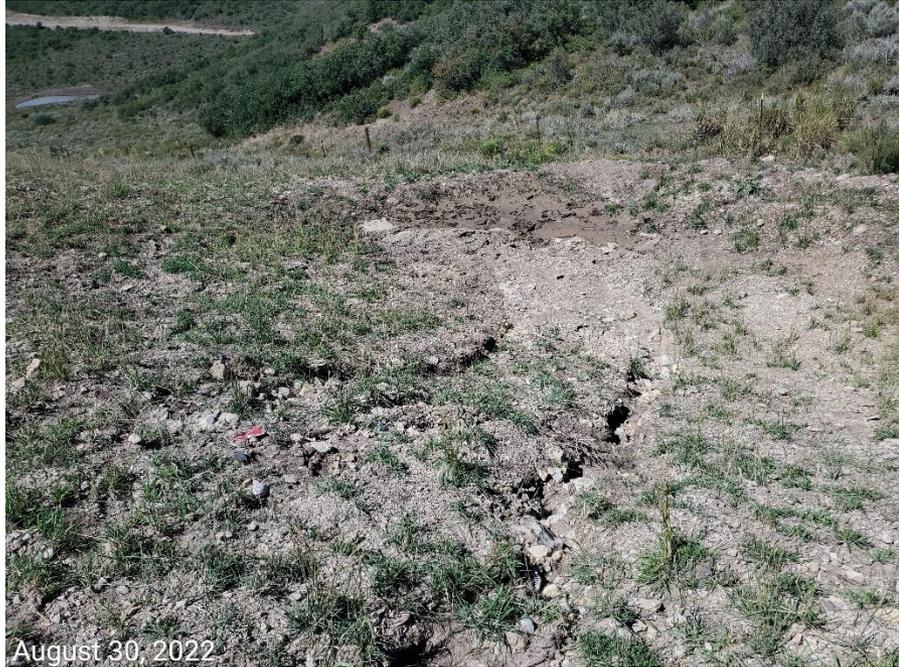
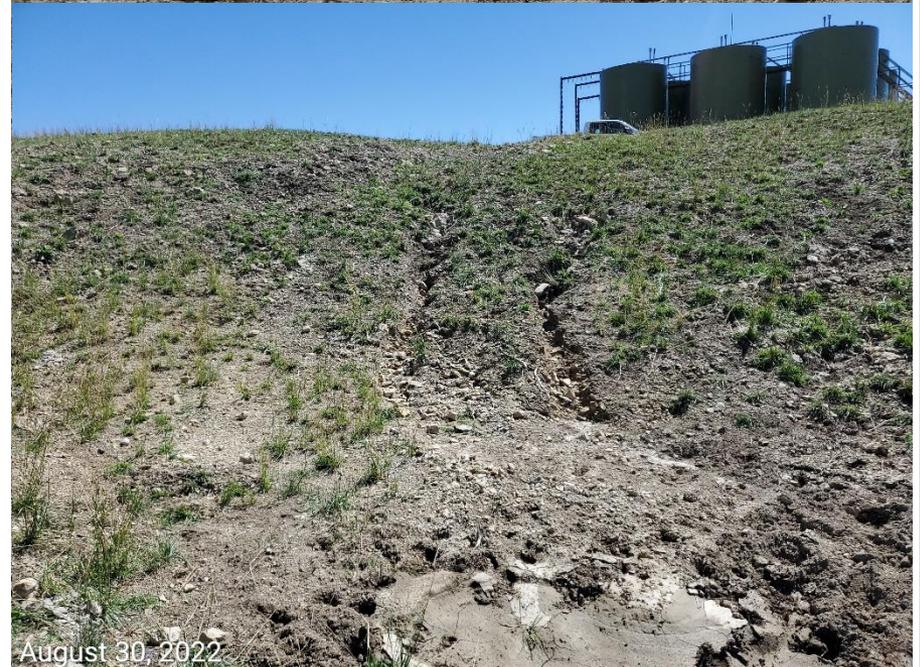
**Photo 11:** Photo taken from the sediment trap on the north end of the Location, adjacent to the Location entrance; BMP has not been installed or maintained per good engineering practices, resulting in degradation at the inlet and outlet of the control.

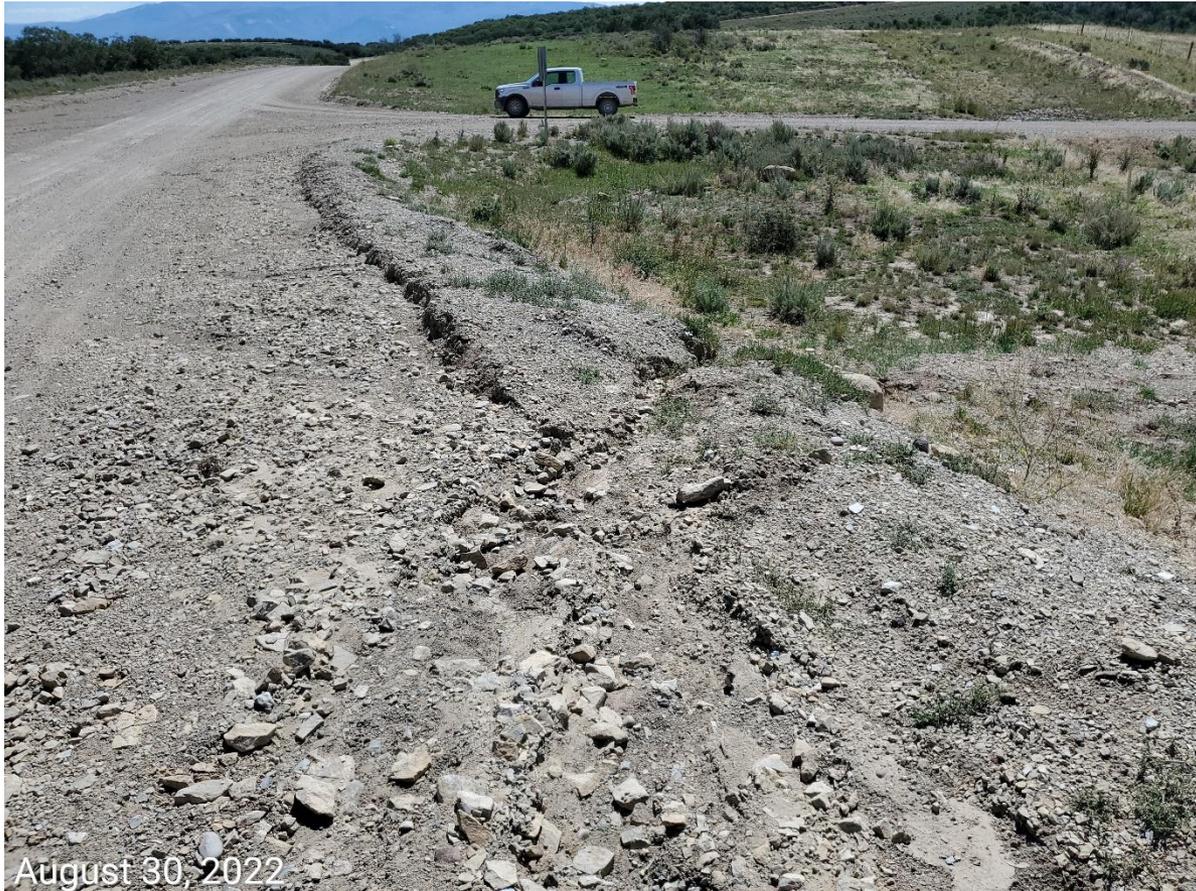
**Photo 12:** Photo taken from the main access road north of the Location (~ 39.500266/-108.182963). Photo shows stormwater runoff has resulted erosion degradation at the slope, and sediment transport/deposition.

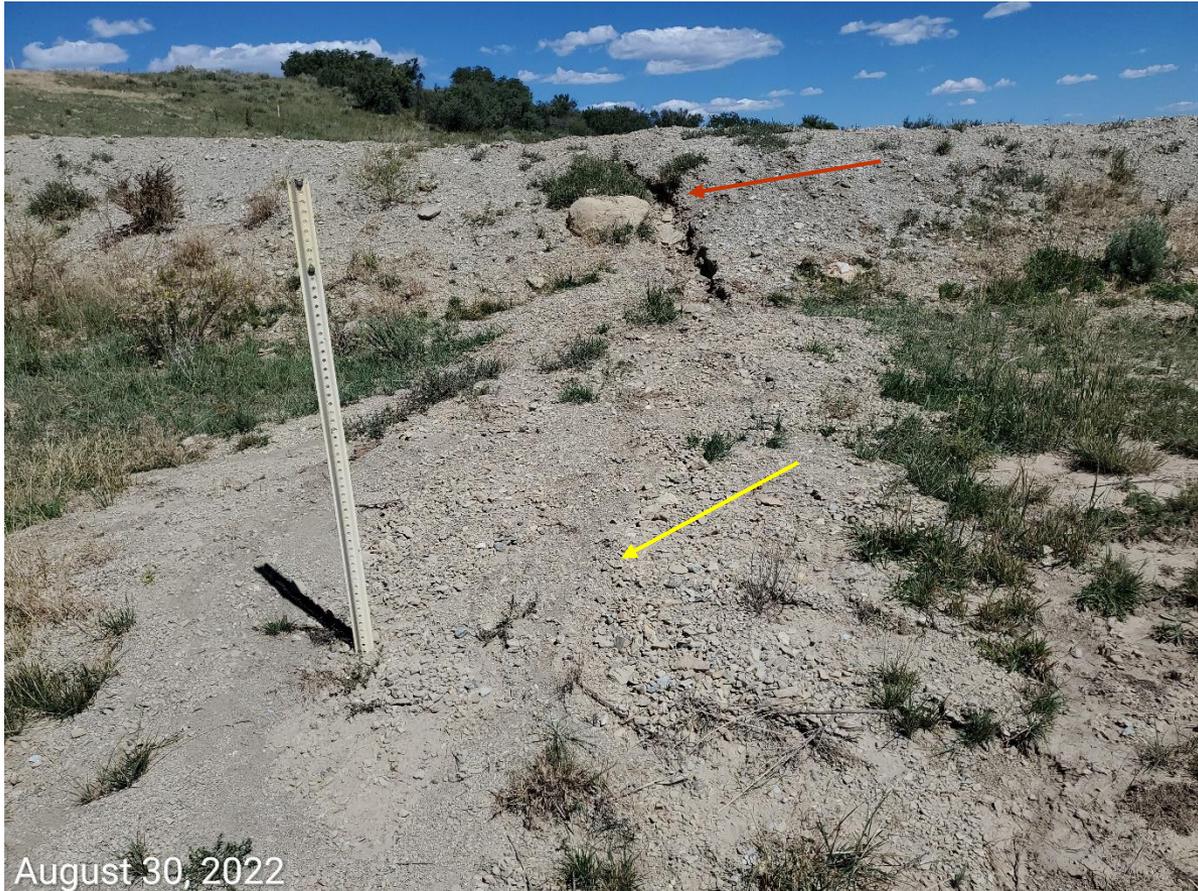
**Photo 13:** Continued from photo 12. Photo shows Stormwater runoff from the main access road north of the Location has resulted in gully erosion (red arrow) and sediment transport/deposition (yellow arrow).
