Inspection Photos

Operator: Antler Energy LLC - #10407

Location Name: Sand Hills Federal-611N91W /15SWSW

Inspection Document #: 702800630

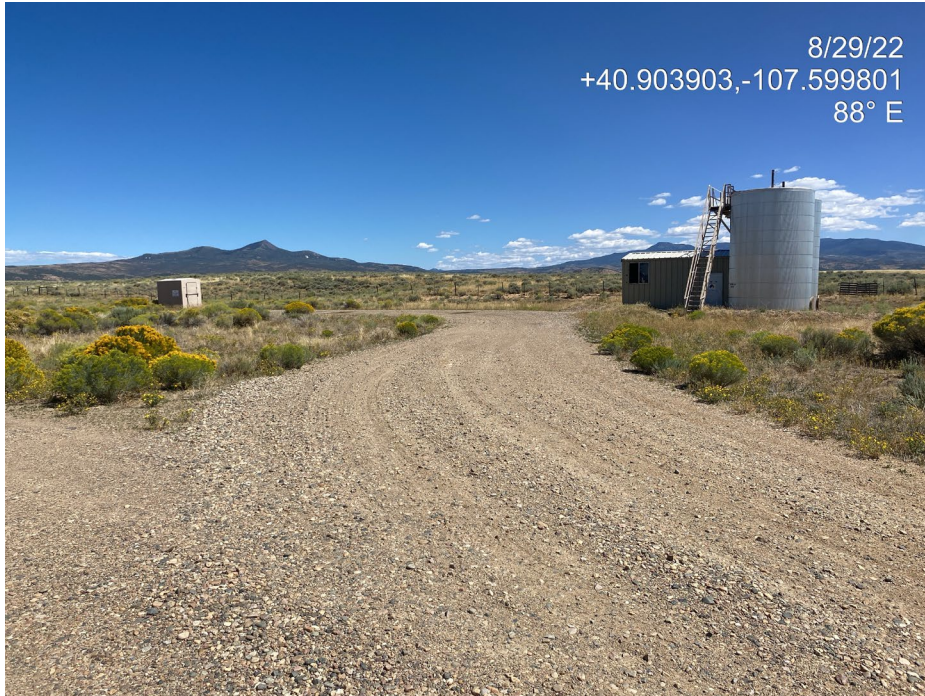
Photo 1. Photo taken from the southwest shows an overview of the working pad area.

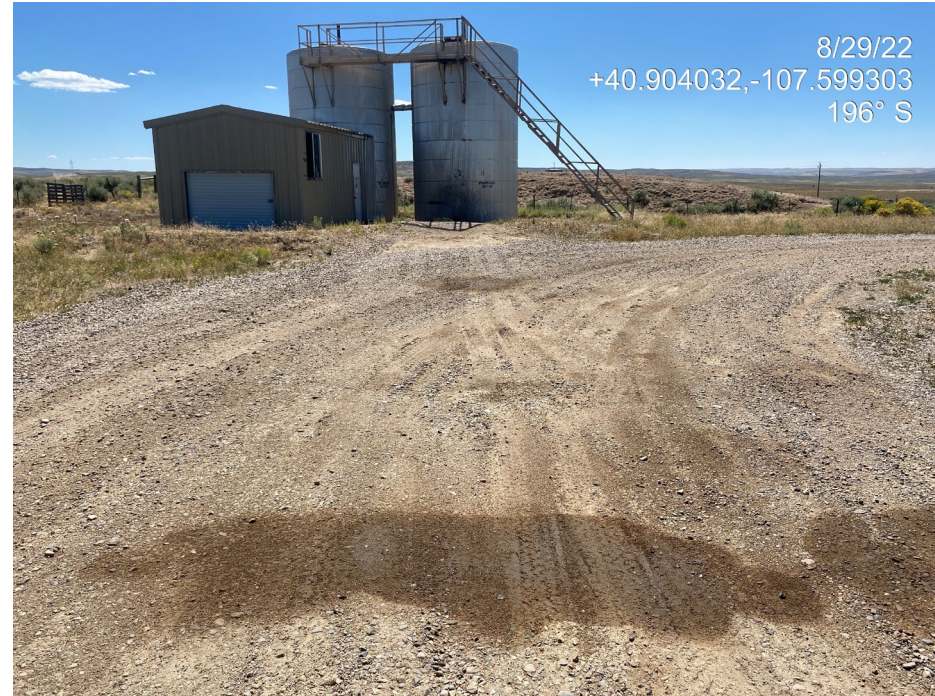
Photo 2. Photo shows stained soils.

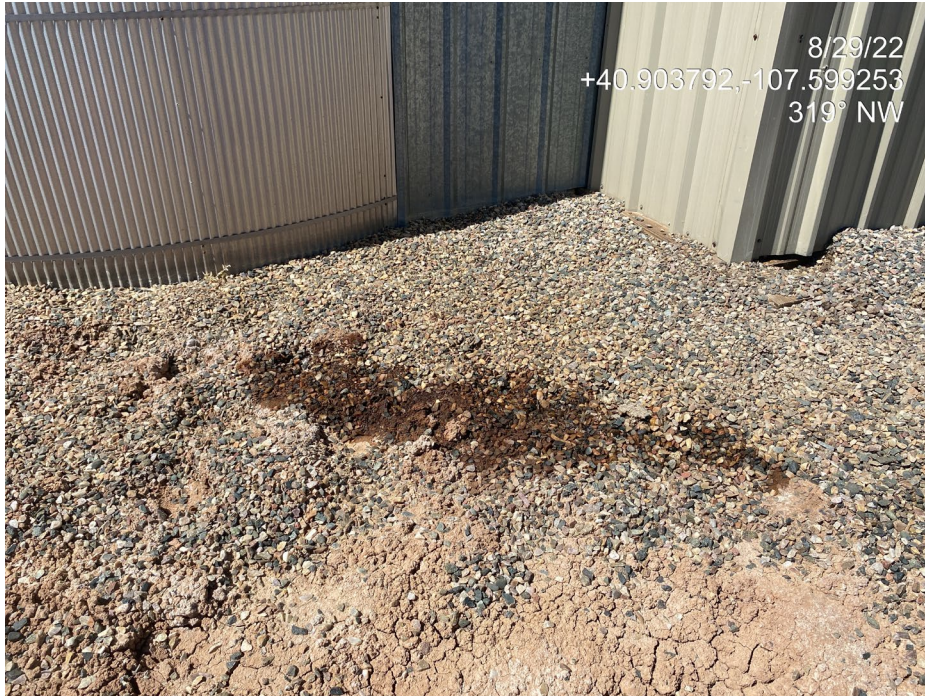
Photo 3. Photo shows stained soils adjacent to the pump house and produced water tanks.

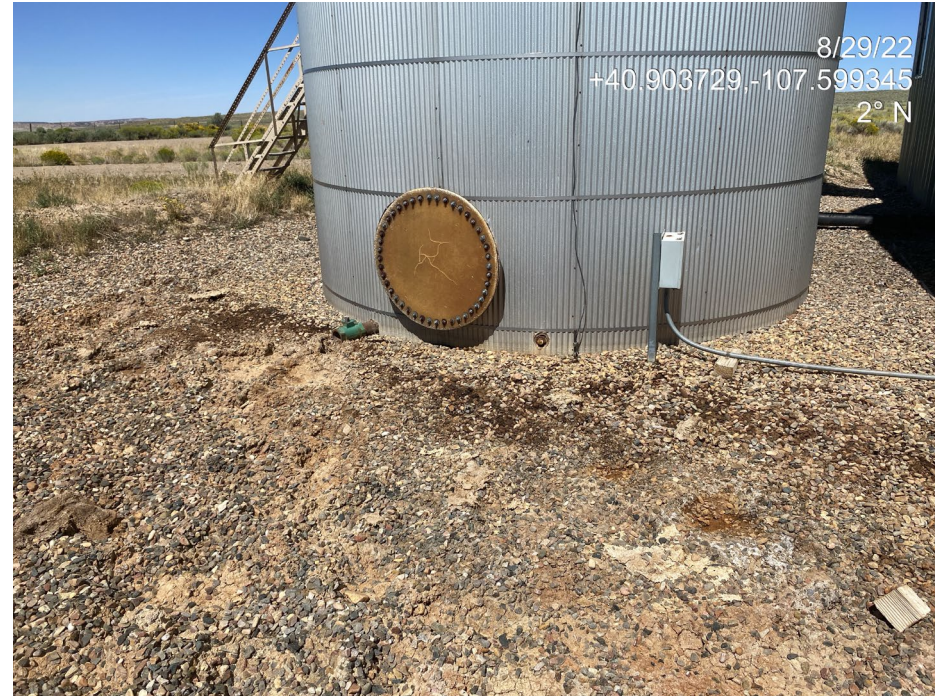
Photo 4. Photo shows stained soils adjacent to the produced water tanks.

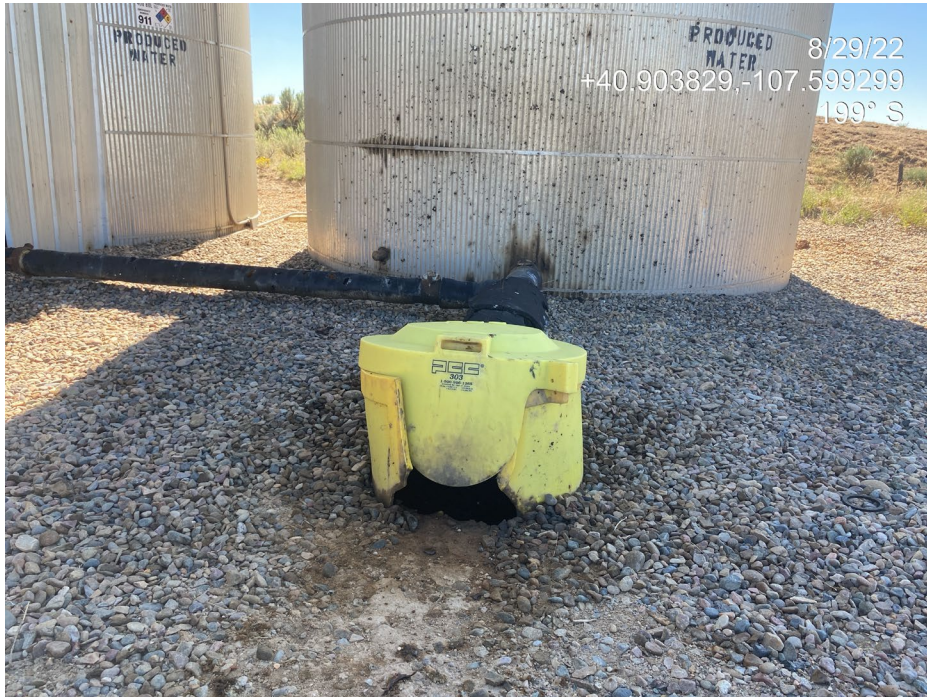
Photo 5. Photo shows stained soils at load lines.

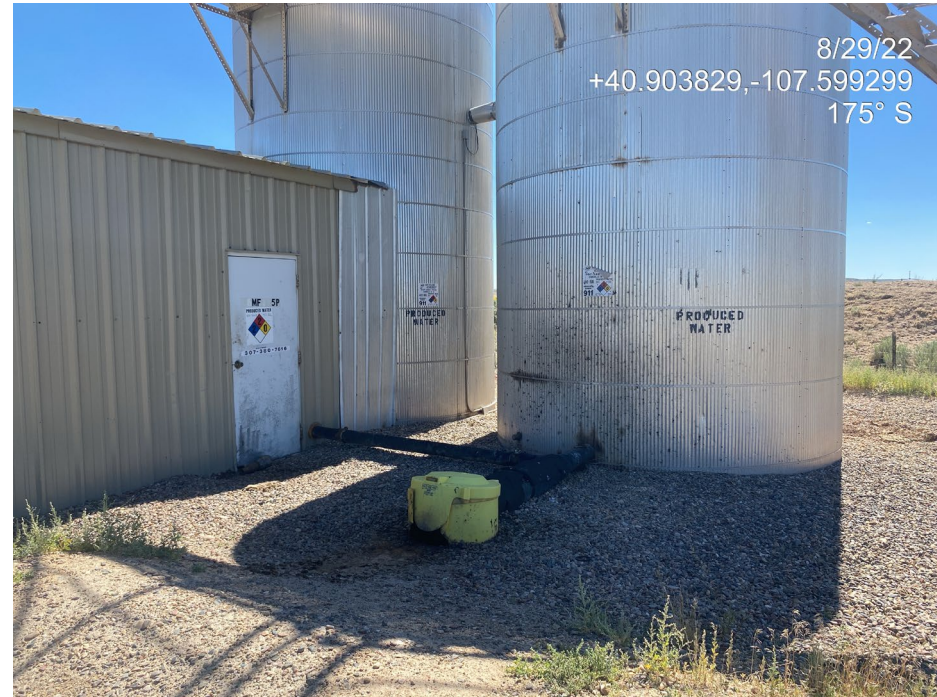
Photo 6. Refer to Photo 5 comment.

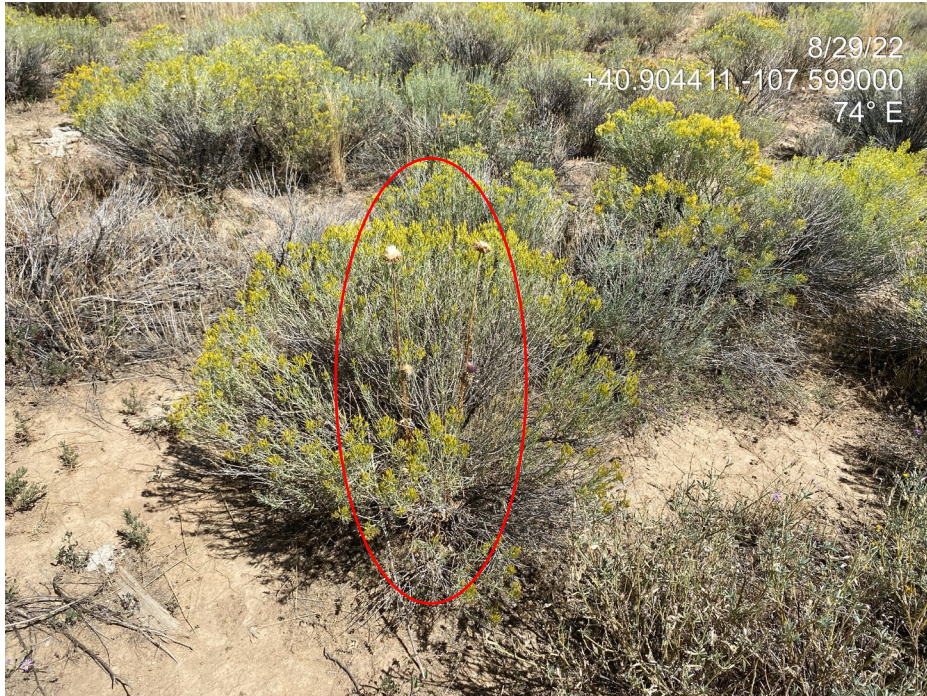
Photo 7. Photo taken from the north of the Location shows a bull thistle (List B Noxious) plant which has gone to seed.

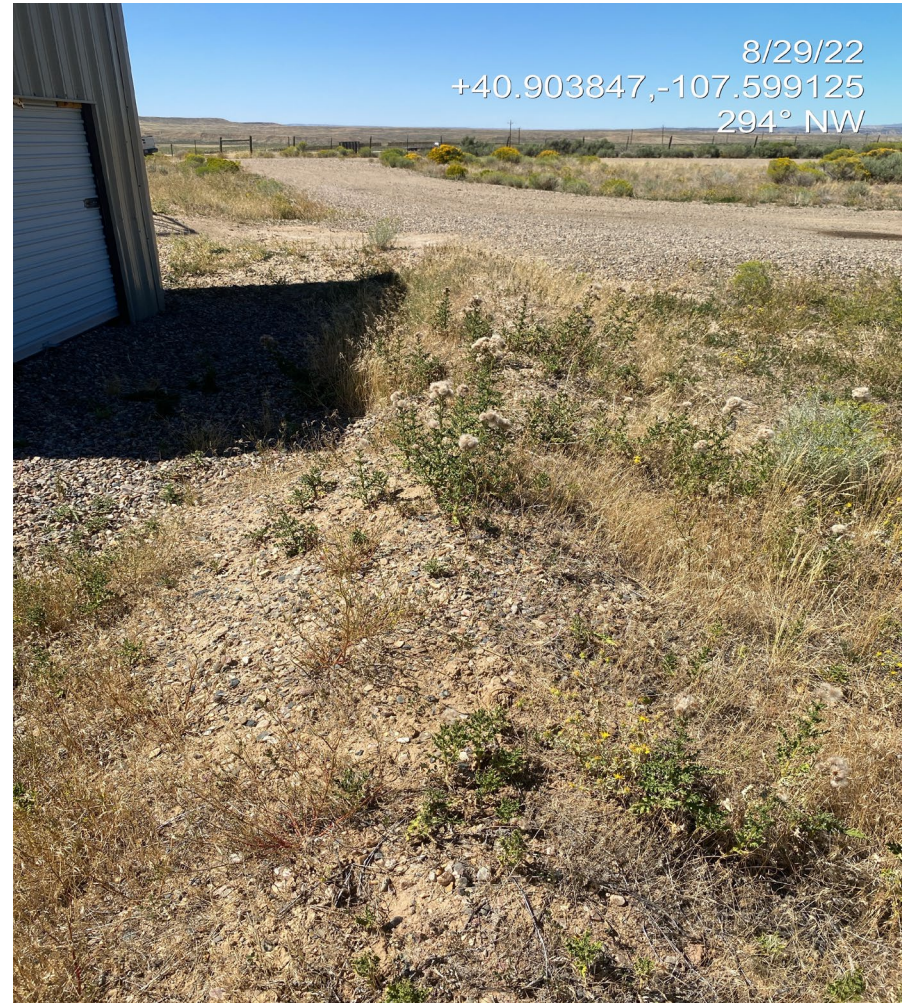
Photo 8. Photo taken adjacent to the pump shed shows Canada thistle (List B Noxious) plants which have gone to seed.

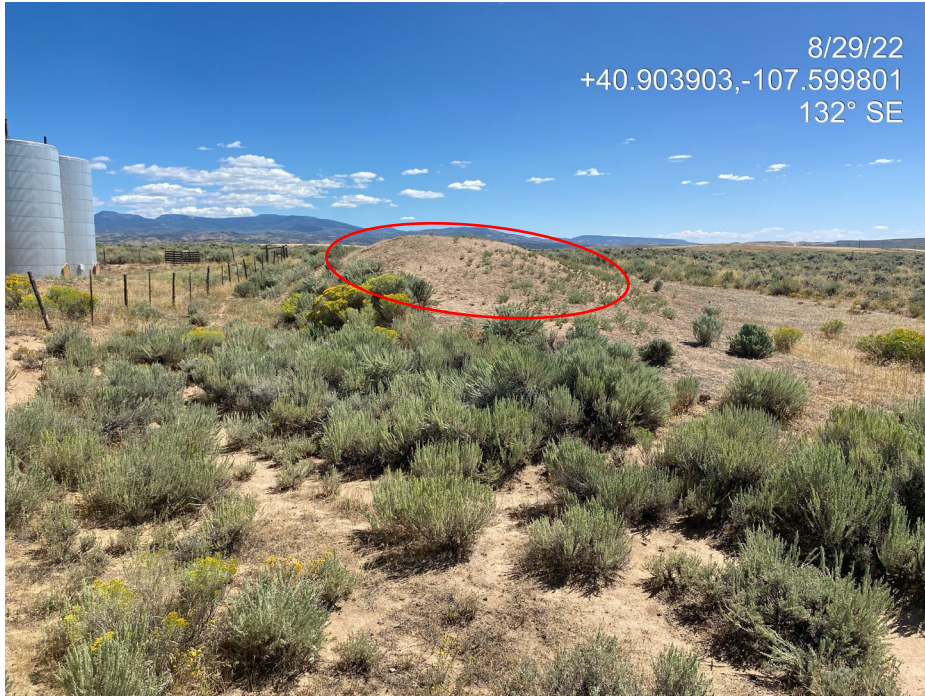
Photo 9. Photo taken from the southwest of the Location shows the topsoil stockpile is bare and unprotected.

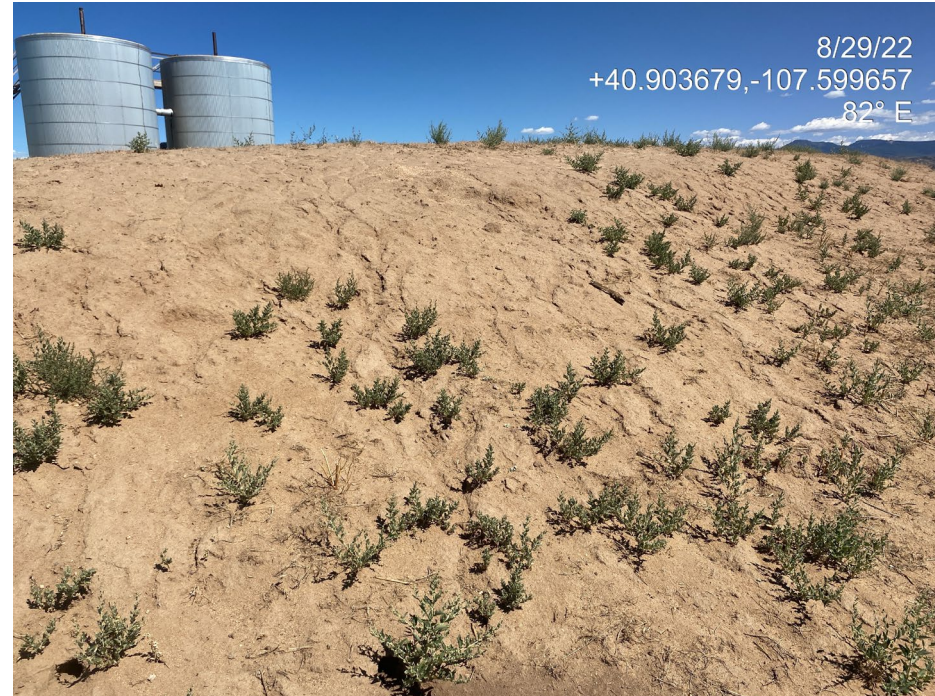
Photo 10. Photo taken from the southwest of the Location shows the topsoil stockpile is bare and unprotected. Rill erosion is occurring.
