Inspection Photos and Issue Report

8/30/2022

Operator: CAERUS PICEANCE LLC

Location #441653

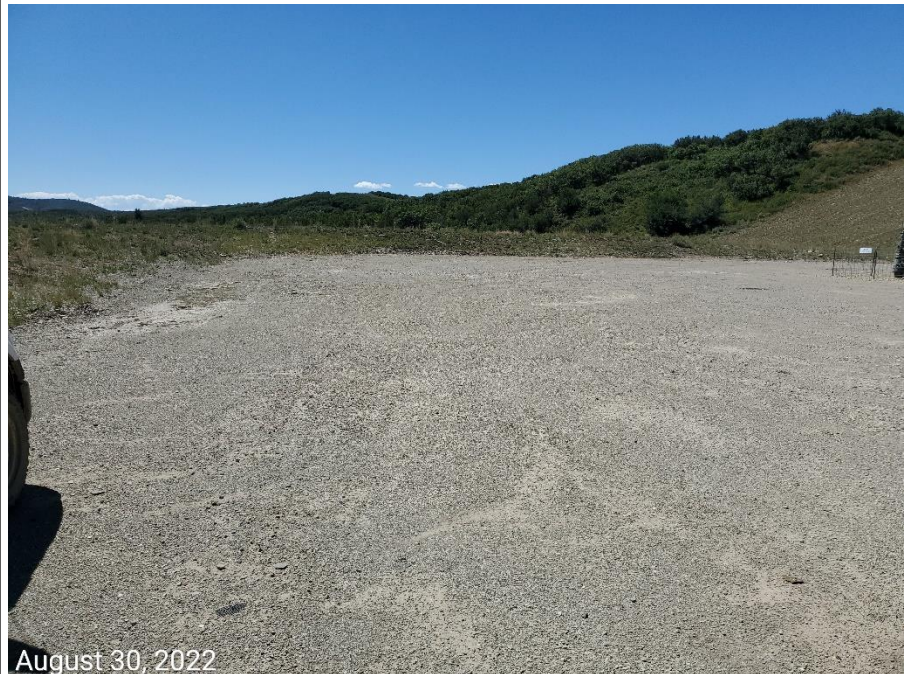
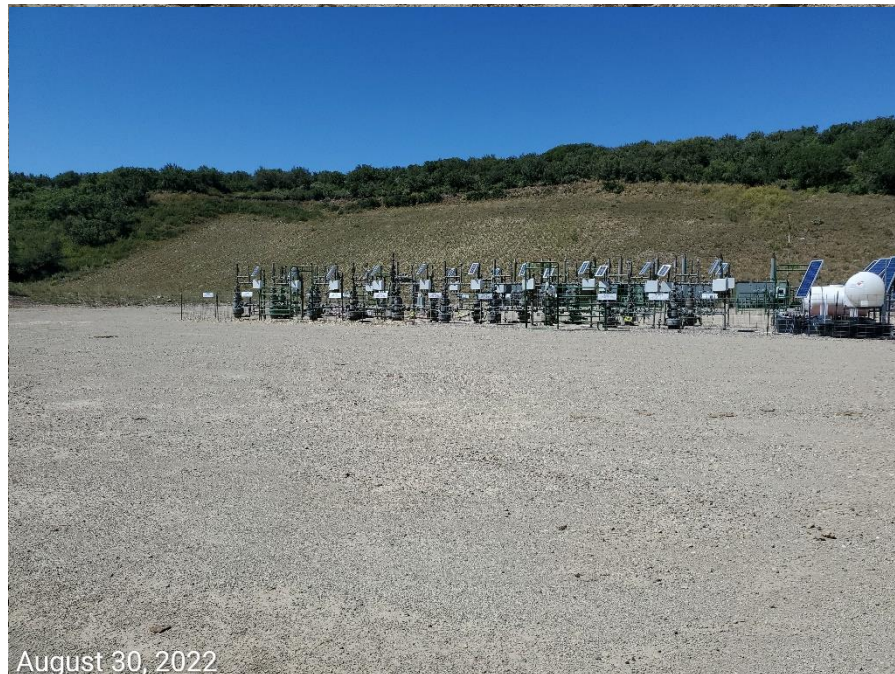
Photo 1: Photos taken from the east end of the working pad area end on the Location. Photos 1-2 provide an overview of the Location from south, southwest, northwest to west.

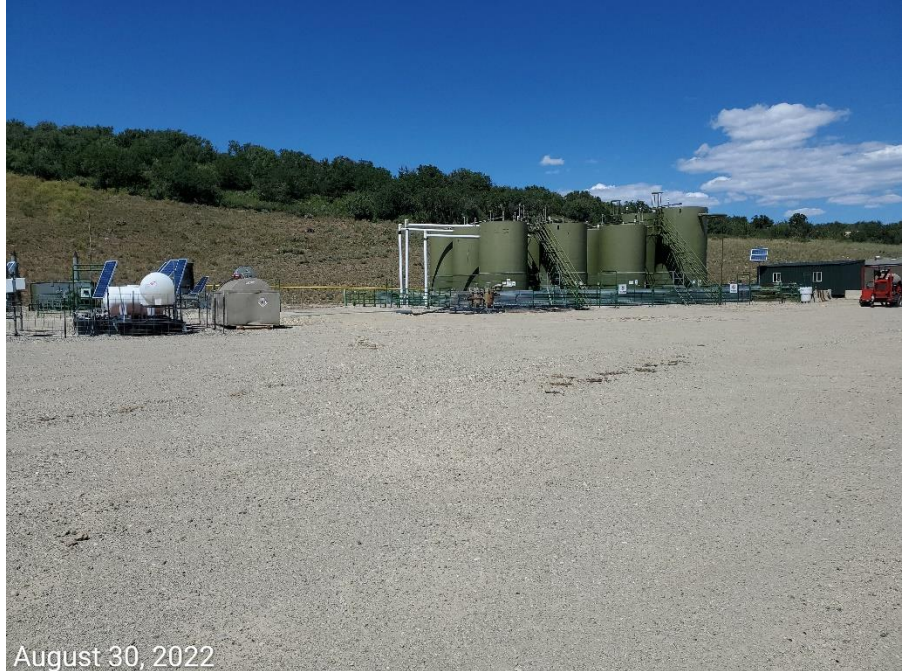
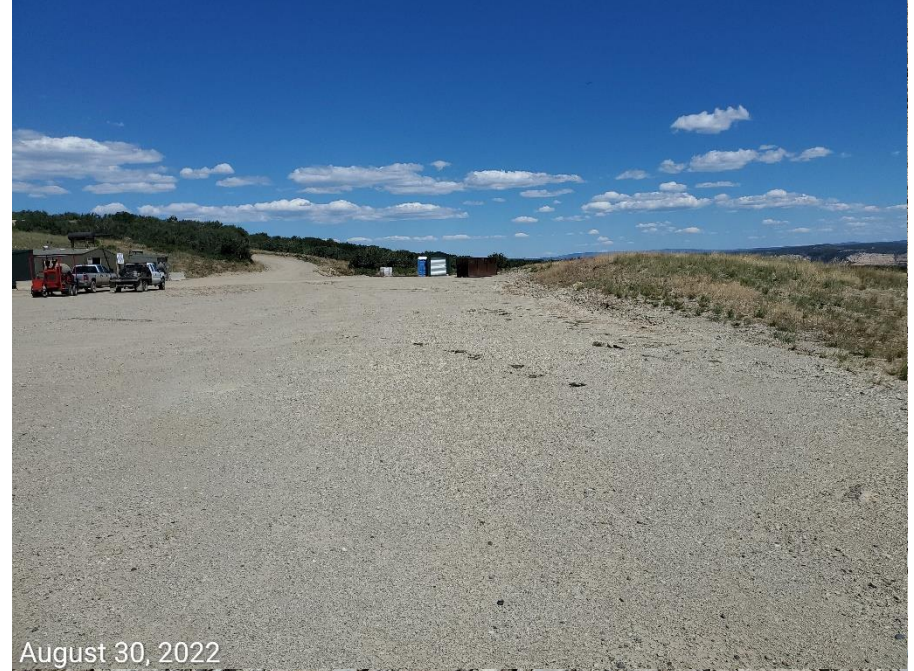
Photo 2: See comments under photo 1.

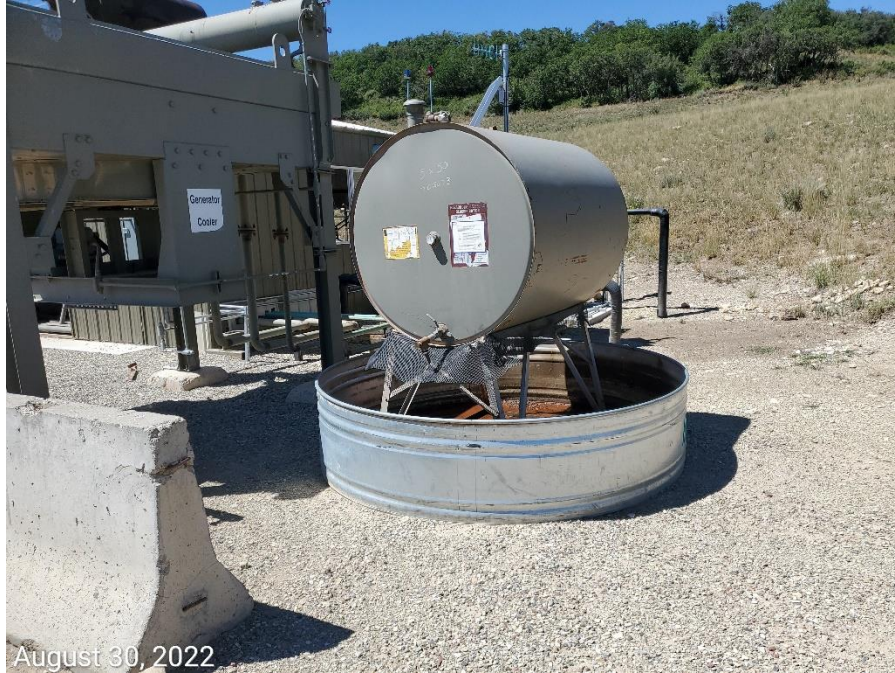
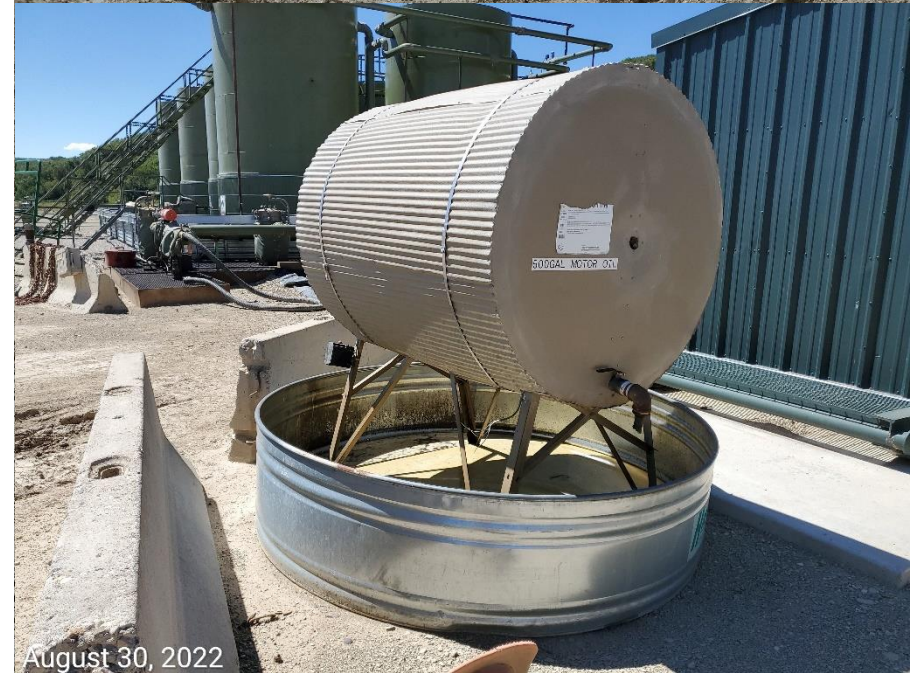
Photo 3: Photo shows tanks on the location with missing wildlife protection BMPs

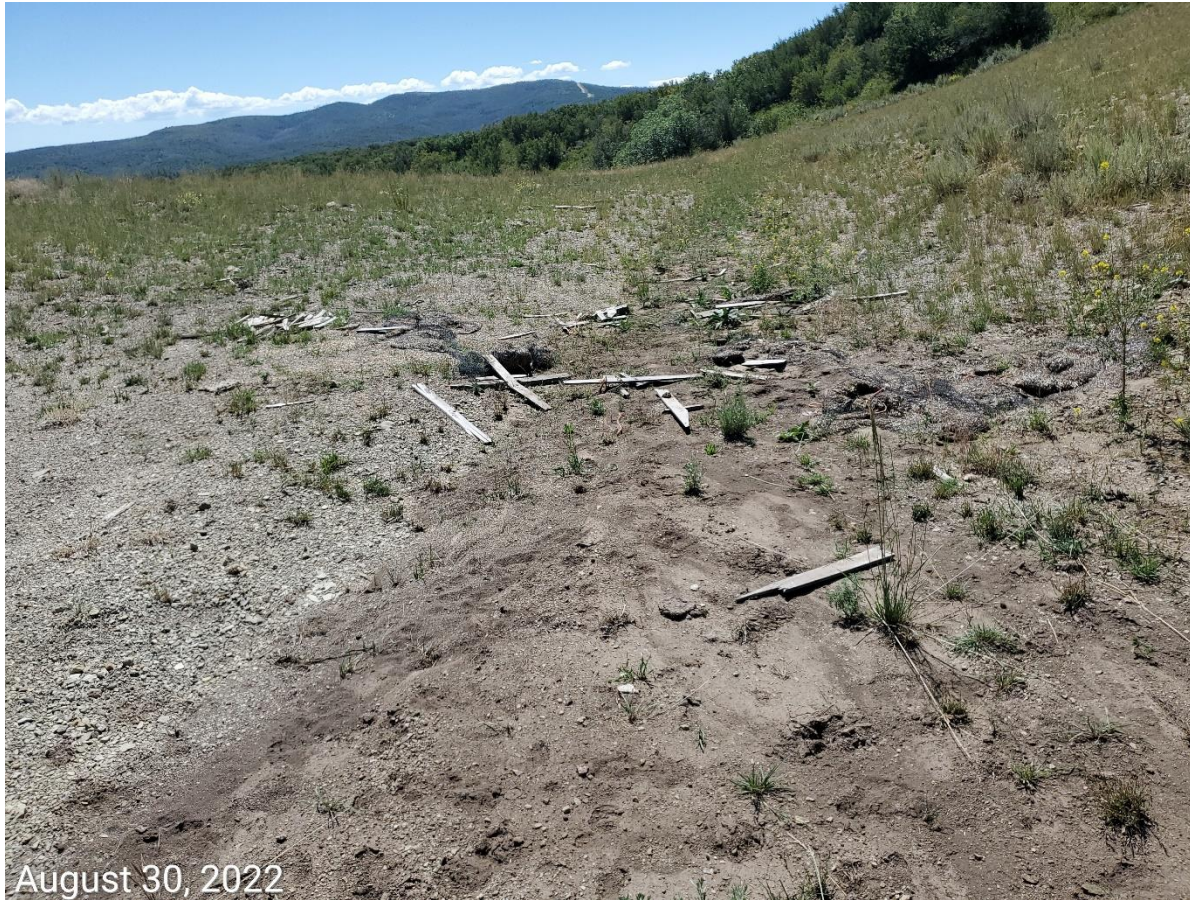
Photo 4: Photo shows various debris observed on the south end of the working pad.

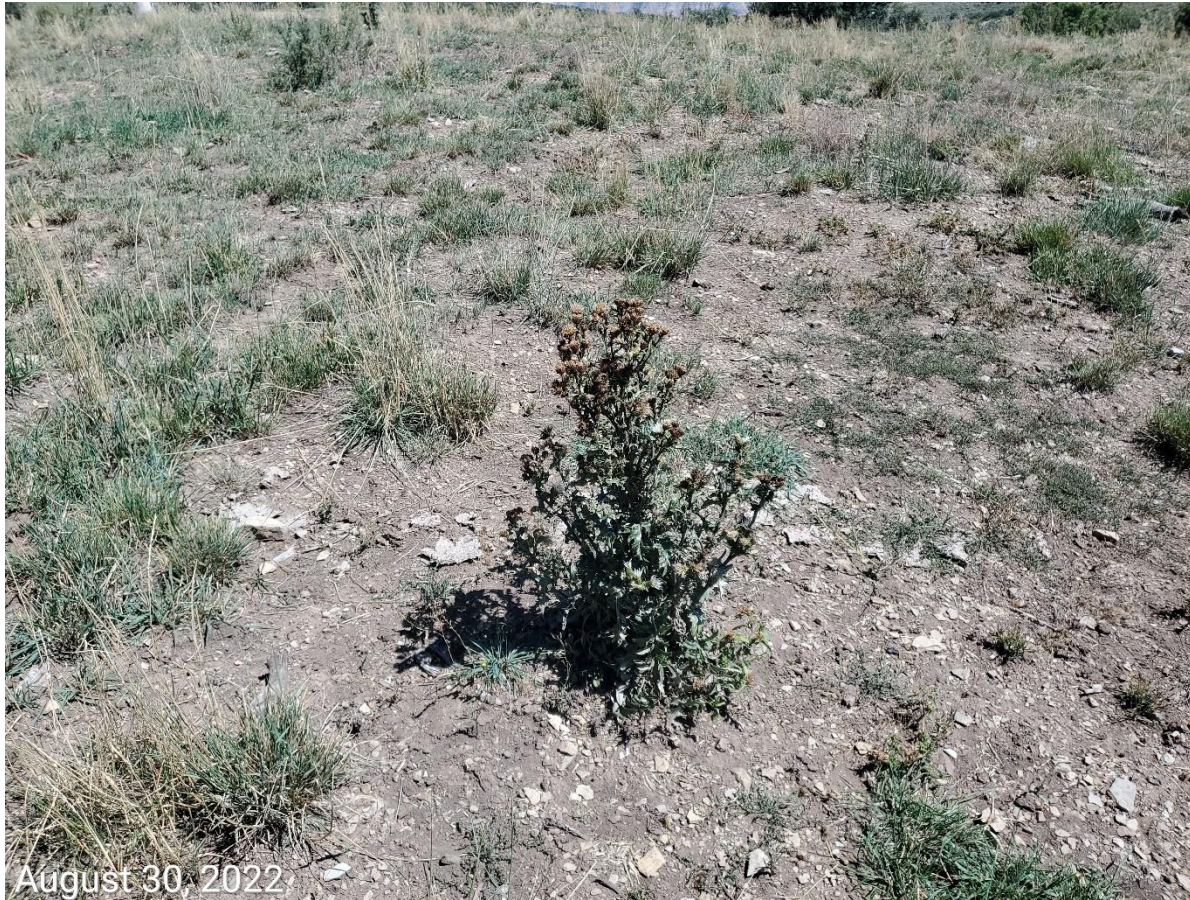
Photo 5: Photo example of plumeless thistle observed on Interim areas; Though in low densities, noxious weeds were observed establishing throughout the interim areas of the Location; many plants appear to have matured and dispersed seeds. Additional monitoring/management efforts will be necessary in the 2023 growing season.

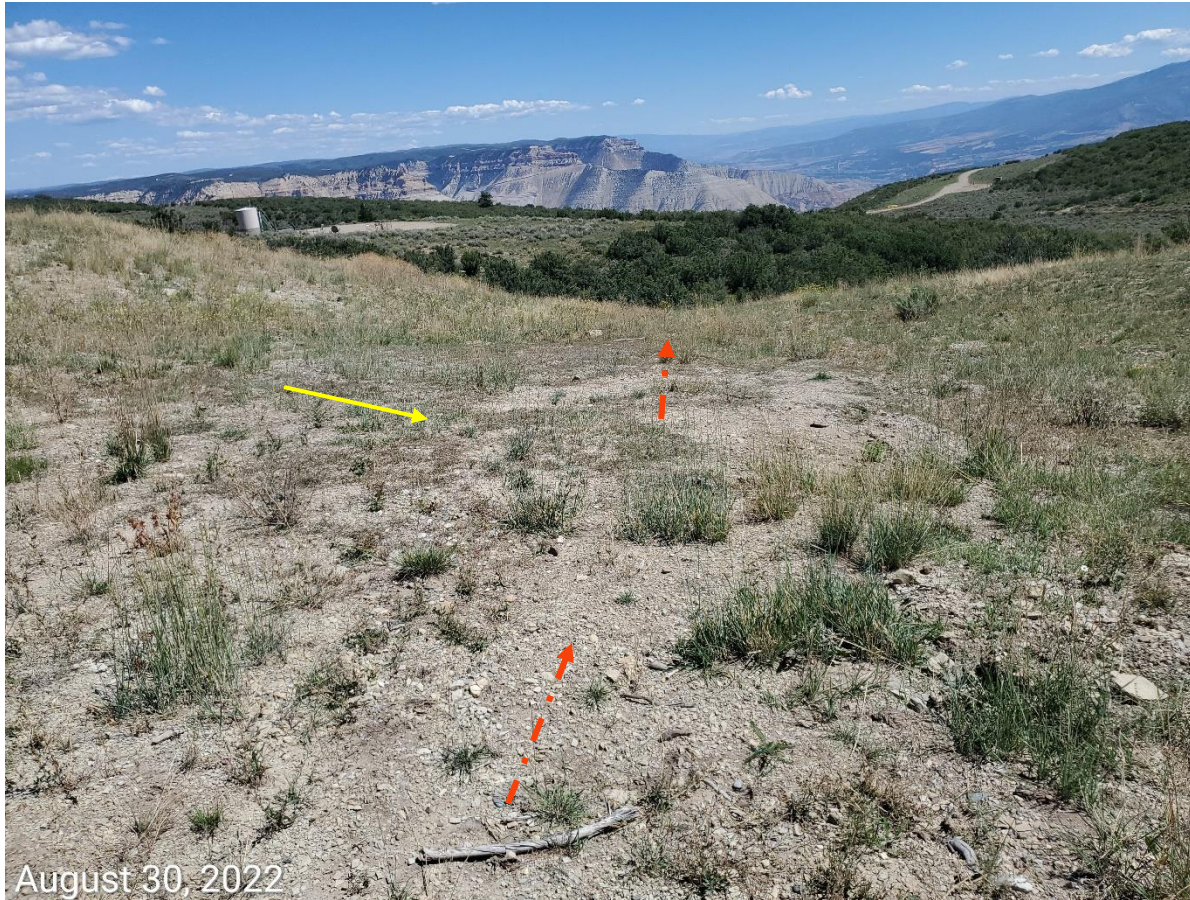
Photo 6: Photo taken from the east end of the working pad areas, facing east. Photo shows area where stormwater runoff is discharging from the working pad area, onto the interim areas, leading to the sediment trap on the east end of the Location. Photo shows sediment transport/deposition from the pad onto the interim areas. Red arrow represents direction of water movement. BMPs to manage runoff from the working pad, to the sediment trap downhill from this photo are missing or insufficient.

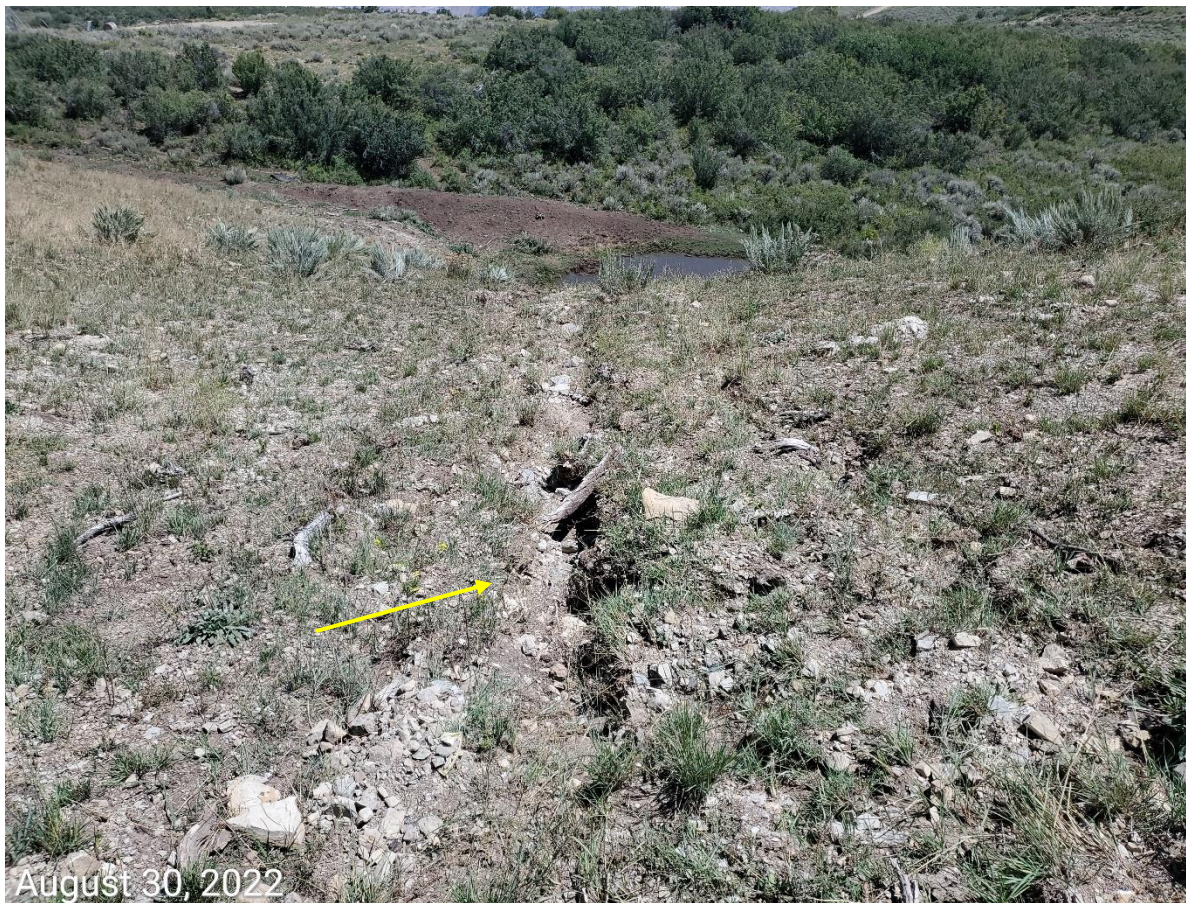
Photo 7: Continue from photo 6. Photo taken from the east end of the Location, between the working pad and the sediment trap. Photo shows BMPs to manage runoff from the working pad area to the sediment trap on the east end of the Location are missing or insufficient, resulting in erosion and degradation.

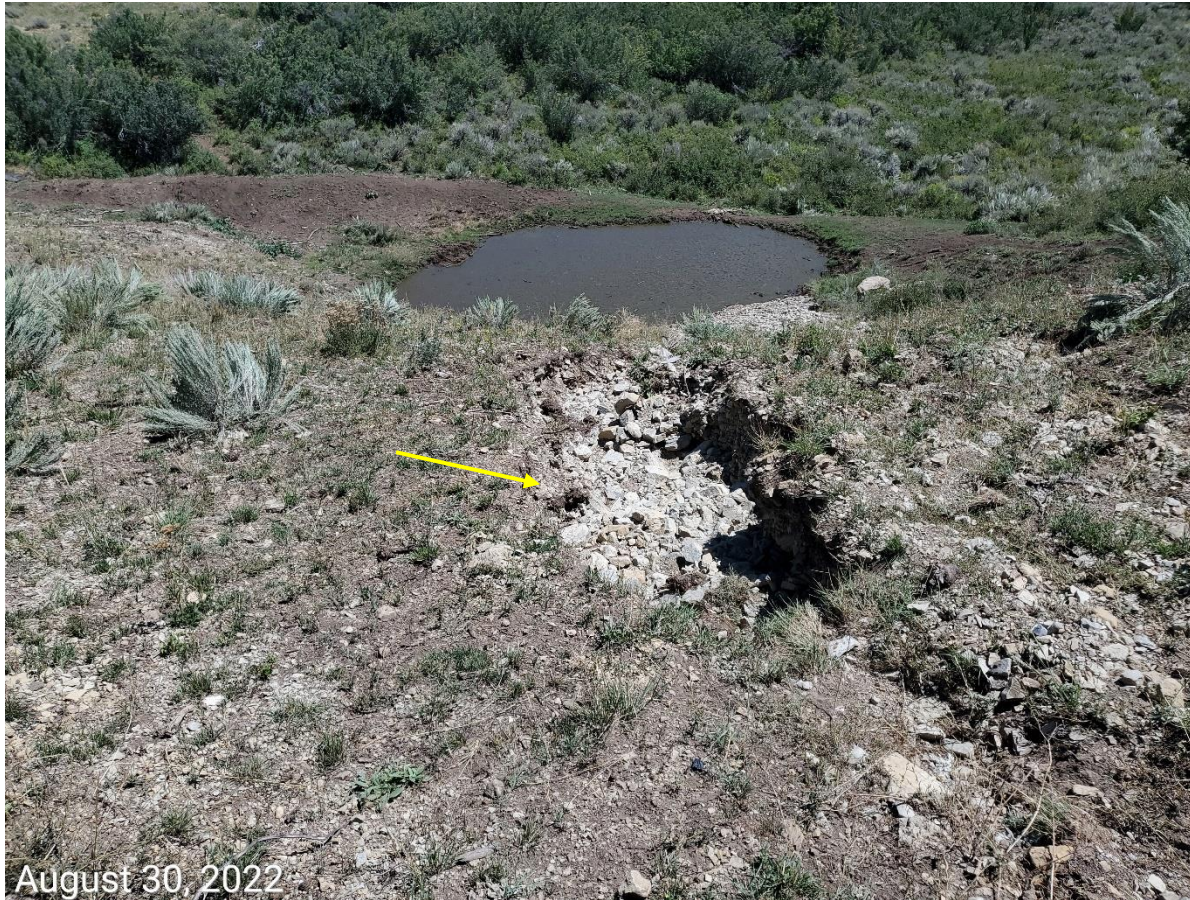
Photo 8: Continue from photo 7. Photo taken from the east end of the Location, between the working pad and the sediment trap. Photo shows BMPs to manage runoff from the working pad area to the sediment trap on the east end of the Location are missing or insufficient, resulting in erosion and degradation.

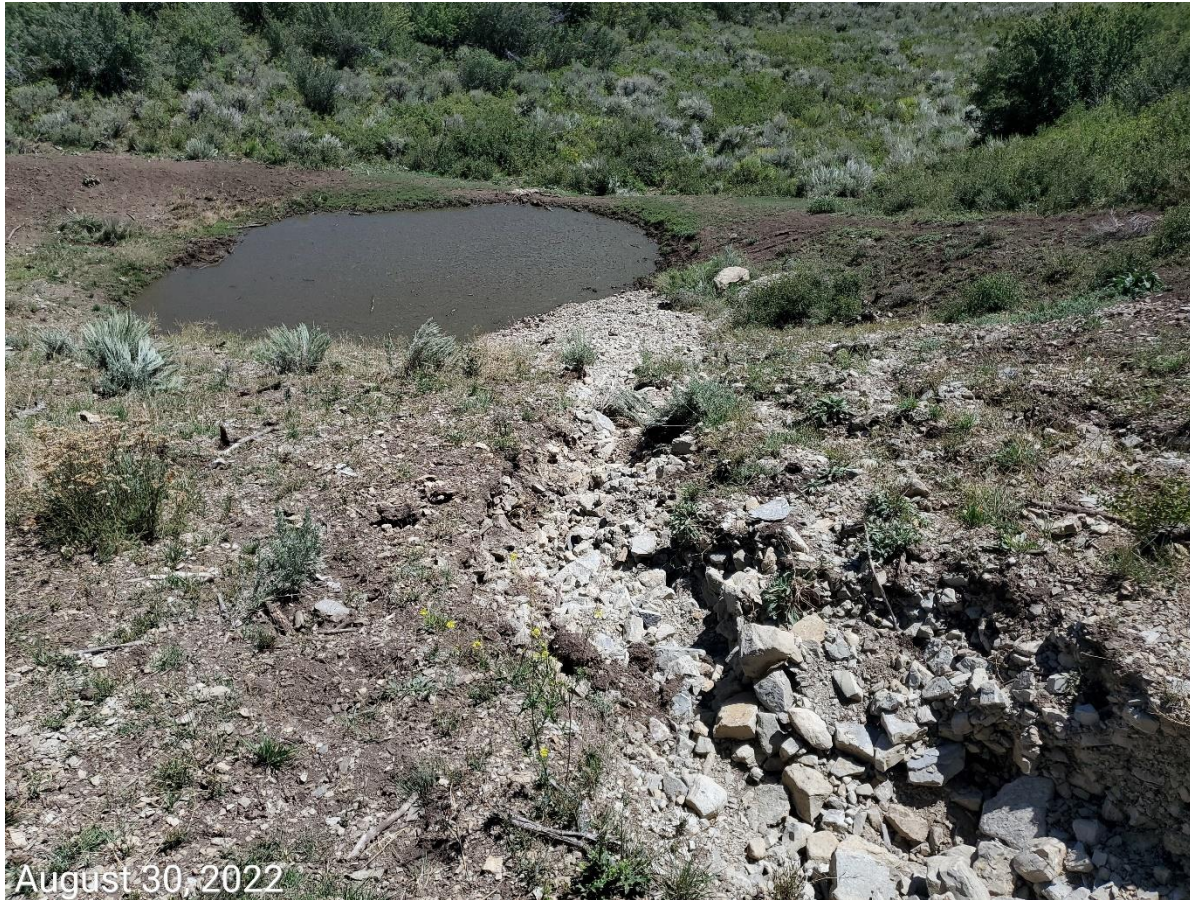
Photo 9: Continue from photo 8. Photo taken from the east end of the Location, between the working pad and the sediment trap. Photo shows BMPs to manage runoff from the working pad area to the sediment trap on the east end of the Location are missing or insufficient, resulting in erosion and degradation.

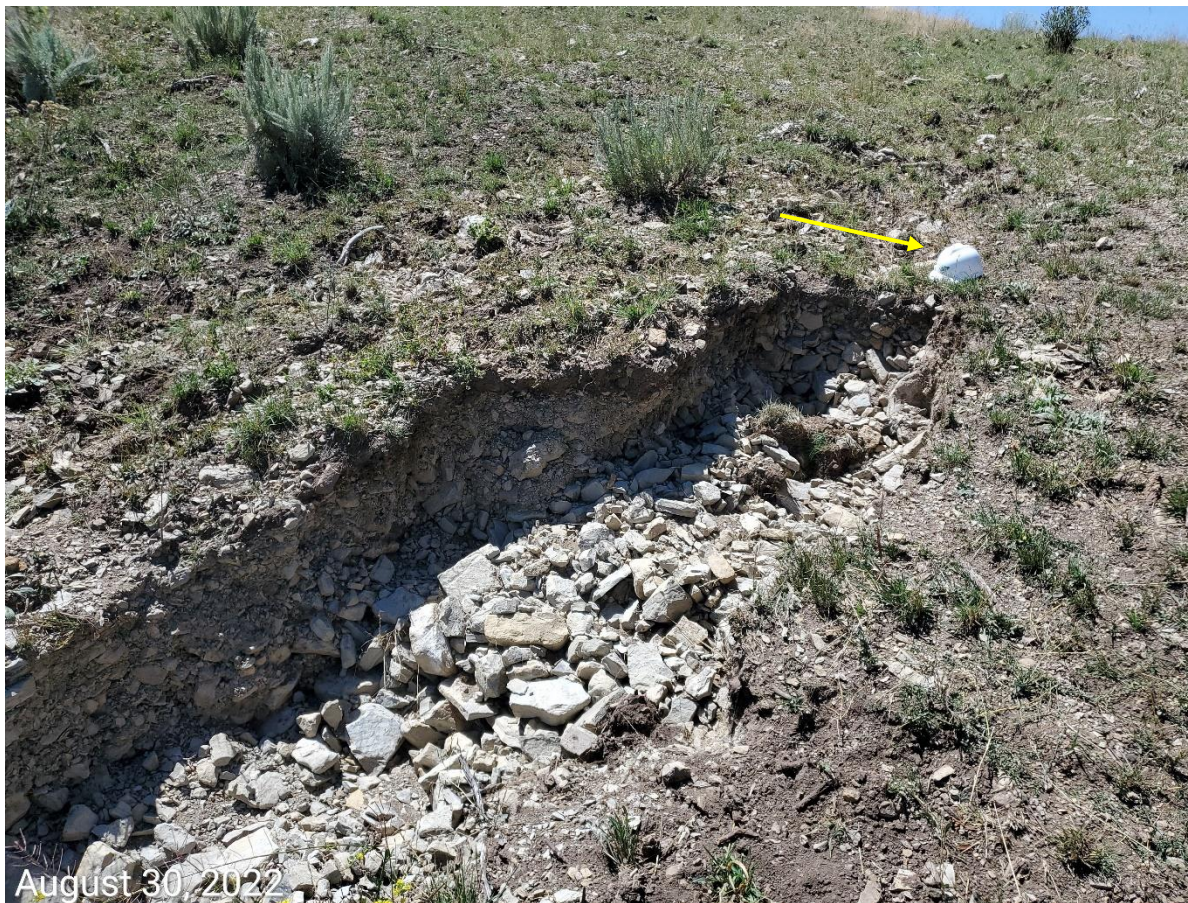
Photo 10: Continue from photo 9. Photo taken from the east end of the Location, between the working pad and the sediment trap. Photo shows BMPs to manage runoff from the working pad area to the sediment trap on the east end of the Location are missing or insufficient, resulting in erosion and degradation. Hard hat (arrow) within photo used for reference.

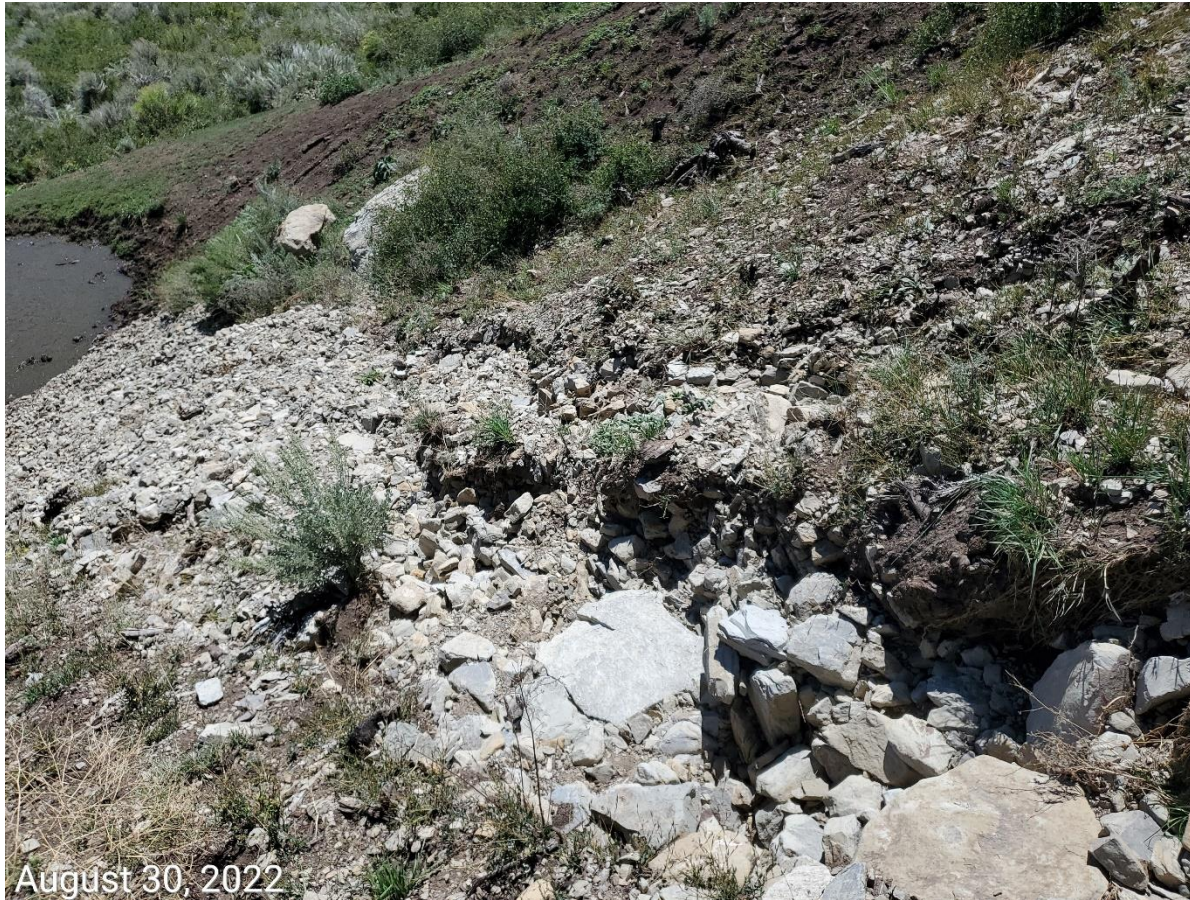
Photo 11: Continue from photo 10. Photo taken from the east end of the Location, between the working pad and the sediment trap. Photo shows BMPs to manage runoff from the working pad area to the sediment trap on the east end of the Location are missing or insufficient, resulting in erosion and degradation.

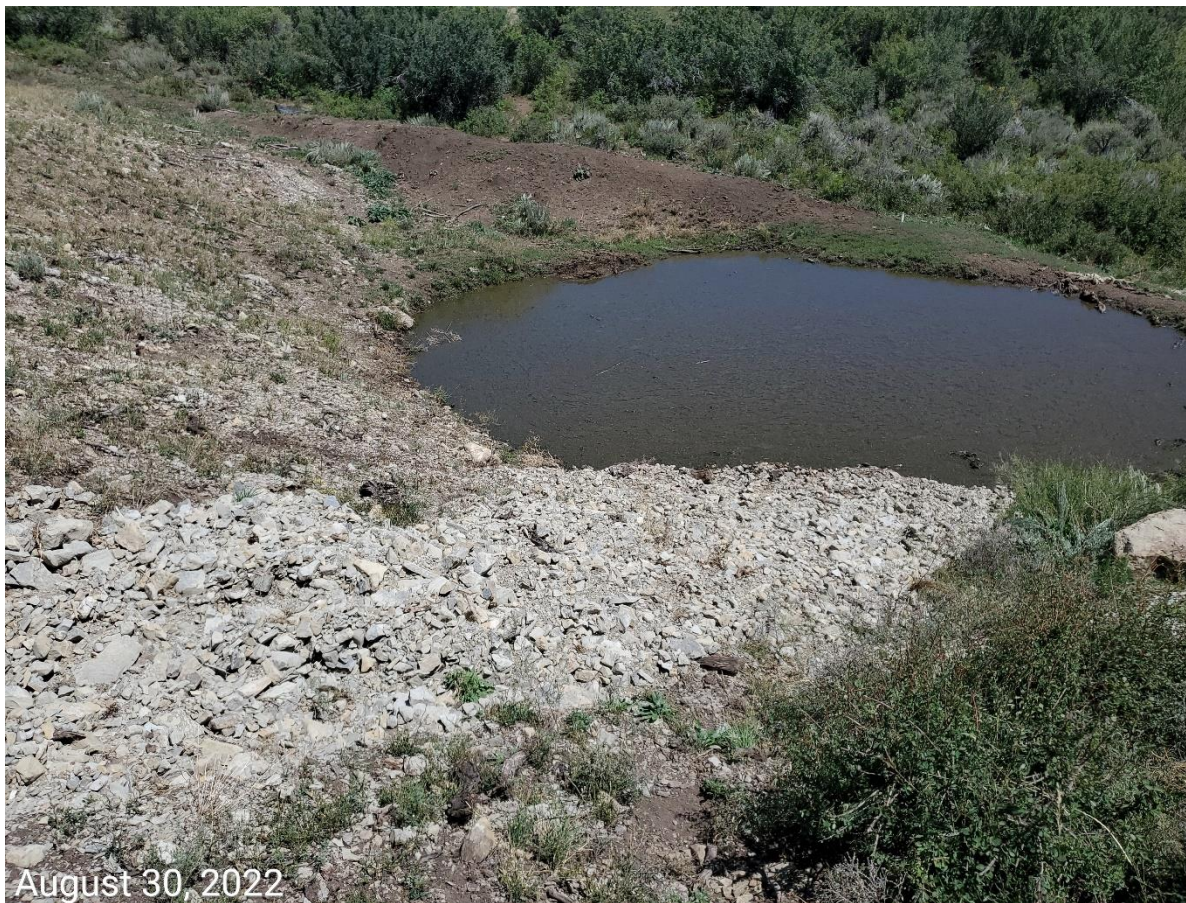
Photo 12: Continue from photo 11. Photo taken from the east end of the Location, between the working pad and the sediment trap. Photo shows BMPs to manage runoff from the working pad area to the sediment trap on the east end of the Location are missing or insufficient, resulting in erosion and degradation.

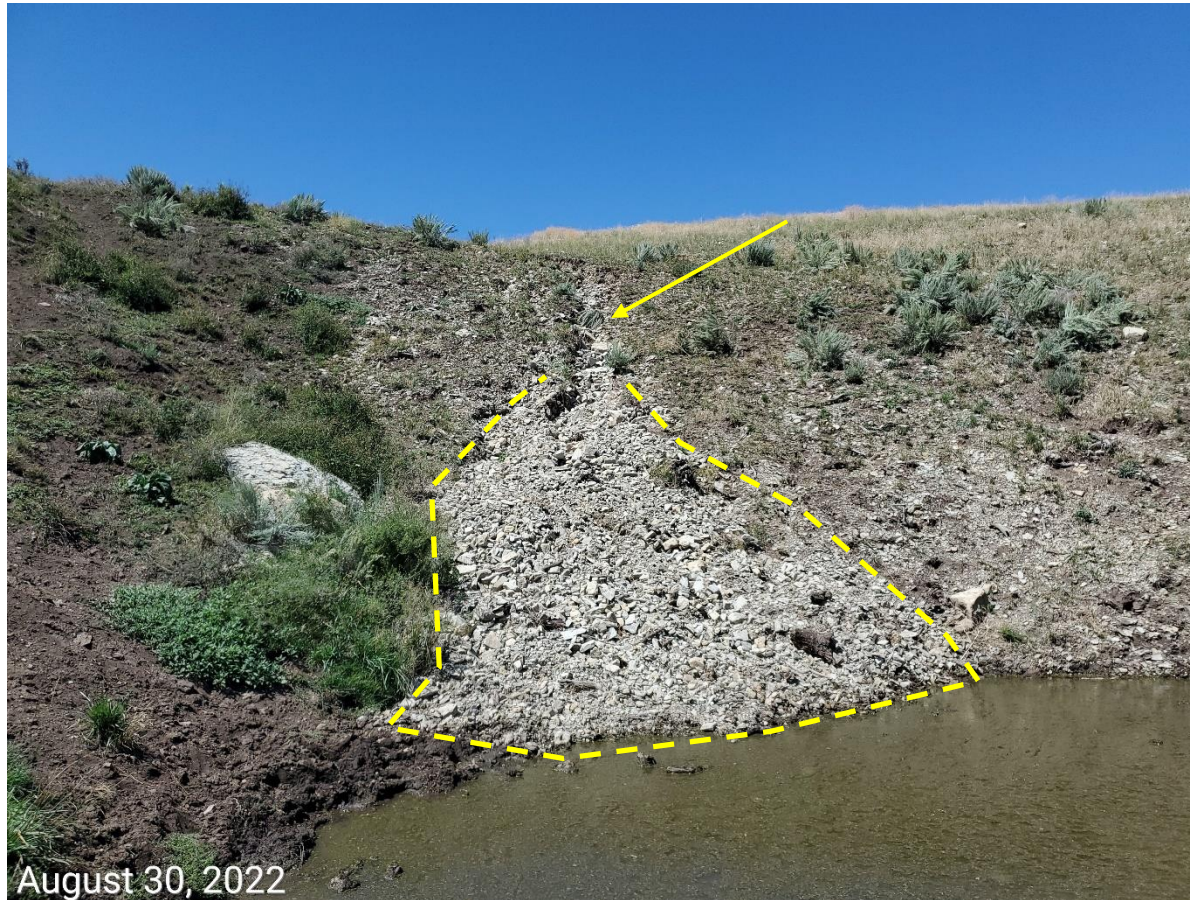
Photo 13: Photo taken from the sediment trap on the east end of the Location, facing west. Photo shows BMPs to manage runoff from the working pad area to the sediment trap are missing or insufficient, resulting in erosion and degradation. Yellow polygon shows subsoil deposition resulting from stormwater erosion and degradation.
