## ENVIRONMENTAL DAILY FIELD REPORT

**PROJECT NAME:** RA 11 Flowline Investigation

**DATE:** 6/10/2022

**SITE LOCATION:** RA 11 Pad

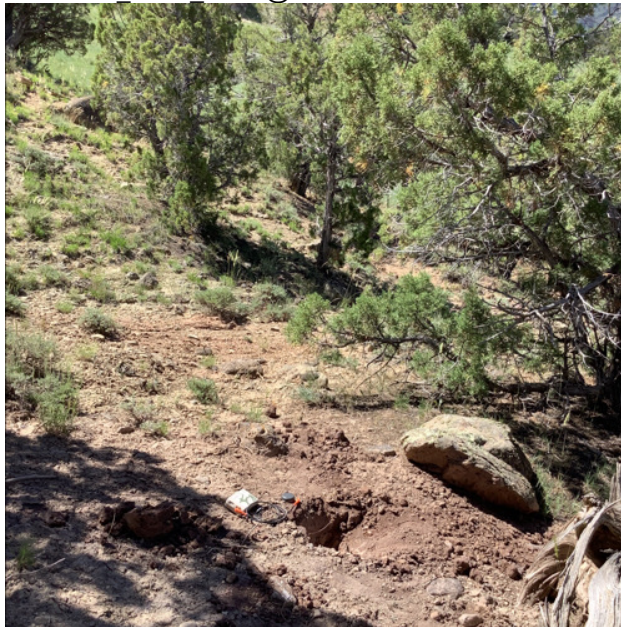
| Sample ID | Sample Type | Date | Time | Depth | PID (ppmv) | Odor | Staining | Comments |
|---|---|---|---|---|---|---|---|--|
| 20220610_RA<br>11_BG02@1ft | Background | 06/10/2022 | 11:10 AM | 1 to 1 | 0 | N | N | Soil is light red/orange color. |

**Fig. 6:** Looking south towards pad from 20220610\_RA11\_BG02@1ft..

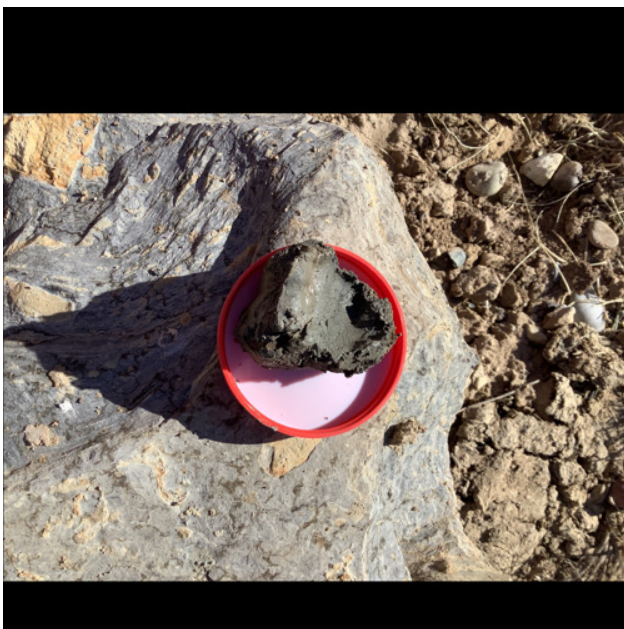
| Sample ID | Sample Type | Date | Time | Depth | PID (ppmv) | Odor | Staining | Comments |
|---|---|---|---|---|---|---|---|--|
| 20220610_RA<br>11_POR@5ft | Spill Area | 06/10/2022 | 09:45 AM | 5 to 5 | 552.4 | Y | Y | Strong hydrocarbon odor detected around excavation. Small amount of unknown water source is pooled in base of excavation. Soil appears discolored. |

**Fig. 7:** 20220610\_RA11\_POR@5ft sample.

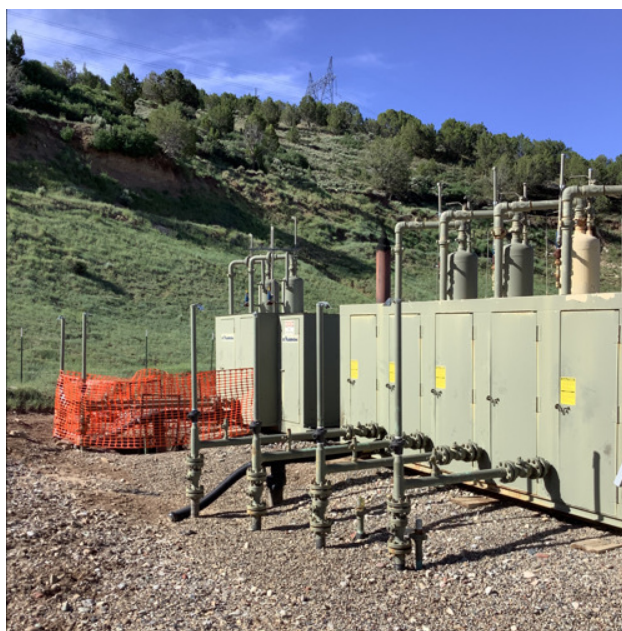
**Fig. 8:** Hydrovac excavation around south most separator unit. Orange safety net is around excavation.

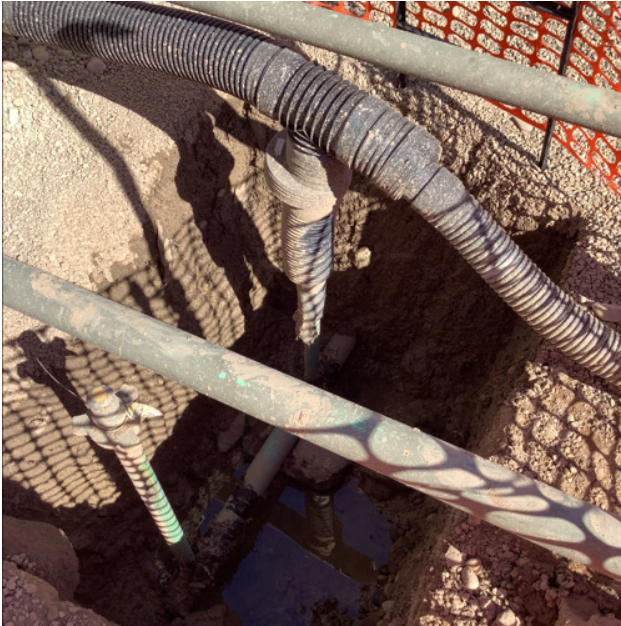
Upon arrival to the site, met with Brett Middleton of Caerus to complete a site walk and discuss sampling approach. One open hydrovac excavation was identified east of the southern most separator unit. The excavation measured approximately 7'L x 5'W x 5'D. Hydrocarbon odors and visible soil staining were observed within the excavation. All sidewalls of the excavation appear discolored. Water with an oily sheen was also observed within the base of the excavation. The source of the water observed in the base of the excavation is unknown. Per discussion with Brett, a water sample will not be collected at this time and only one POR soil sample from the base of the excavation will be collected. The POR sample (20220610\_RA11\_POR@5ft) was collected using an extended stainless-steel hand auger while remaining out of the excavation. The POR sample appeared darkly discolored (black/gray color) with a strong hydrocarbon smell detected. The PID reading for this sample was measured at 552.4 parts per million (PPM). See attached table for additional details on samples.

**Fig. 9:** Hydrovac excavation. Dimensions are approximately 7'L x 5'W x 5'D.

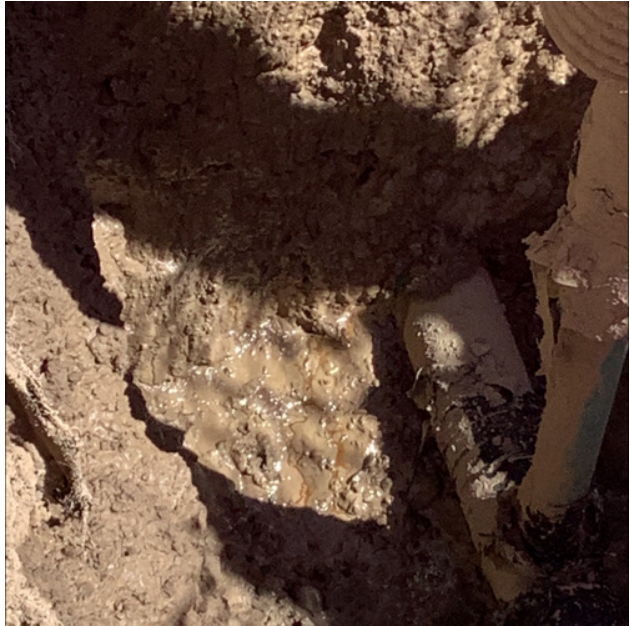
**Fig. 10:** Discolored soil and sheen on water observed within excavation.

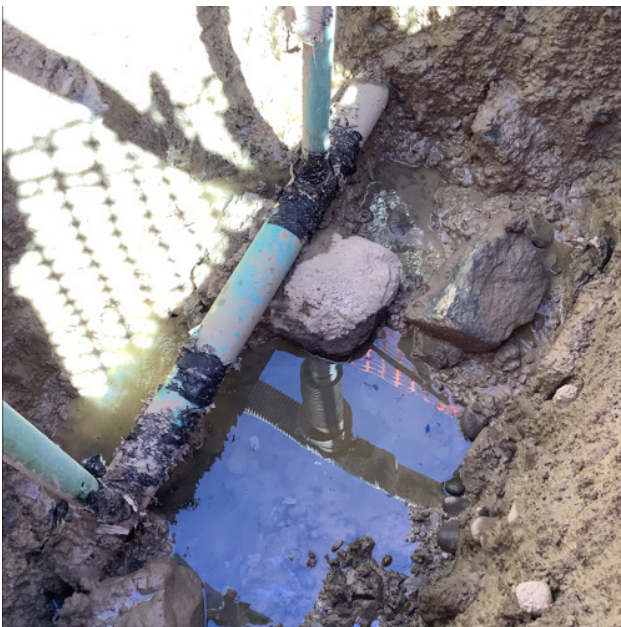
**Fig. 11:** Unknown water source pooled in base of excavation.

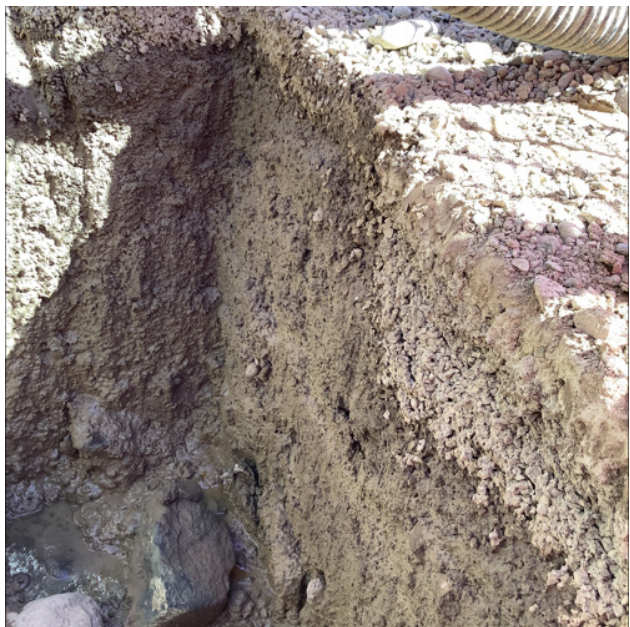
**Fig. 12:** All sidewalls within excavation appear discolored.
