ENVIRONMENTAL DAILY FIELD REPORT

PROJECT NAME: RA 11 Flowline Investigation

DATE: 7/7/2022

SITE LOCATION: RA 11 Pad

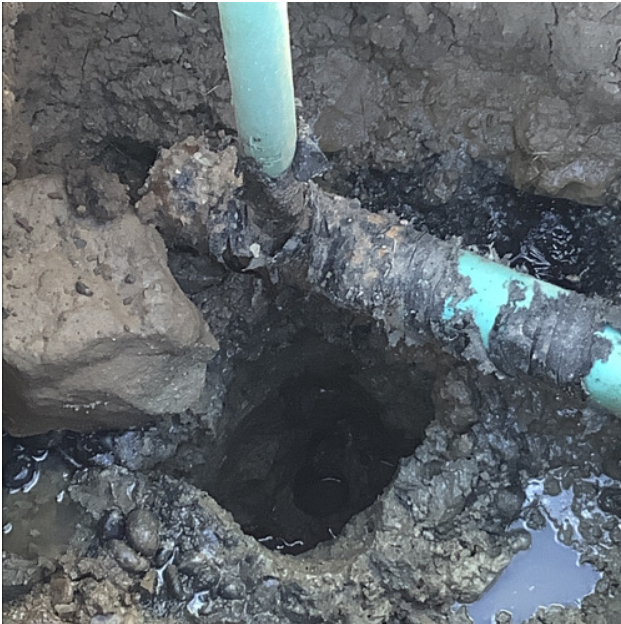
Fig. 1: 20220707_RA11_POR@7ft

- POR at 7 feet below ground surface (bgs). This pothole was field screened at 7 feet bgs. The soil was saturated at 7 feet bgs and a soil sample was collected for lab analysis.
- Pothole #1 (PH01) is flush against east side of south most separator and is to be used for the west horizontal delineation. This pothole was field screened at 2, 5, and 7 feet bgs. The soil was saturated at 7 feet bgs and a soil sample was collected for lab analysis.

20220707_RA11_ POR@7ft	Spill Area	07/07/2022	08:10 AM	7 to 7	2.4	N	N	Minimal hydrocarbon odor and staining observed. Sample is saturated. Sample collected.
20220707_RA11_ PH01@7ft	Spill Area	07/07/2022	09:00 AM	7 to 7	60	Y	Y	Soil is saturated. Flush against south separator. Sample collected.
20220707_RA11_ PH04@7ft	Spill Area	07/07/2022	10:25 AM	7 to 7	52.4	N	N	Sample is saturated.
20220707_RA11_ PH07@7ft	Spill Area	07/07/2022	11:38 AM	7 to 7	250.5	Y	Y	High hydrocarbon scent.
20220707_RA11_ PH07@9ft	Spill Area	07/07/2022	11:50 AM	9 to 9	17.6	N	N	Sample is saturated. Sample collected.

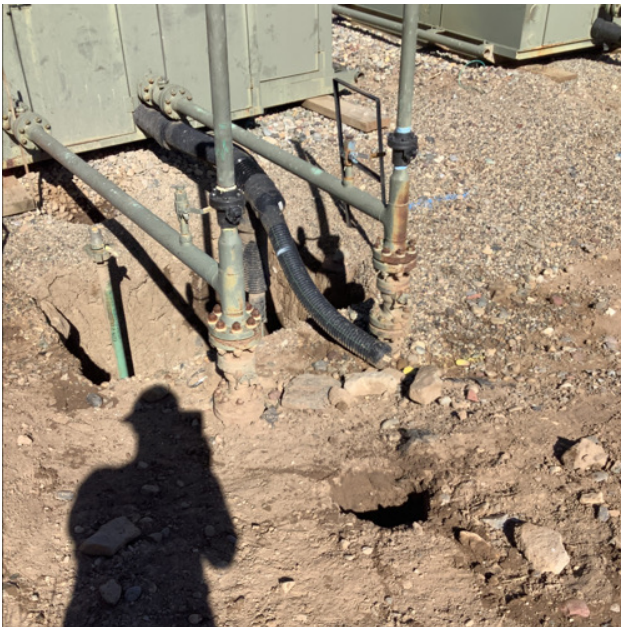
Fig. 3: 20220707_RA11_PH02@5ft

- PH02 is approximately 9 feet east of the POR at the edge of the disturbed pad surface. This pothole was field screened at 5 feet bgs. The soil was saturated at 5 feet bgs and a soil sample was collected for lab analysis.

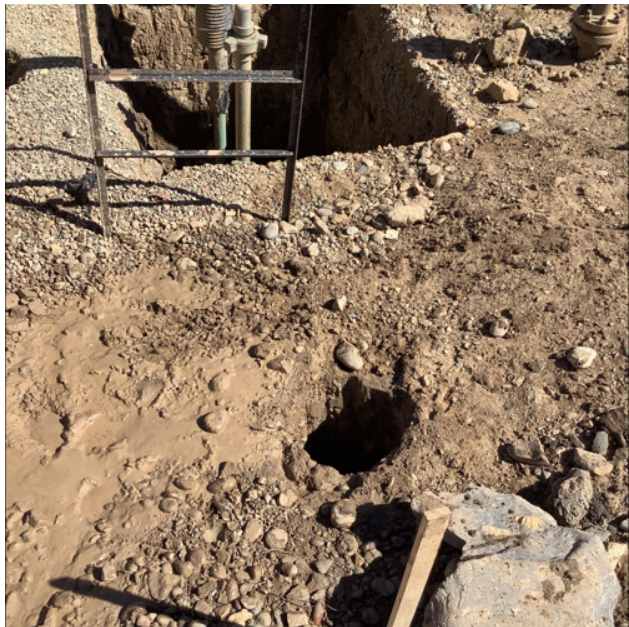
Fig. 4: 20220707_RA11_PH03@5ft

- PH03 is approximately 5 feet south of the POR at the edge of the disturbed pad surface and is to be used for the south horizontal delineation. This pothole was field screened at 5 feet bgs. The soil was saturated at 5 feet bgs and a soil sample was collected for lab analysis.

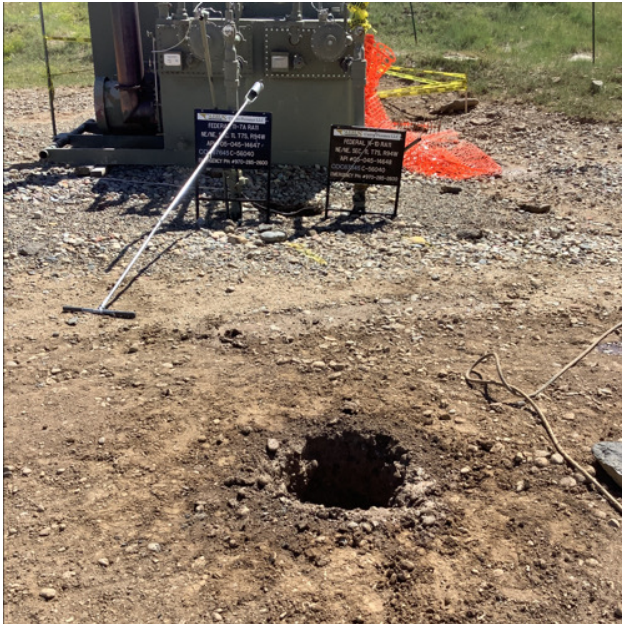
Fig. 5: 20220707_RA11_PH05@6ft

- PH05 is approximately 15 feet west of PH04. This pothole was field screened at 6 feet bgs. The soil was less wet than the other soil samples. A PID reading of 111.1 ppm at this pothole. A soil sample was collected for lab analysis.

The field screening at PH01 suggested the west delineation had been completed adjacent to the POR. However, the field screening results at PH04 and PH05 which are west of PH01 indicate additional contamination in this area and may not be associated with the spill.

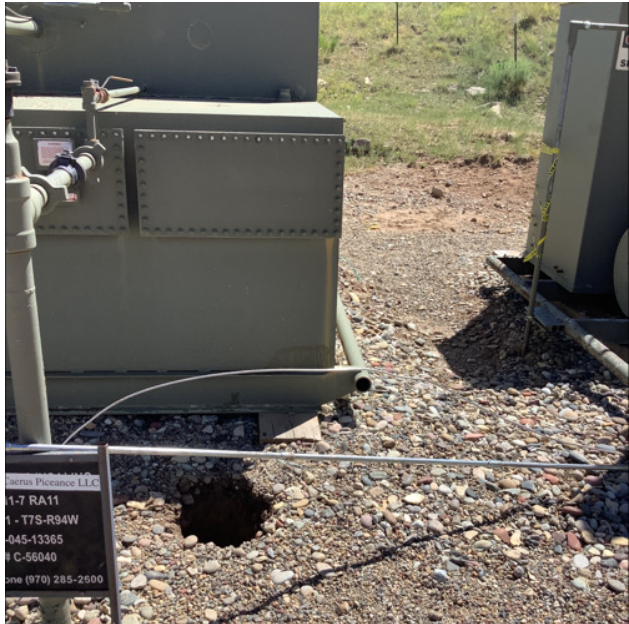
Fig. 6: 20220707_RA11_PH06@6ft

- PH06 is approximately 6 feet west of the north most separator adjacent to PH07. This pothole was field screened at 6 feet bgs. The soil was saturated at 6 feet bgs and a soil sample was collected for lab analysis.

20220707_RA11_PH10@5ft	Spill Area	07/07/2022	12:45 PM	5 to 5	0.5	N	N	Soil is moist. Sample collected.
20220707_RA11_PH06@6ft	Spill Area	07/07/2022	11:10 AM	6 to 6	0.2	N	N	Soil is saturated. Sample collected.

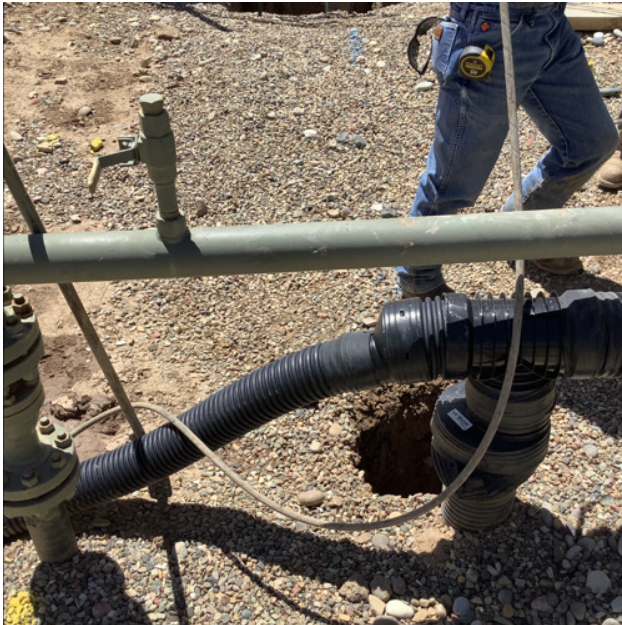
Fig. 7: 20220707_RA11_PH07@9ft

- PH07 is approximately 15 feet north of the POR along the flowline and is to be used for the vertical delineation. This pothole was field screened at 5, 7, and 9 feet bgs. The soil was saturated beginning at 5 feet bgs. A sample was collected at 9 feet bgs for laboratory analysis.

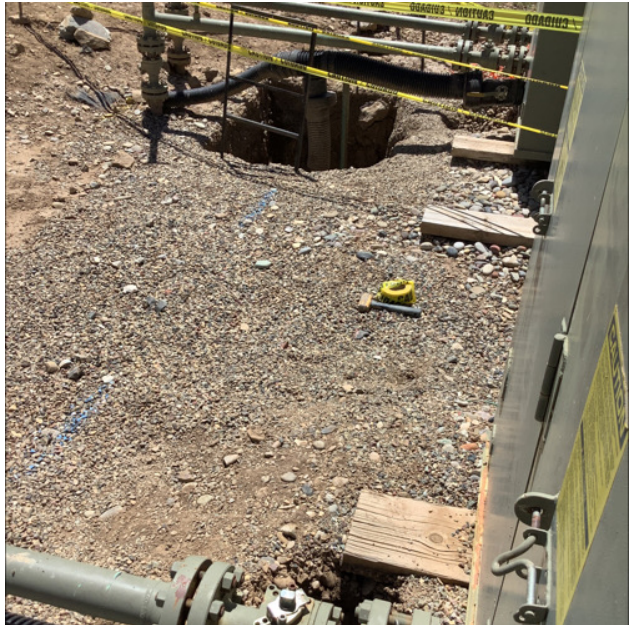
Fig. 8: 20220707_RA11_PH08@5ft

- PH08 is flush against the east side of the north most separator. This pothole was field screened at 5 feet bgs. The soil was saturated. A soil sample was collected for lab analysis.

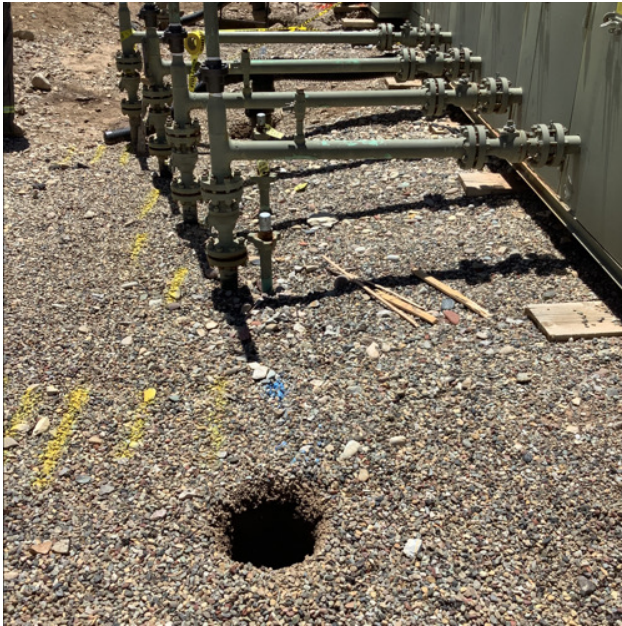
Fig. 9: 20220707_RA11_PH09@5ft

- PH09 is approximately 15 feet north along the flowline from PH07 and is to be used for the north horizontal delineation. The pothole was field screened at 5 feet bgs. The soil was saturated. A sample was collected at 5 feet bgs for laboratory analysis.

Sample ID	Sample Type	Date	Time	Depth	PID (ppmv)	Odor	Staining	Comments
20220707_RA11_PH01@2ft	Spill Area	07/07/2022	08:20 AM	2 to 2	50	N	N	No sample collected.
20220707_RA11_PH01@5ft	Spill Area	07/07/2022	08:43 AM	5 to 5	72	Y	Y	No sample collected.
20220707_RA11_PH02@5ft	Spill Area	07/07/2022	09:20 AM	5 to 5	0.8	N	N	Sample is saturated. Sample collected.
20220707_RA11_PH03@5ft	Spill Area	07/07/2022	09:45 AM	5 to 5	39.1	Y	N	Sample saturated. Sample collected.
20220707_RA11_PH04@5ft	Spill Area	07/07/2022	10:10 AM	5 to 5	76.4	Y	Y	Soil is saturated.
20220707_RA11_PH05@6ft	Spill Area	07/07/2022	10:45 AM	5 to 5	111.1	Y	Y	Soil is drying out. Sample collected.
20220707_RA11_PH07@5ft	Spill Area	07/07/2022	11:29 AM	5 to 5	1946	Y	Y	Very strong hydrocarbon scent.
20220707_RA11_PH08@5ft	Spill Area	07/07/2022	12:10 PM	5 to 5	0.2	N	N	Soil is saturated. Sample collected.
20220707_RA11_PH09@5ft	Spill Area	07/07/2022	12:25 PM	5 to 5	0.2	N	N	Soil is saturated. Sample collected.

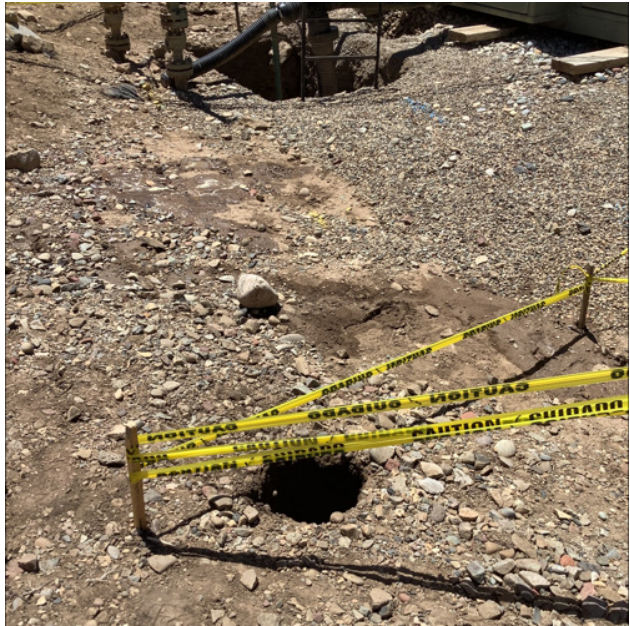
Fig. 10: 20220707_RA11_PH10@5ft

- PH10 is approximately 6 feet east of PH07 and is to be used for the east horizontal delineation. The pothole was field screened at 5 feet bgs. The sample is moist. A sample was collected at 5 feet bgs for laboratory analysis.
