Site Inspection Report

Site: RODGERS #1 FLOWLINE
08/30/2022

SITE/LOCATION	DATE	TIME	INSPECTOR
RODGERS #1 FLOWLINE	08/30/2022	12:23 PM	COGCC Representative
Comments			
Work Activity Notes	Excavation crew, KPK		
Changes since previous inspection?	No	Drive by inspection	No
Actively being worked?	Yes		
Fieldwork Oversight Performed?	No	Oversight Type	
Were Oversight Samples Collected?	No	Sample Details

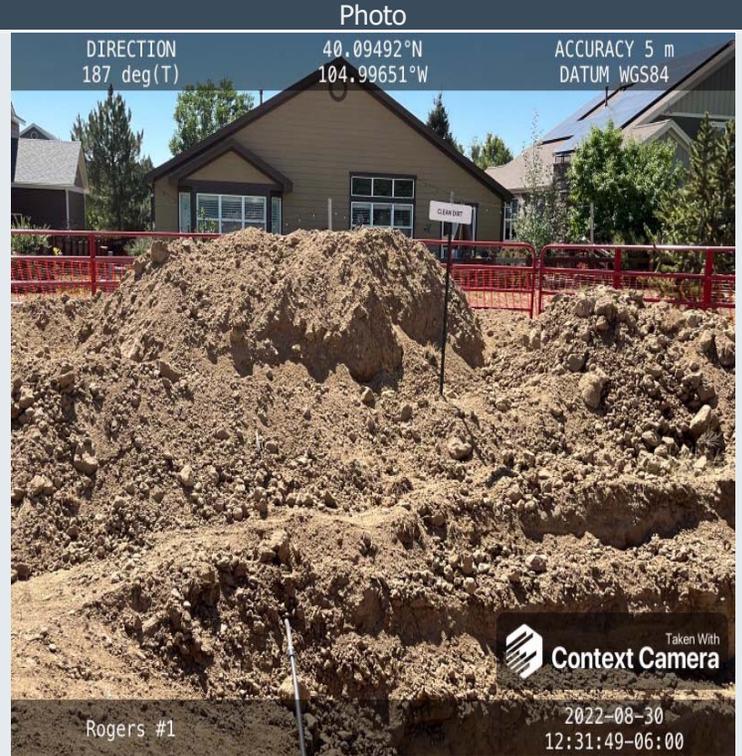
Question: E&P waste signage present, legible, accurate and up to date (labelled per KPK CWMP)?

Response: Yes

Notes: Clean soil signage, contaminated soil being hauled off as it is excavated

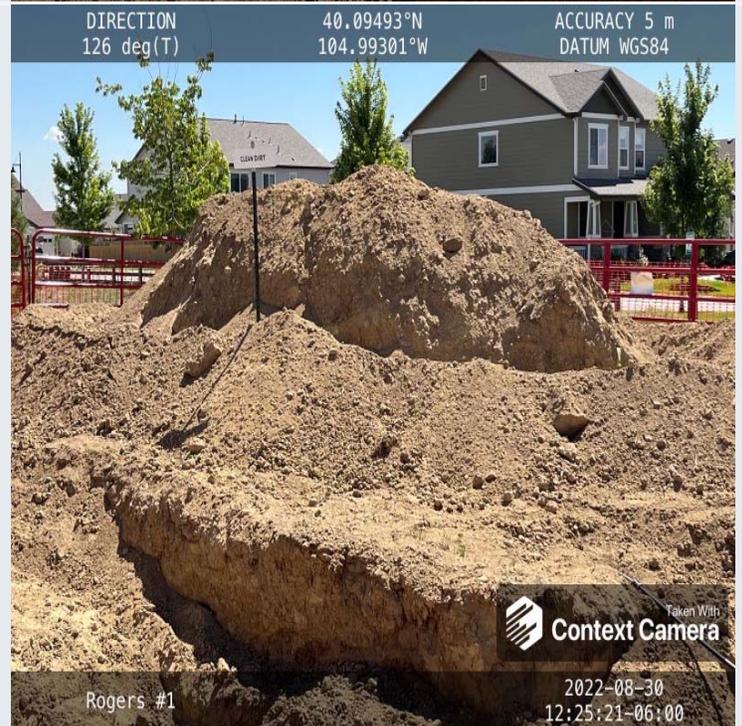
Question: E&P waste signage present, legible, accurate and up to date (labelled per KPK CWMP)?

Response: Yes

Notes: Clean soil signage, contaminated soil being hauled off as it is excavated

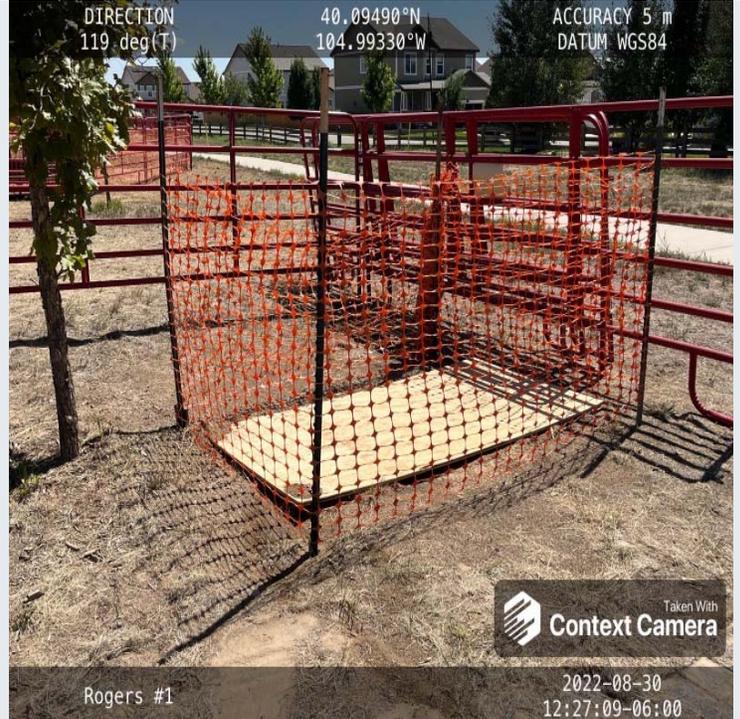
Question: Open excavation properly fenced/covered (in accordance with Rule 913.b.(5)B.i.)?

Response: Yes

Notes: All excavations fenced besides for spill excavation which is currently being worked on

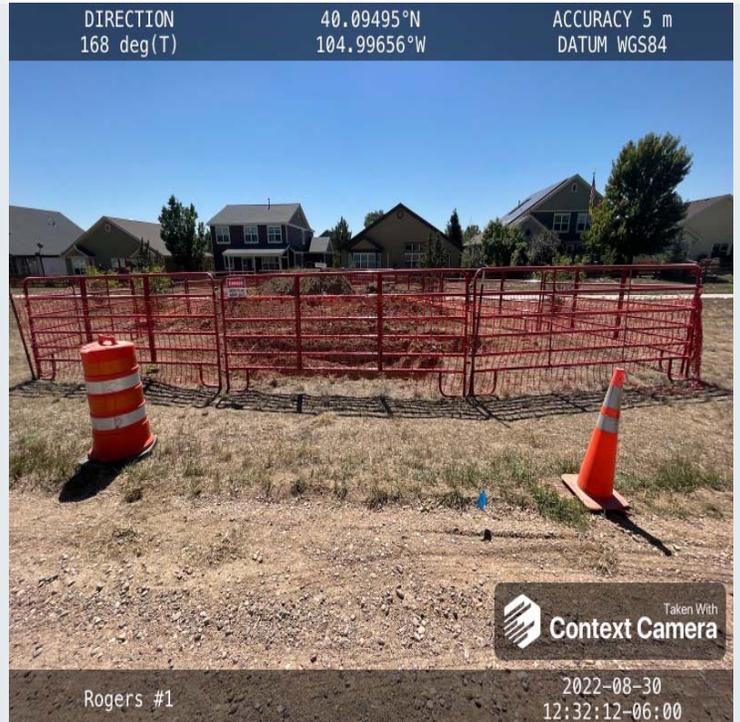
Question: Open excavation properly fenced/covered (in accordance with Rule 913.b.(5)B.i.)?

Response: Yes

Notes: All excavations fenced besides for spill excavation which is currently being worked on

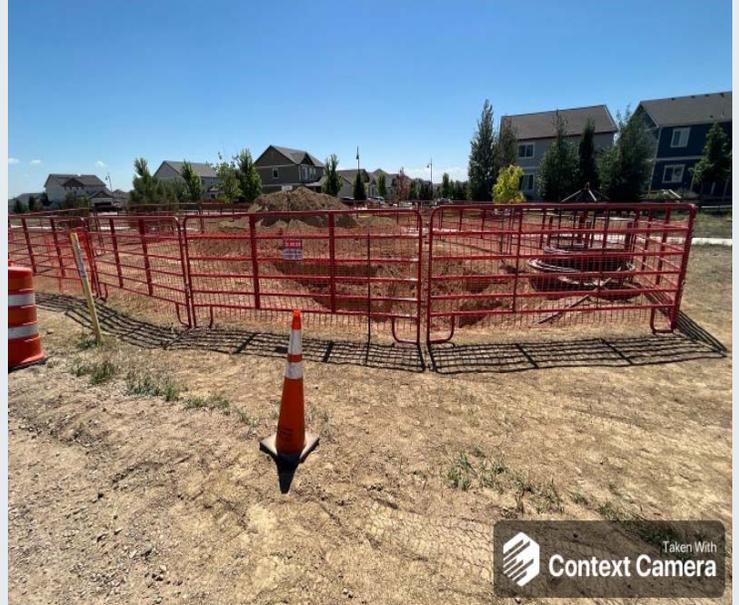
Question: Open excavation properly fenced/covered (in accordance with Rule 913.b.(5)B.i.)?

Response: Yes

Notes: All excavations fenced besides for spill excavation which is currently being worked on

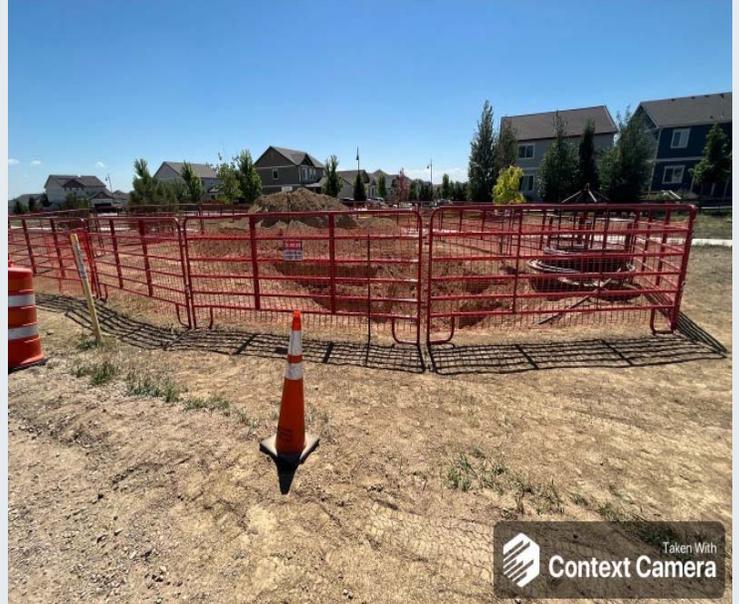
Question: Is fencing adequate/appropriate for site and well(s) and maintained?

Response: Yes

Notes: No fencing around spill excavation, currently being worked on while on-site

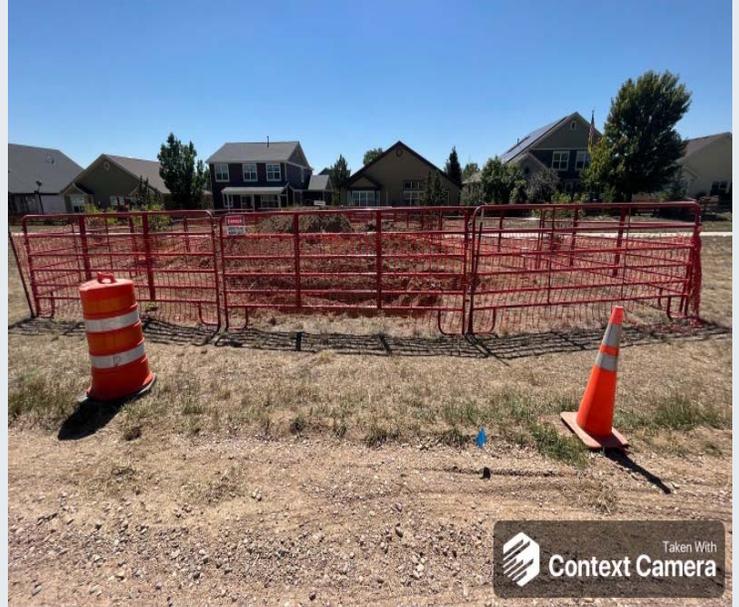
Question: Is fencing adequate/appropriate for site and well(s) and maintained?

Response: Yes

Notes: No fencing around spill excavation, currently being worked on while on-site

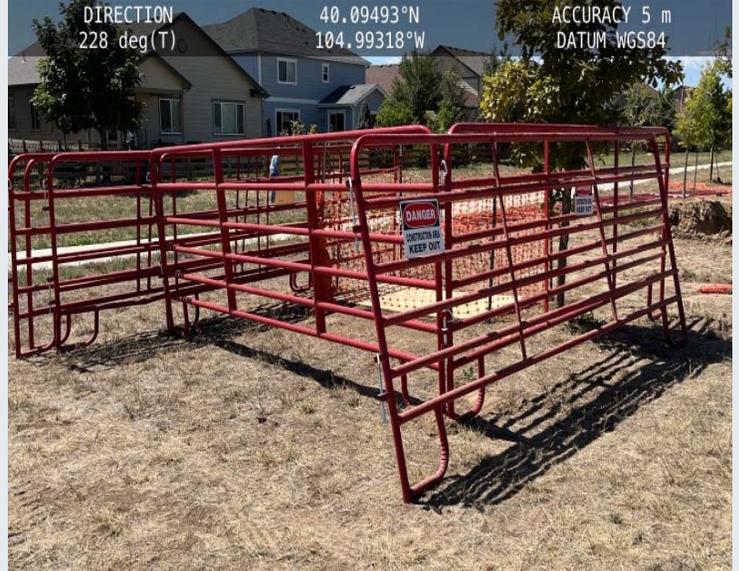
Question: Is fencing adequate/appropriate for site and well(s) and maintained?

Response: Yes

Notes: No fencing around spill excavation, currently being worked on while on-site

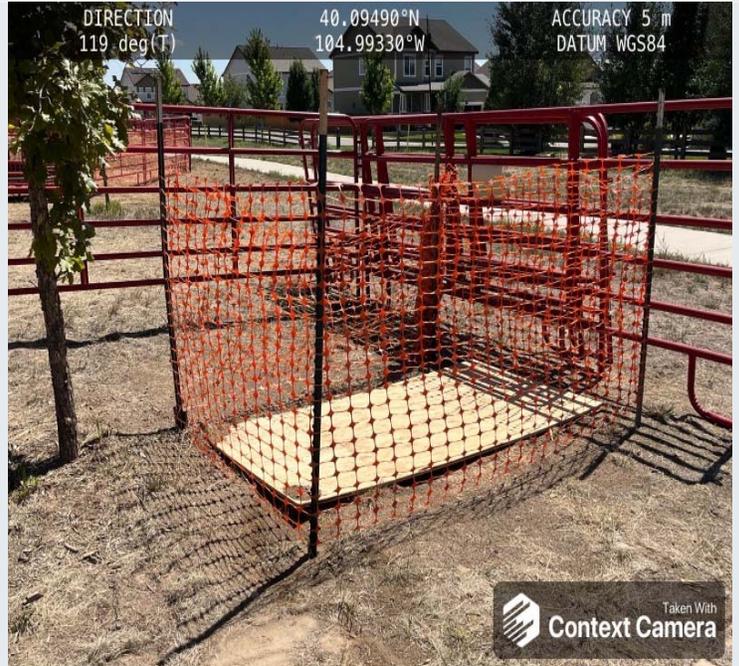
Question: Is fencing adequate/appropriate for site and well(s) and maintained?

Response: Yes

Notes: No fencing around spill excavation, currently being worked on while on-site

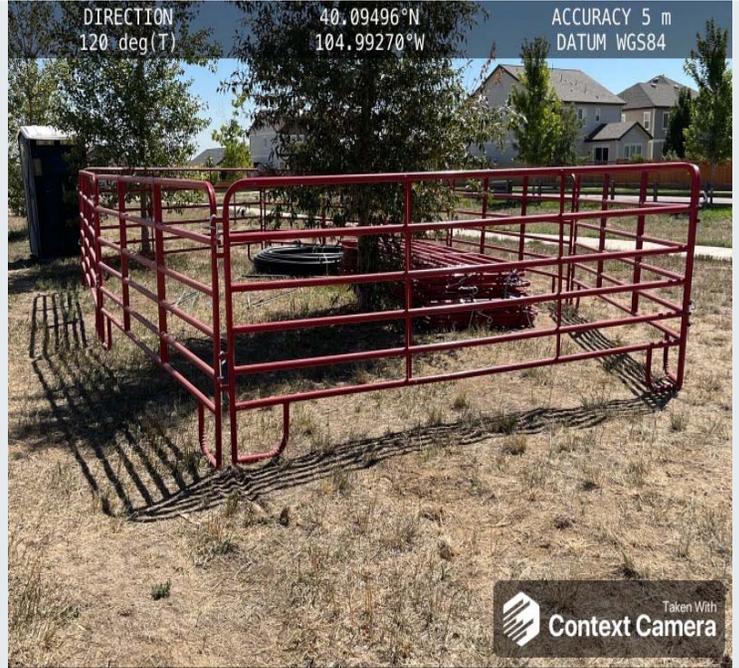
Question: Is fencing adequate/appropriate for site and well(s) and maintained?

Response: Yes

Notes: No fencing around spill excavation, currently being worked on while on-site

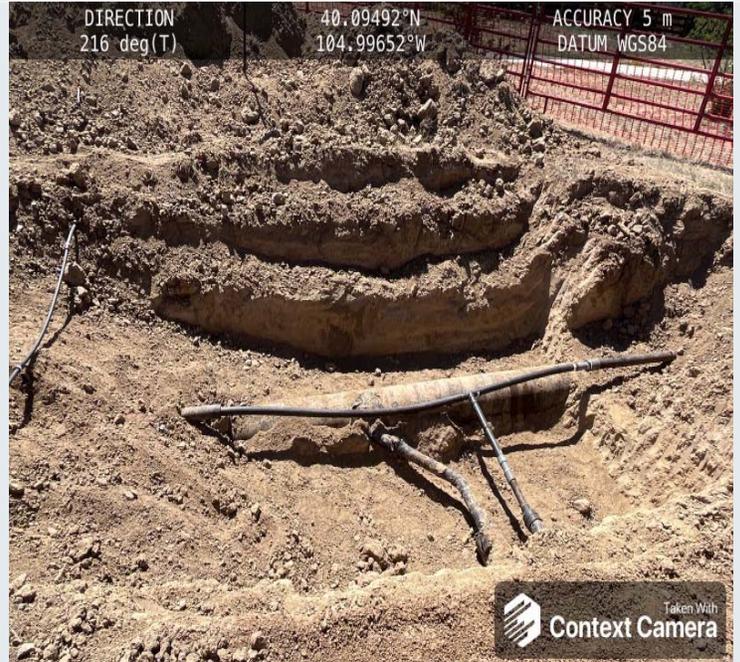
Question: Exposed buried/underground flowlines within excavation?

Response: Yes

Notes: Exposed flow line in all 4 excavations

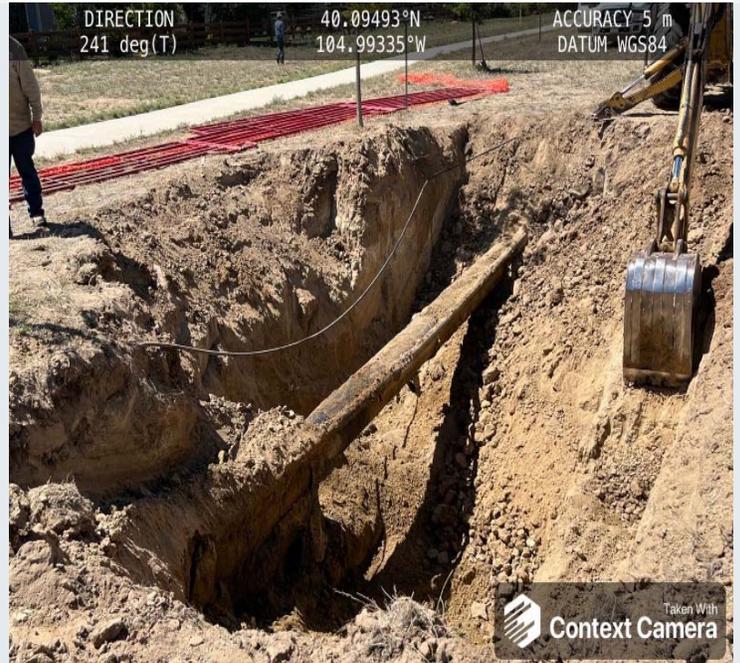
Question: Exposed buried/underground flowlines within excavation?

Response: Yes

Notes: Exposed flow line in all 4 excavations

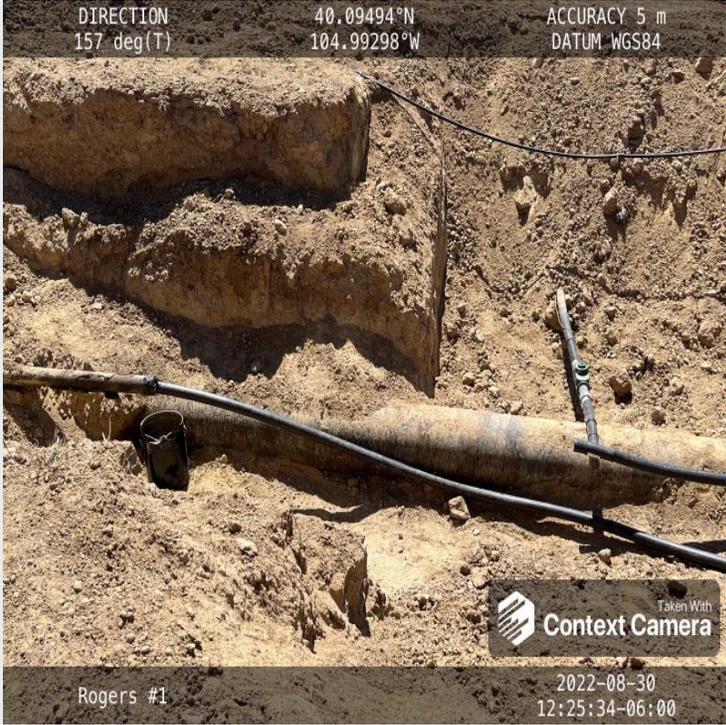
Photo
<p>Question: Exposed buried/underground flowlines within excavation?</p> <p>Response: Yes</p> <p>Notes: Exposed flow line in all 4 excavations</p>

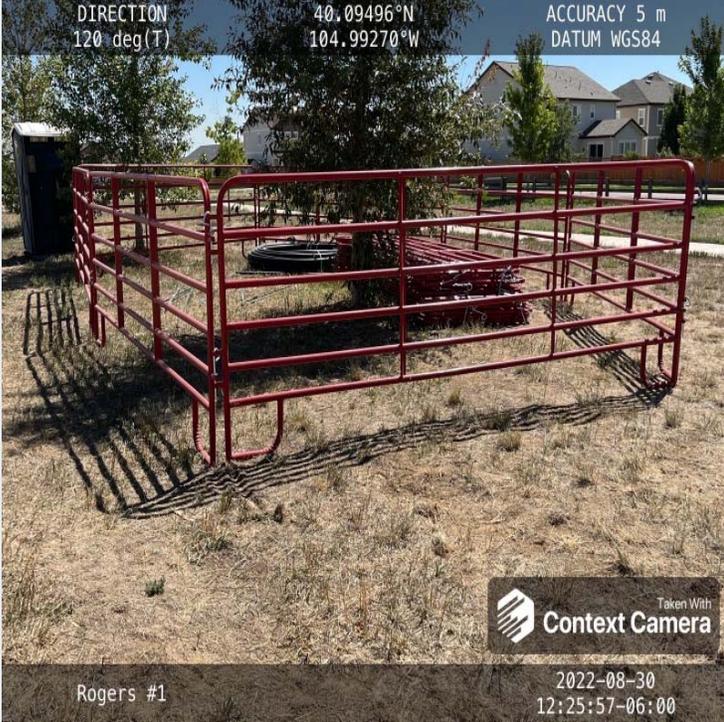
General Site - Equipment area

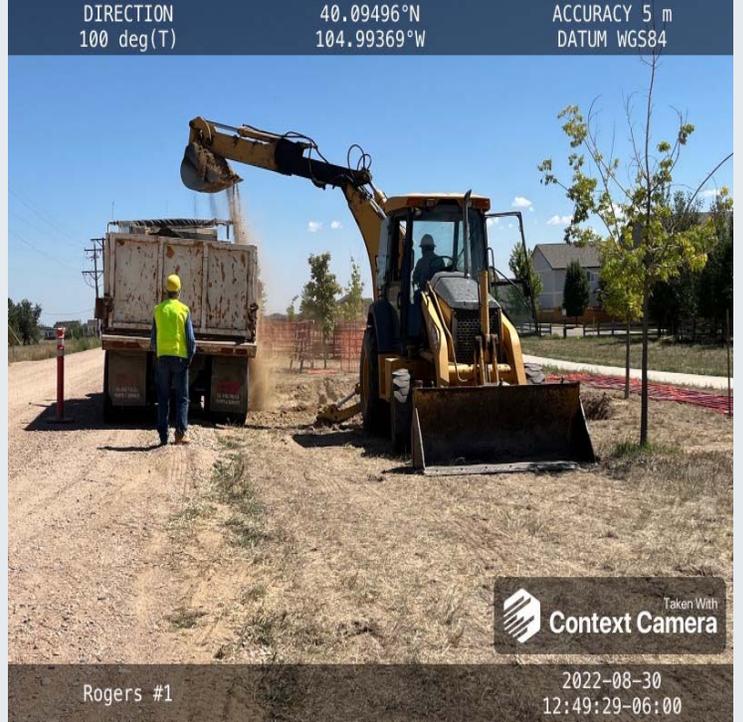
General Site - Equipment/trucks on-site
