Site Inspection Report

Site: RODGERS #1 FLOWLINE
09/01/2022

SITE INSPECTION REPORT

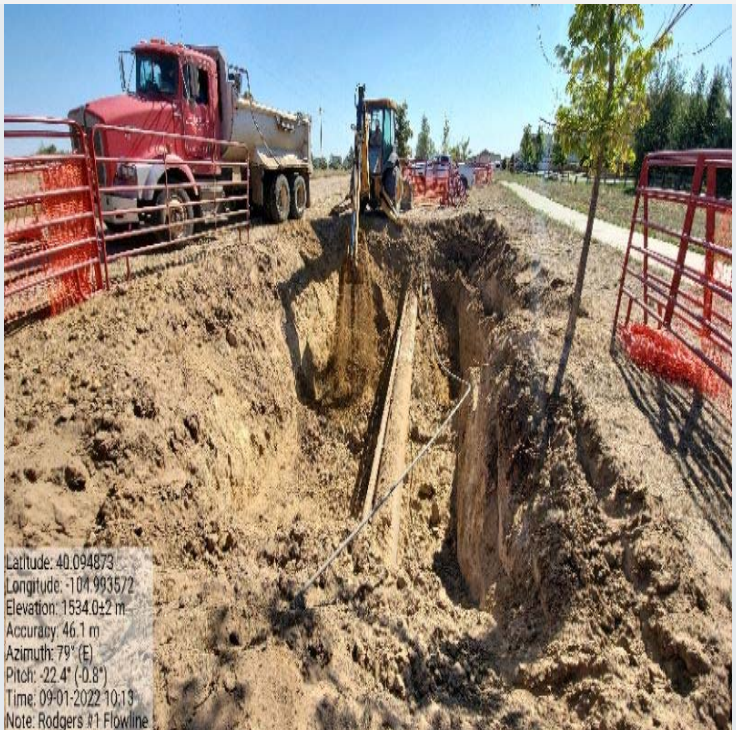
Remediation Activity Checklist	
	Photo
<p>Question: Open excavation(s)? Note: Approximate size(s) (Length x Width x Depth, ft)</p> <p>Response: Yes</p> <p>Notes: 4</p>

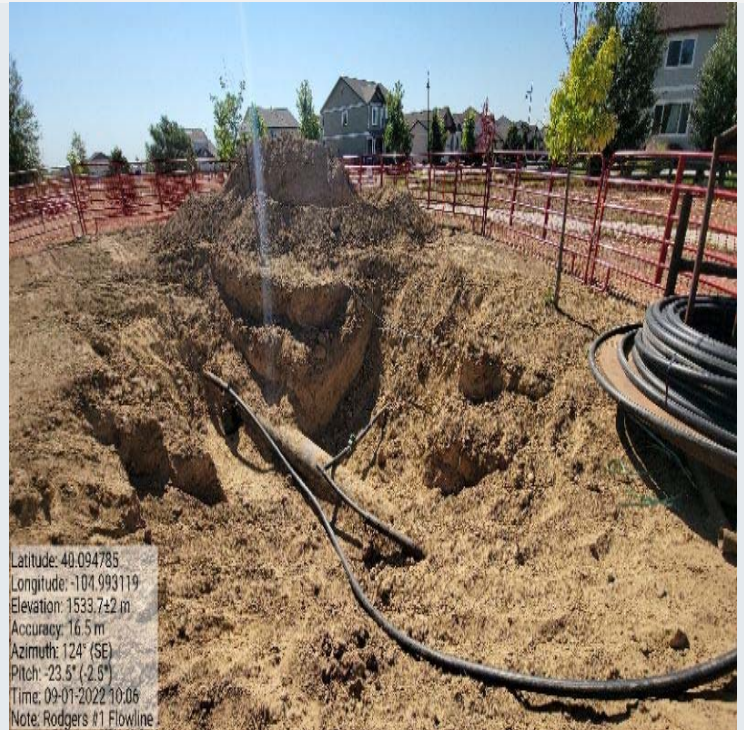
Question: Open excavation(s)? Note: Approximate size(s)
(Length x Width x Depth, ft)

Response: Yes

Notes: 4

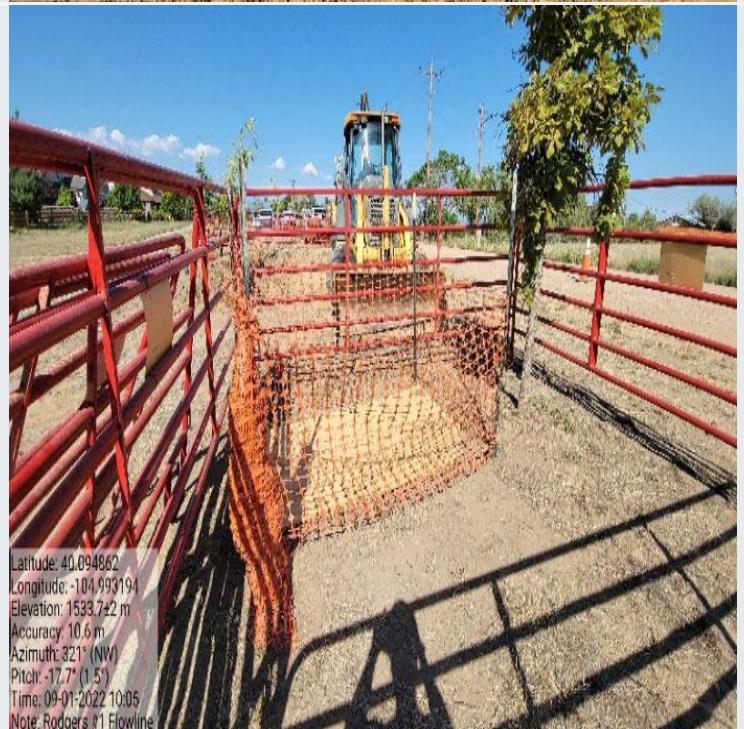
Question: Open excavation(s)? Note: Approximate size(s)
(Length x Width x Depth, ft)

Response: Yes

Notes: 4

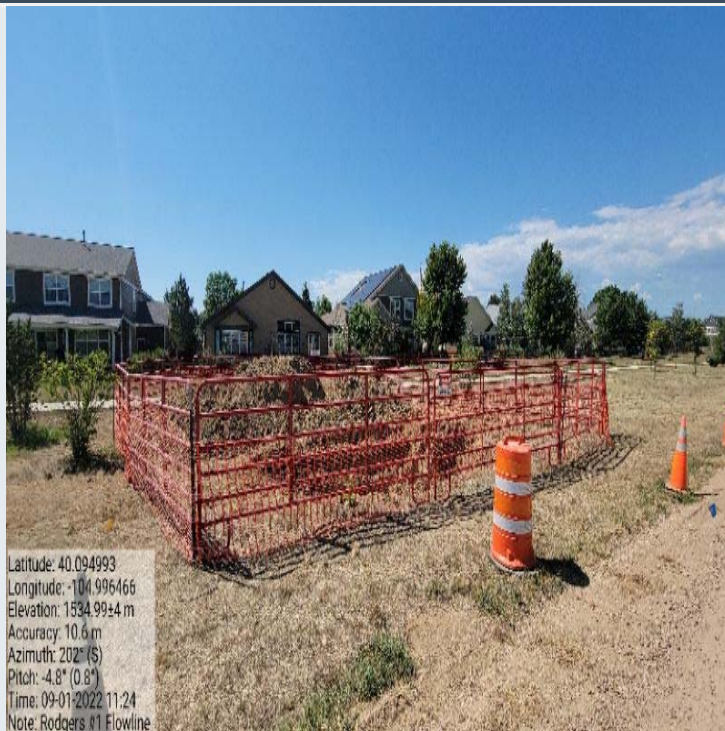
Question: Open excavation(s)? Note: Approximate size(s) (Length x Width x Depth, ft)

Response: Yes

Notes: 4

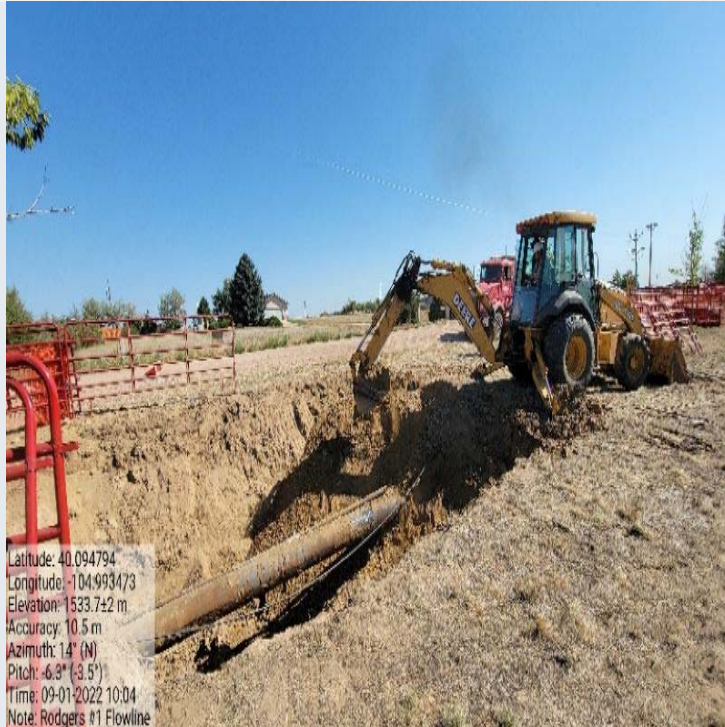
Question: Open excavation(s)? Note: Approximate size(s) (Length x Width x Depth, ft)

Response: Yes

Notes: 4

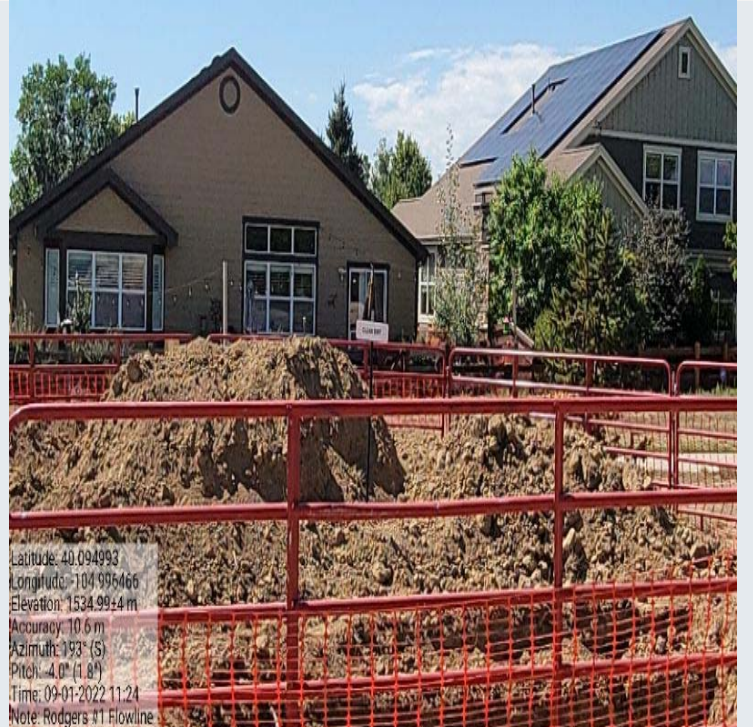
Photo
Question: E&P waste signage present, legible, accurate and up to date (labelled per KPK CWMP)? Response: Yes Notes: Clean.

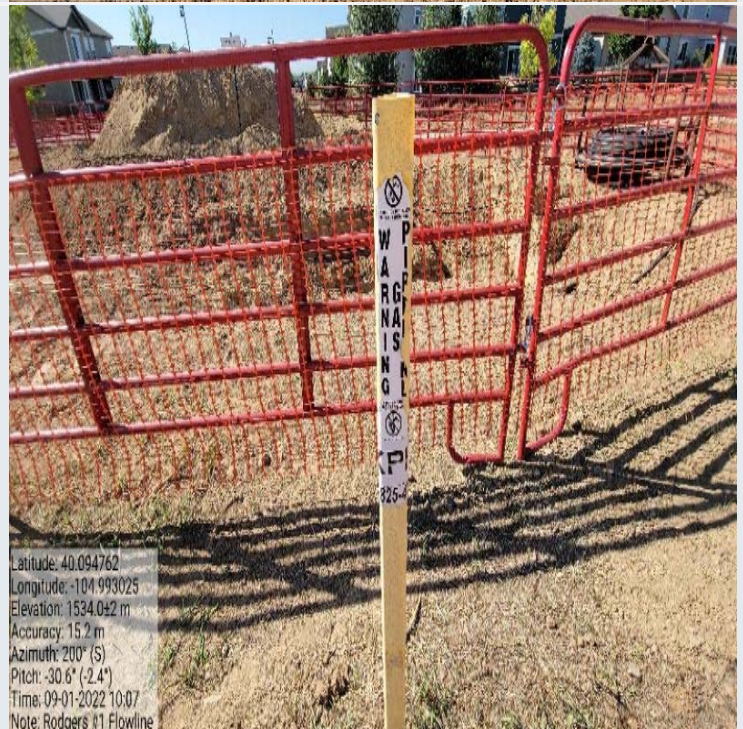
Question: Emergency signage in compliance with 605.g.?
Note: Location of signage - Location entrance, Tank Battery, Wellhead(s).

Notes: Emergency signage was added.

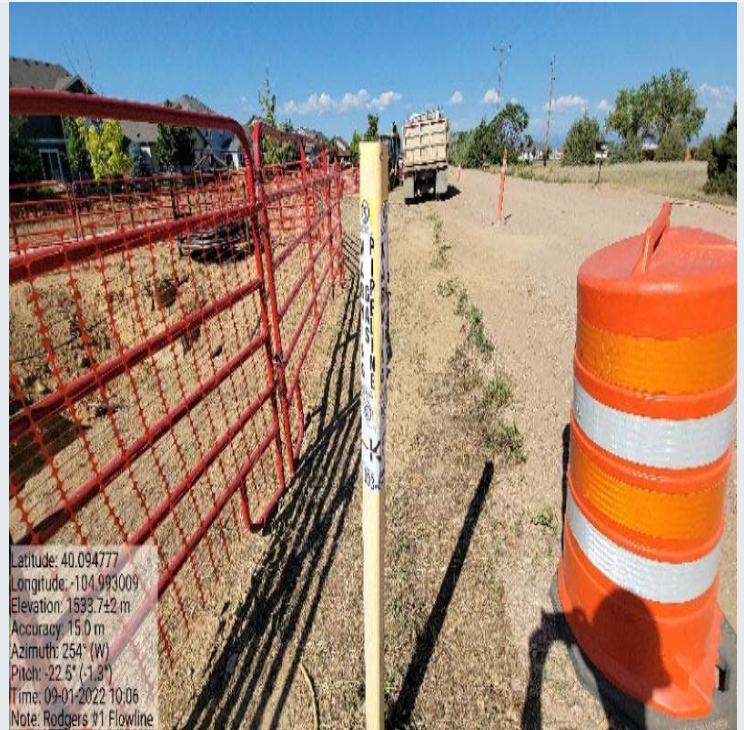
Question: Emergency signage in compliance with 605.g.?
Note: Location of signage - Location entrance, Tank Battery, Wellhead(s).

Notes: Emergency signage was added

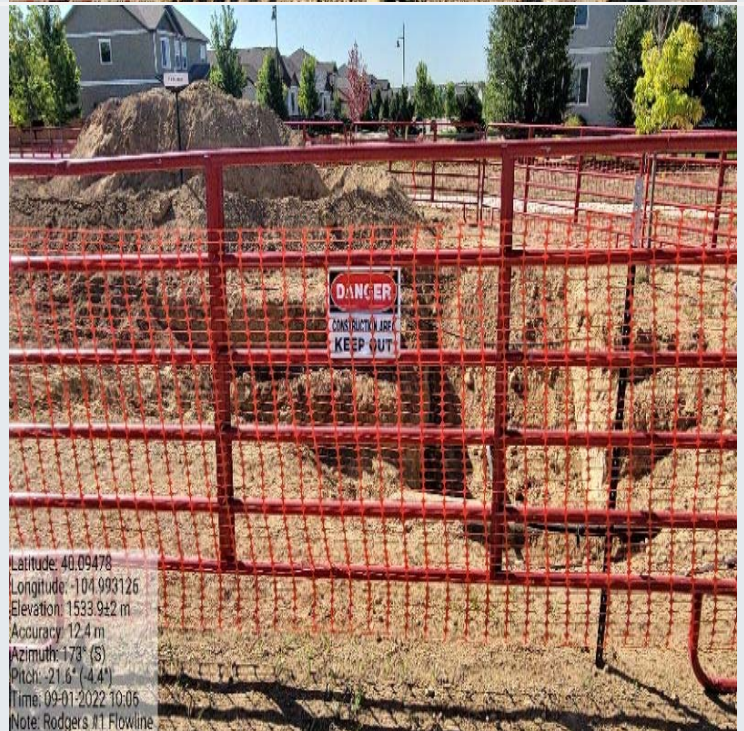
Question: Emergency signage in compliance with 605.g.?
Note: Location of signage - Location entrance, Tank Battery, Wellhead(s).

Notes: Emergency signage was added.

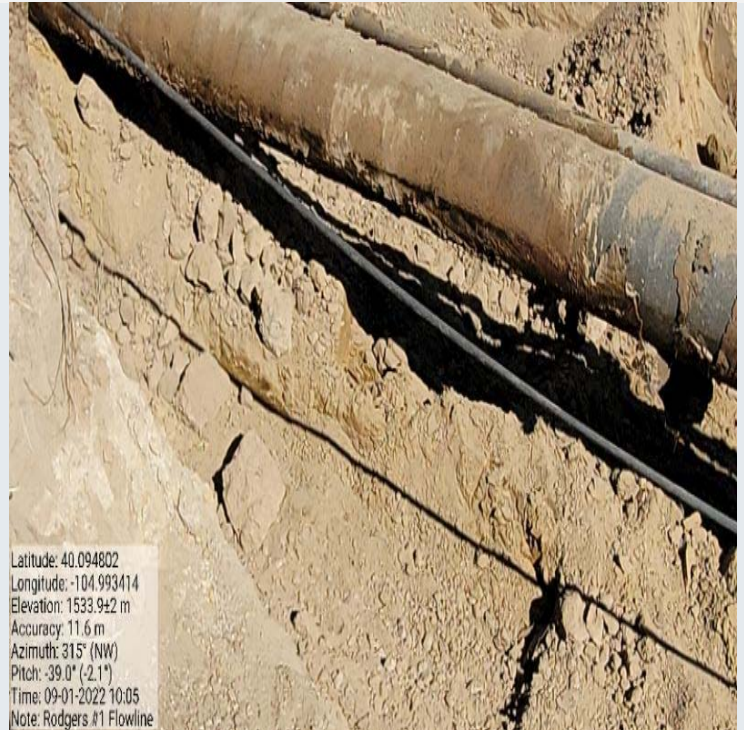
Question: Ground surface appears clean (no evidence of new equipment leaks, oil leaks, spills, or releases)?

Response: No

Notes: Staining is still visible within the spill excavation

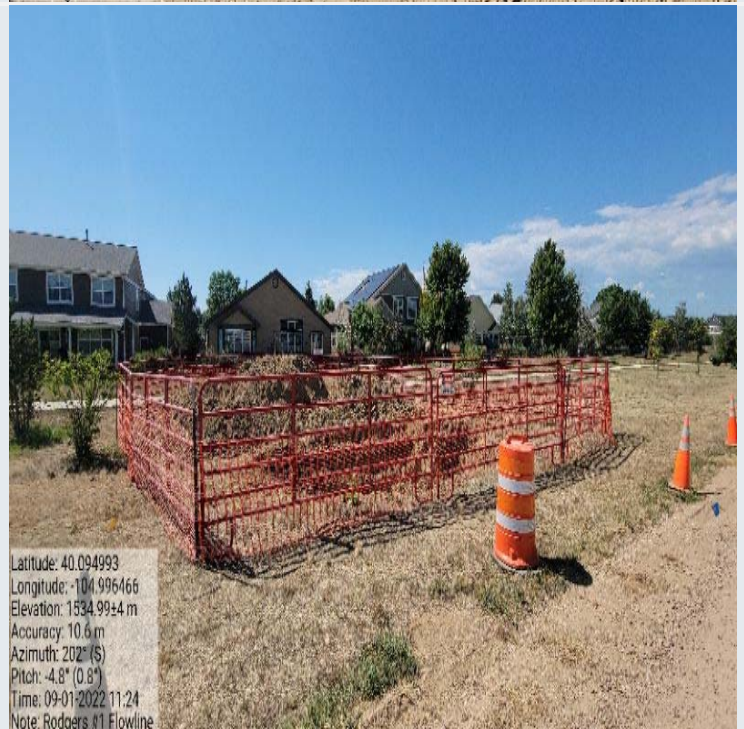
Question: Open excavation properly fenced/covered (in accordance with Rule 913.b.(5)B.i.)?

Response: Yes

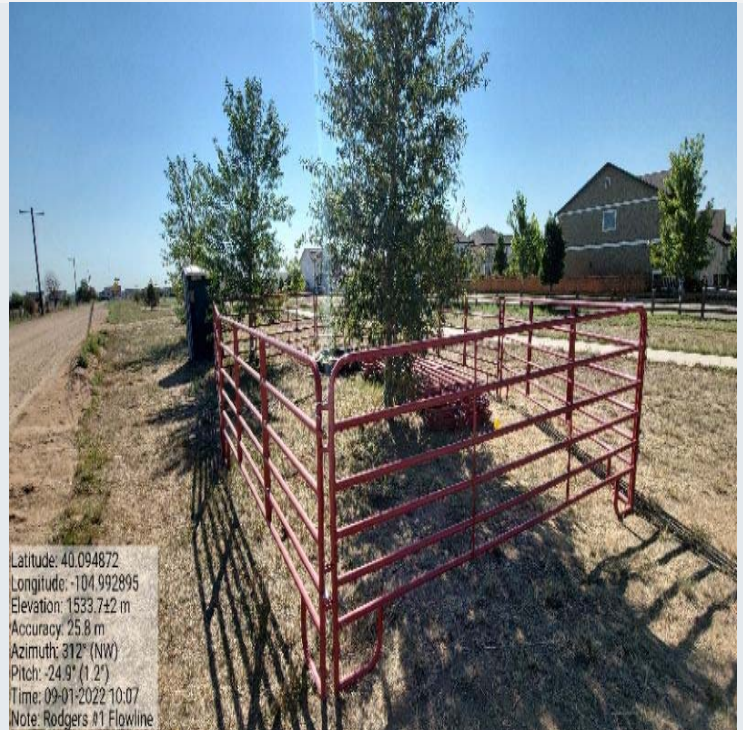
Question: Open excavation properly fenced/covered (in accordance with Rule 913.b.(5)B.i.)?

Response: Yes

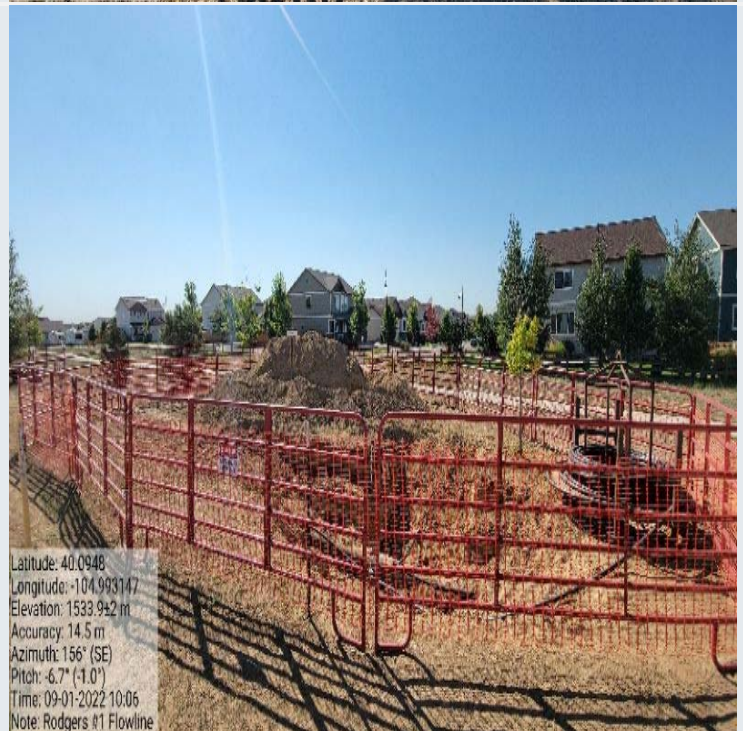
Question: Open excavation properly fenced/covered (in accordance with Rule 913.b.(5)B.i.)?

Response: Yes

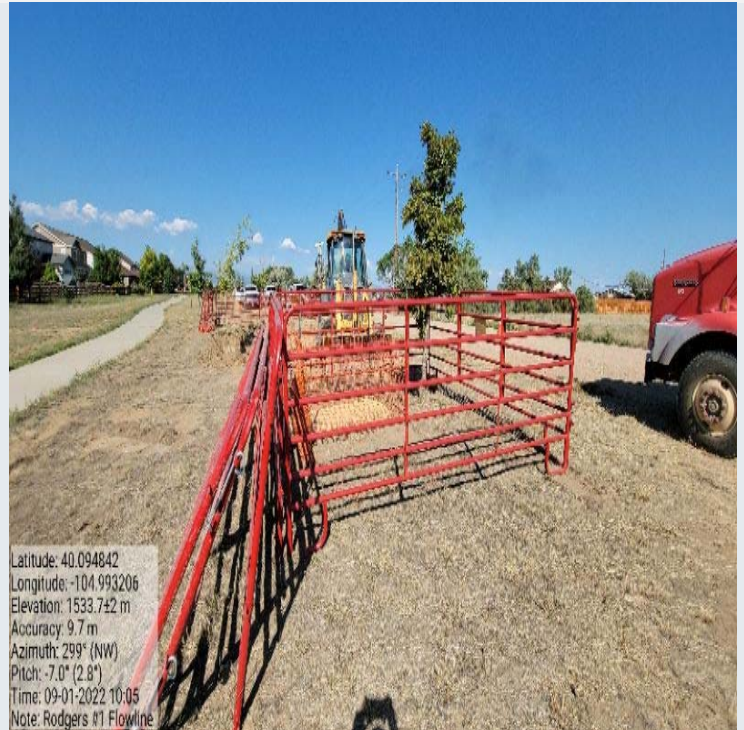
Question: Open excavation properly fenced/covered (in accordance with Rule 913.b.(5)B.i.)?

Response: Yes

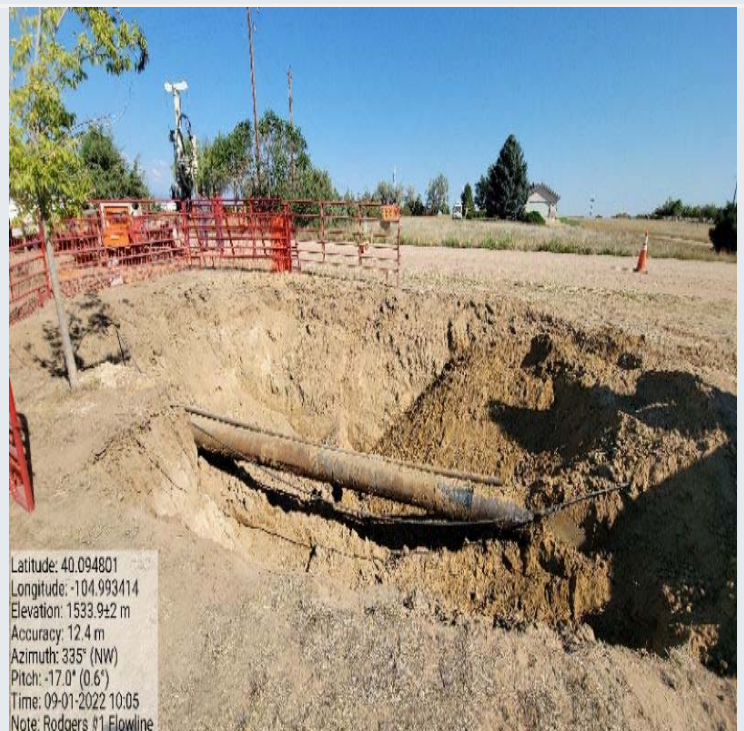
Question: Exposed buried/underground flowlines within excavation?

Response: Yes

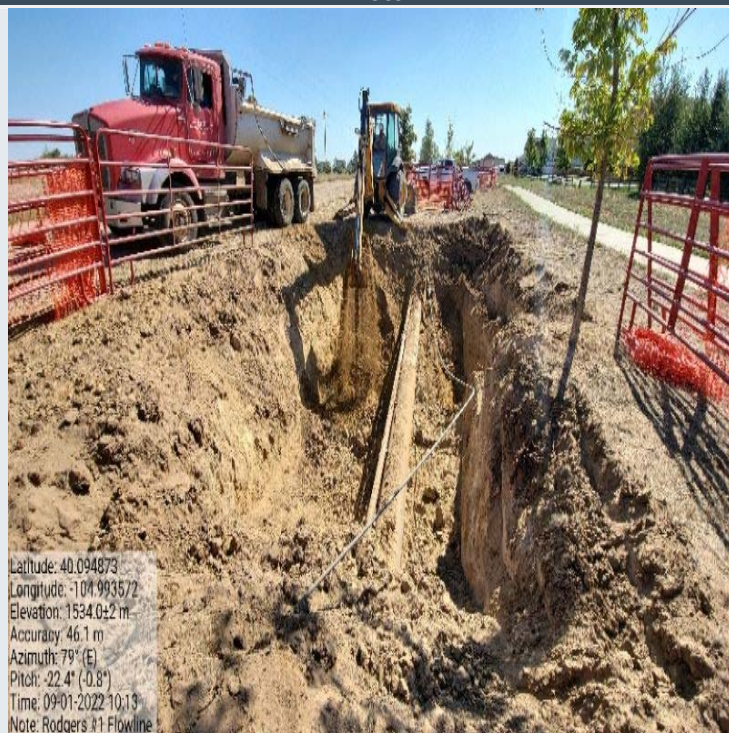
Question: Exposed buried/underground flowlines within excavation?

Response: Yes

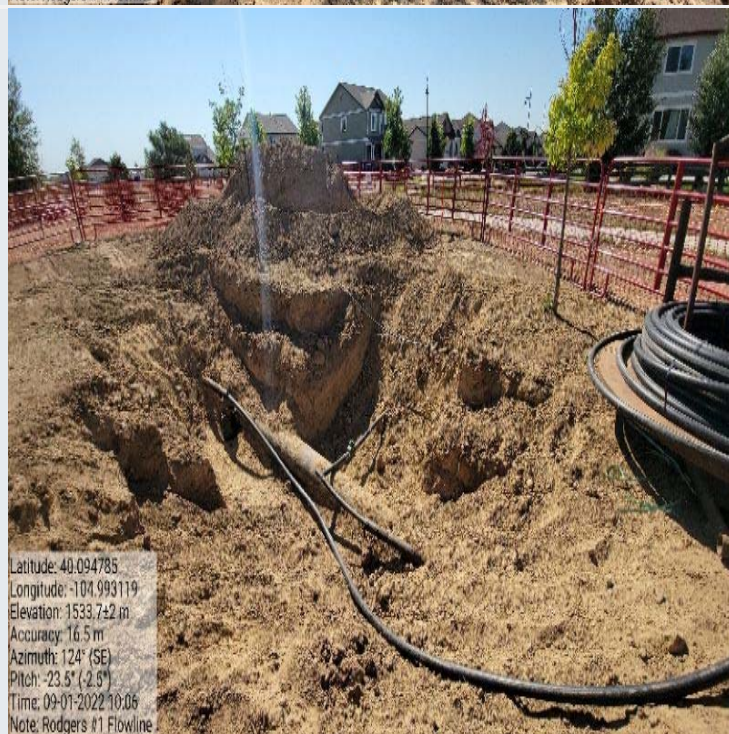
Question: If flowlines are exposed are they properly capped (bullnose plug, etc.)?

Response: Yes

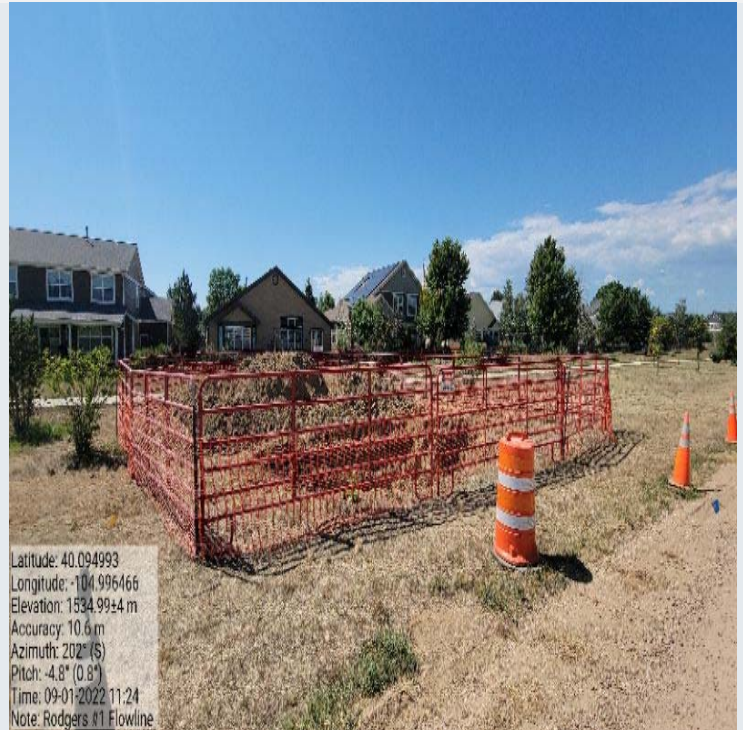
Question: Site is protected from vehicular traffic (properly fenced, gated or barricaded)?

Response: Yes

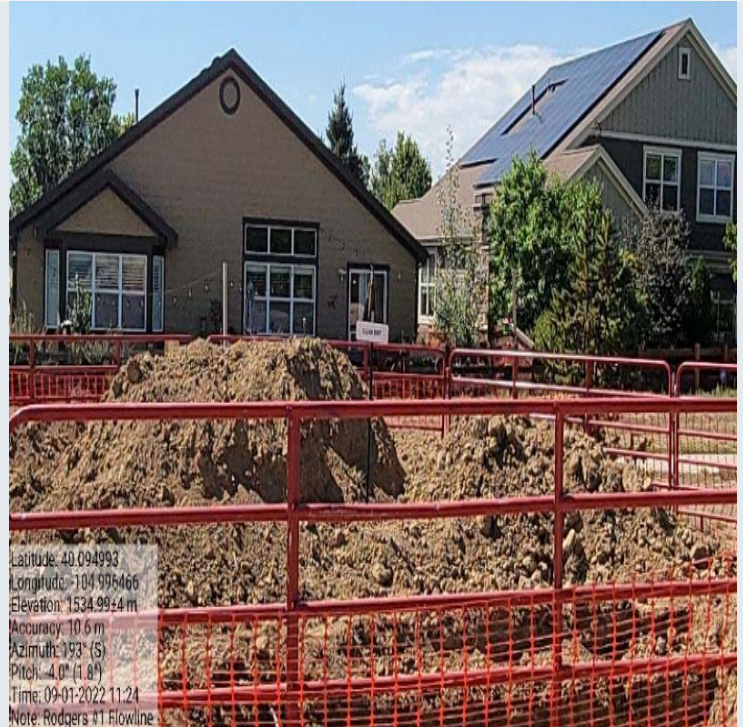
Question: Is earthen berm secondary containment present and in good condition (compacted, complete, no evidence of erosion, animal burrowing, etc.)?

Response: Yes

Notes: Around clean stockpile

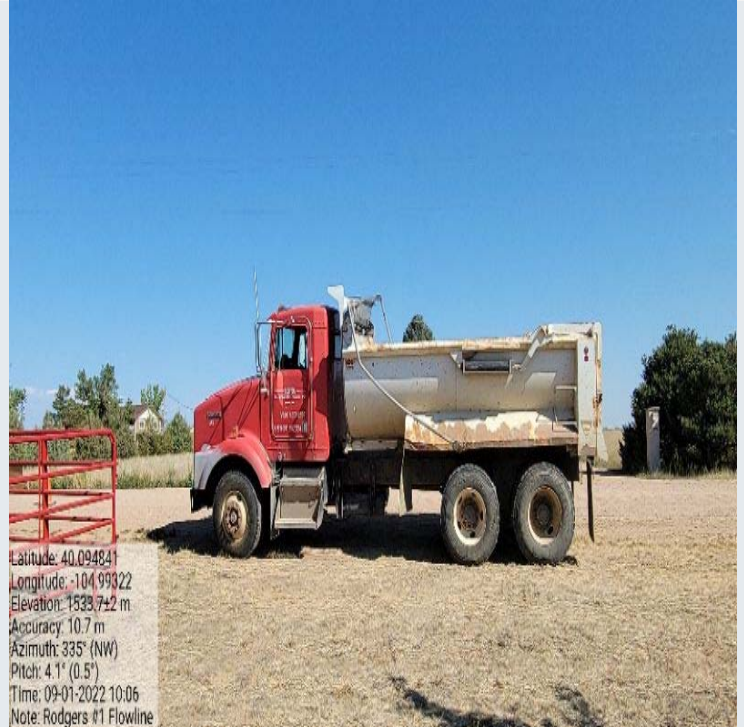
Question: Stockpiled waste stored and handled in compliance with Rule 913.b.(5).B.iv.?

Notes: All stockpiled waste is being removed immediately from the site

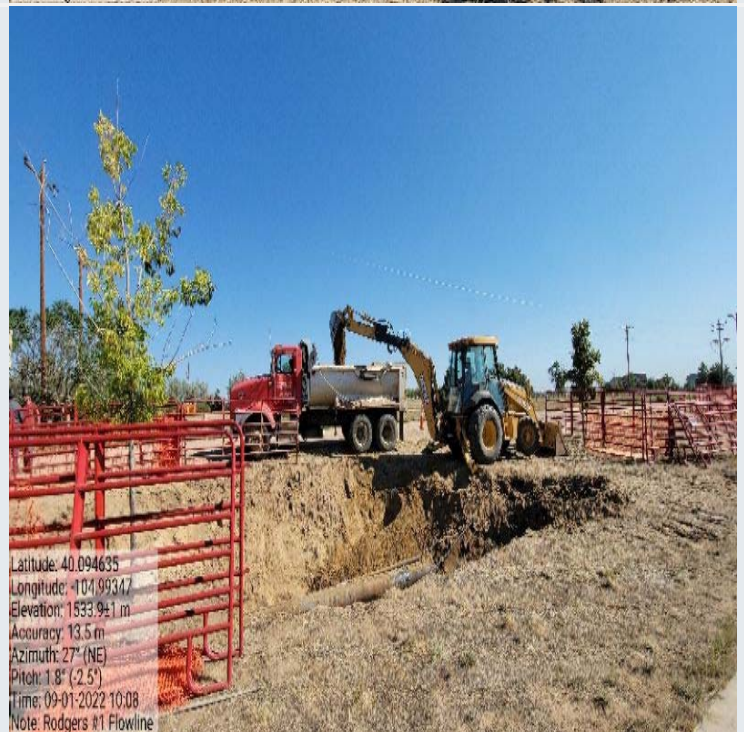
Question: Stockpiled waste stored and handled in compliance with Rule 913.b.(5).B.iv.?

Notes: All stockpiled waste is being removed immediately from the site
