Site Inspection Report

Site: RODGERS #1 FLOWLINE
09/06/2022

SITE/LOCATION	DATE	TIME	INSPECTOR
RODGERS #1 FLOWLINE	09/06/2022	12:32 PM	COGCC Representative
Comments			
Work Activity Notes			
Changes since previous inspection?	Yes	Drive by inspection	No
Actively being worked?	No		
Fieldwork Oversight Performed?	No	Oversite Type	
Were Oversight Samples Collected?	No	Sample Details

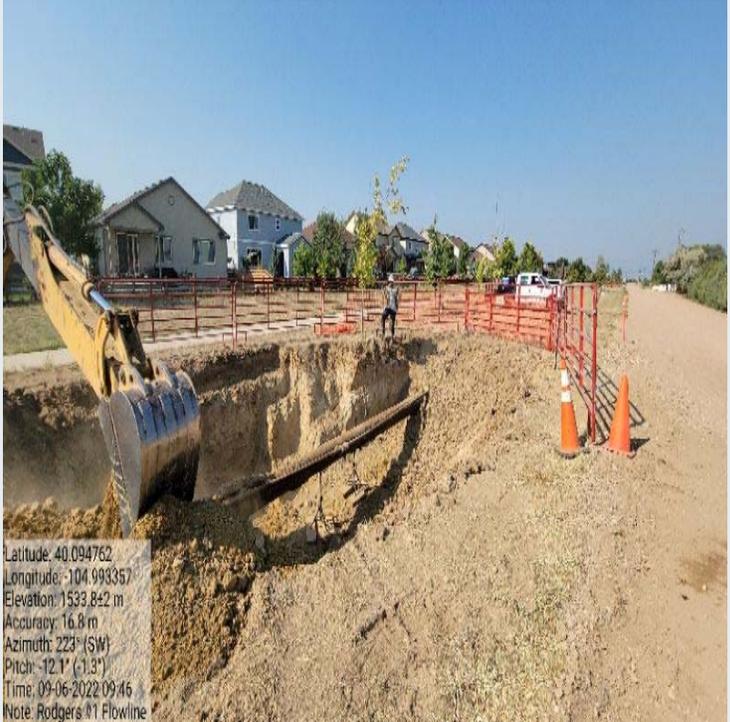
Photo
<p>Question: Open excavation(s)? Note: Approximate size(s) (Length x Width x Depth, ft)</p> <p>Response: Yes</p> <p>Notes: Spill excavation has consolidation into one larger excavation. 52'x31'x8'. The other excavations at the ends of the flowline remain unchanged</p>

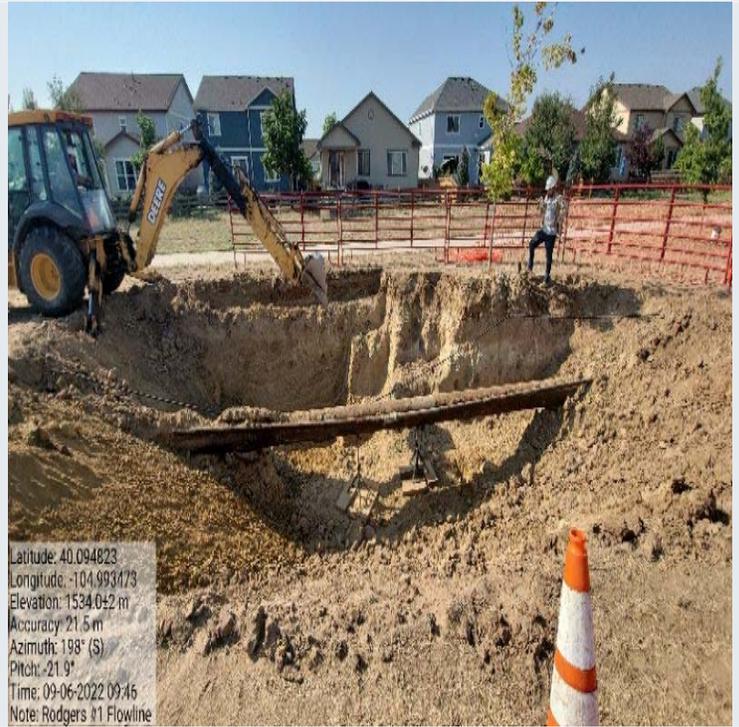
Question: Open excavation(s)? Note: Approximate size(s) (Length x Width x Depth, ft)

Response: Yes

Notes: Spill excavation has consolidation into one larger excavation. 52'x31'x8'.

The other excavations at the ends of the flowline remain unchanged

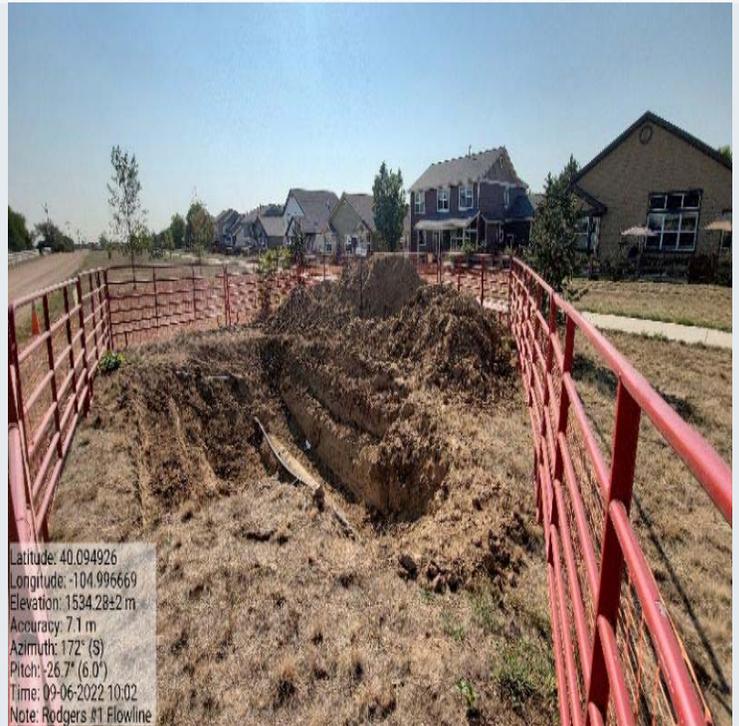
Question: Open excavation(s)? Note: Approximate size(s) (Length x Width x Depth, ft)

Response: Yes

Notes: Spill excavation has consolidation into one larger excavation. 52'x31'x8'.

The other excavations at the ends of the flowline remain unchanged

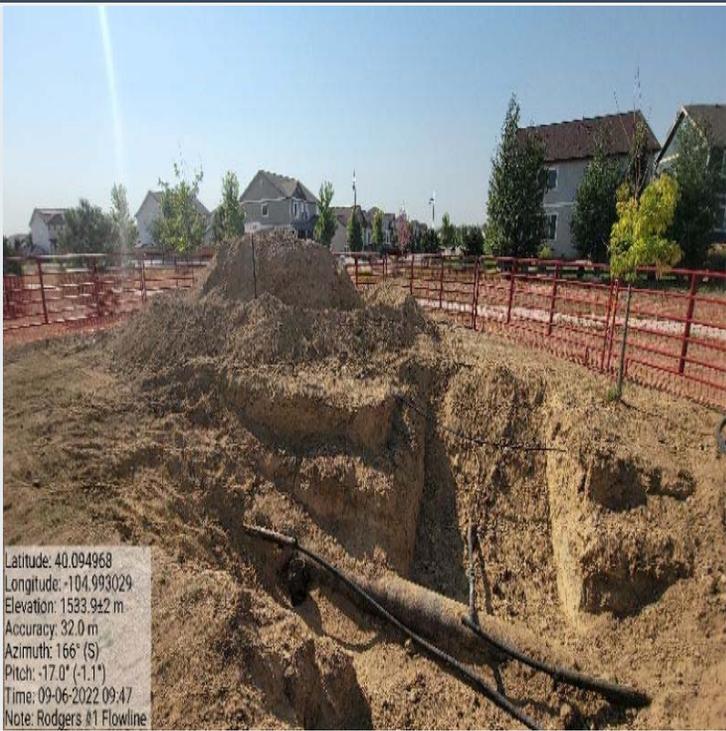
Photo
<p>Question: Open excavation(s)? Note: Approximate size(s) (Length x Width x Depth, ft) Response: Yes Notes: Spill excavation has consolidation into one larger excavation. 52'x31'x8'. The other excavations at the ends of the flowline remain unchanged</p>

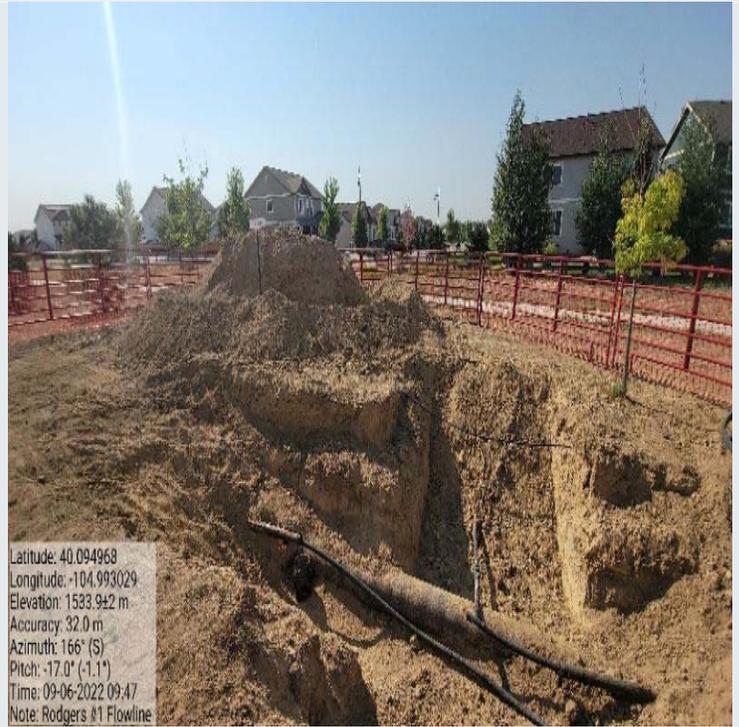
Question: E&P waste signage present, legible, accurate and up to date (labelled per KPK CWMP)?

Response: Yes

Notes: Clean dirt. All impacted soil is being hauled off immediately

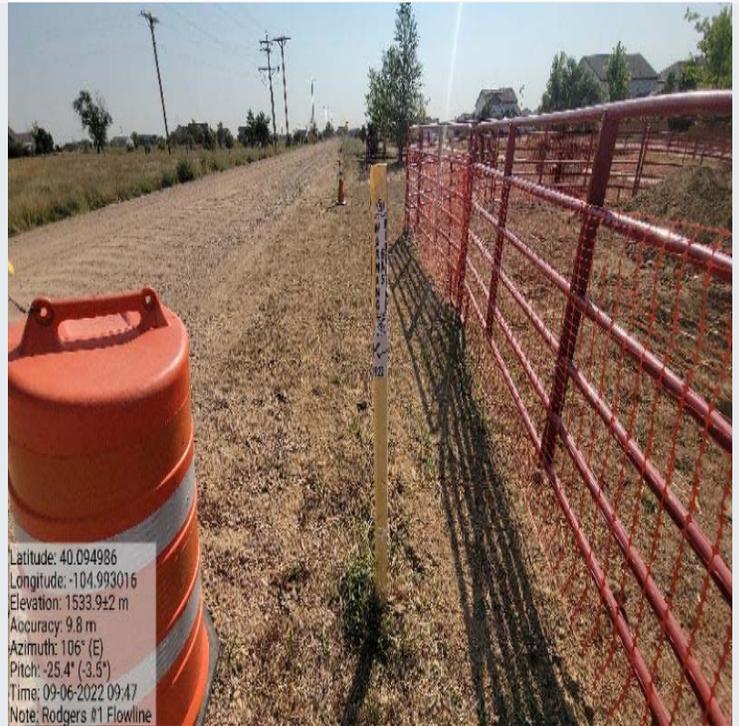
Question: Emergency signage in compliance with 605.g.?
Note: Location of signage - Location entrance, Tank Battery, Wellhead(s).

Response: Yes

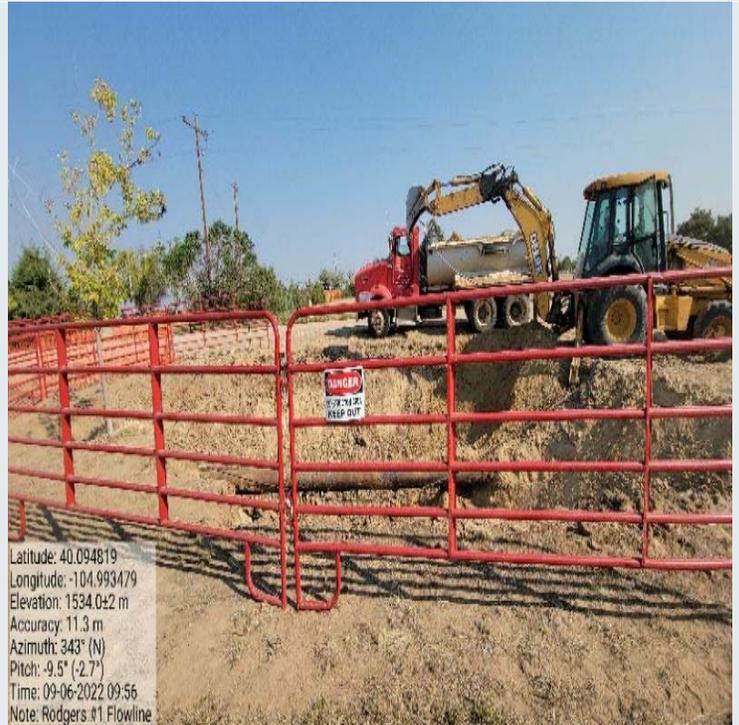
Question: Emergency signage in compliance with 605.g.?
Note: Location of signage - Location entrance, Tank Battery, Wellhead(s).
Response: Yes
Notes:

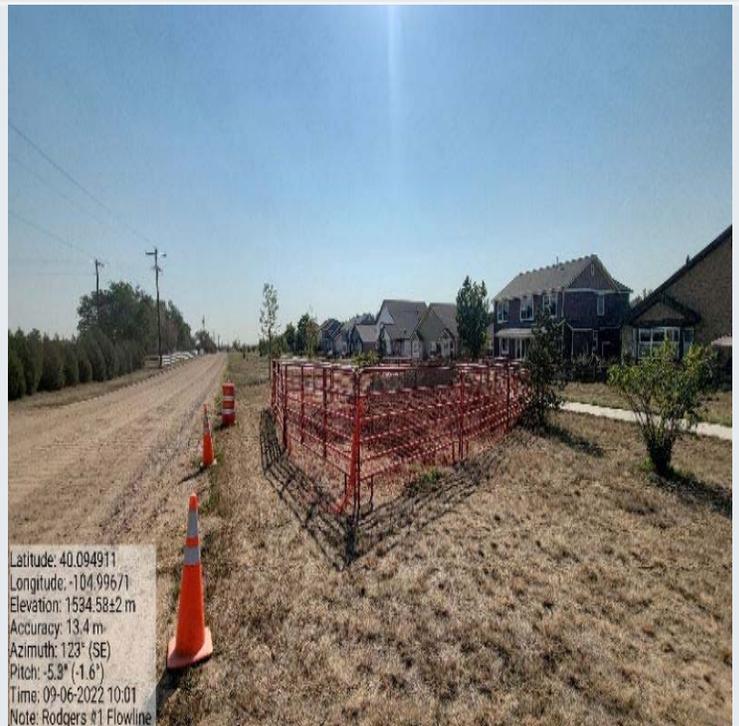
Question: Open excavation properly fenced/covered (in accordance with Rule 913.b.(5)B.i.)?
Response: Yes
Notes:

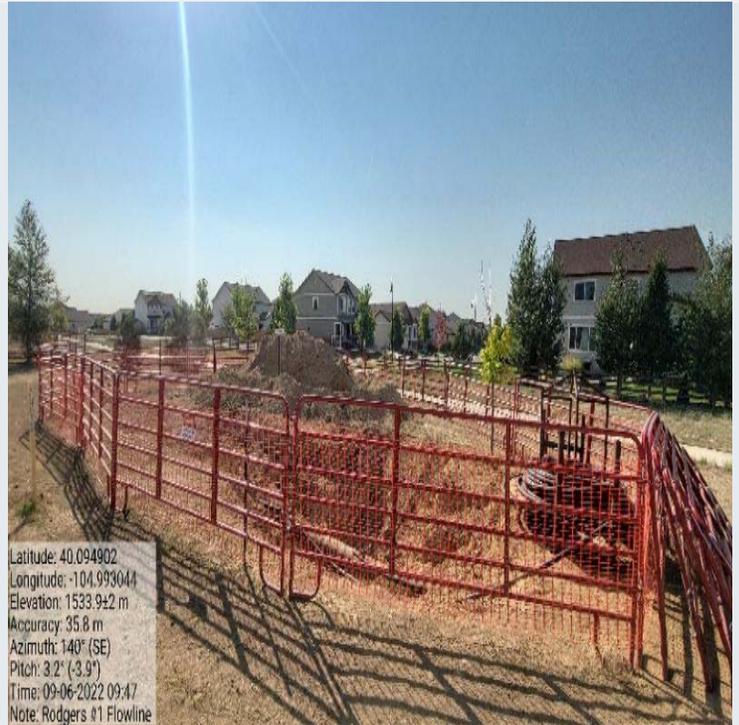
Question: Open excavation properly fenced/covered (in accordance with Rule 913.b.(5)B.i.)?

Response: Yes

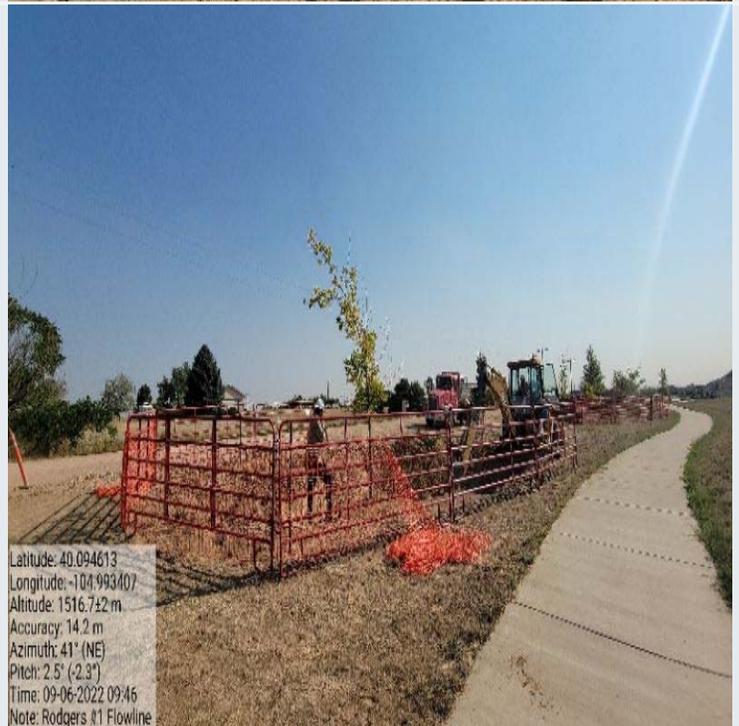
Question: Open excavation properly fenced/covered (in accordance with Rule 913.b.(5)B.i.)?

Response: Yes

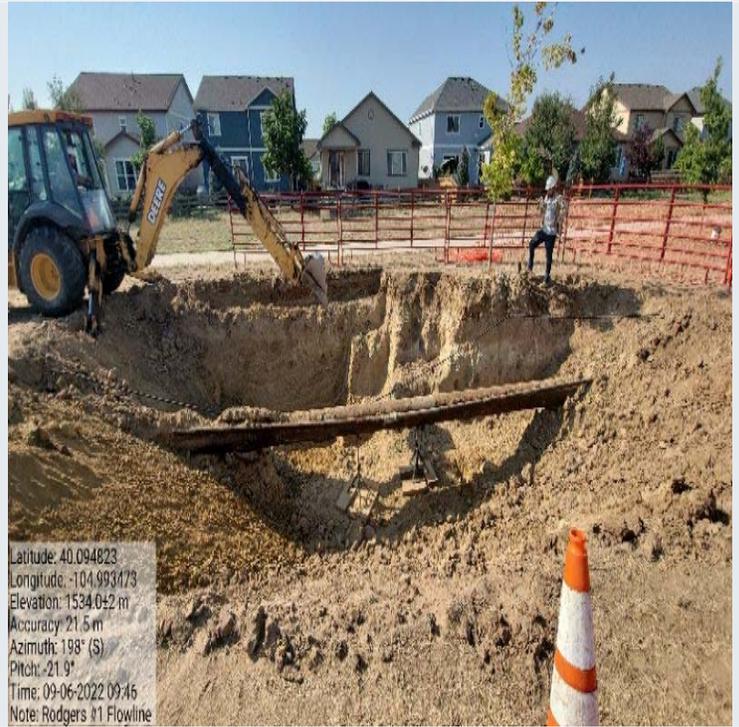
Question: Exposed buried/underground flowlines within excavation?

Response: Yes

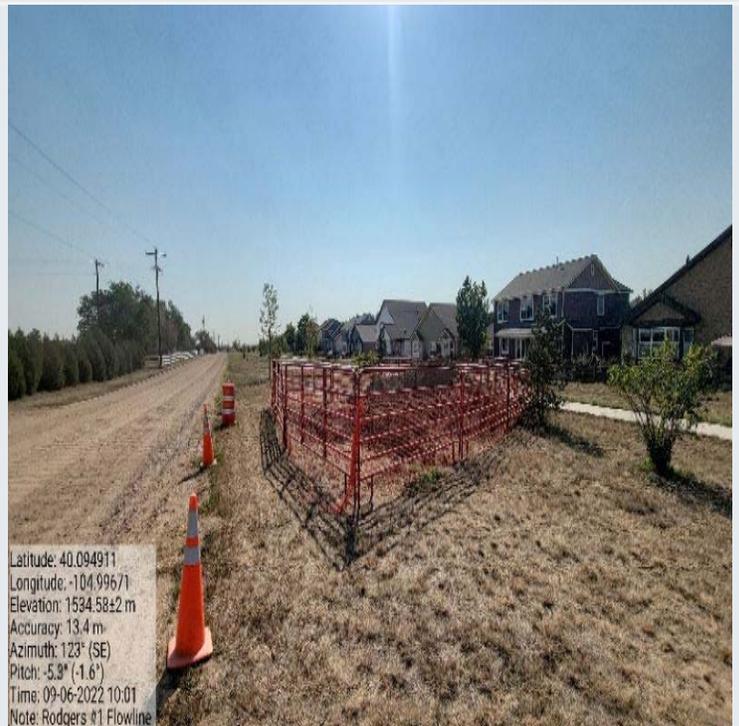
Question: Site is protected from vehicular traffic (properly fenced, gated or barricaded)?

Response: Yes

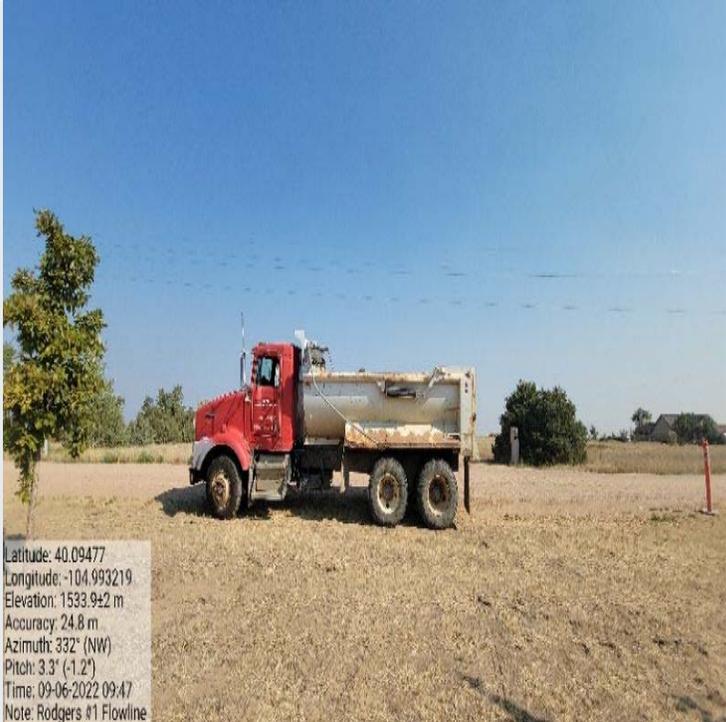
Photo
<p>Question: Is earthen berm secondary containment present and in good condition (compacted, complete, no evidence of erosion, animal burrowing, etc.)? Response: N/A Notes:</p>	<p>No Photo</p>
<p>Question: Is work being conducted in a minimal footprint? Note: Any property/crop damage Response: Yes Notes:</p>	<p>No Photo</p>
<p>Question: Is location adjacent to any Potential Receptors? Note: Livestock, surface water, occupied structure, adjacent land use, etc. Response: Yes Notes: Neighborhood</p>	<p>No Photo</p>
<p>Question: Stockpiled waste stored and handled in compliance with Rule 913.b.(5).B.iv.? Response: N/A Notes: Being hauled off site immediately</p>

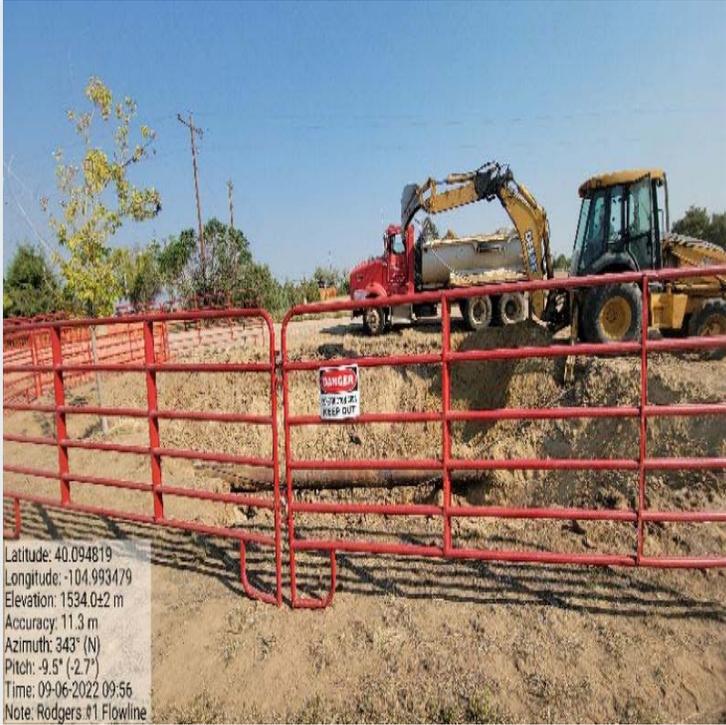
Photo
<p>Question: Stockpiled waste stored and handled in compliance with Rule 913.b.(5).B.iv.? Response: N/A Notes: Being hauled off site immediately</p>
