Site: CAMENISCH 1SX NEW RELEASE
09/08/2022

SITE INSPECTION REPORT

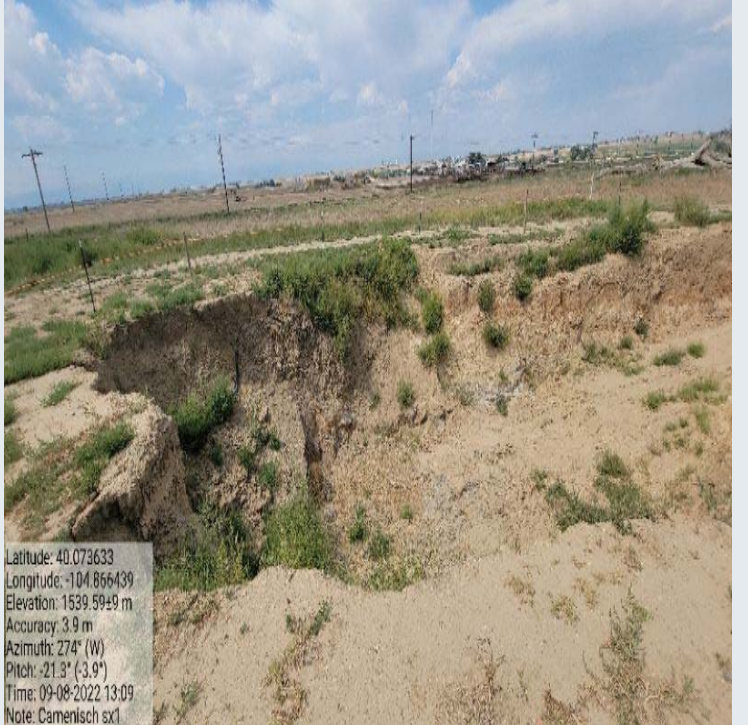
Remediation Activity Checklist	
	Photo
Question: Open excavation(s)? Note: Approximate size(s) (Length x Width x Depth, ft) Response: Yes Notes:

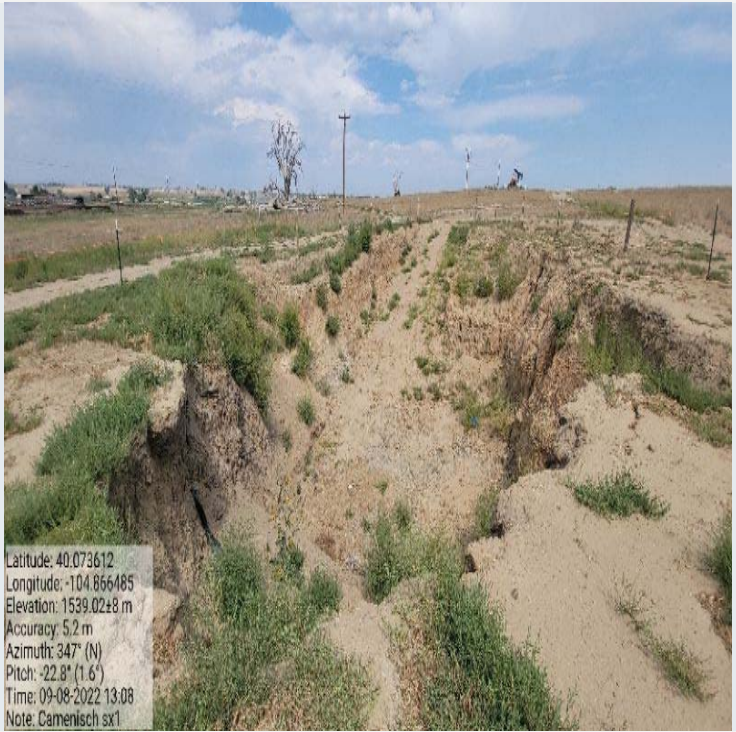
Photo
Question: Open excavation(s)? Note: Approximate size(s) (Length x Width x Depth, ft) Response: Yes Notes:

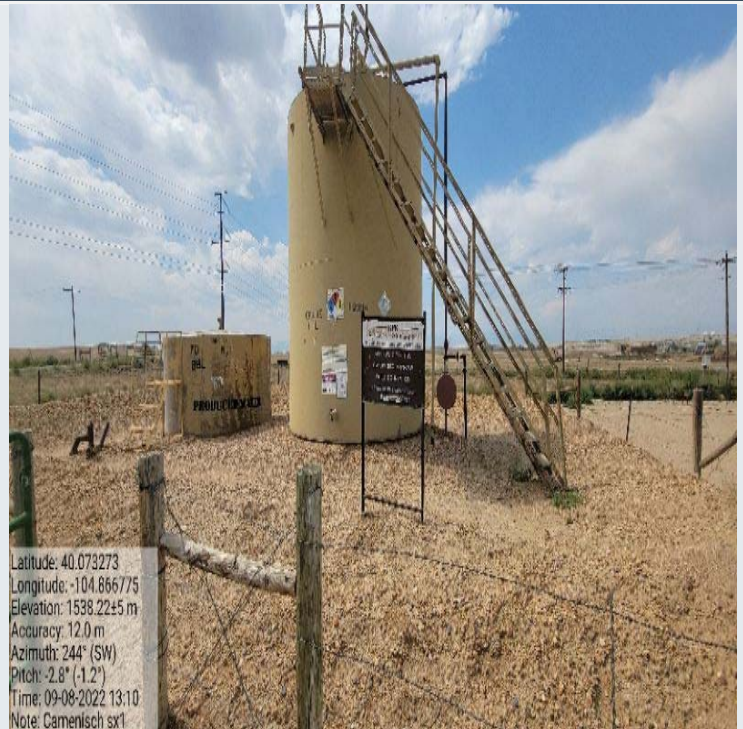
Question: Emergency signage in compliance with 605.g.?
Note: Location of signage - Location entrance, Tank Battery, Wellhead(s).

Response: Yes

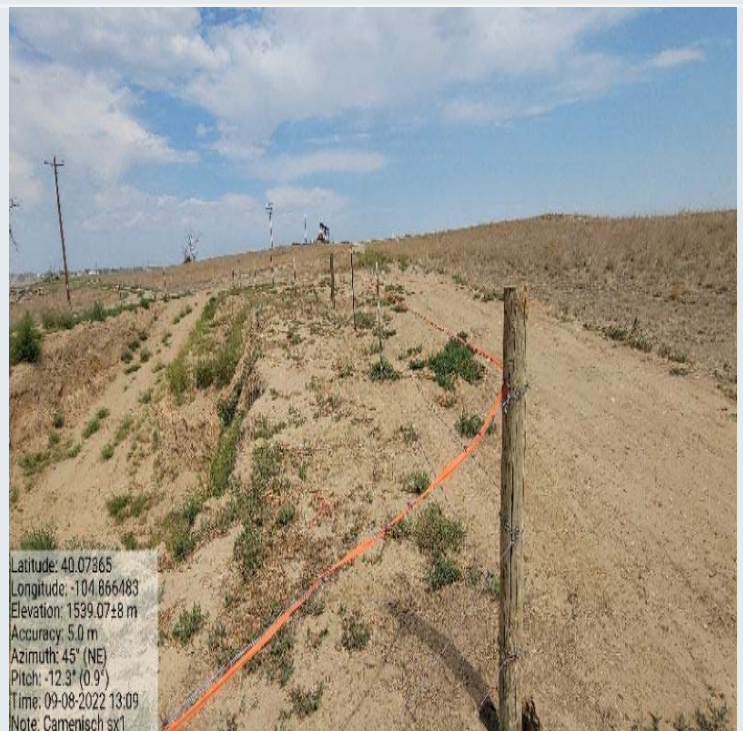
Question: Open excavation properly fenced/covered (in accordance with Rule 913.b.(5)B.i.)?

Response: Yes

Notes: Fencing has changed from orange construction fencing to barbed wire fencing

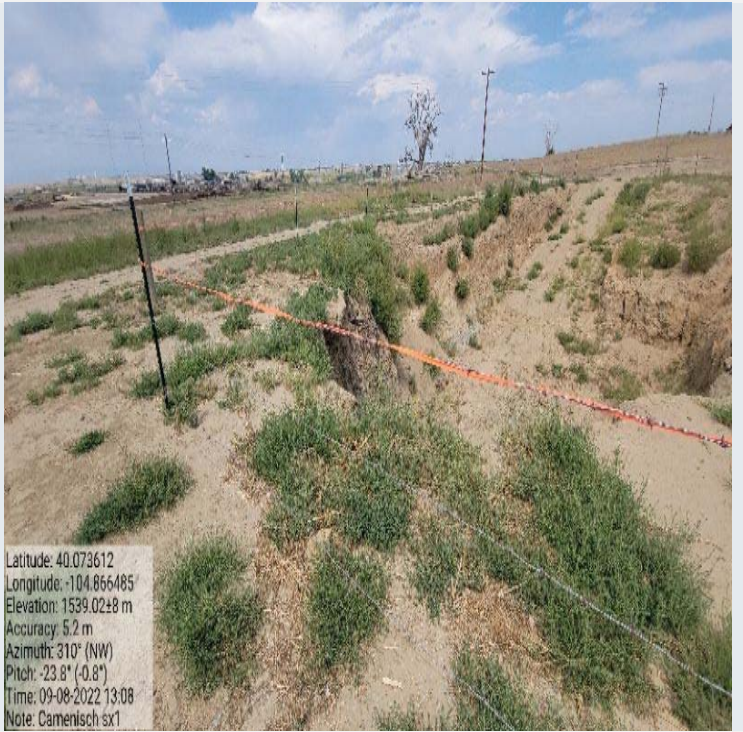
Site Condition Checklist	
	Photo
<p>Question: Open excavation properly fenced/covered (in accordance with Rule 913.b.(5)B.i.)?</p> <p>Response: Yes</p> <p>Notes: Fencing has changed from orange construction fencing to barbed wire fencing</p>

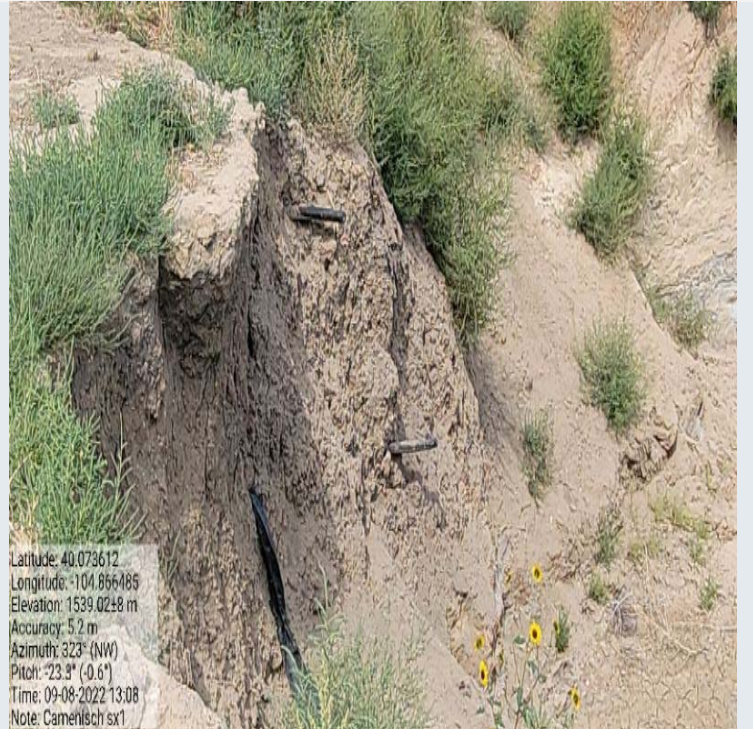
Site Condition Checklist	
<p>Question: Exposed buried/underground flowlines within excavation?</p> <p>Response: Yes</p> <p>Notes:</p>	<p>Photo</p> <p>No Photo</p>
<p>Question: If flowlines are exposed are they properly capped (bullnose plug, etc.)?</p> <p>Response: No</p> <p>Notes:</p>

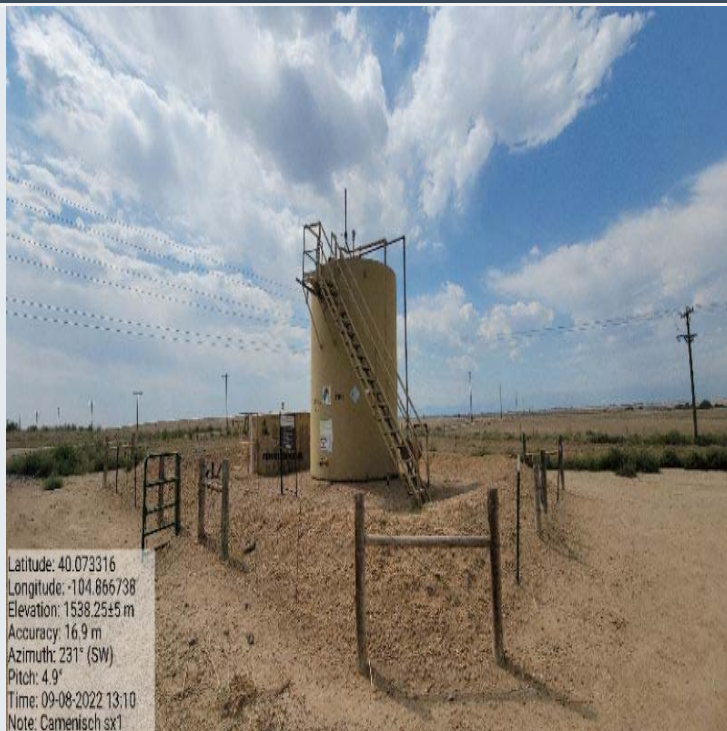
Question: Is earthen berm secondary containment present and in good condition (compacted, complete, no evidence of erosion, animal burrowing, etc.)?

Response: Yes

Notes: Yes at the tank battery

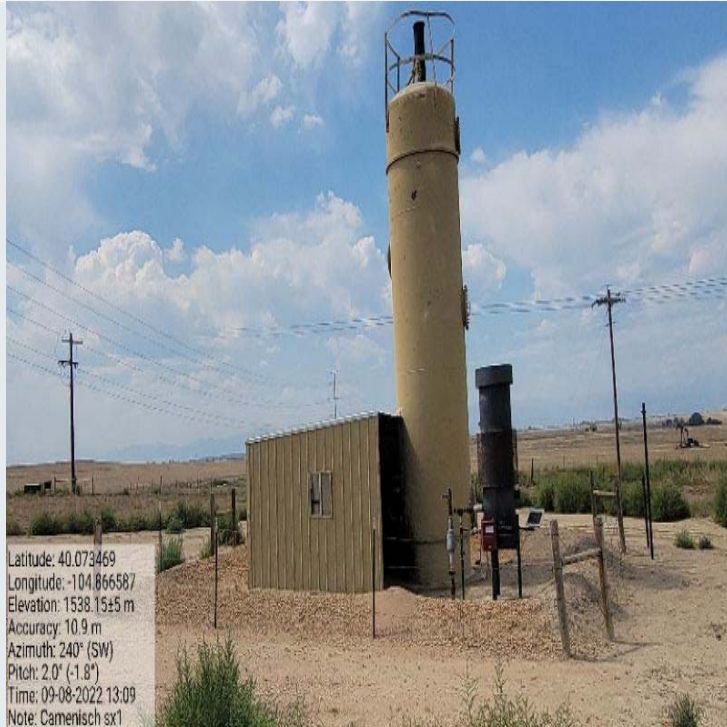
Question: Is earthen berm secondary containment present and in good condition (compacted, complete, no evidence of erosion, animal burrowing, etc.)?

Response: Yes

Notes: Yes at the tank battery

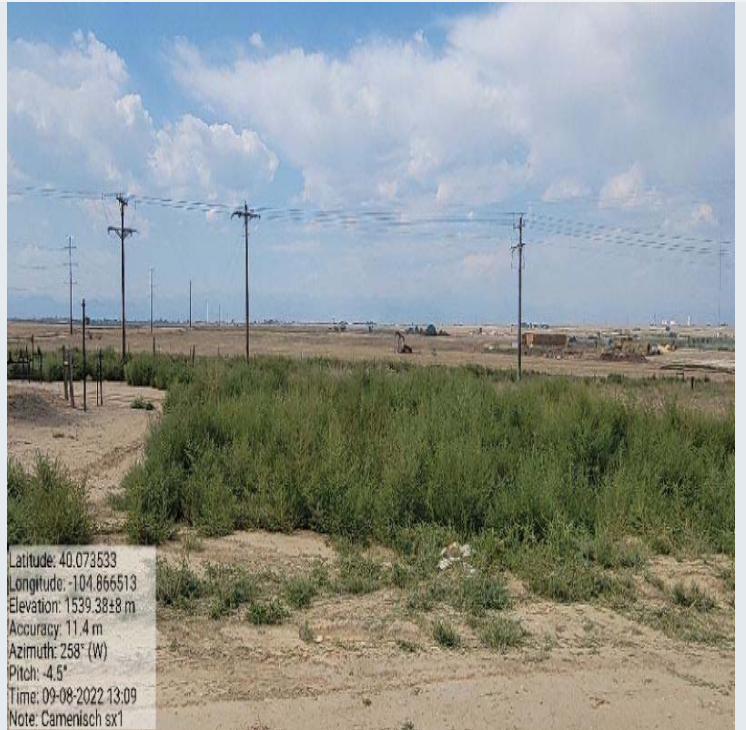
Stormwater Checklist	
	Photo
Question: Evidence of pollutants being discharged off-site? Response: No Notes:	No Photo
Question: All stormwater erosion control measures and BMPs are present and in good/working condition? Response: Yes Notes:	No Photo
Question: Site free of unused equipment, weeds, debris/trash? Response: No Notes: Weeds overgrown throughout the site

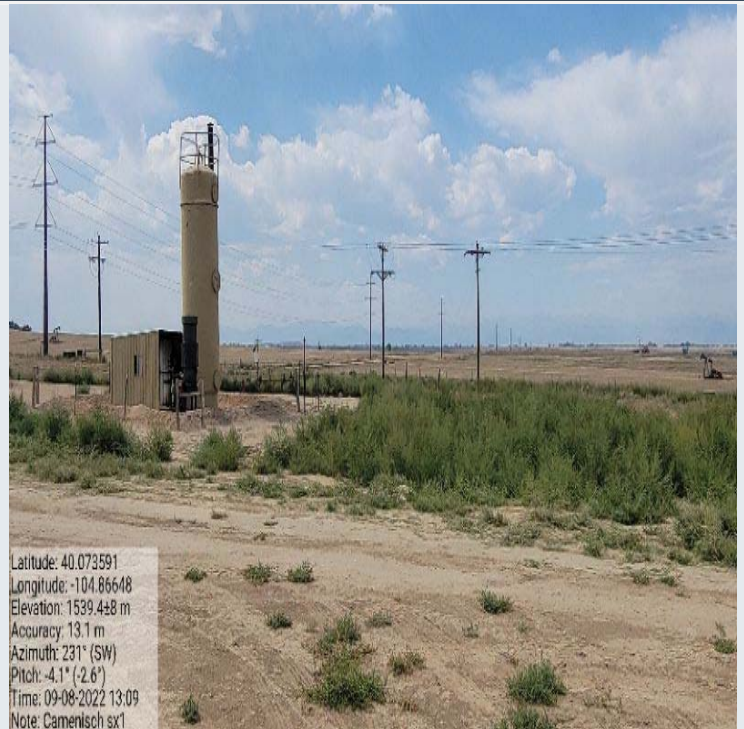
Question: Site free of unused equipment, weeds, debris/trash?

Response: No

Notes: Weeds overgrown throughout the site

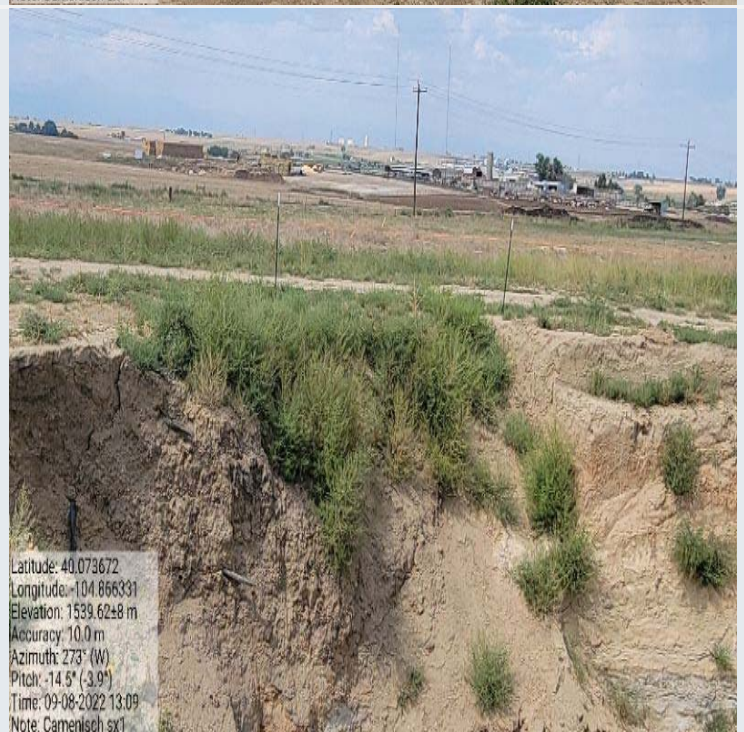
Question: Site free of unused equipment, weeds, debris/trash?

Response: No

Notes: Weeds overgrown throughout the site
