Site Inspection Report

**Site: KPK TANK BATTERY 28SWNE
(HORSE-SCHUTT STORAGE VESSEL)**
09/08/2022

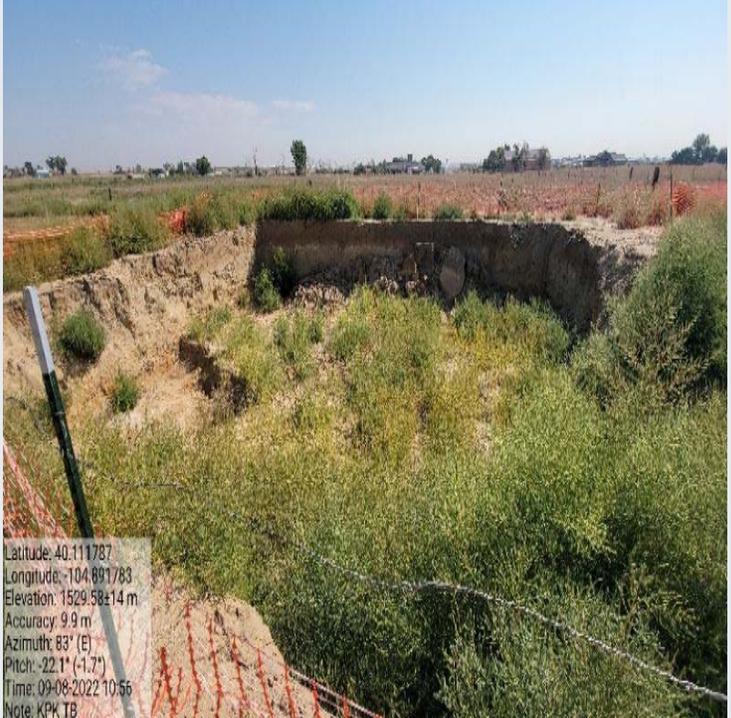
Remediation Activity Checklist	
	Photo
<p>Question: Open excavation(s)? Note: Approximate size(s) (Length x Width x Depth, ft)</p> <p>Response: Yes</p> <p>Notes:</p>

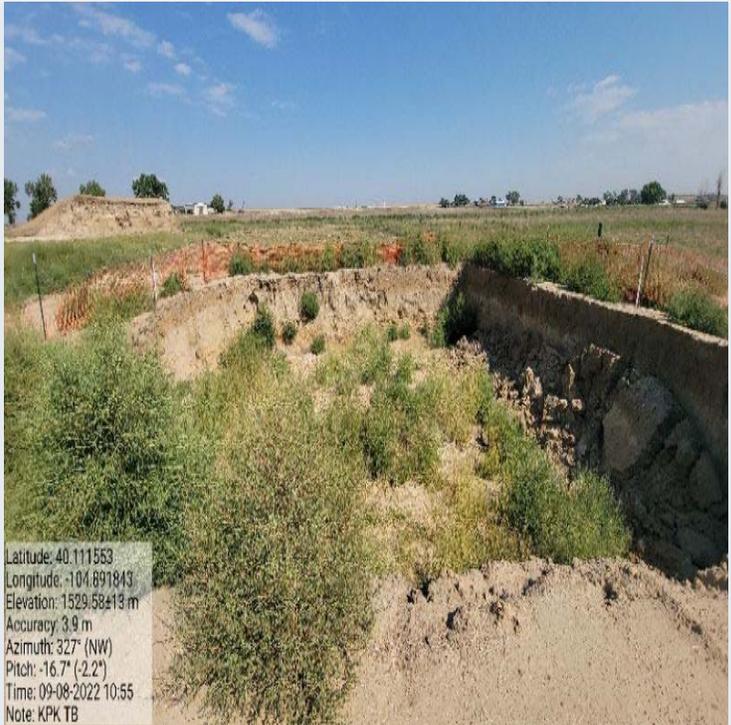
Photo
<p>Question: Open excavation(s)? Note: Approximate size(s) (Length x Width x Depth, ft)</p> <p>Response: Yes</p> <p>Notes:</p>

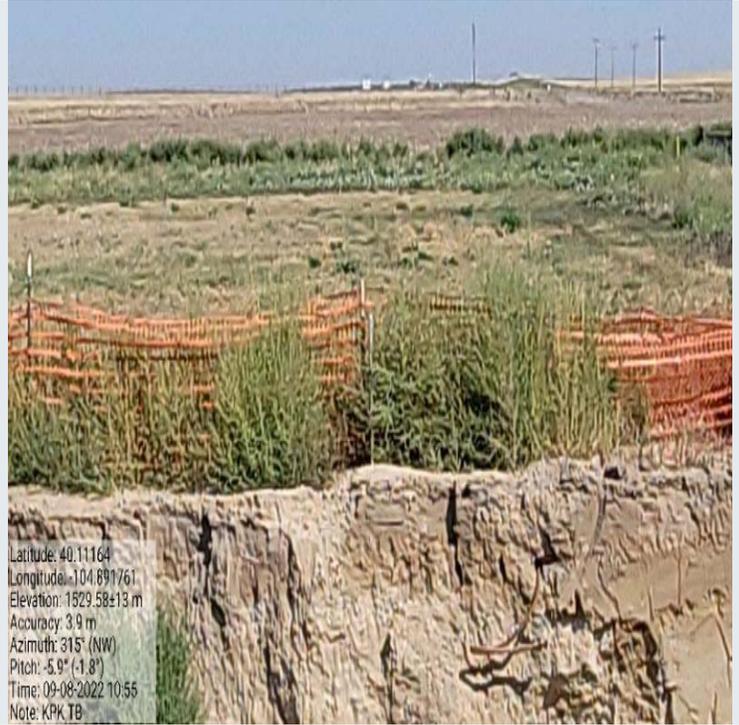
Question: Monitoring well(s) present? Note: Number, approximate location(s), condition

Response: Yes

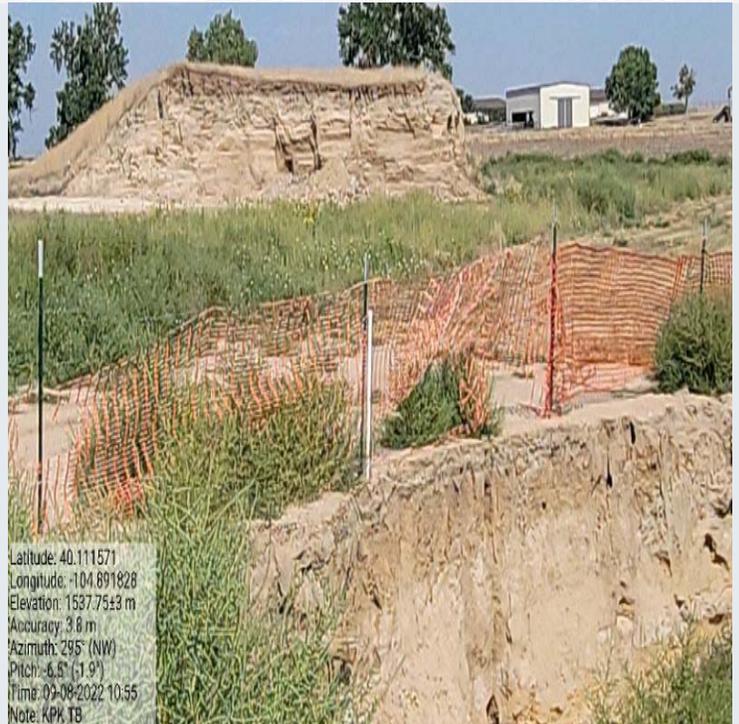
Question: Monitoring well(s) present? Note: Number, approximate location(s), condition

Response: Yes

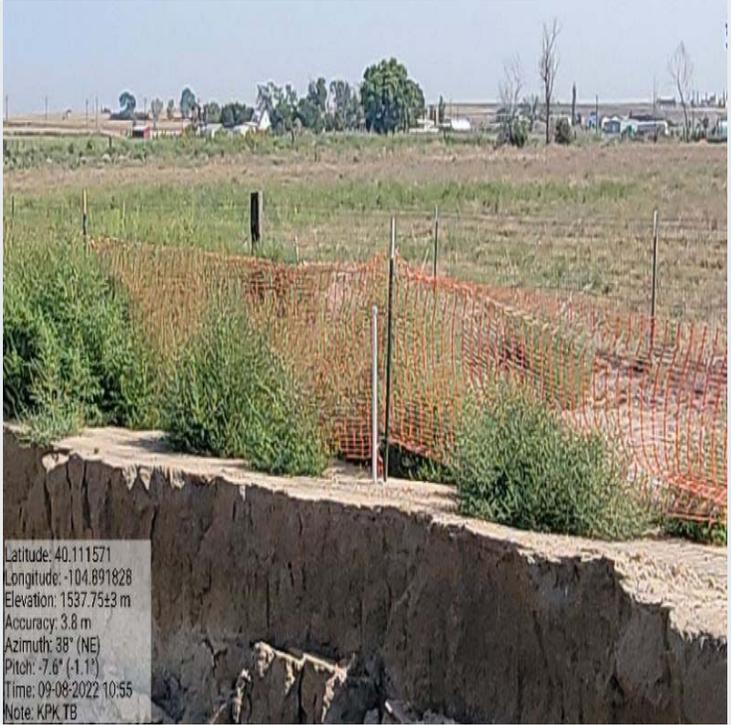
Photo
<p>Question: Monitoring well(s) present? Note: Number, approximate location(s), condition</p> <p>Response: Yes</p> <p>Notes:</p>

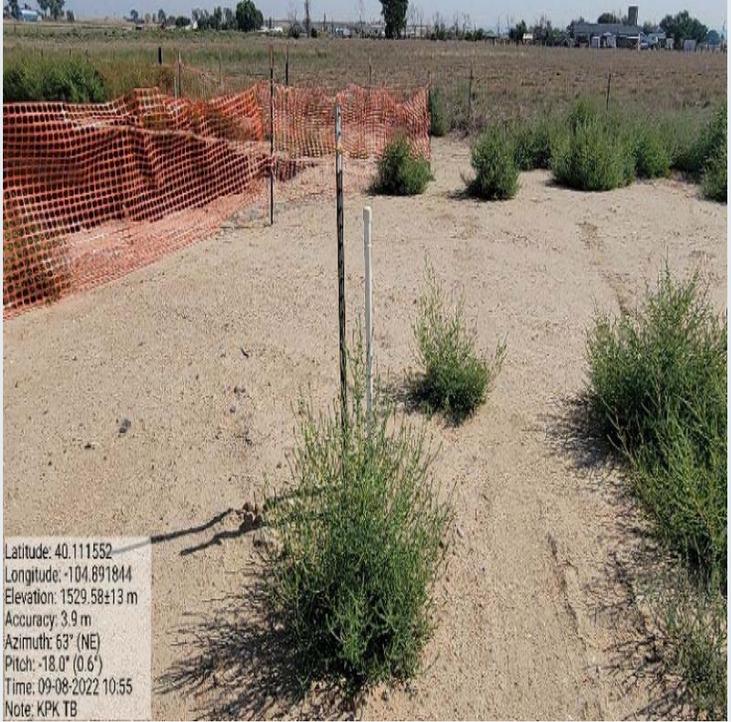
<p>Latitude: 40.111571 Longitude: -104.891828 Elevation: 1537.75±3 m Accuracy: 3.8 m Azimuth: 38° (NE) Pitch: -7.6° (-1.1°) Time: 09-08-2022 10:55 Note: KPK TB</p>
<p>Question: Monitoring well(s) present? Note: Number, approximate location(s), condition</p> <p>Response: Yes</p> <p>Notes:</p>

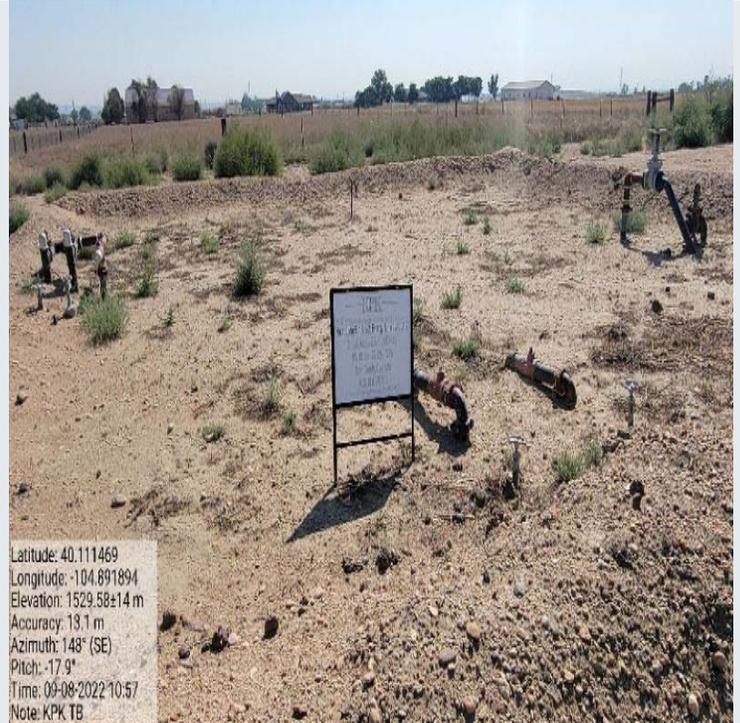
Question: Emergency signage in compliance with 605.g.?

Note: Location of signage - Location entrance, Tank Battery, Wellhead(s).

Response: Yes

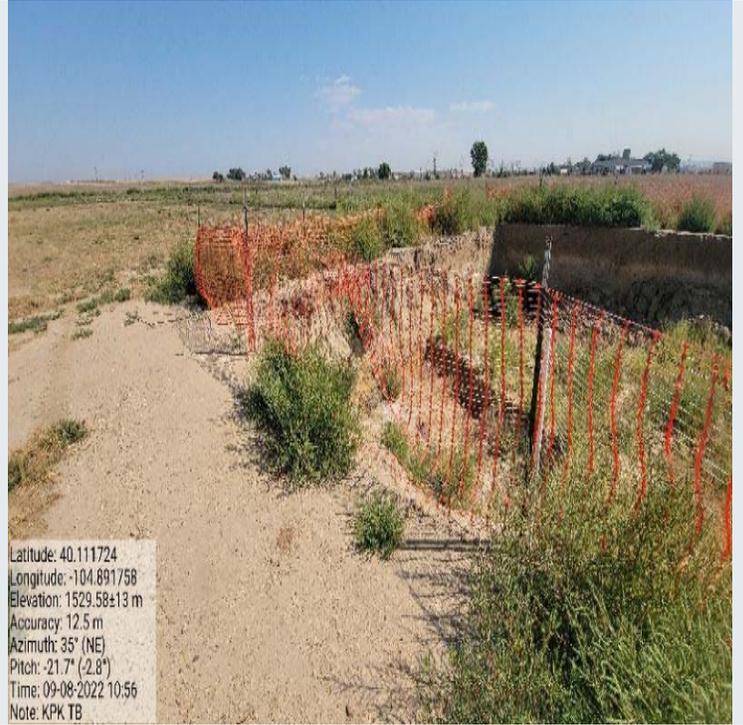
Question: Open excavation properly fenced/covered (in accordance with Rule 913.b.(5)B.i.)?

Response: No

Notes: Fencing is torn and falling around the excavation

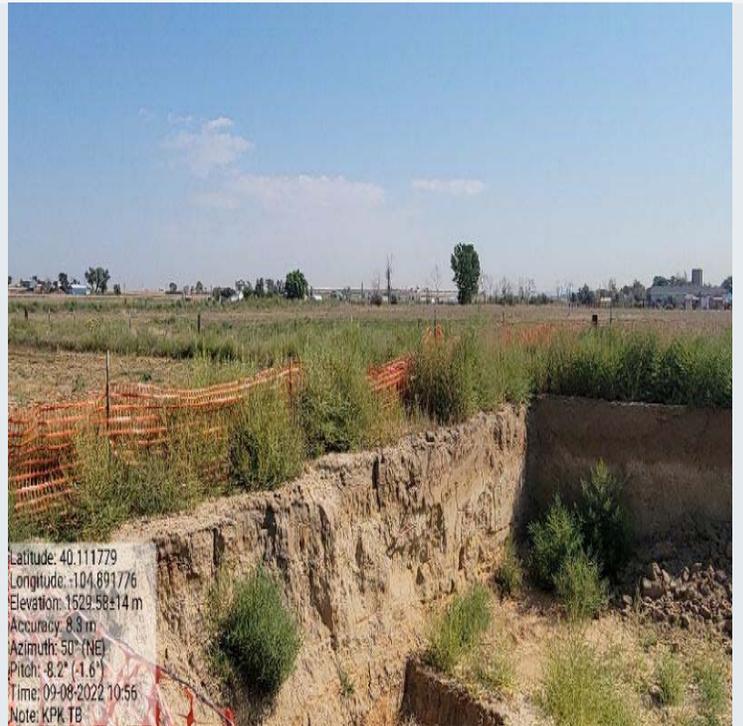
Question: Open excavation properly fenced/covered (in accordance with Rule 913.b.(5)B.i.)?

Response: No

Notes: Fencing is torn and falling around the excavation

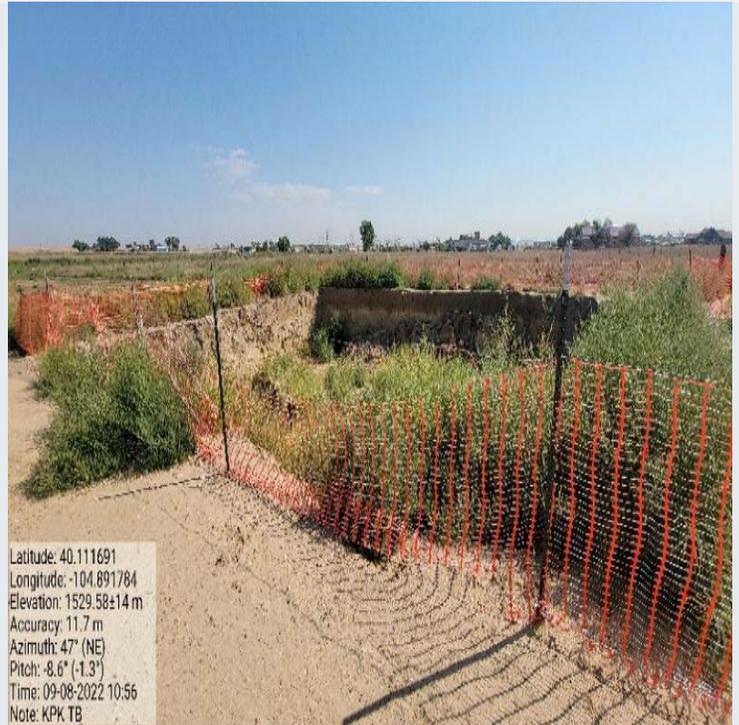
Question: Open excavation properly fenced/covered (in accordance with Rule 913.b.(5)B.i.)?

Response: No

Notes: Fencing is torn and falling around the excavation

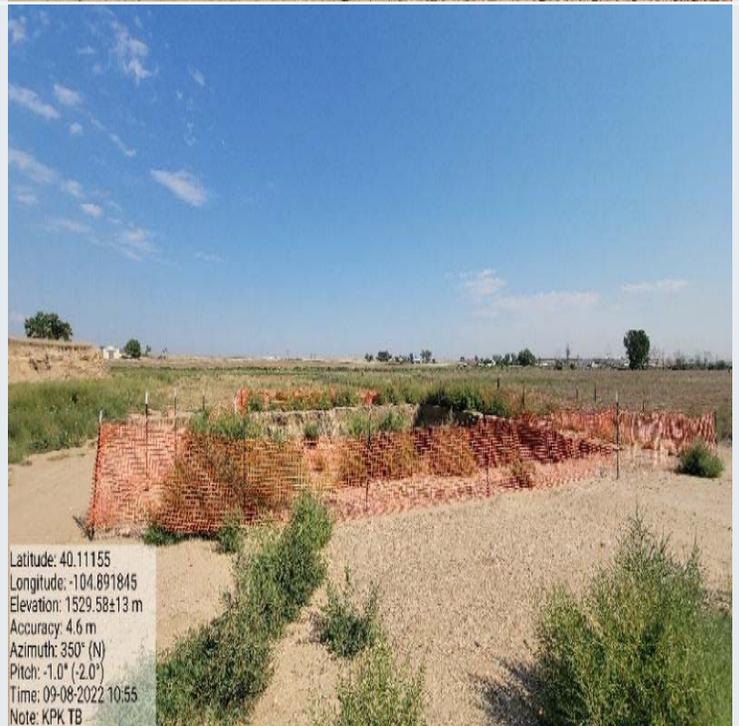
Question: Open excavation properly fenced/covered (in accordance with Rule 913.b.(5)B.i.)?

Response: No

Notes: Fencing is torn and falling around the excavation

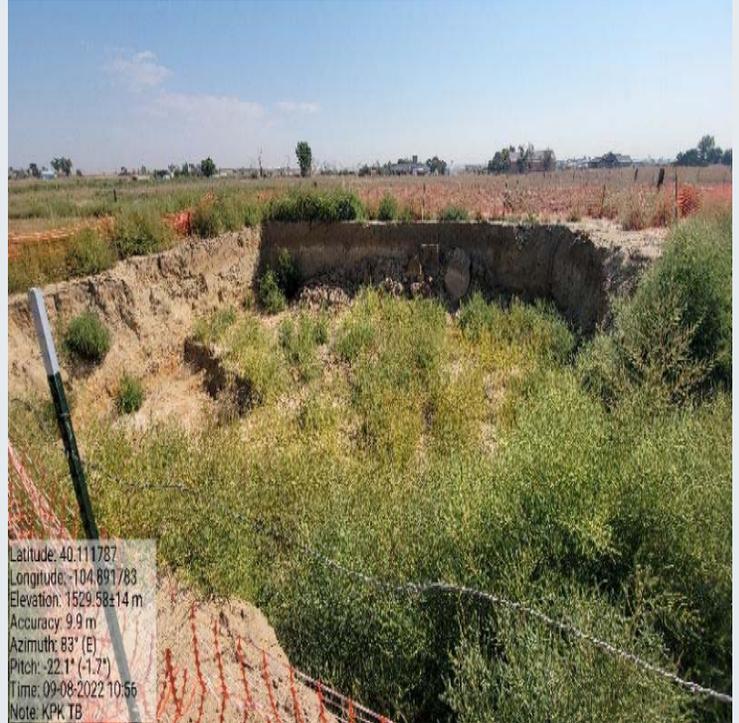
Question: Site free of unused equipment, weeds, debris/trash?

Response: No

Notes: Weeds are overgrown throughout the site. Some weeds are tearing through excavation fencing

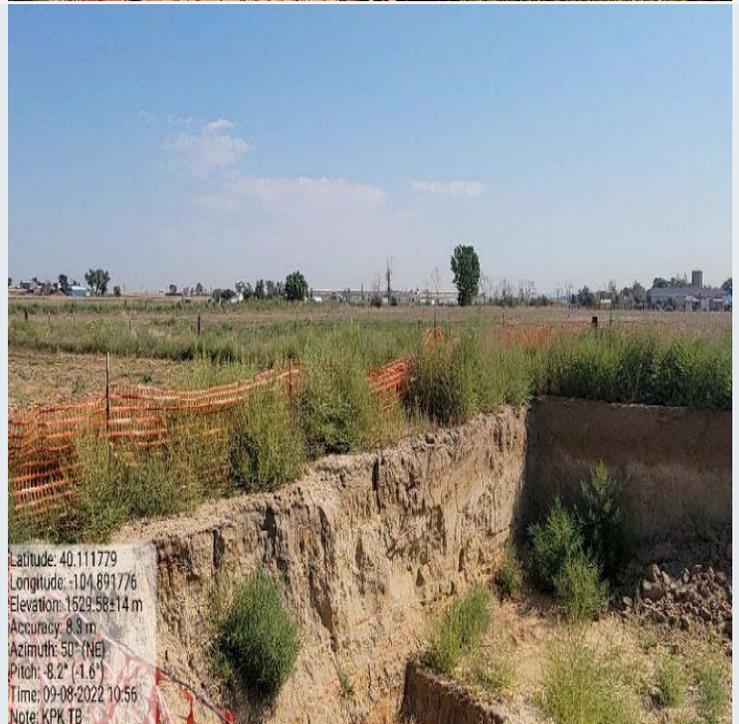
Question: Site free of unused equipment, weeds, debris/trash?

Response: No

Notes: Weeds are overgrown throughout the site. Some weeds are tearing through excavation fencing

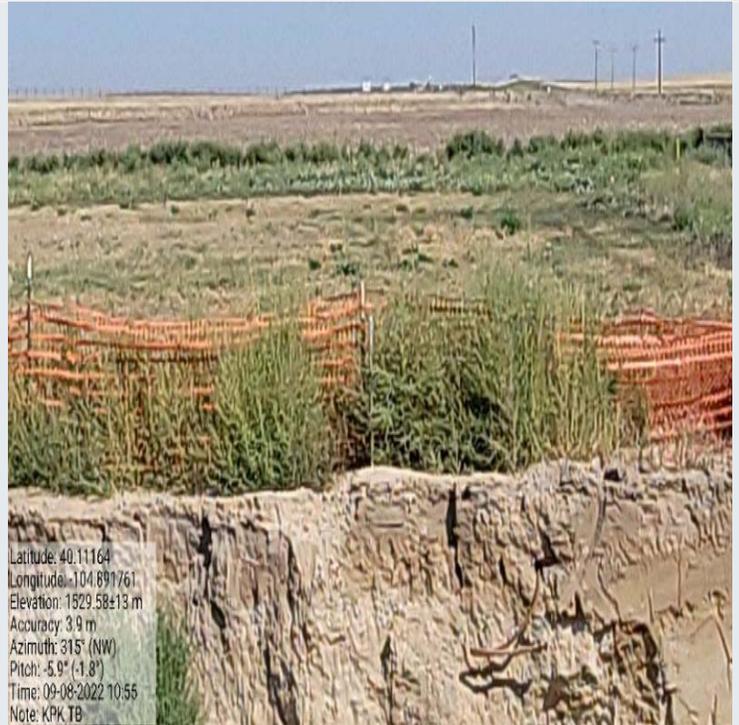
Question: Site free of unused equipment, weeds, debris/trash?

Response: No

Notes: Weeds are overgrown throughout the site. Some weeds are tearing through excavation fencing

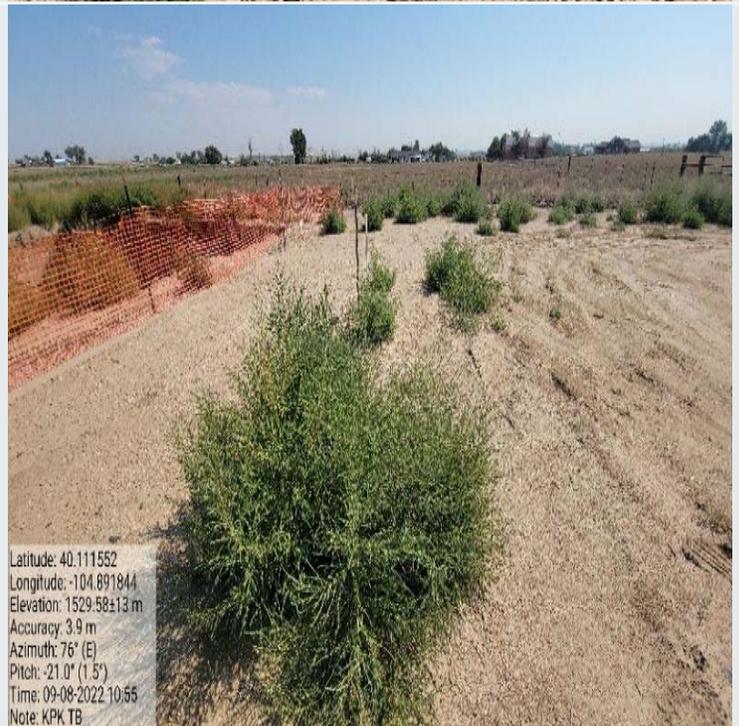
Question: Site free of unused equipment, weeds, debris/trash?

Response: No

Notes: Weeds are overgrown throughout the site. Some weeds are tearing through excavation fencing

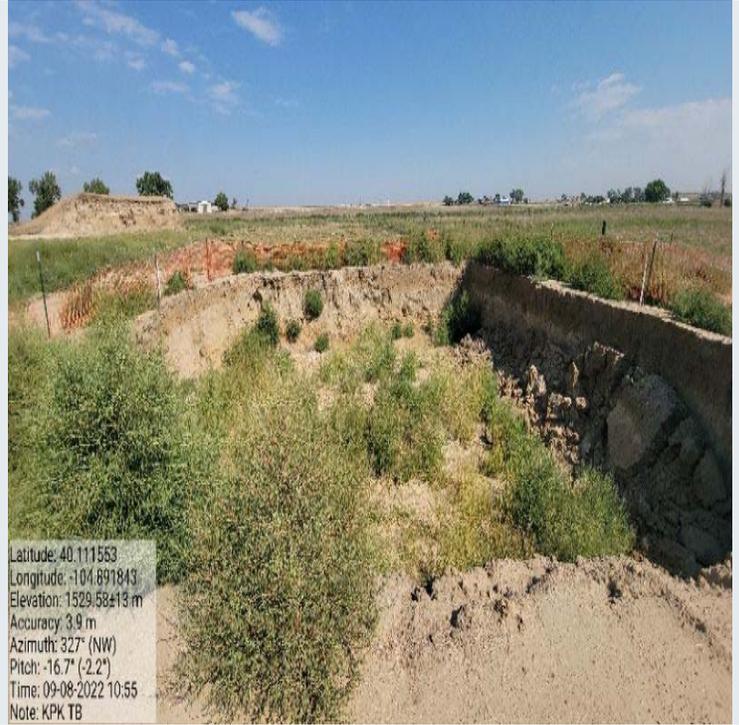
Question: Site free of unused equipment, weeds, debris/trash?

Response: No

Notes: Weeds are overgrown throughout the site. Some weeds are tearing through excavation fencing
