Site Inspection Report

Site: MARIE GERHART 9
09/08/2022

INSPECTION DETAILS

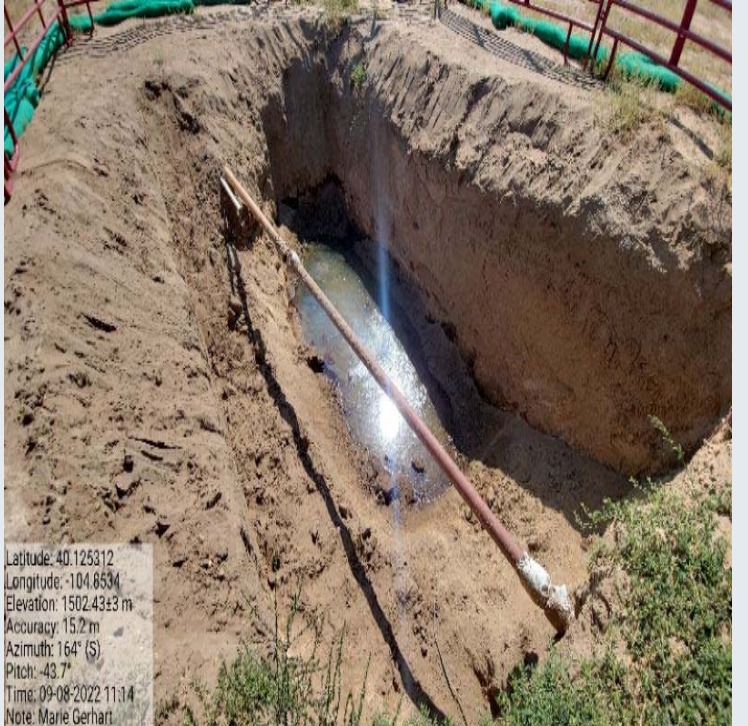
Photo
<p>Question: Open excavation(s)? Note: Approximate size(s) (Length x Width x Depth, ft)</p> <p>Response: Yes</p> <p>Notes:</p>

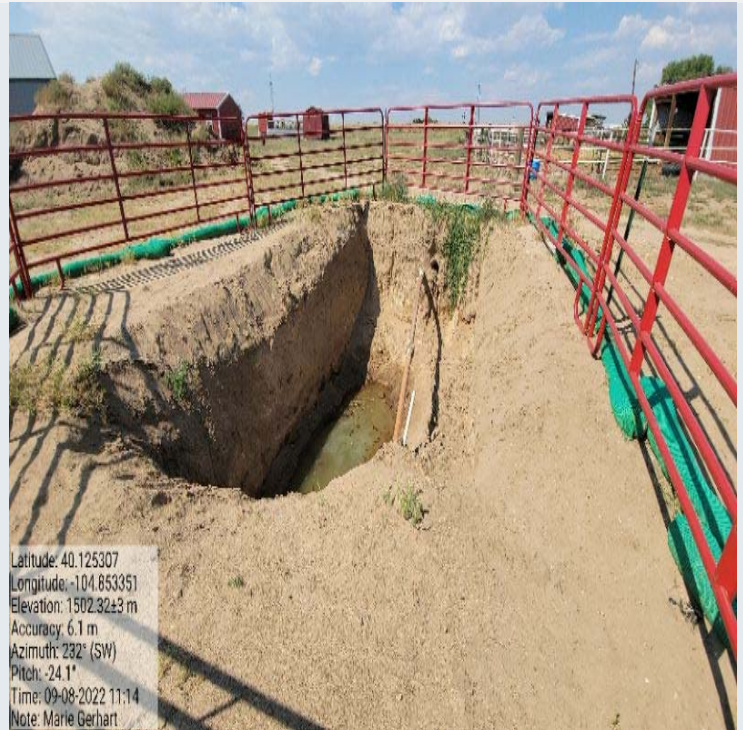
Question: Open excavation(s)? Note: Approximate size(s)
(Length x Width x Depth, ft)

Response: Yes

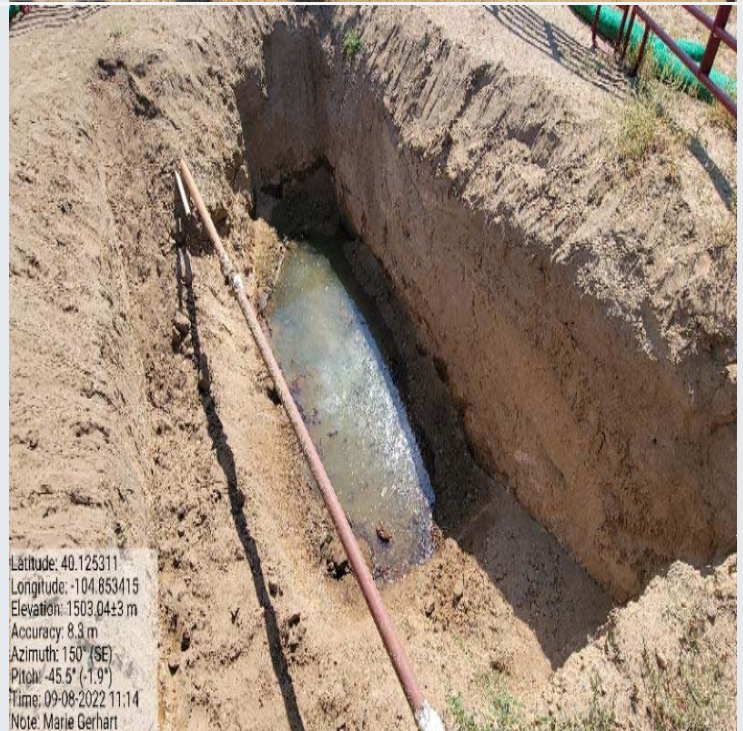
Question: Open excavation(s)? Note: Approximate size(s)
(Length x Width x Depth, ft)

Response: Yes

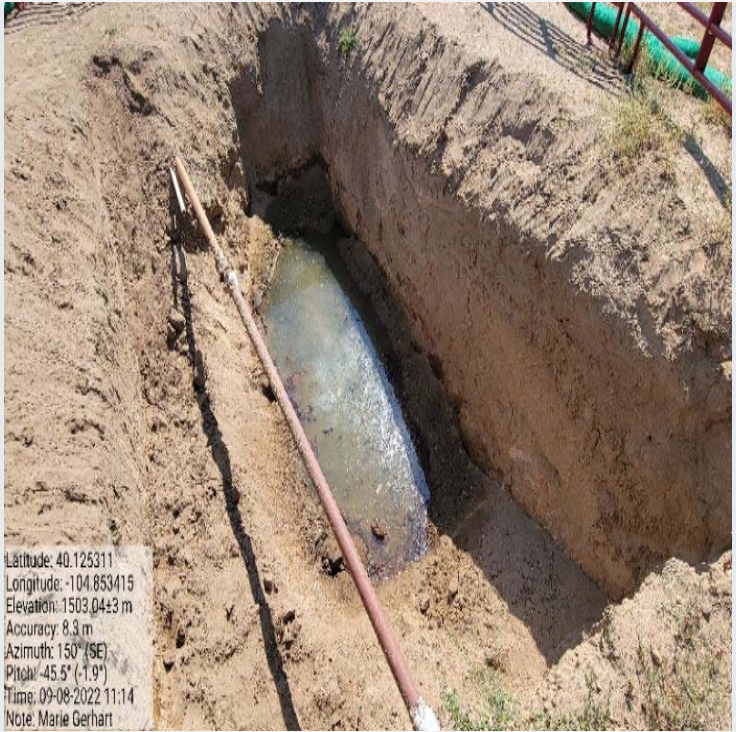
Photo
<p>Question: Groundwater present within excavation? Note: Depth to water below grade surface (ft), free product/sheen</p> <p>Response: Yes</p> <p>Notes: Groundwater seen within excavation. A KPK representative onsite mentioned that groundwater had been seen within the excavation after hydrovac operations</p>

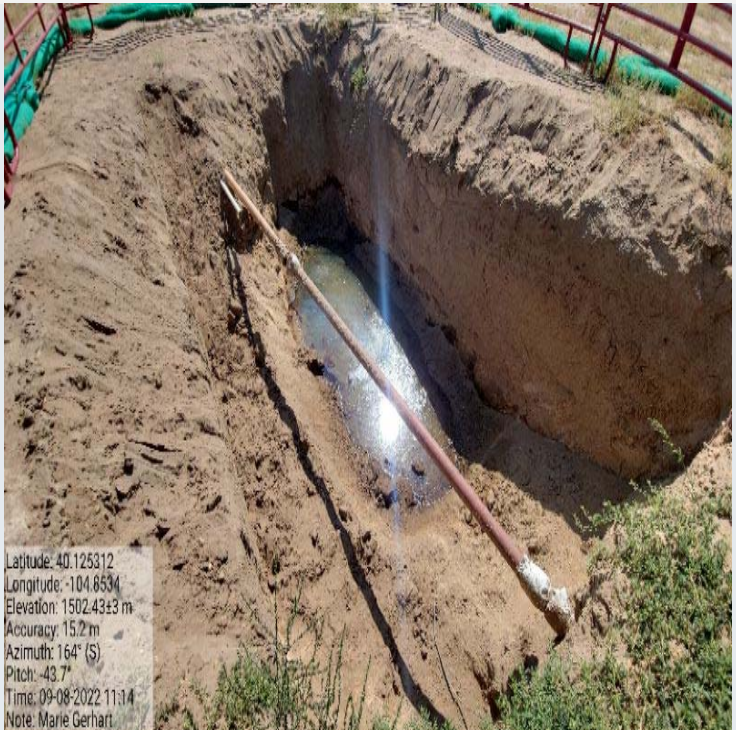
<p>Latitude: 40.125311 Longitude: -104.853415 Elevation: 1503.04±3 m Accuracy: 8.3 m Azimuth: 150° (SE) Pitch: -45.5° (-1.9°) Time: 09-08-2022 11:14 Note: Marie Gerhart</p>
<p>Question: Groundwater present within excavation? Note: Depth to water below grade surface (ft), free product/sheen</p> <p>Response: Yes</p> <p>Notes: Groundwater seen within excavation. A KPK representative onsite mentioned that groundwater had been seen within the excavation after hydrovac operations</p>

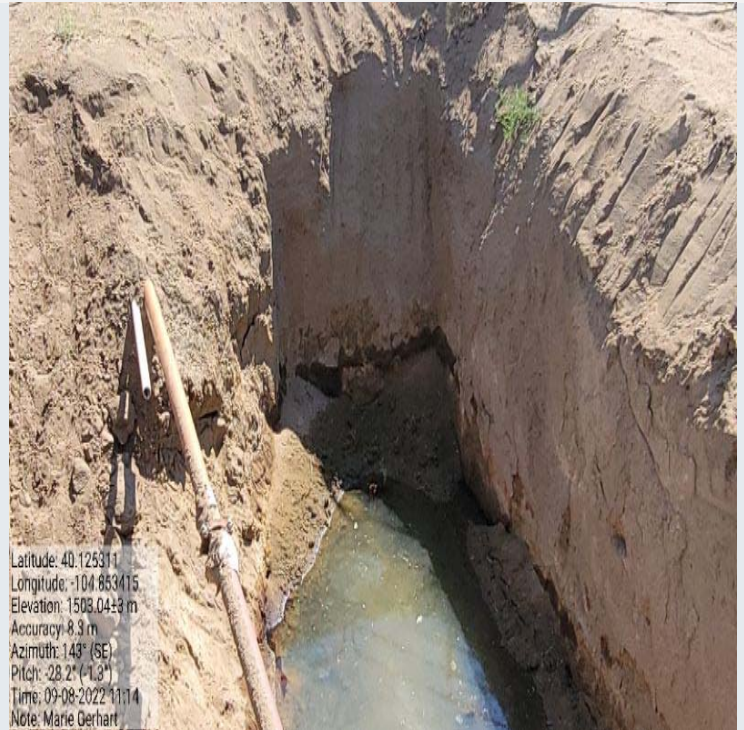
Question: Ground surface appears clean (no evidence of new equipment leaks, oil leaks, spills, or releases)?

Response: No

Notes: Staining seen within excavation

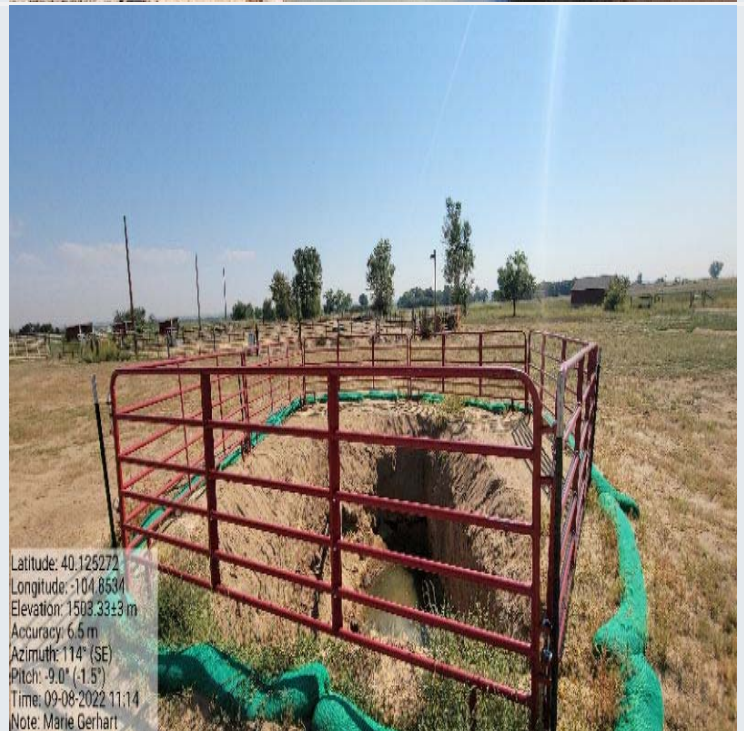
Question: Open excavation properly fenced/covered (in accordance with Rule 913.b.(5)B.i.)?

Response: Yes

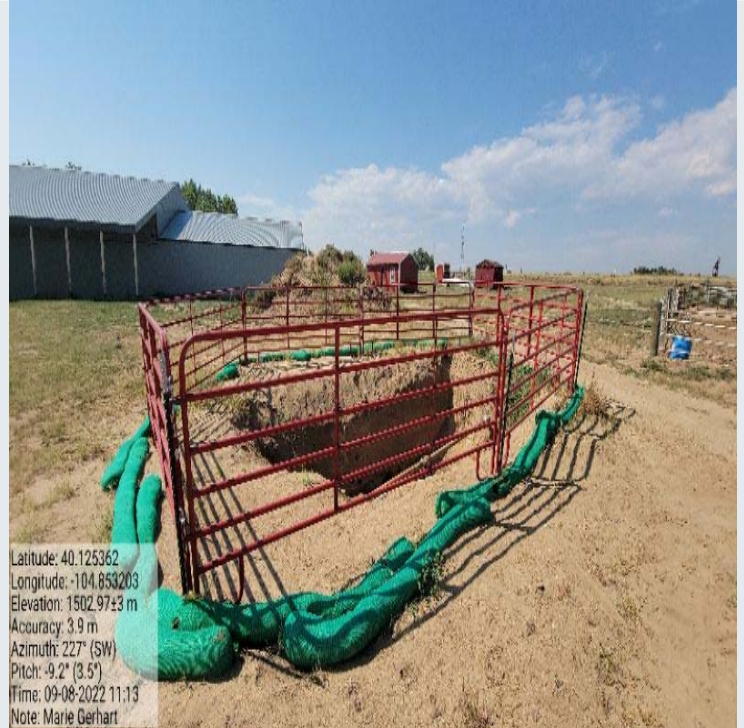
Question: Open excavation properly fenced/covered (in accordance with Rule 913.b.(5)B.i.)?

Response: Yes

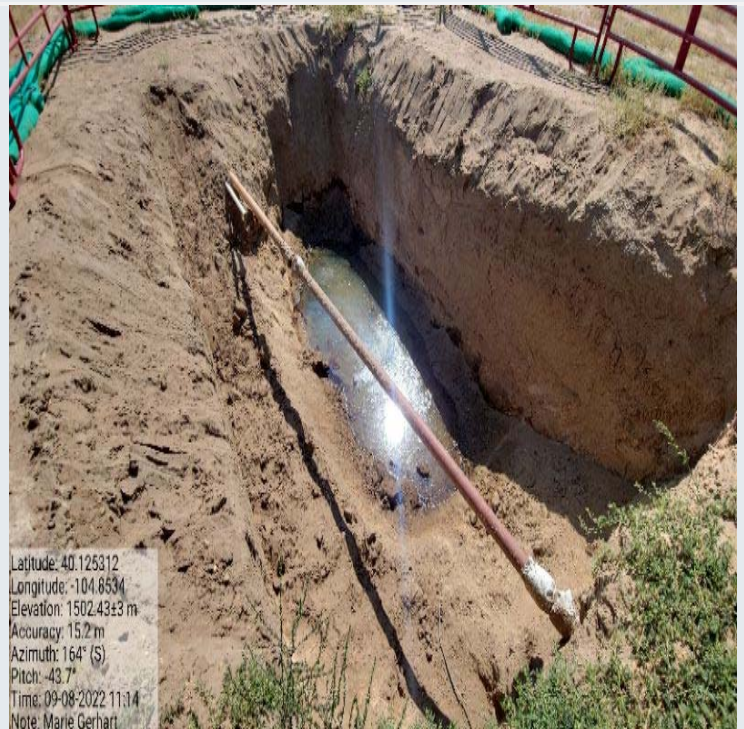
Question: Exposed buried/underground flowlines within excavation?

Response: Yes

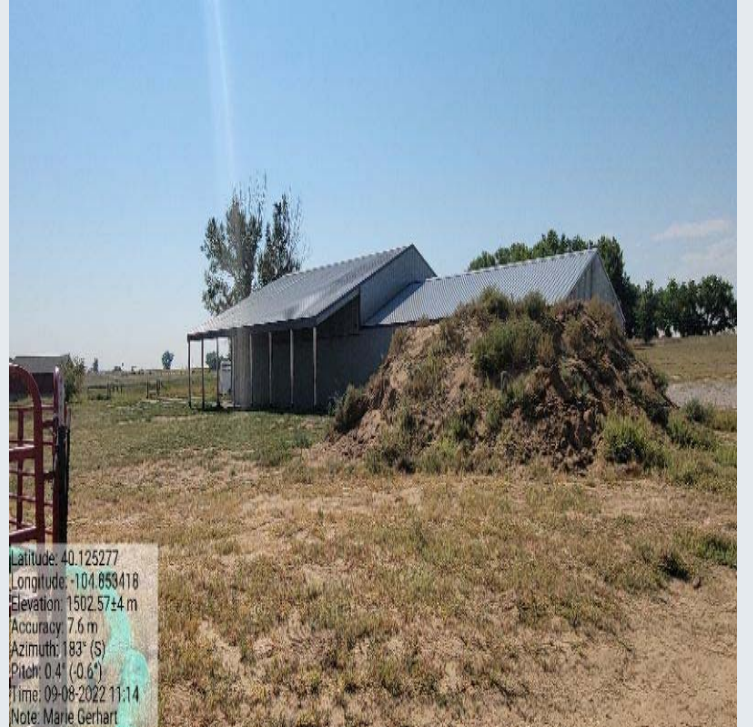
Question: Is work being conducted in a minimal footprint? Note: Any property/crop damage Response: Yes Notes:	No Photo
Question: Is location adjacent to any Potential Receptors? Note: Livestock, surface water, occupied structure, adjacent land use, etc. Response: Yes Notes: Livestock and occupied structure

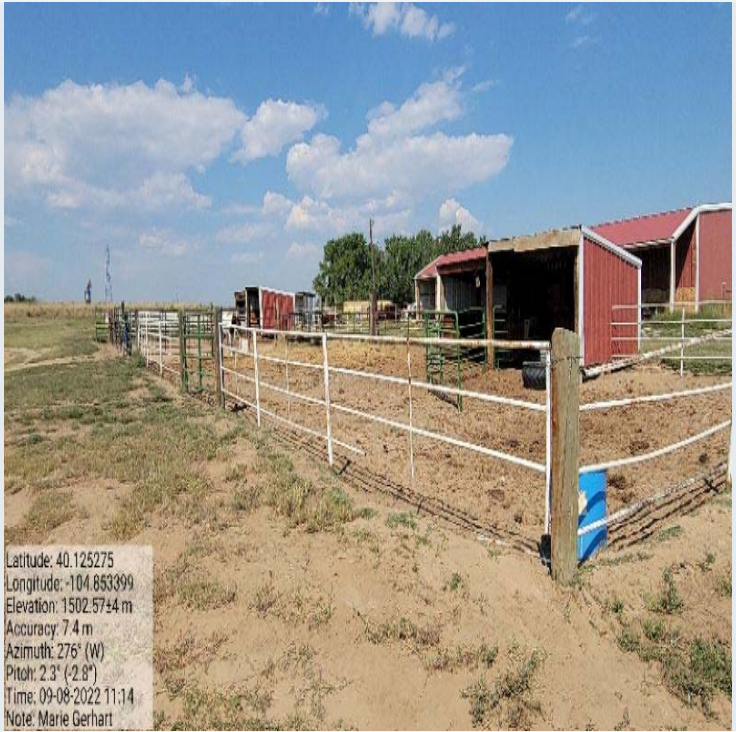
Photo
<p>Question: Is location adjacent to any Potential Receptors? Note: Livestock, surface water, occupied structure, adjacent land use, etc. Response: Yes Notes: Livestock and occupied structure</p>
