Inspection Photos
Location Name: Herrera Gas Unit B 5
Location ID: 311913

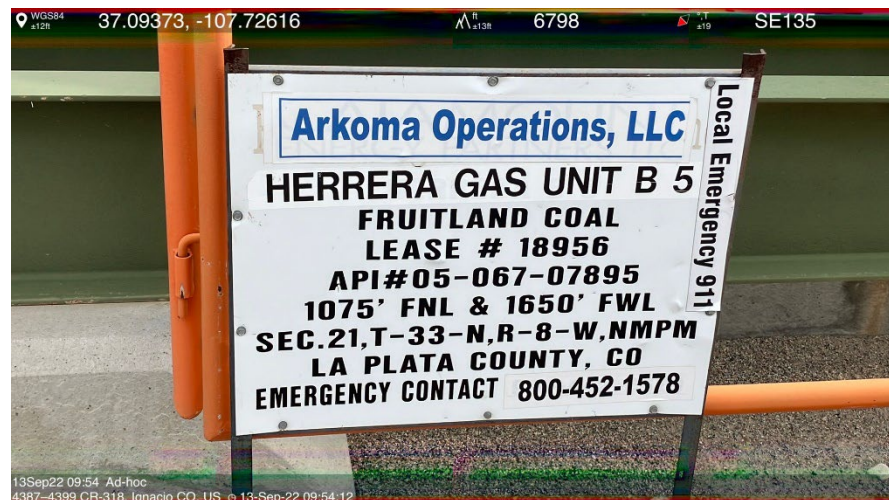
IMG 01
Well sign

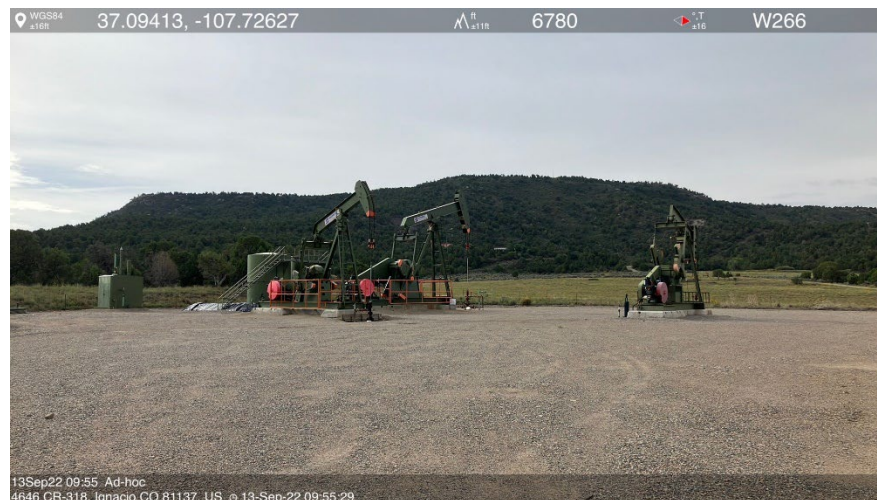
IMG 02
Location overview

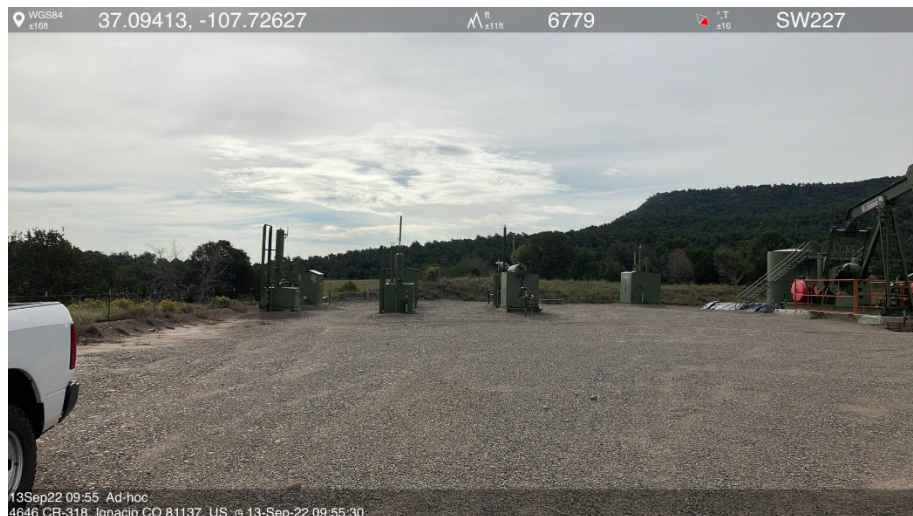
IMG 03
Location overview

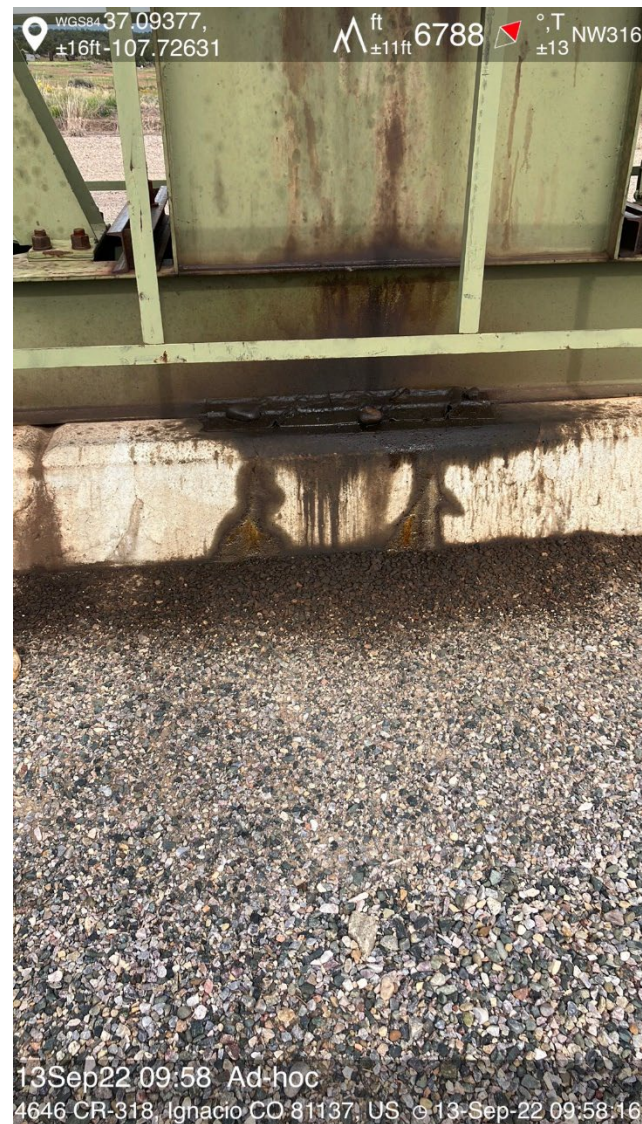
IMG 04
Impacted material

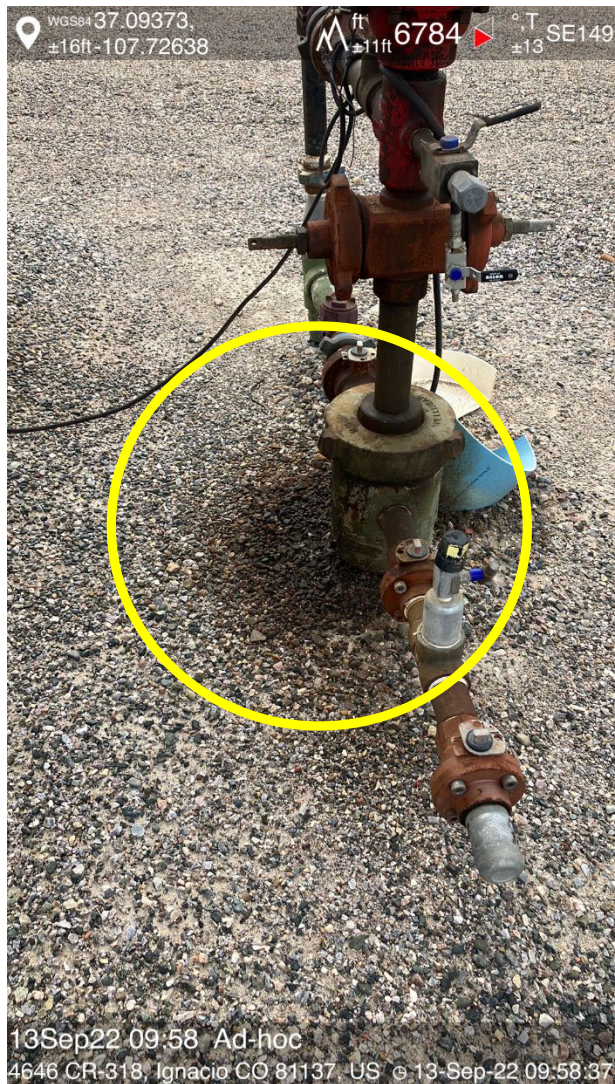
IMG 05
Impacted material

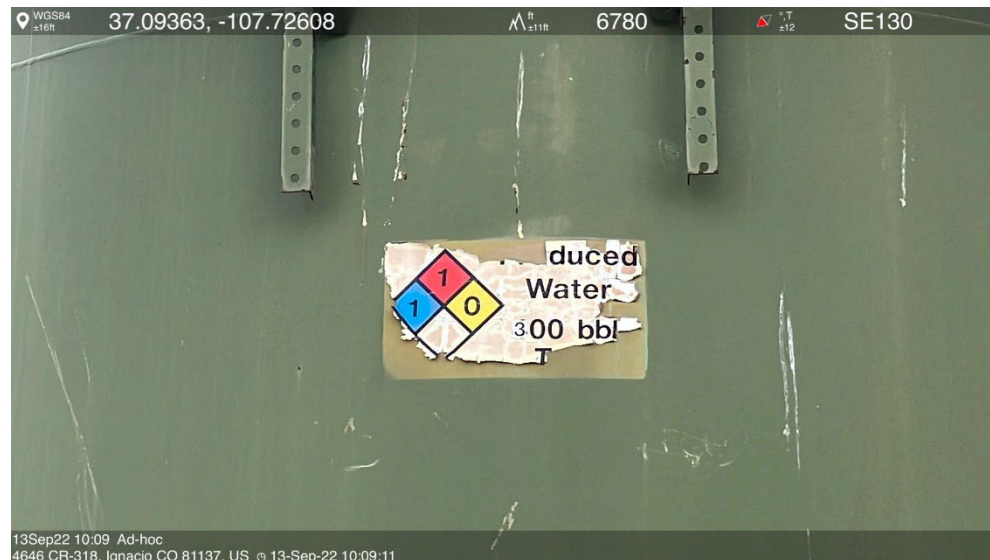
IMG 06
Tank sign

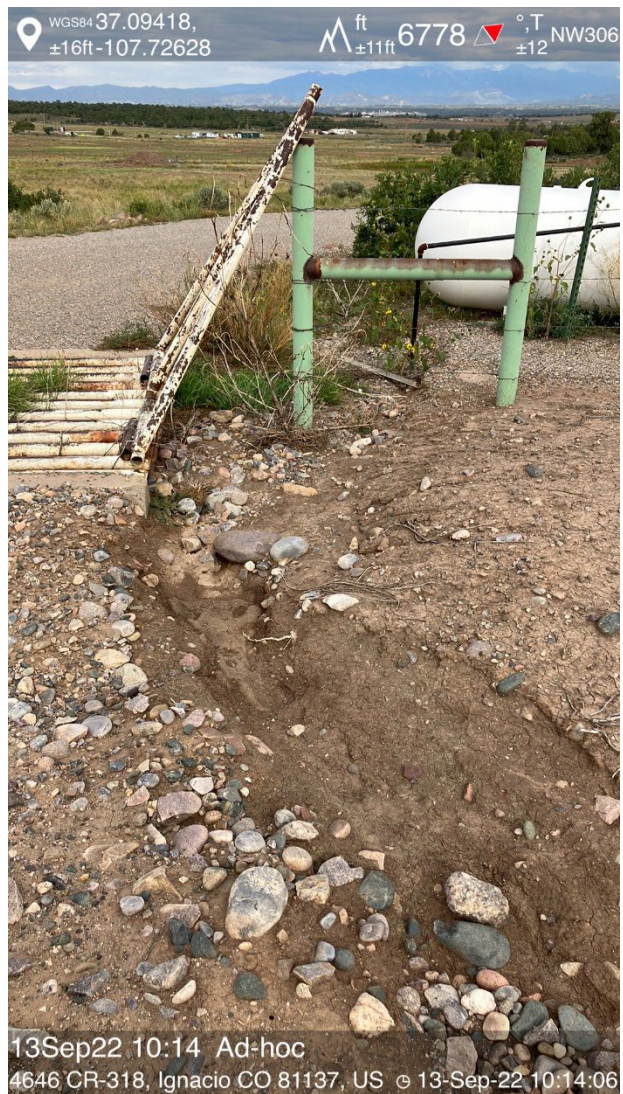
IMG 07

Erosion channel
