Inspection Photos  
Location Name: Crigler MVRD Unit 1  
Location ID: 333914

**COLORADO**  
Oil & Gas Conservation  
Commission  
Department of Natural Resources

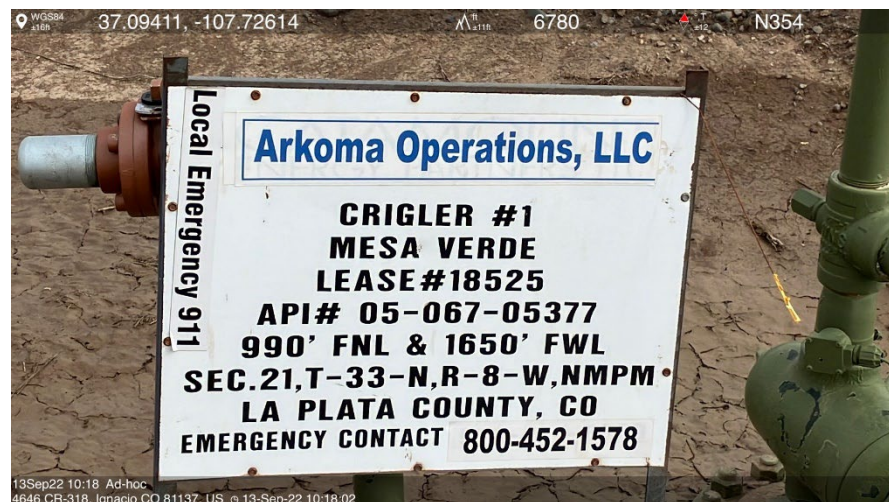
IMG 01  
Well sign

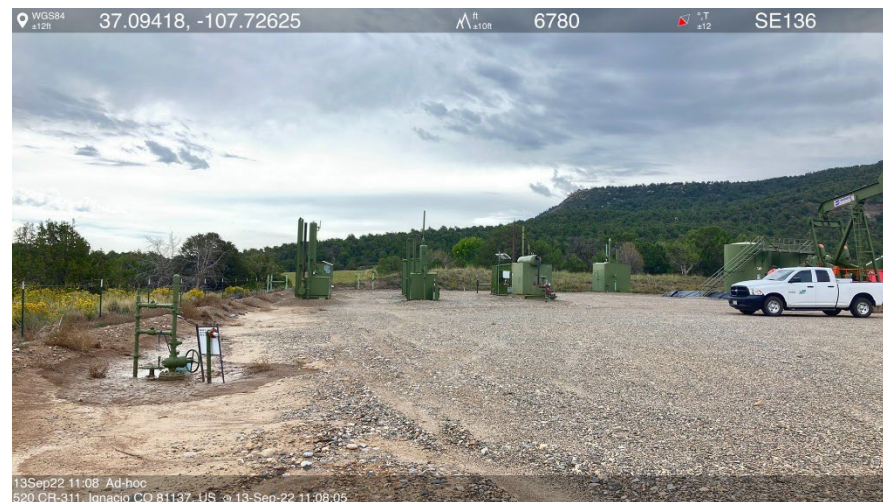
IMG 02  
Location overview
