Inspection Photos

API: 009-06268

Operator: DOVER ATWOOD CORPORATION

Inspection Date: 9/13/2022

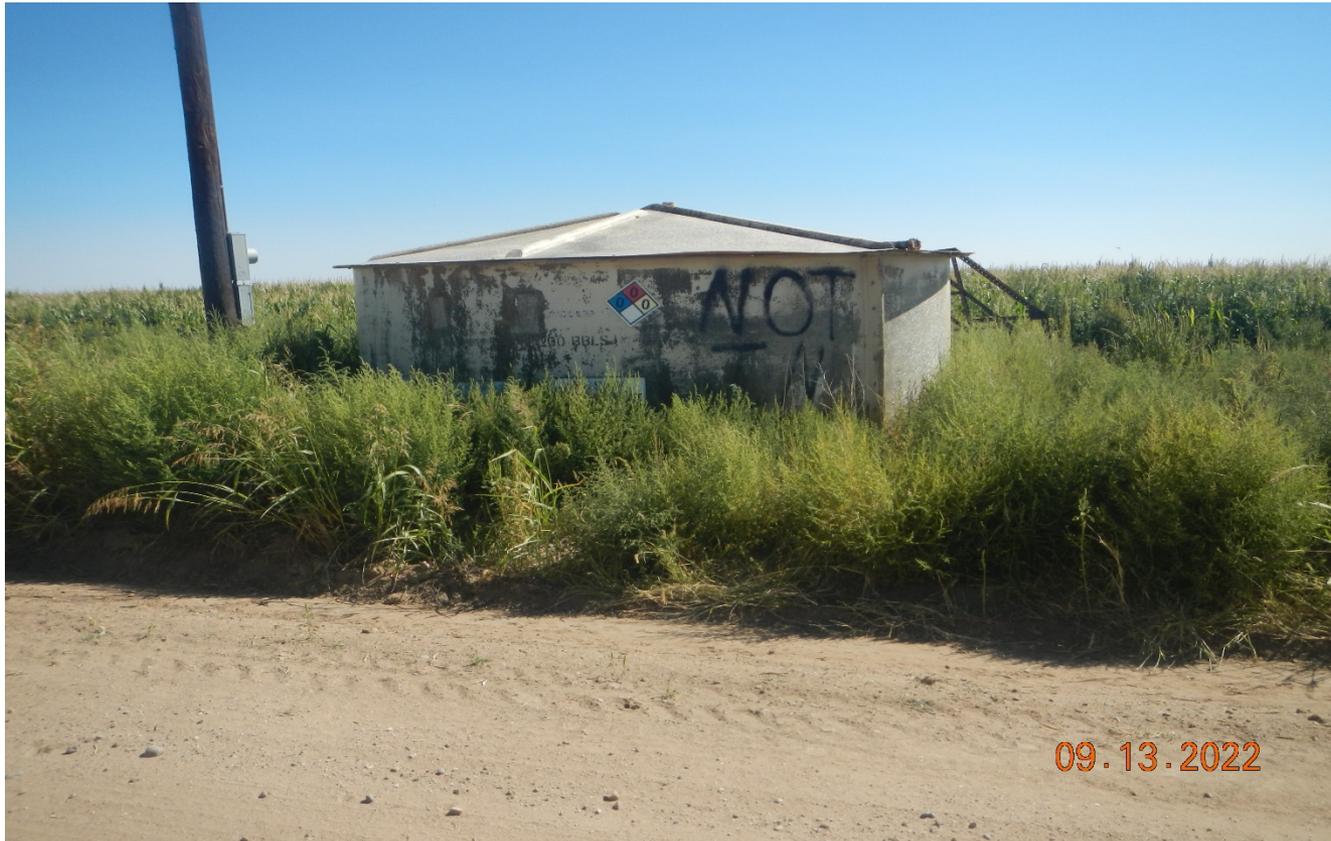
Photo 1. Facing east toward the tank battery along the access road. There is tall undesirable weeds around the tank that need to be removed. If take is not in use it must be removed. Tank berm is inadequate.

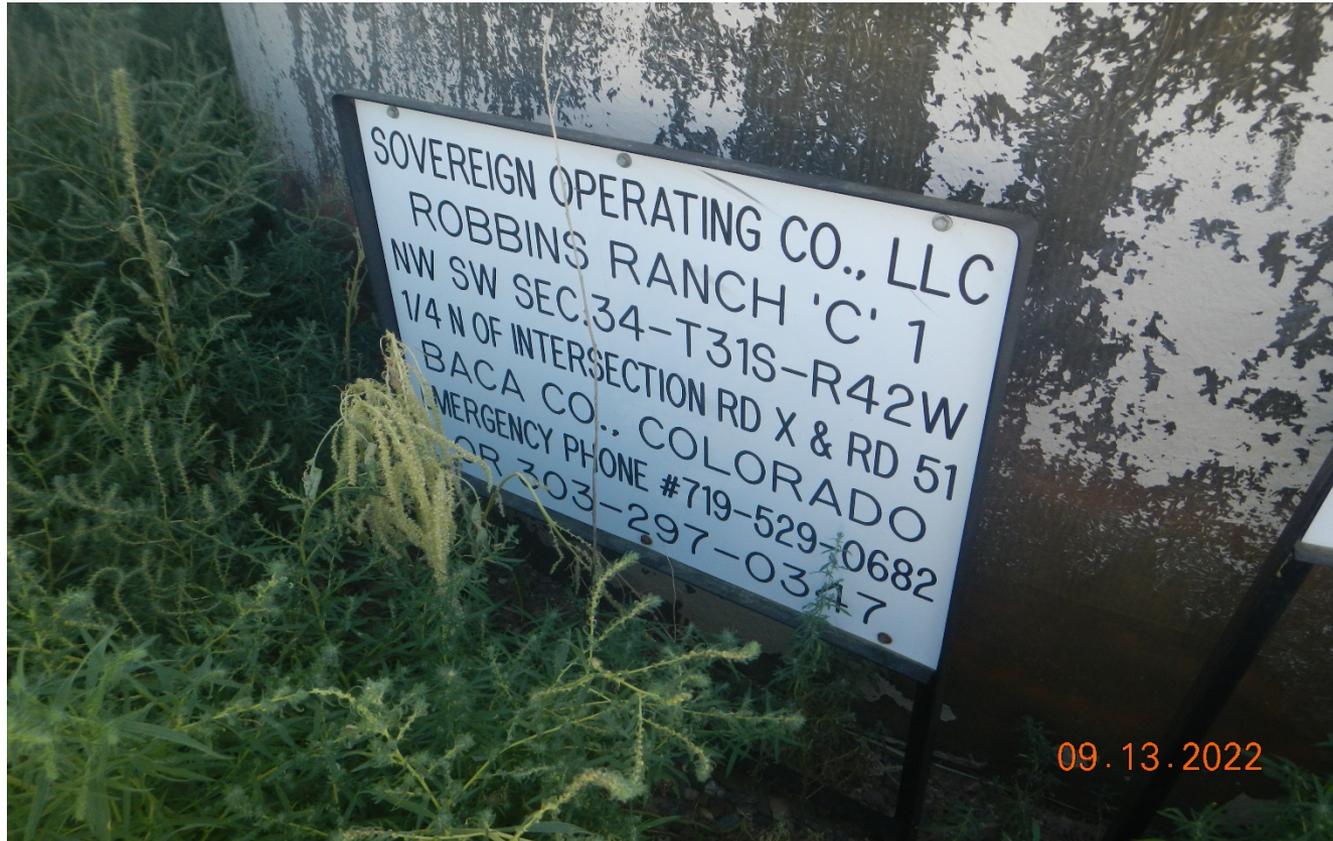
Photo 2. The sign at the tank does not reflect current Operator or emergency contact INFO.

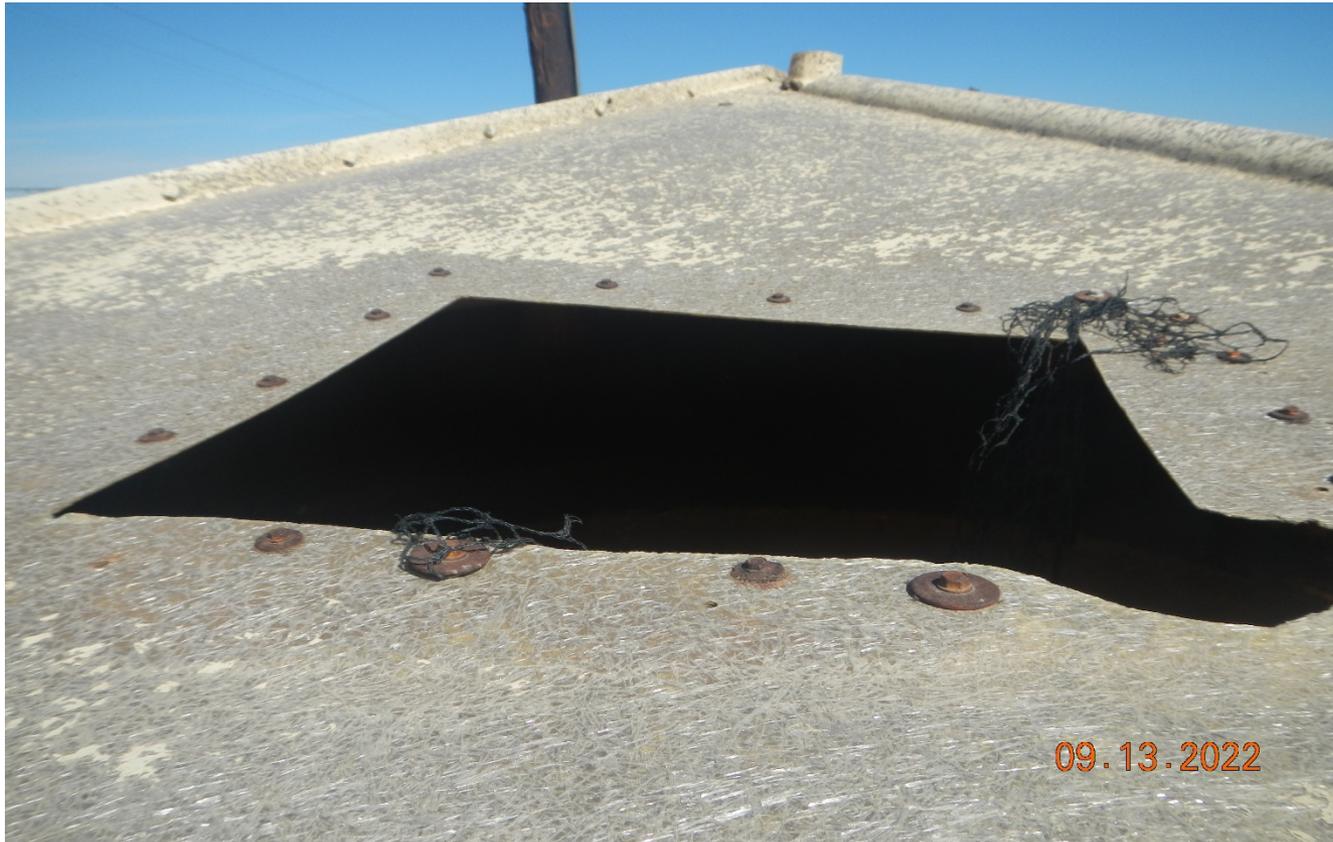
Photo 3. The netting at the top of the tank is inadequate.
