Inspection Photos

Location Name: TEP ROCKY MOUNTAIN LLC FEDERAL-67S96W /4NENW

Location ID: 334832

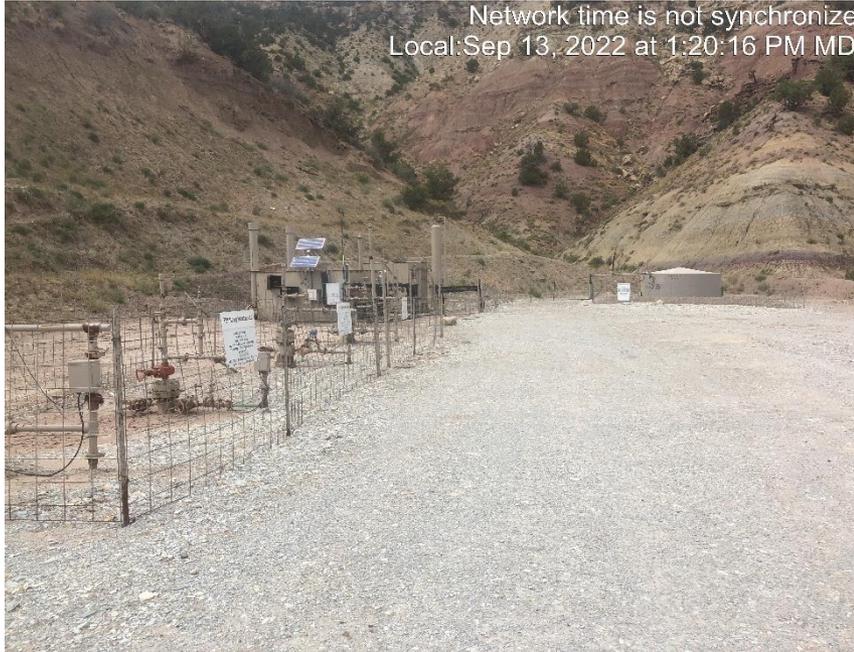
Photo #7655 From entrance to location.

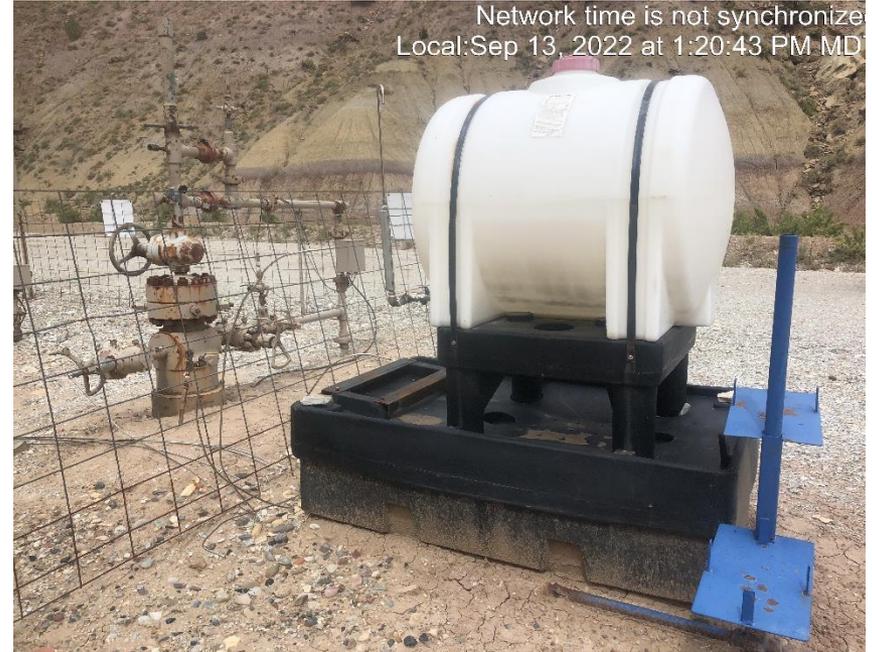
Photo #7656 Unused equipment.

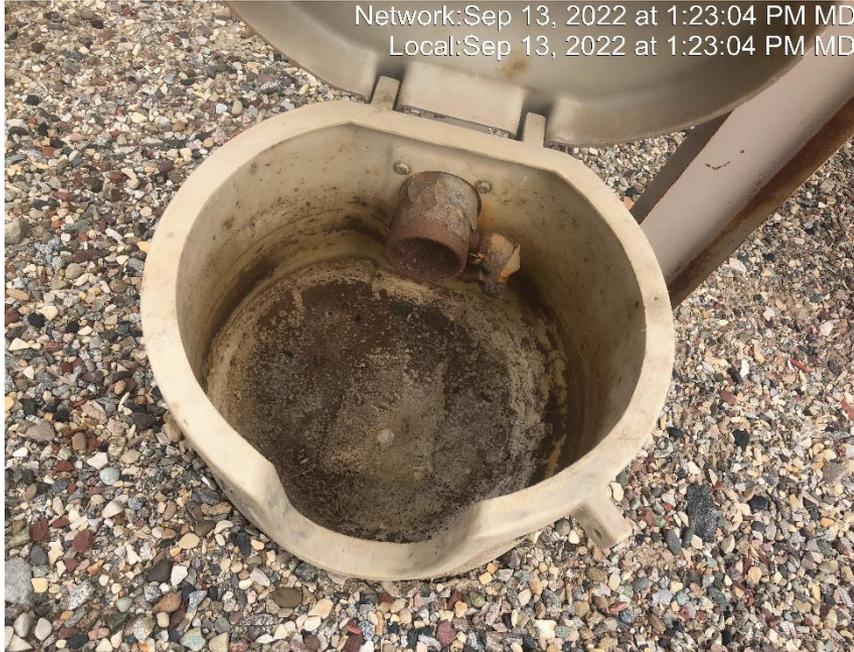
Photo #7658 Loadline open ended.

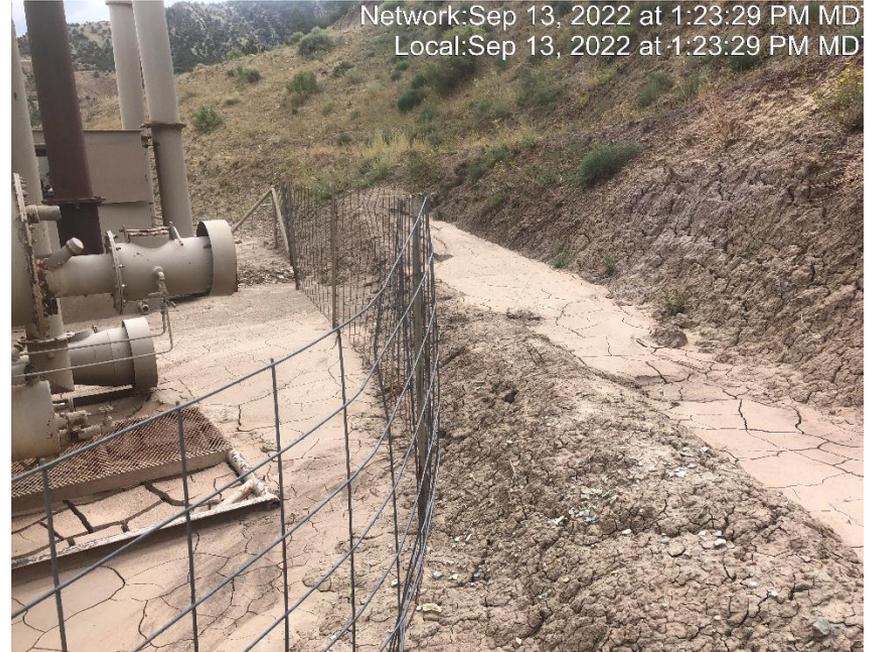
Photo #7659 Run on to location is not being controlled.

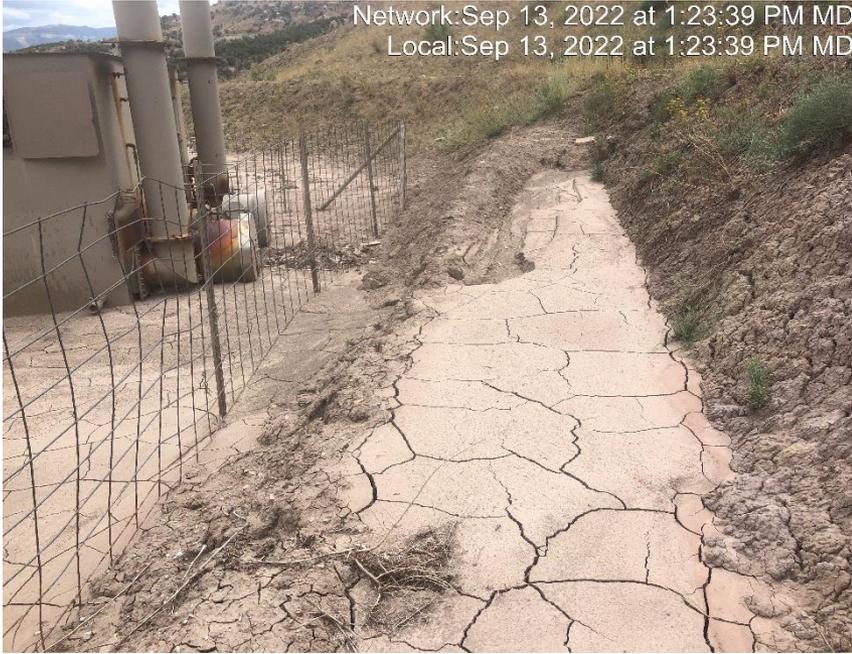
Photo #7660 Run on to location is not being controlled.

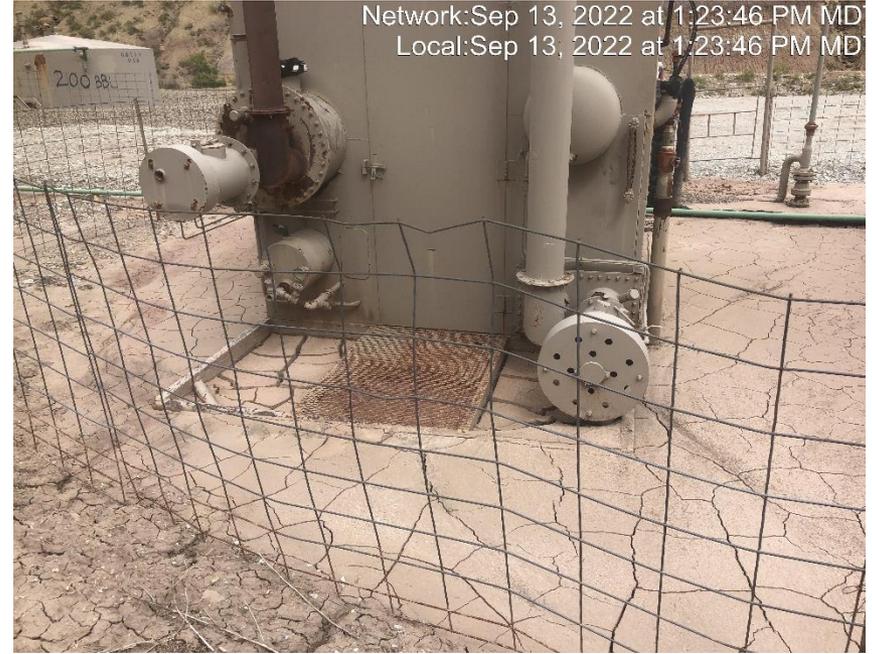
Photo #7661 Sediment is encroaching on equipment.

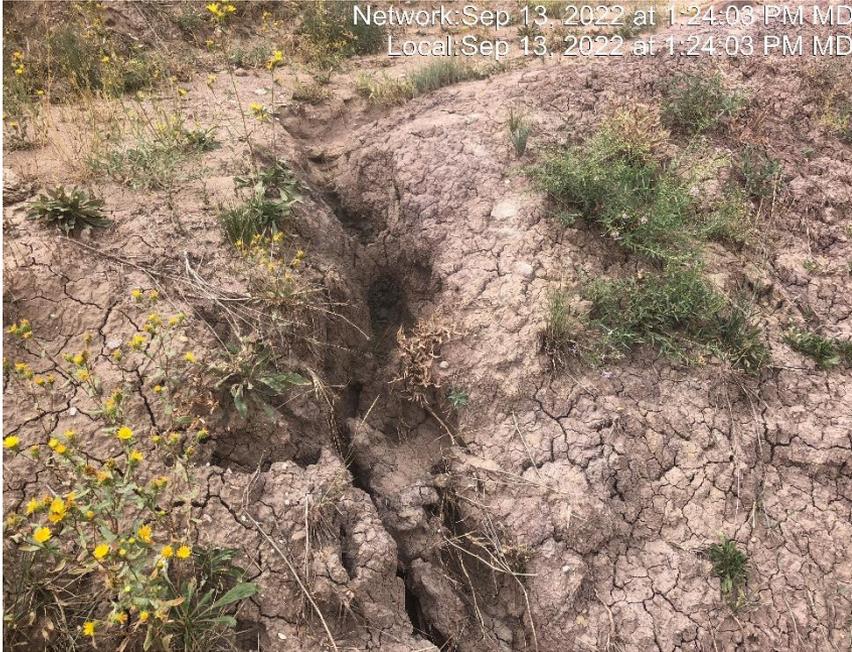
Photo #7662 Rill erosion occurring on cut slope.

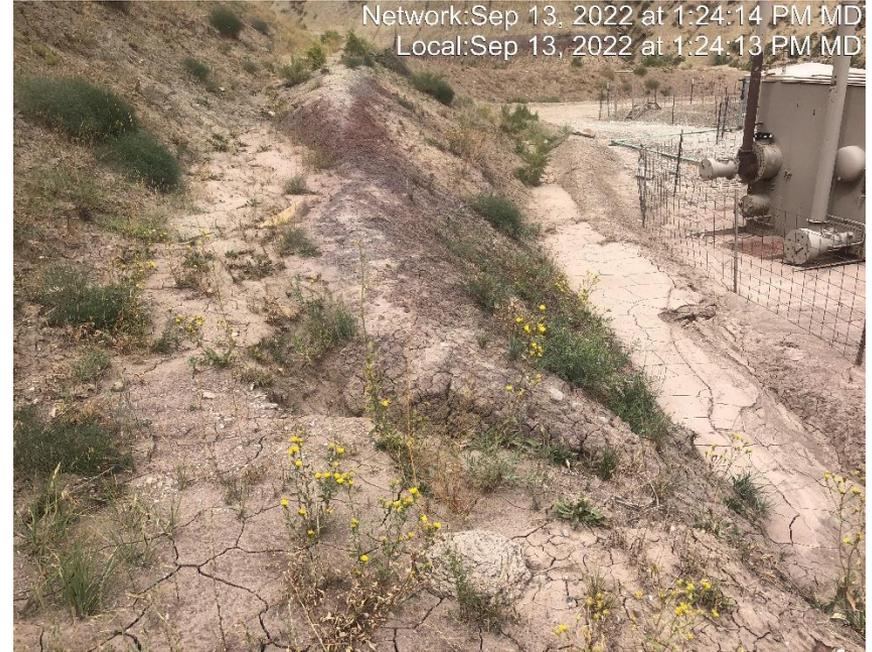
Photo #7663 Rill erosion occurring on cut slope.

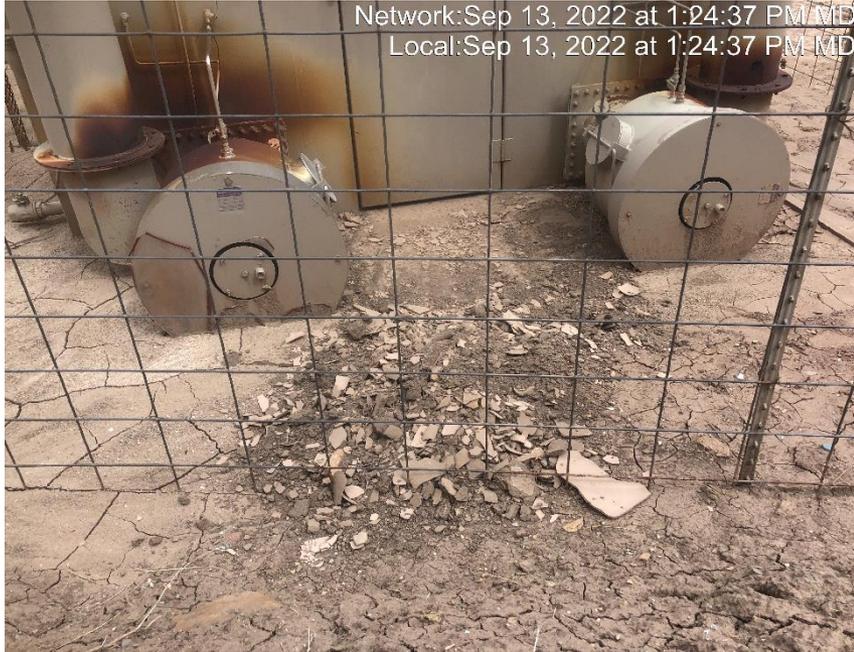
Photo #7665 Sediment encroaching on equipment.
