Inspection Photos

API: 009-06603

Operator: ENERGY ALLIANCE COMPANY INC

Inspection Date: 9/13/2022

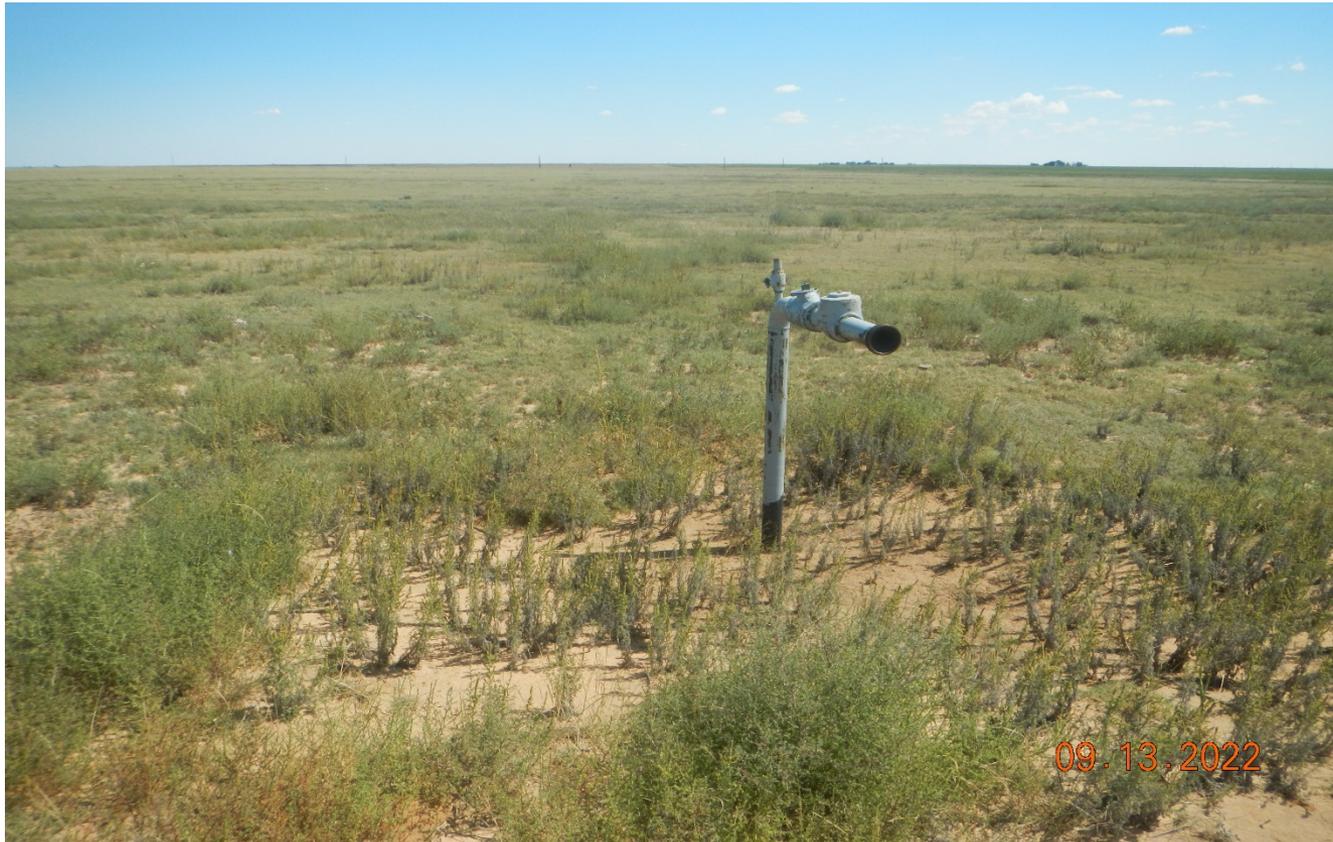
Photo 1. There is a piper riser that still remains along the flowline 1770' east of the wellsite.

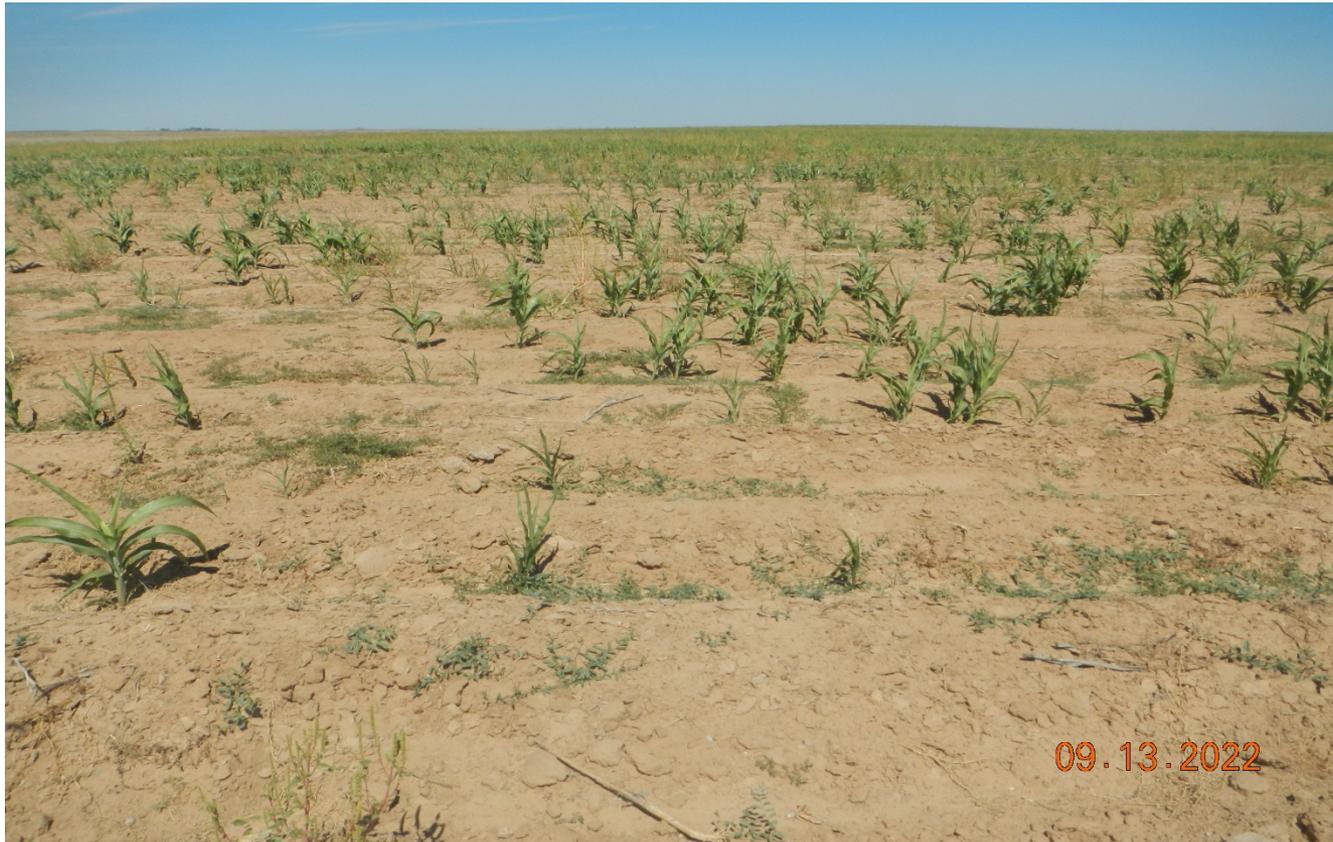
Photo 2. Center of the location facing north.

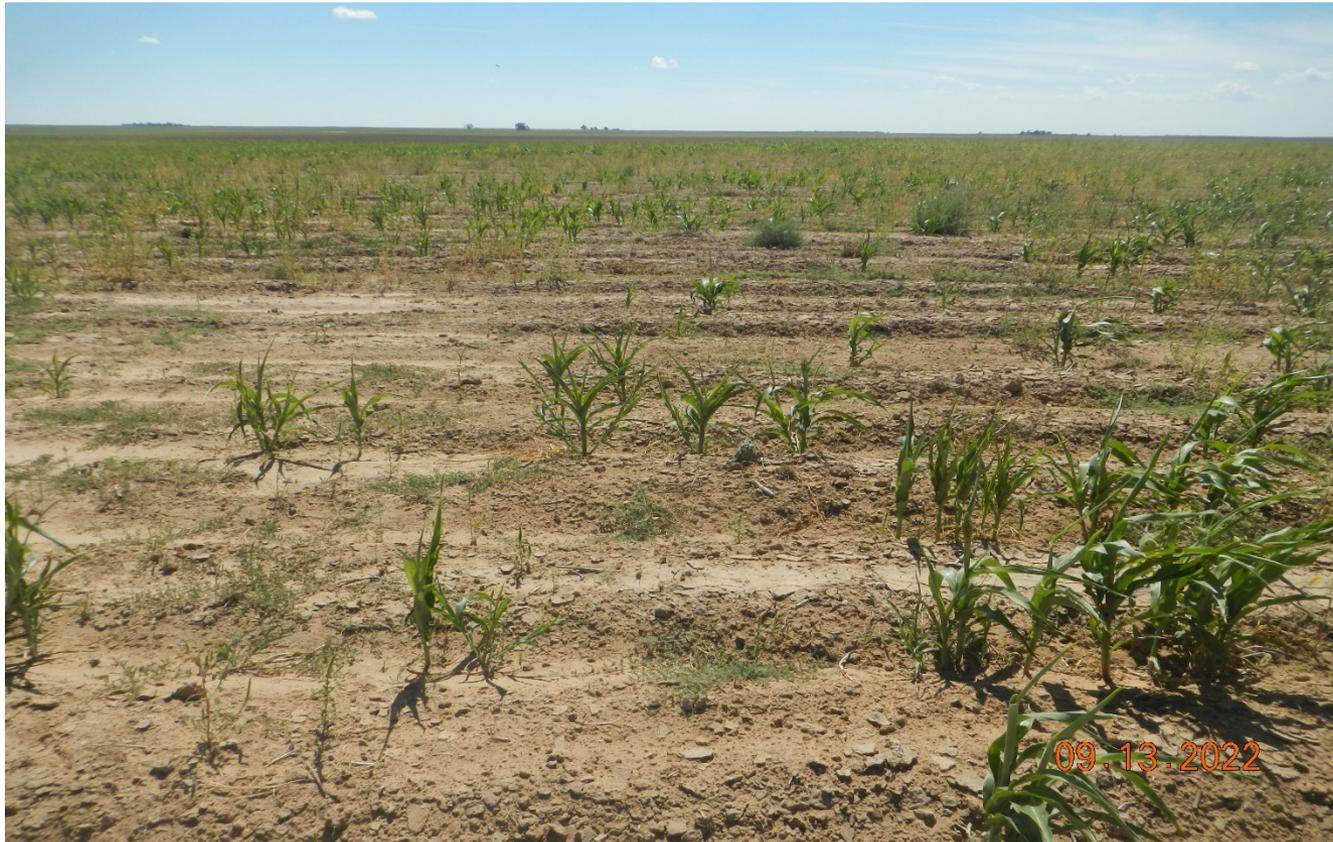
Photo 3. Center of the location facing south.
