Inspection Photos

API: 009-06124

Operator: ENERVEST OPERATING LLC

Inspection Date: 9/13/2022

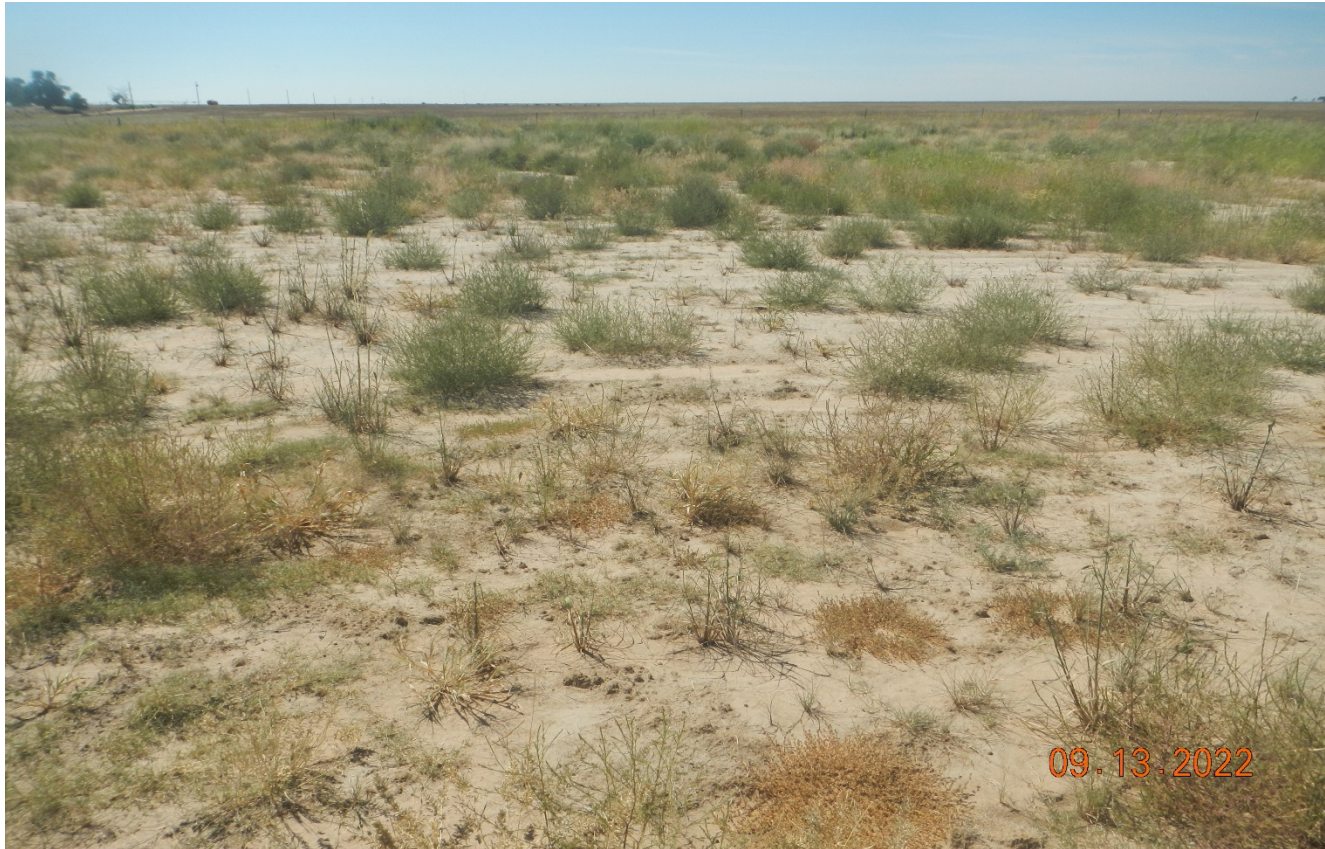
Photo 1. Center of the location facing north. The location has been fenced and it appears decompaction and seeding was performed. Perennial vegetation has not yet established.

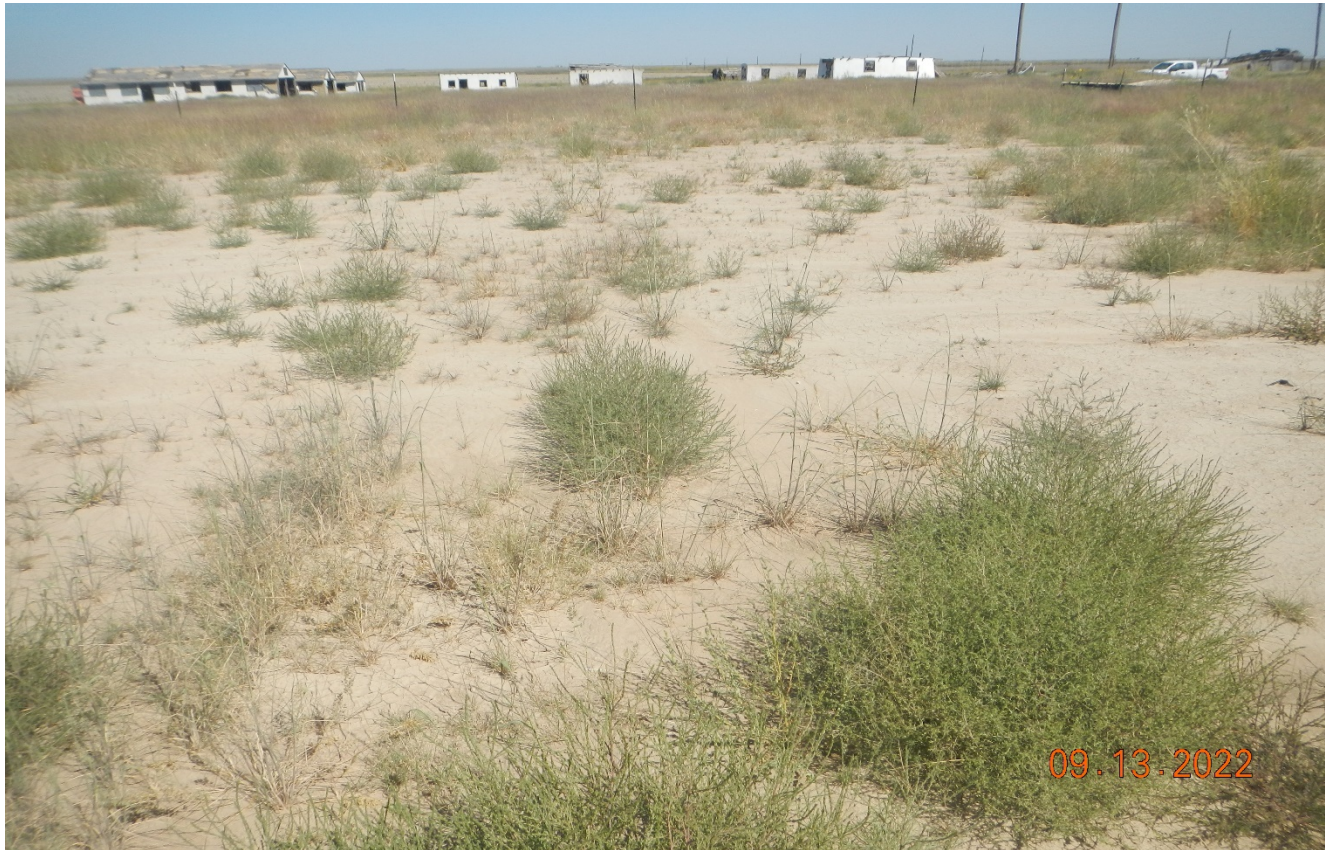
Photo 2. Center of the location facing south.

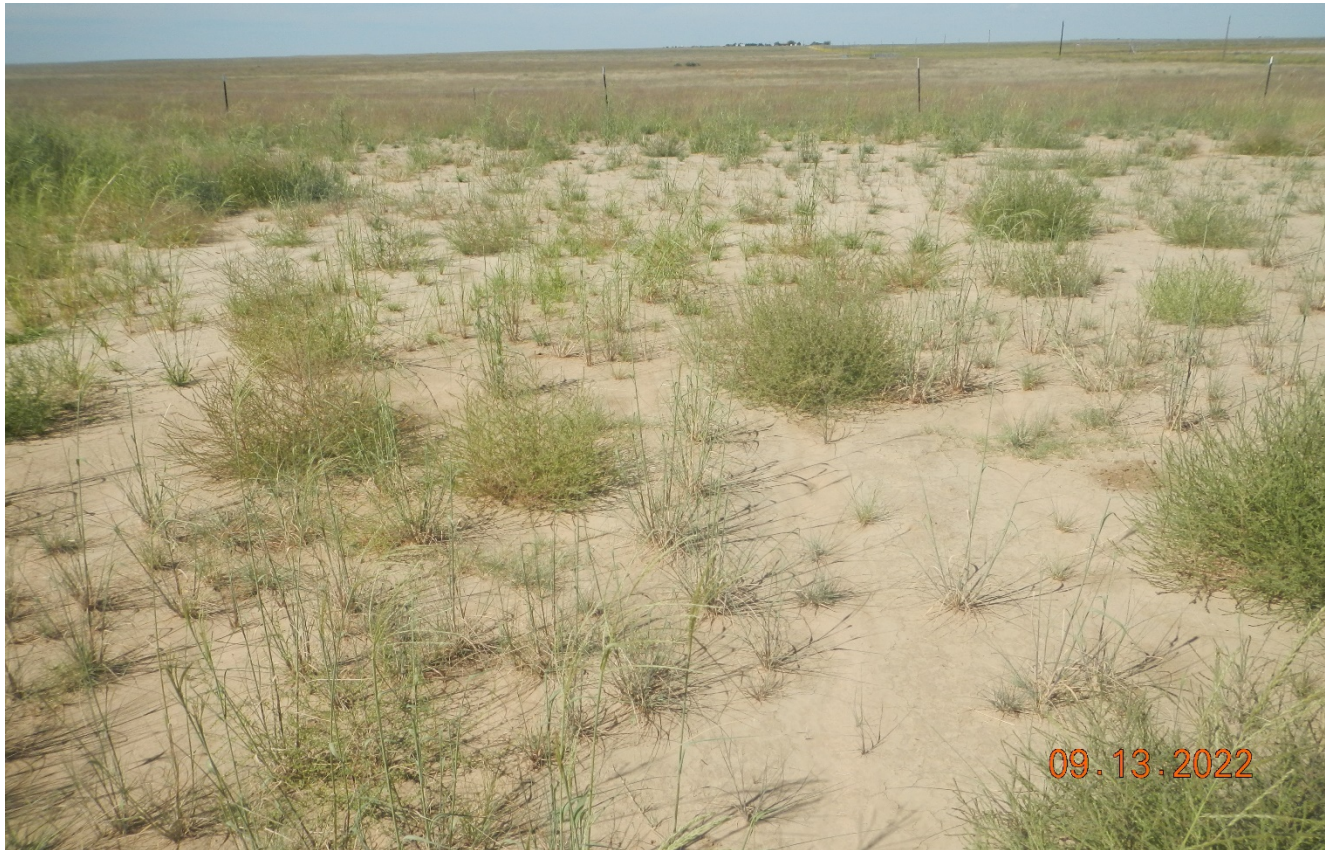
Photo 3. Center of the location facing west.

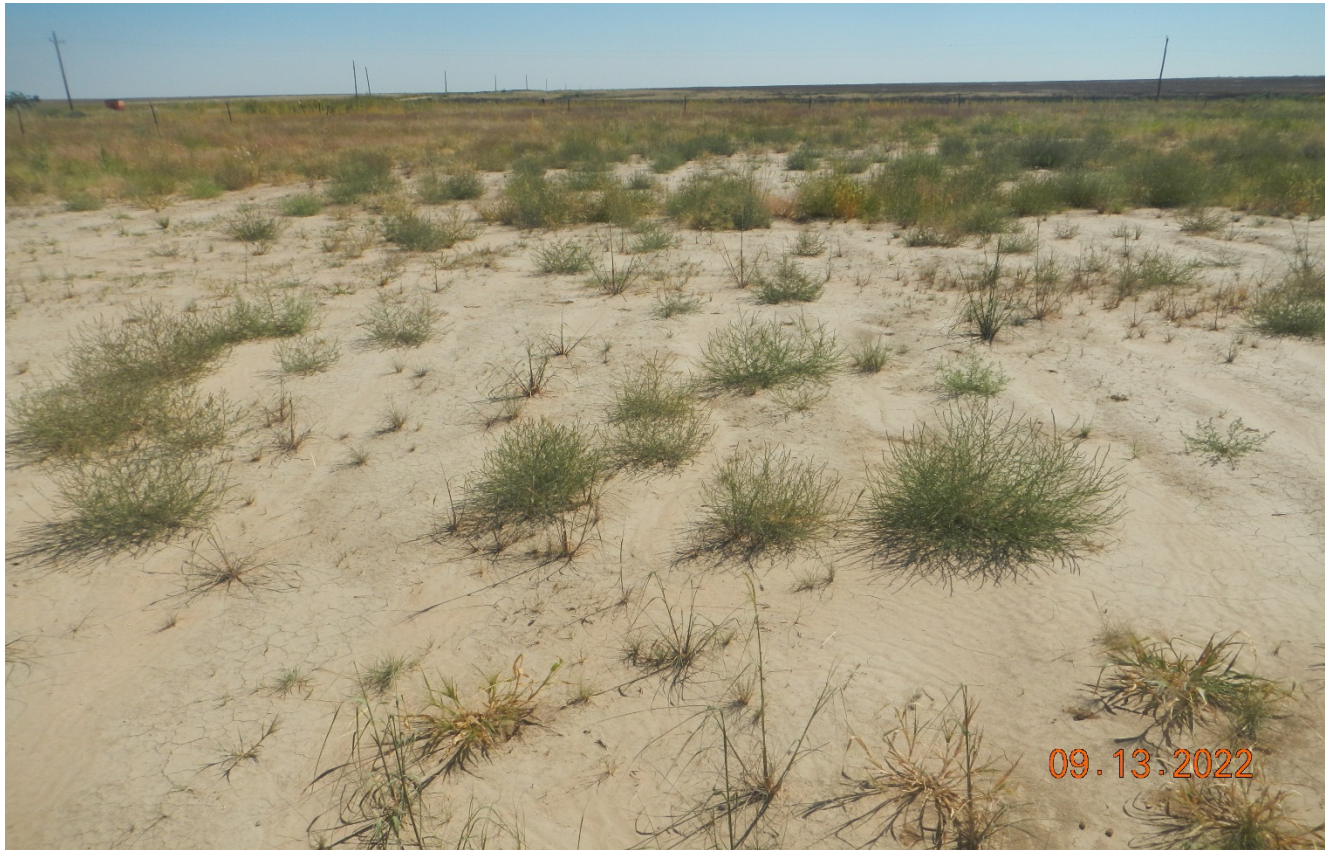
Photo 4. Center of the location facing east.

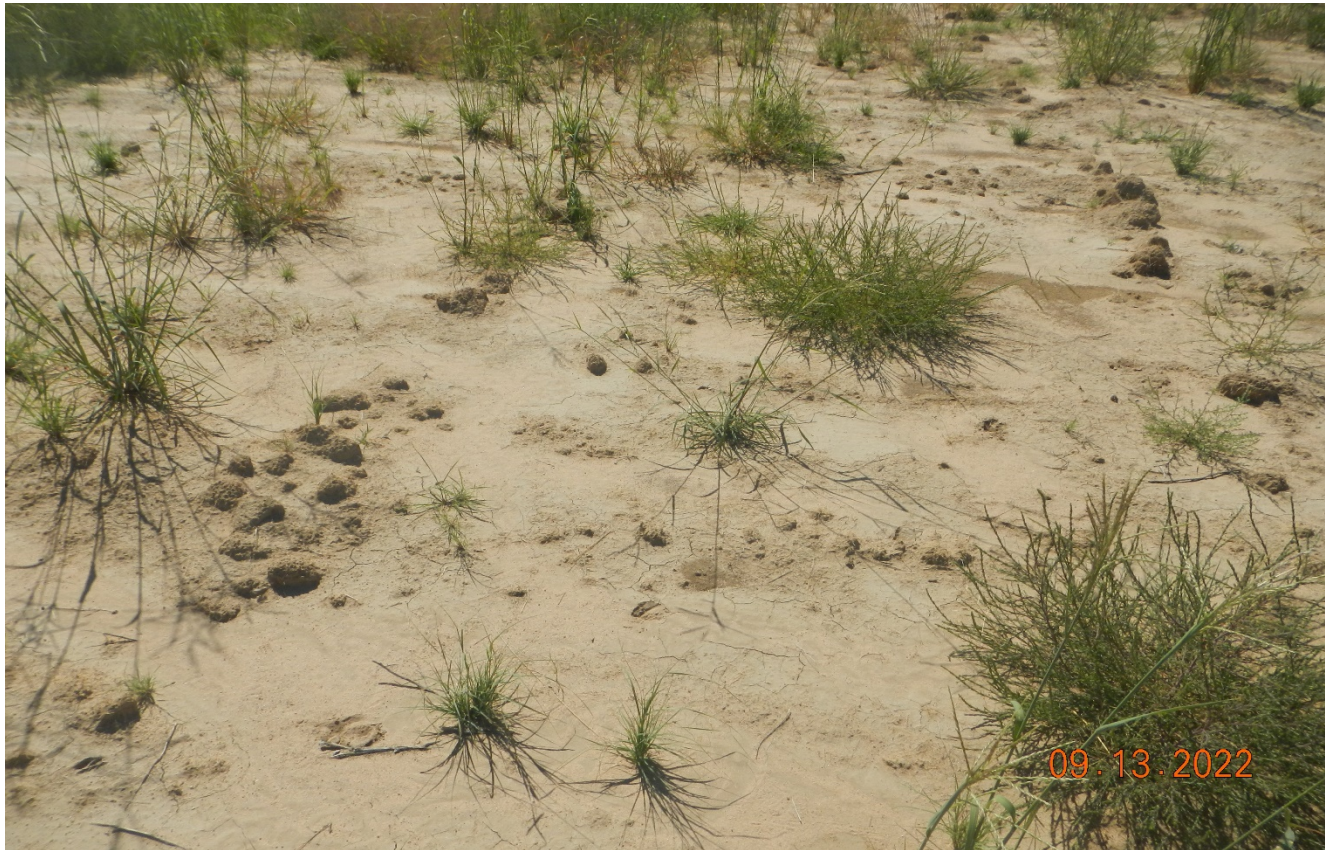
Photo 5. View of ground cover shows some vegetation beginning to establish. Additional growing season and maintenance will be needed to fully establish vegetation.
