Final Reclamation Inspection

September 13, 2022

Location ID: 318656

Inspection Photos
Location Name: DITIRRO, JOHN #1-A
Location ID: 318656

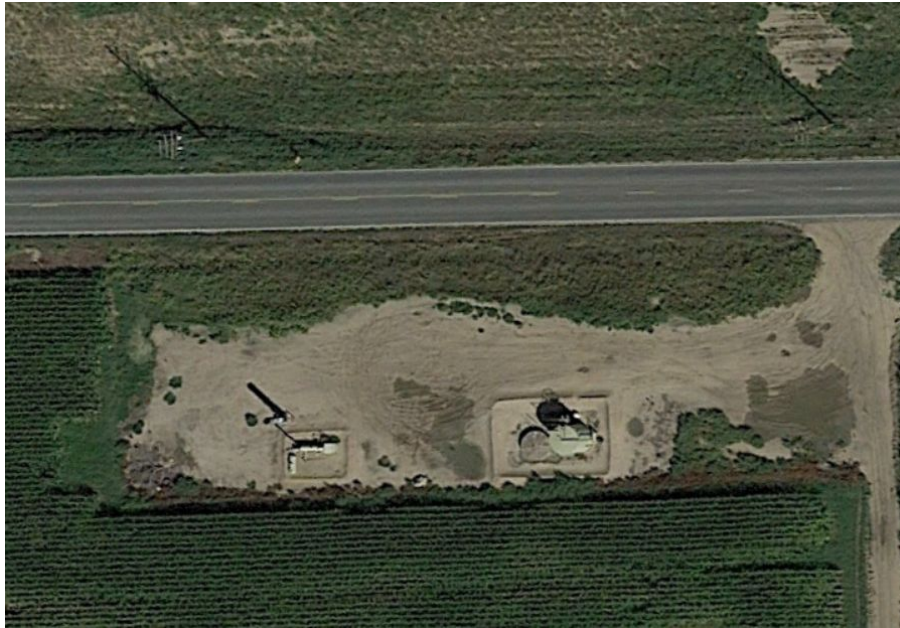
Photo 1. Google Earth aerial imagery from 9/12/2019 illustrates the tank battery during active operations.

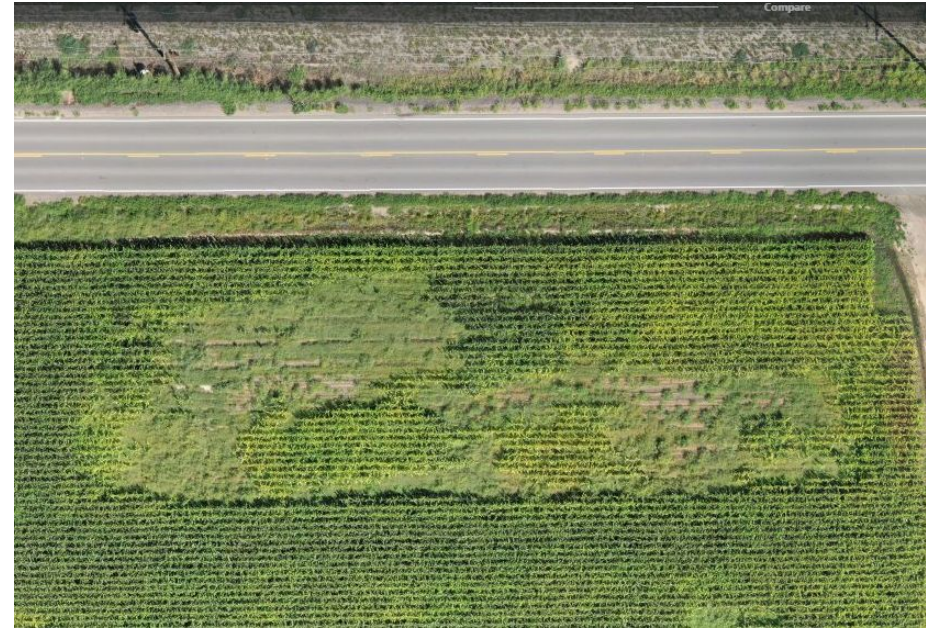
Photo 2. COGCC drone aerial imagery from 9/1/2022 illustrates crop deficiencies within the footprint of the tank battery.

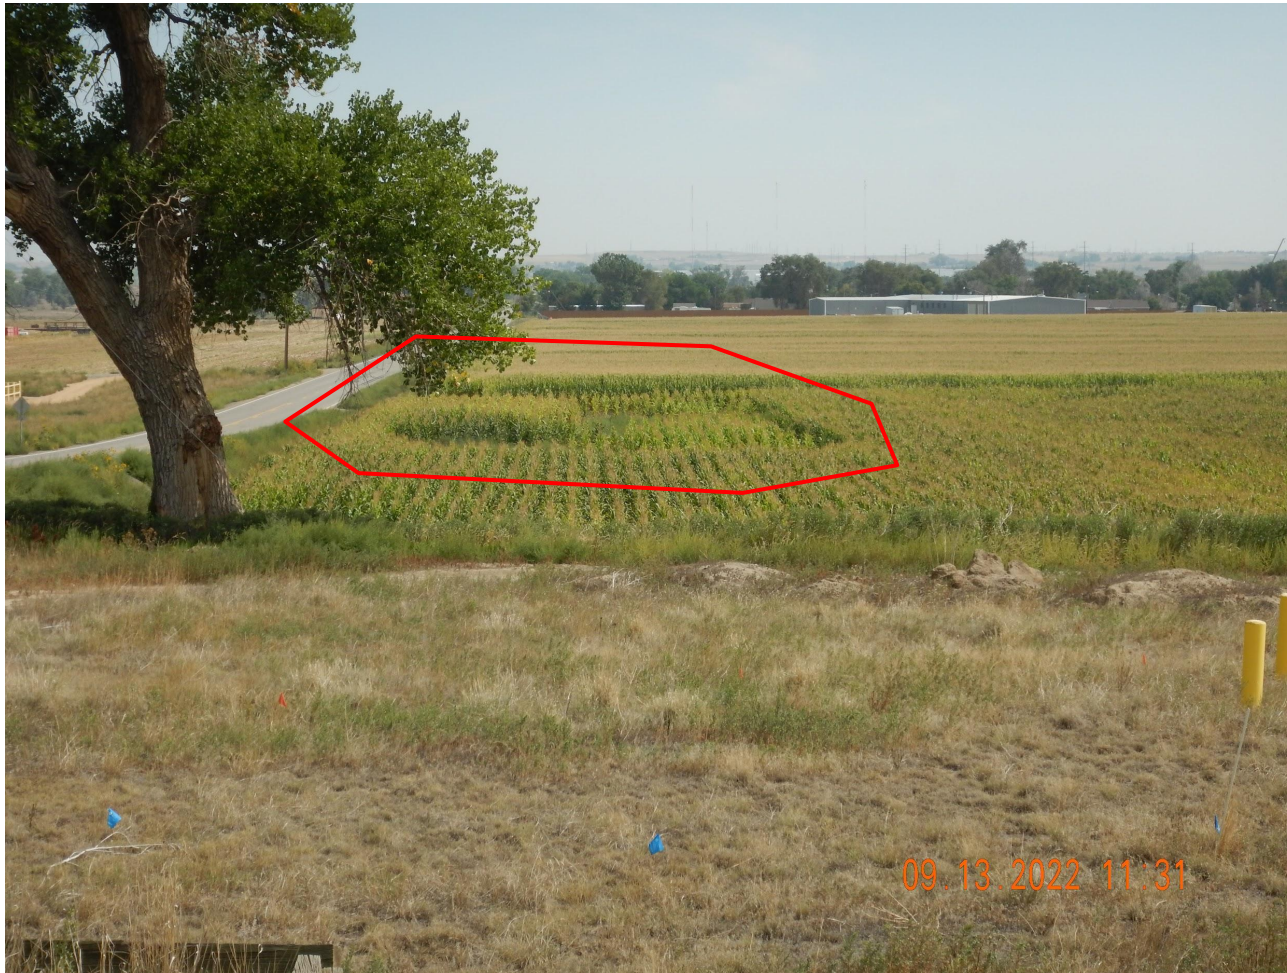
Photo 3. Photo taken west of the tank battery, facing East. Photo illustrates crop deficiencies within the footprint of the tank battery.

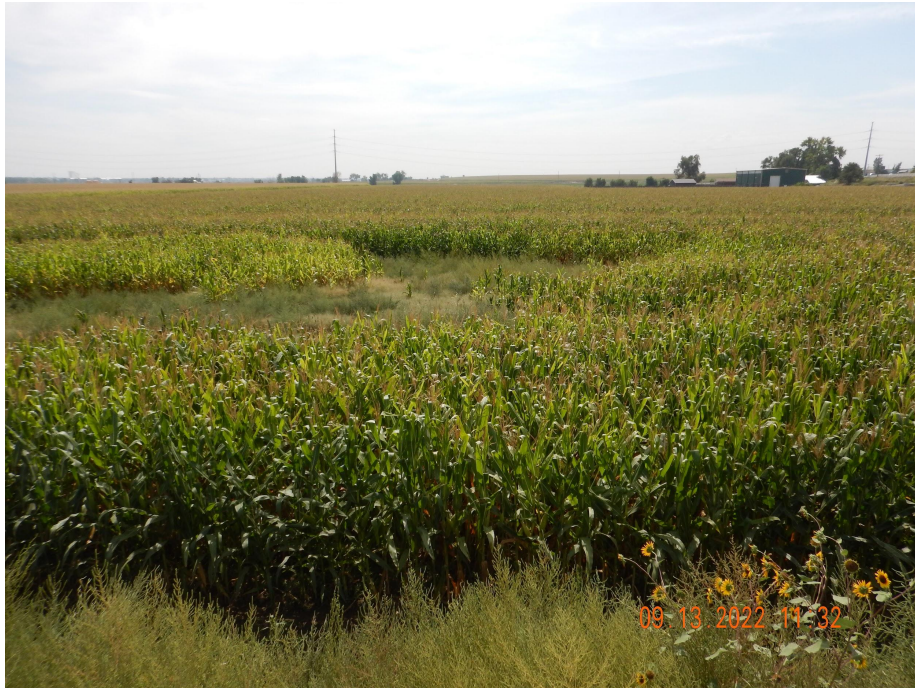
Photo 4. Photo taken north of the tank battery, facing South. See comments under Photo 3.

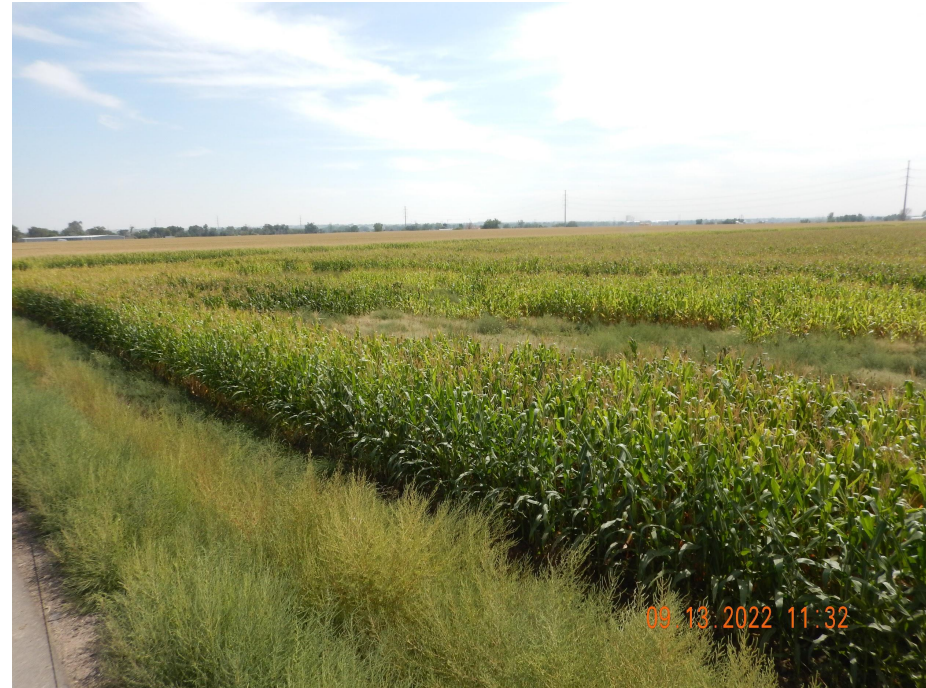
Photo 5. Photo taken north of the tank battery, facing Southeast. See comments under Photo 3.

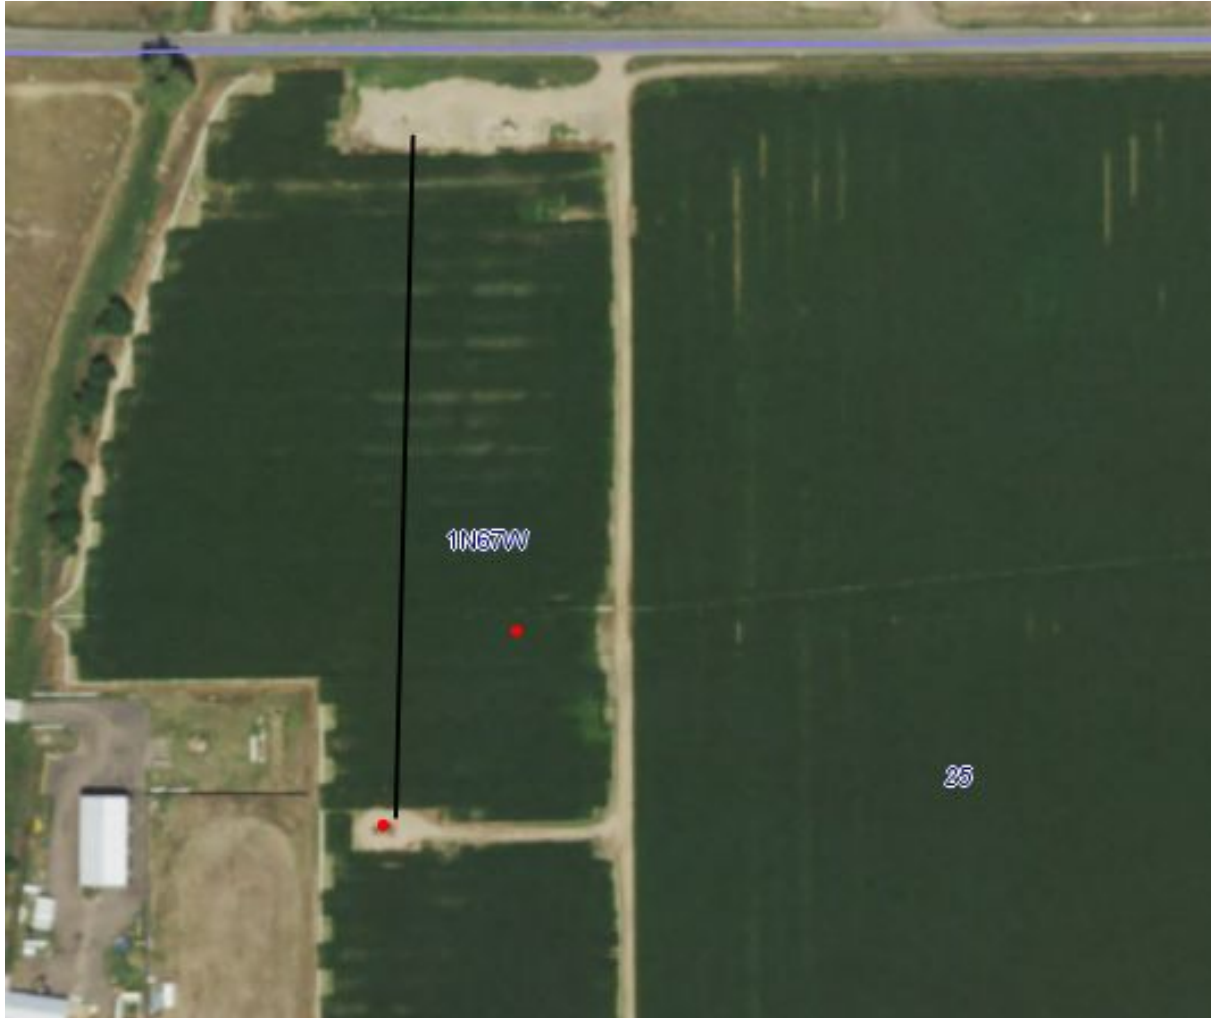
Photo 6. COGCC GISOnline imagery illustrates the path of the flowline.

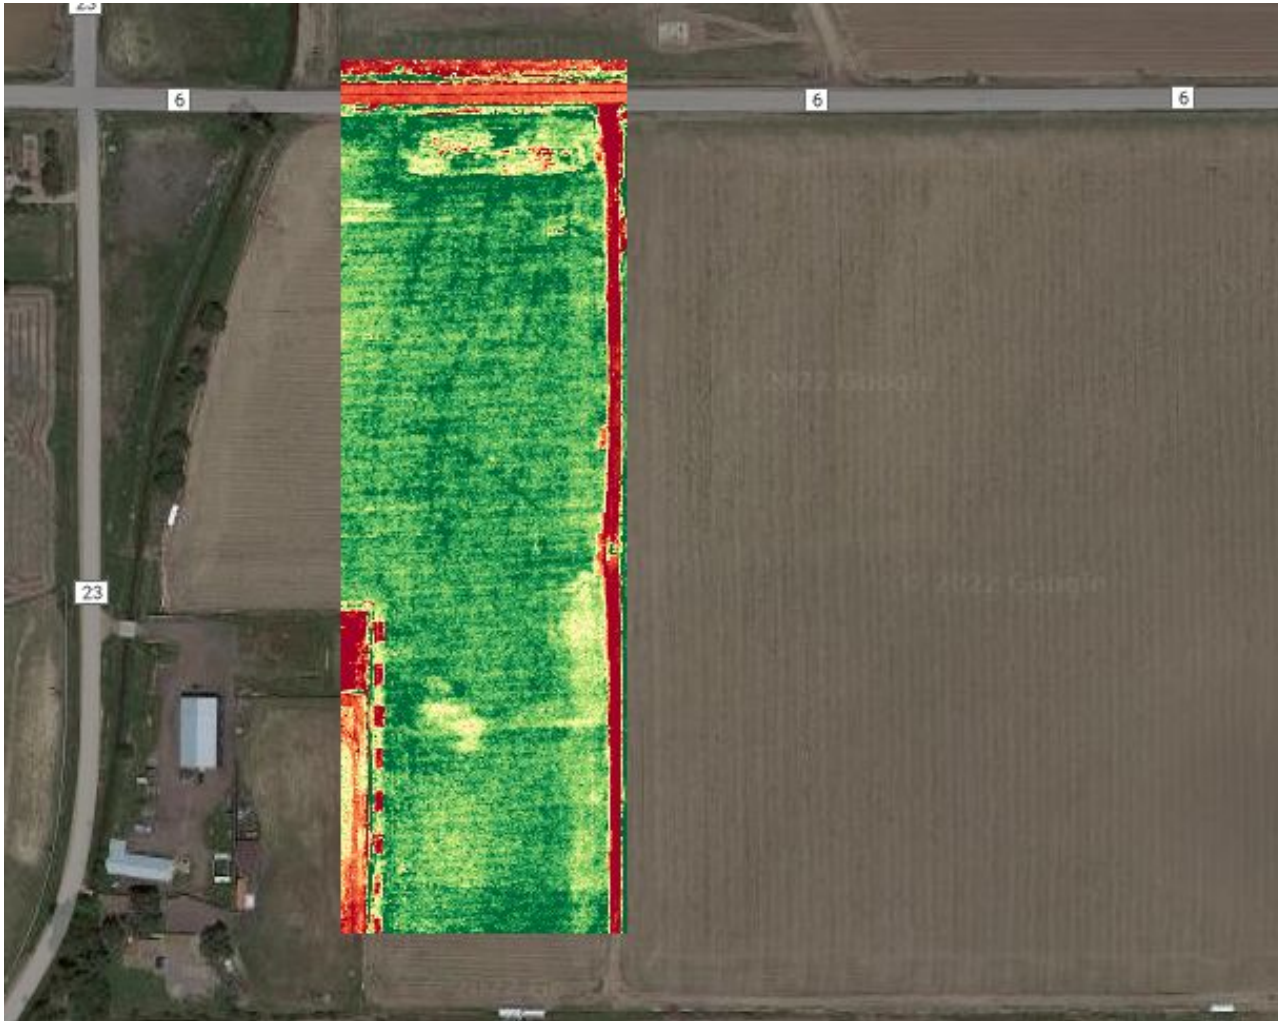
Photo 7. COGCC drone imagery illustrates the Visible Atmospherically Resistant Index which measures how green an image is. Based on this image, there is no observed issues along the flowline area. Note- the tank battery has red coloration which indicates bare soil.

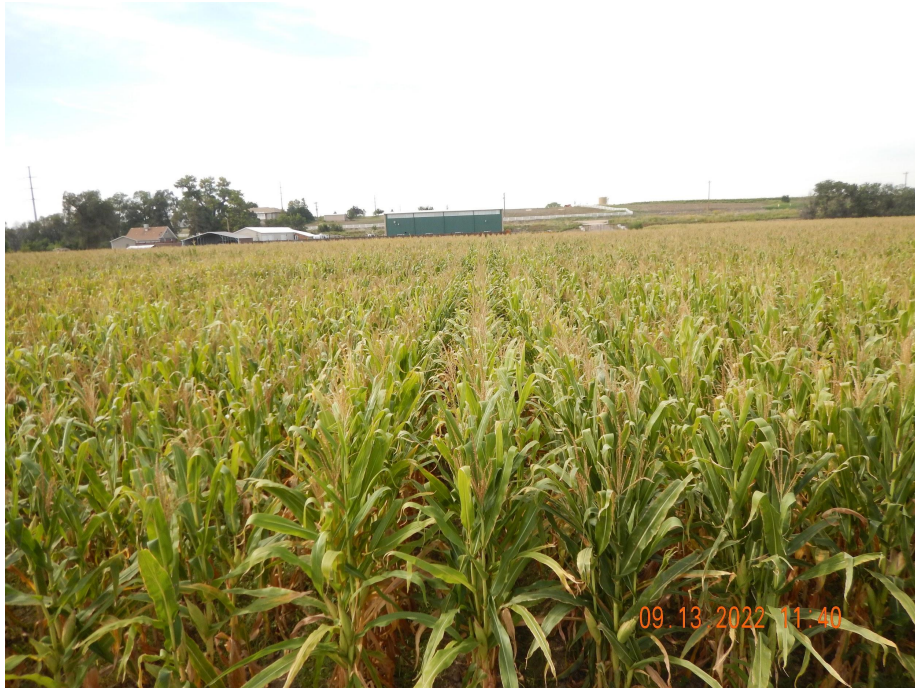
Photo 8. Photo taken from the former well location access road, facing West. Photo illustrates the access road and well location are reflective of reference crop areas.

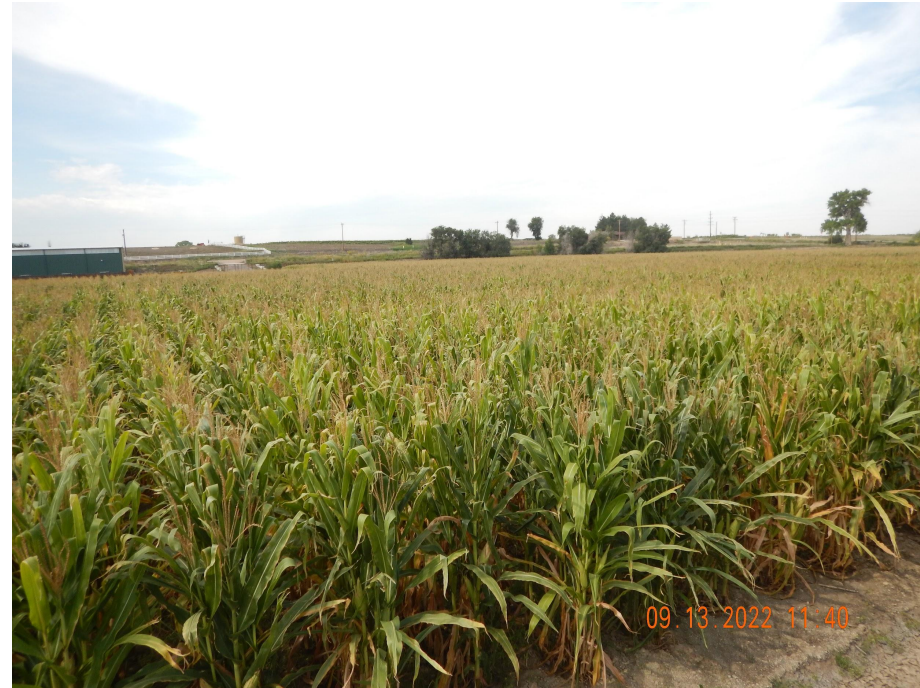
Photo 9. Photo taken from the former well location access road, facing Northwest. Photo illustrates the flowline areas are reflective of reference crop areas.
