Inspection Photos

API: 071-07862

Operator: EVERGREEN NATURAL RESOURCES

Inspection Date: 9/16/2022

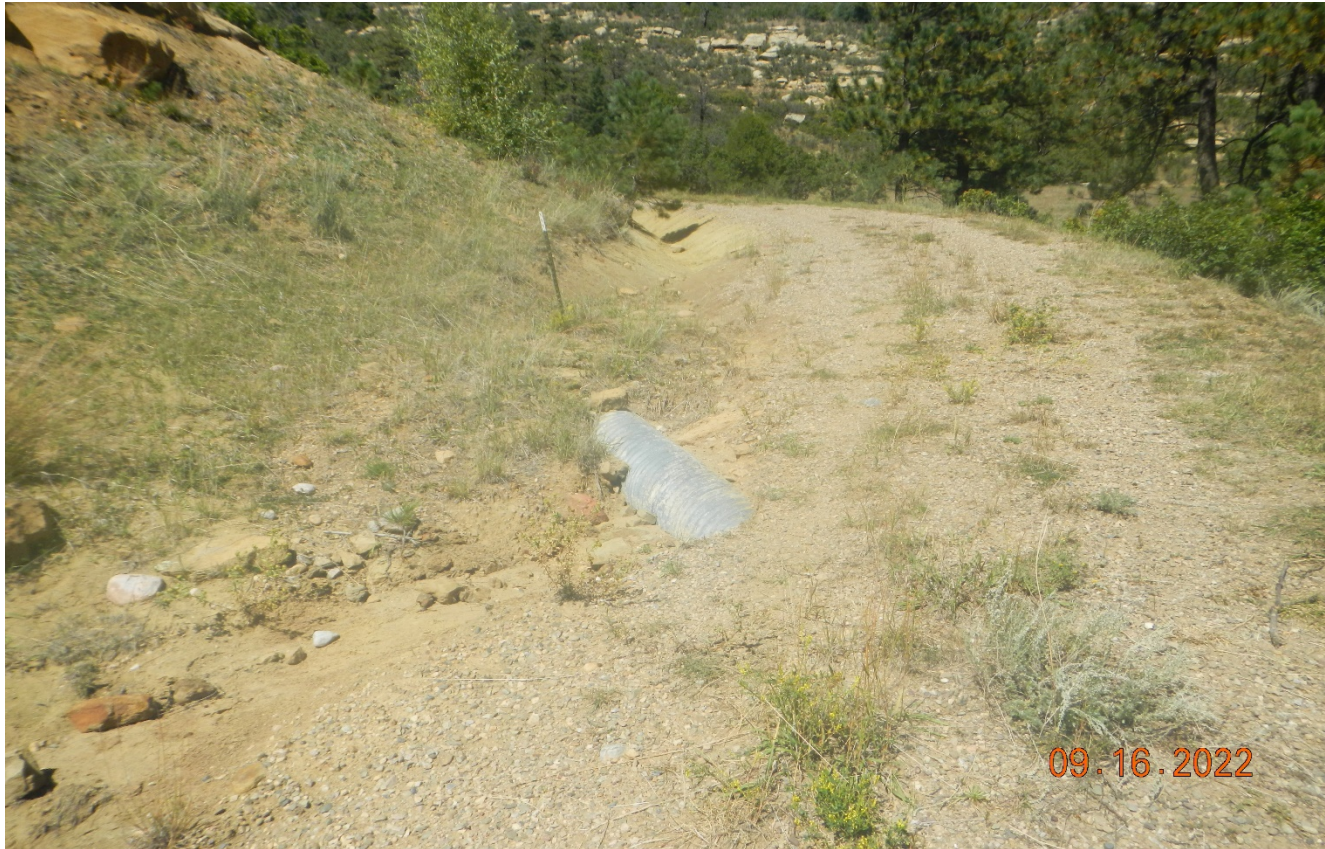
Photo 1. Facing north along the access road. Stormwater is bypassing the culvert causing erosion down the road.

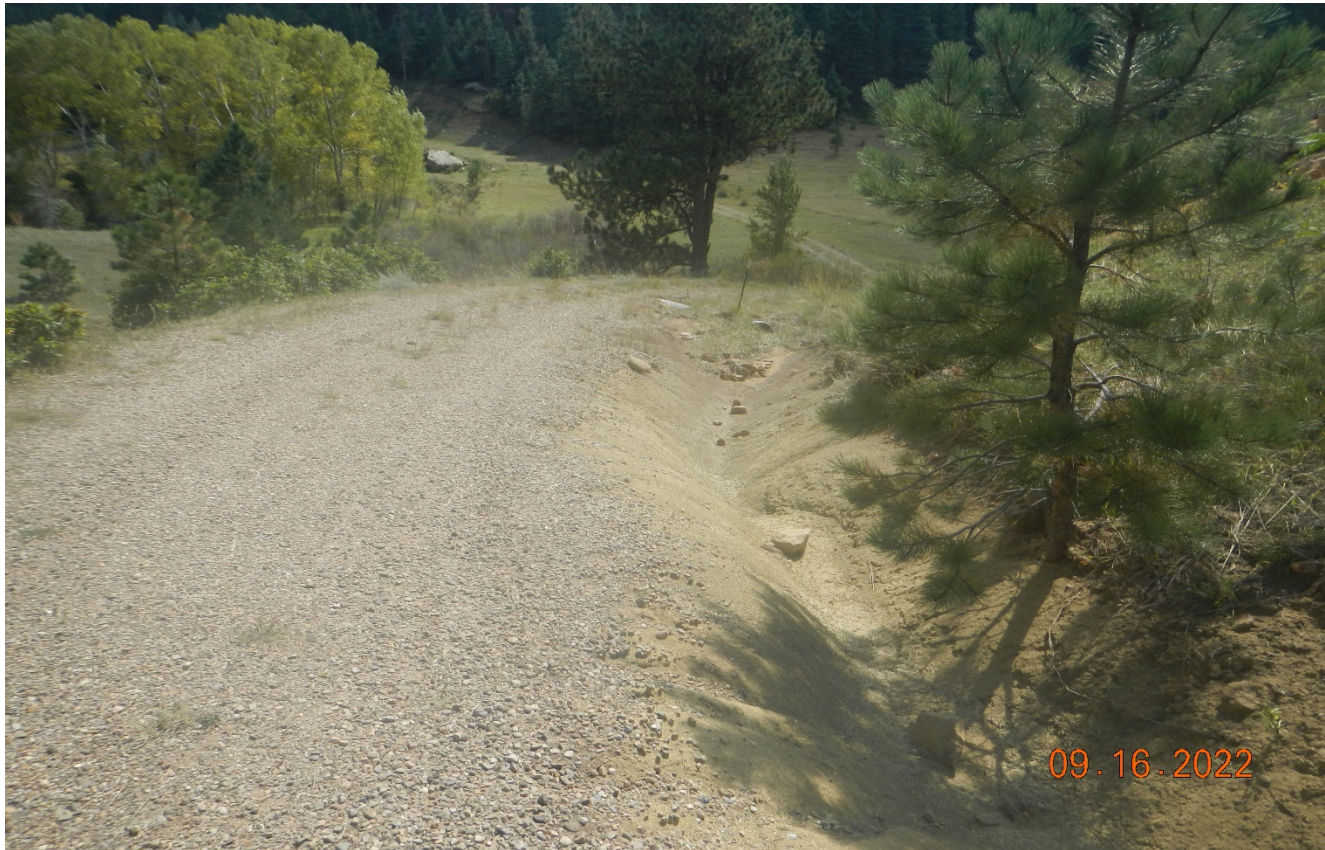
Photo 2. Facing back down the road. There is erosion along the road side that needs to be repaired and stabilized.

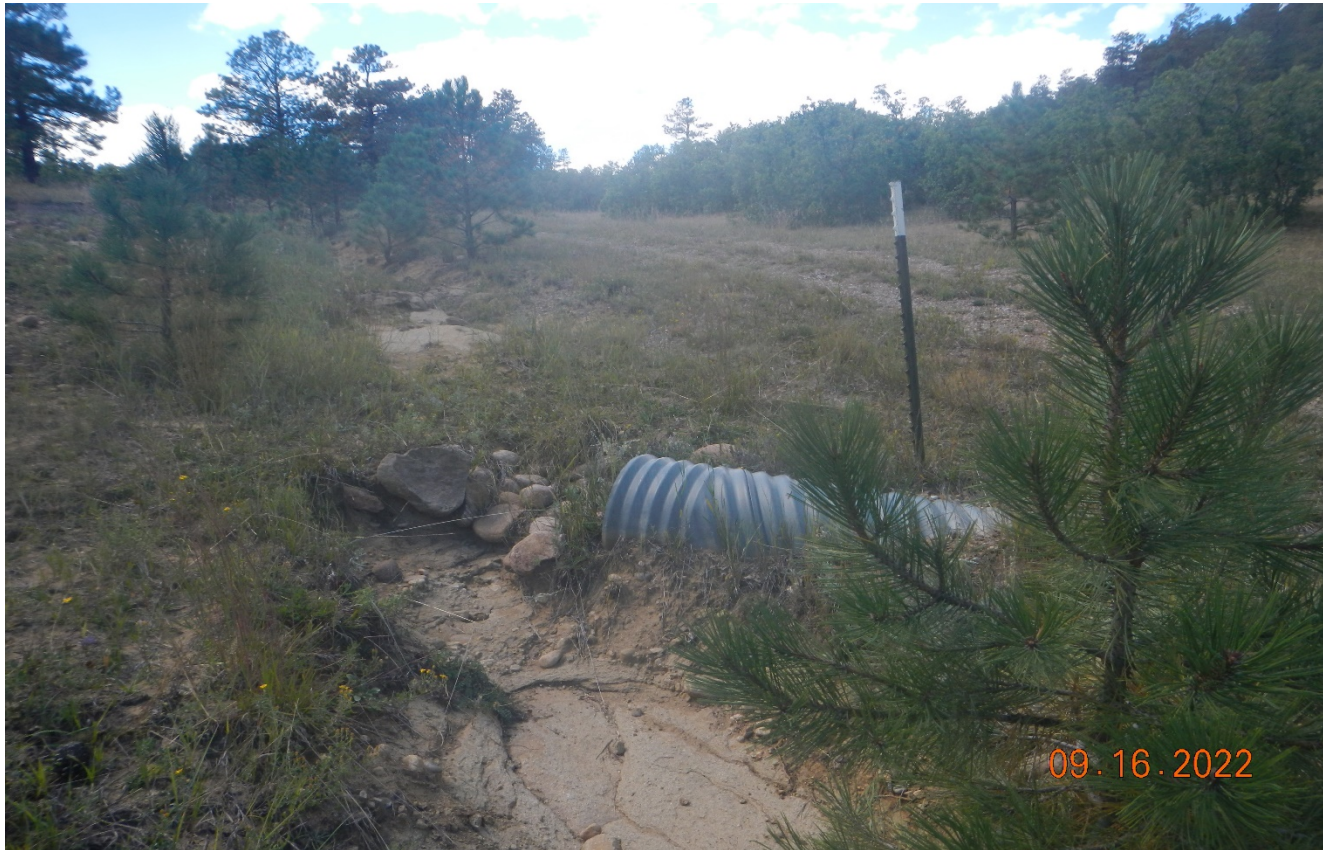
Photo 3. Further up the road is a culvert where stormwater is bypassing. This needs to be dug out to allow stormwater flow.

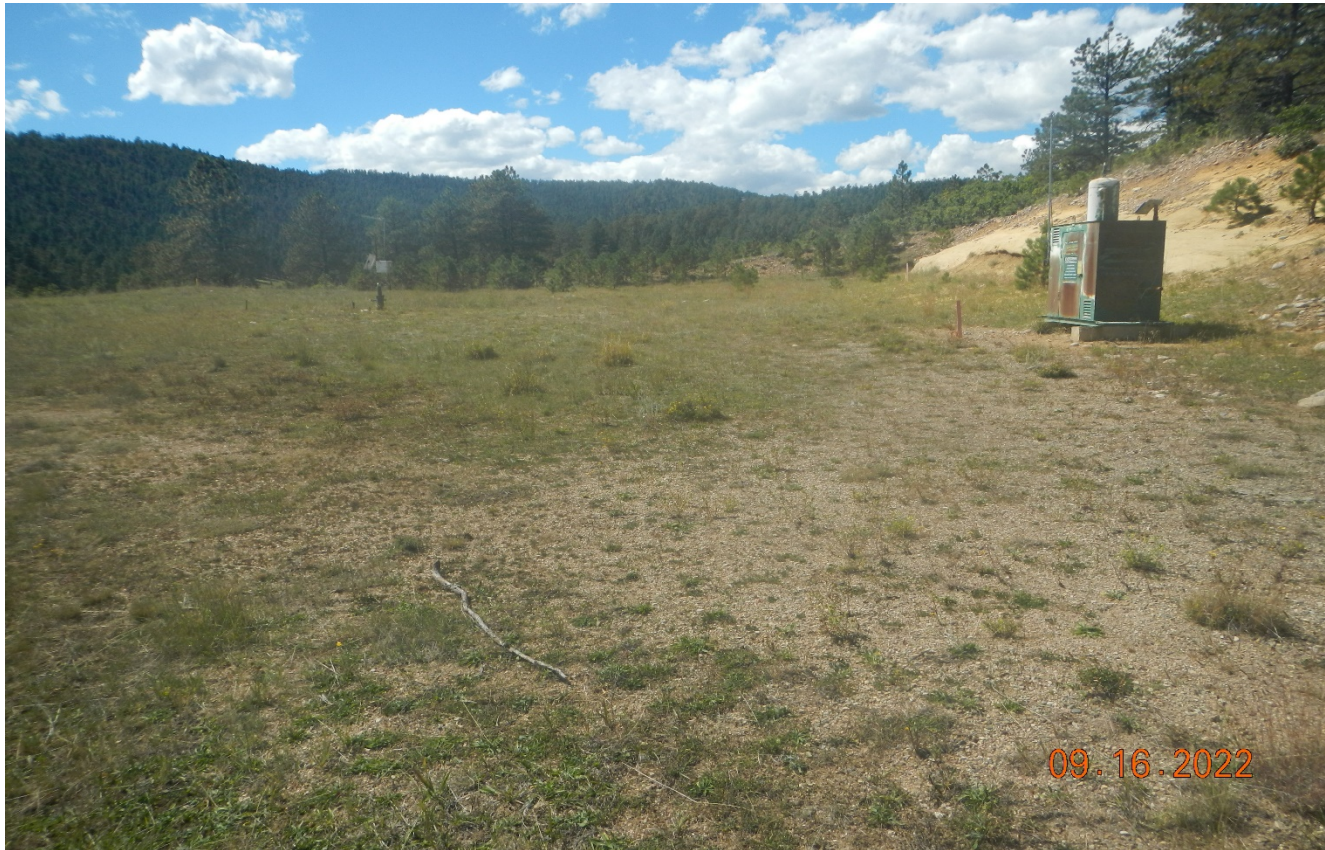
Photo 4. Facing southwest toward the well site.

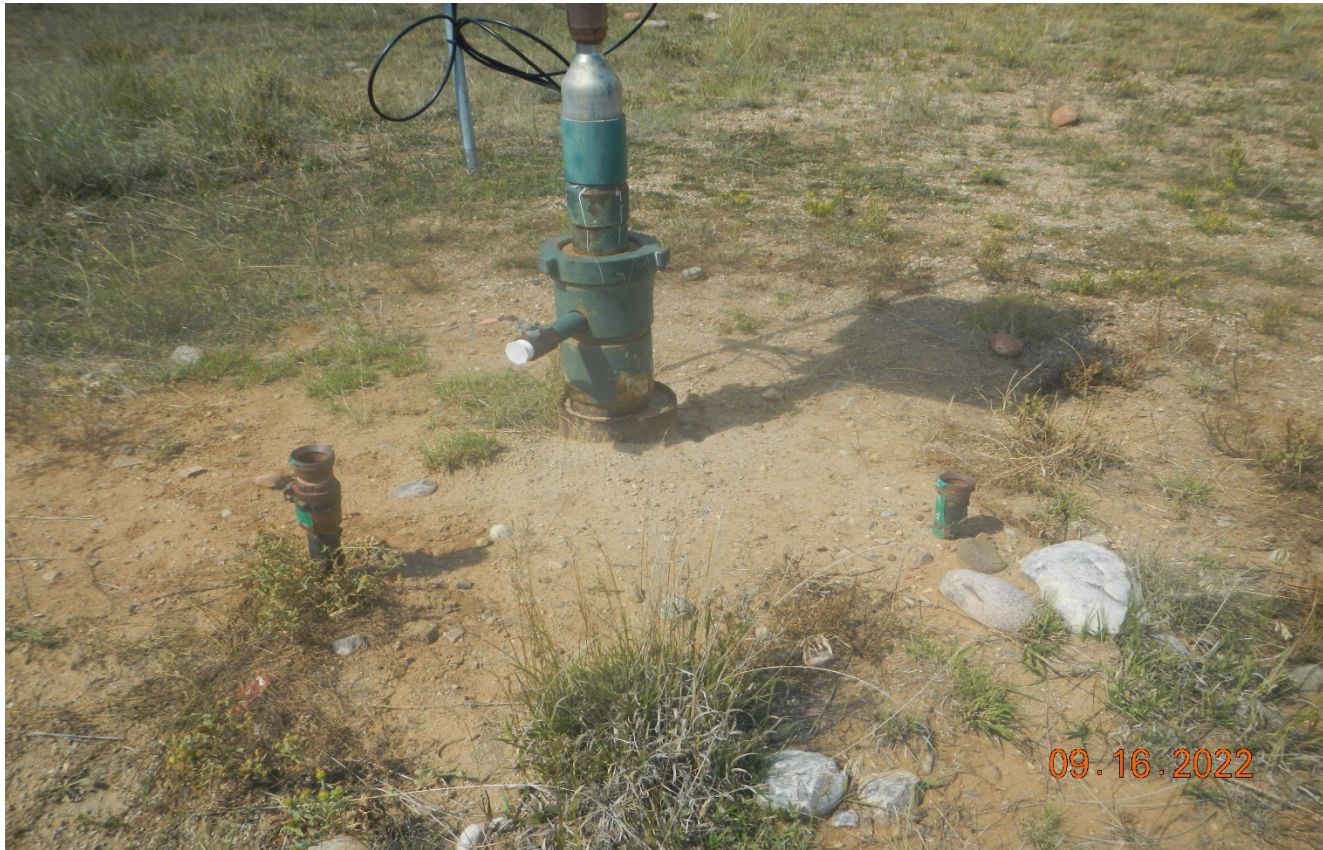
Photo 5. There are 3 pipe risers with no OOSLAT.

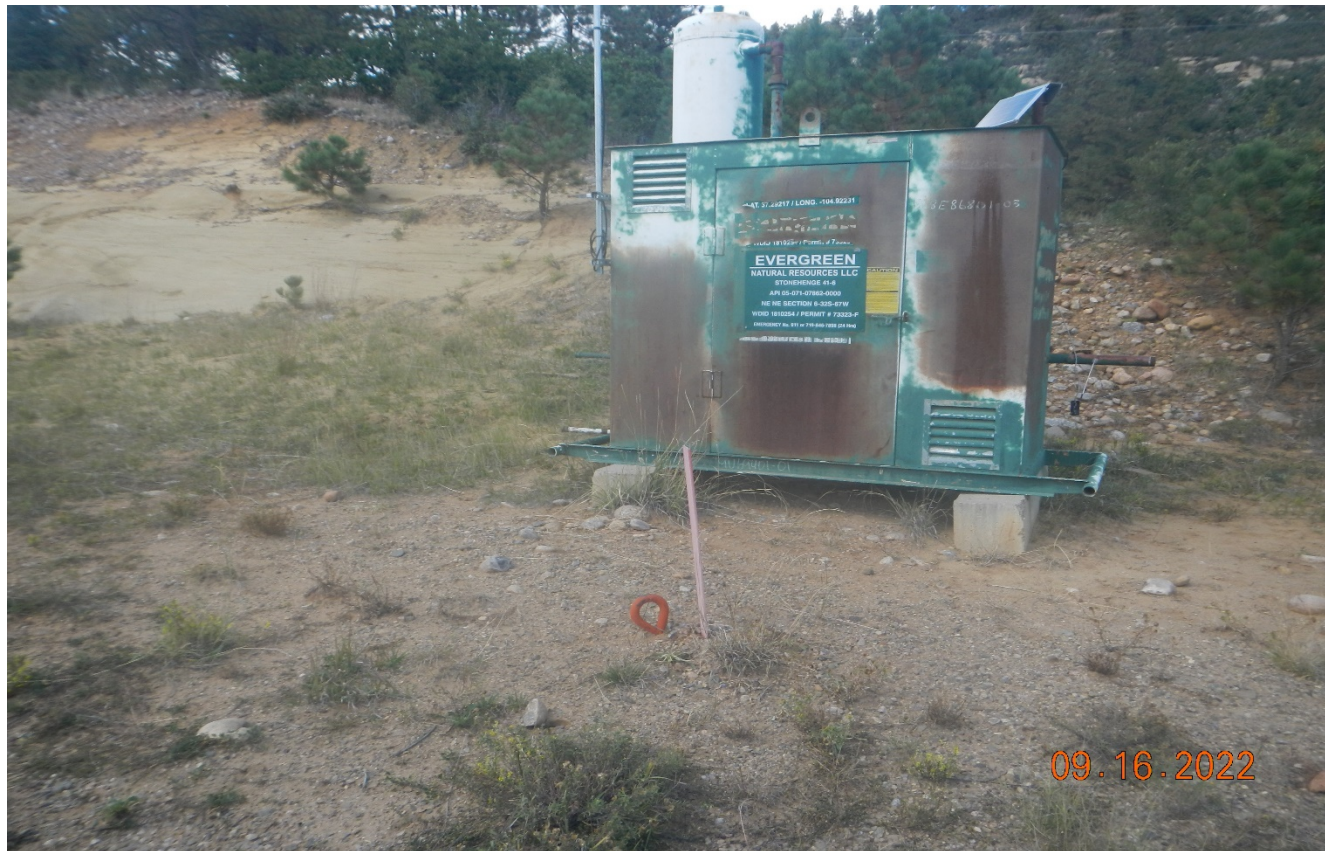
Photo 6. Well sign is posted at the meter shed.
